NASA
Technical Memorandum 106621

Heat Treatment Effects on the Tensile Properties and Microstructures of a SiC/RBSN Composite in Nitrogen

Prepared for the
Eighth Conference on Advanced Structural Fiber Composites
sponsored by International Conferences on Modern Materials & Technologies
Florence, Italy, July 1-4, 1994

HEAT TREATMENT EFFECTS ON THE TENSILE PROPERTIES AND MICROSTRUCTURE OF A SiC/RBSN COMPOSITE IN NITROGEN

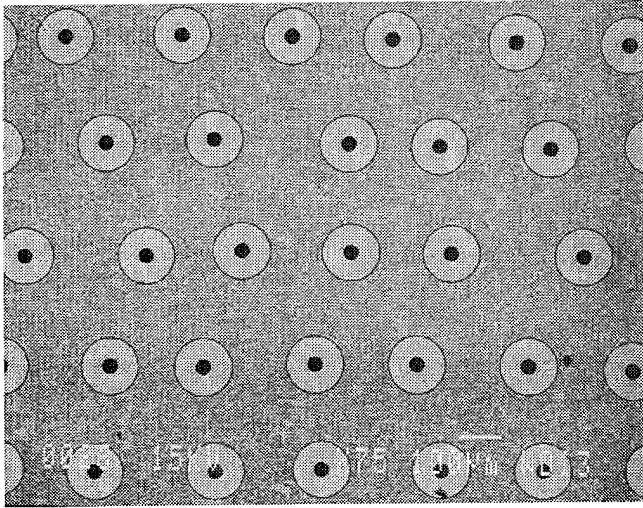
Figure 1.—Cross-section showing microstructure of unidirectional SiC/RBSN composite ($V_f = 24\%$).

A polished cross-section of a typical 24 vol% SiC/RBSN composite specimen is shown in figure 1. The fibers are uniformly distributed in the non-uniform pore size matrix.

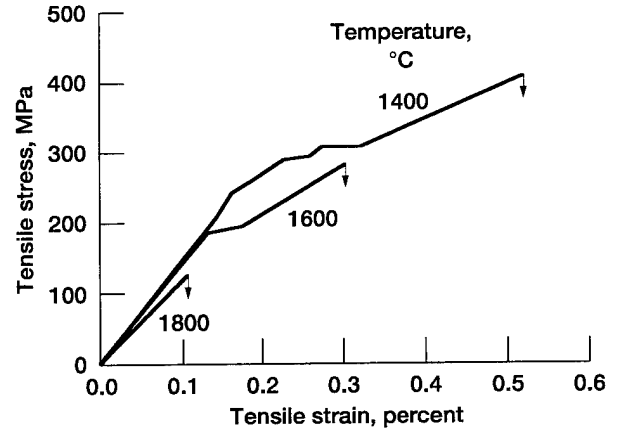
Figure 2.—Room-temperature tensile stress-strain curves of SiC/RBSN composites ($V_f = 24\%$) after 1 hr heat treatment in nitrogen.

The room-temperature tensile stress-strain curves for the 1-D SiC/RBSN composites after 1 hr heat treatment in nitrogen at 1400, 1600, and 1800 $^{\circ}\text{C}$ are shown in figure 2. Since the stress-strain curves of the as-fabricated composite and the composite heat treated in nitrogen for 1 hr at 1400 $^{\circ}\text{C}$ are similar, the stress-strain curve of the as-fabricated composites is not shown in figure 2. The 1400 and 1600 $^{\circ}\text{C}$ curves show three regions: an initial linear elastic region, a non-linear region, and a second linear region. The existence of a non-linear region in the stress-strain curve indicates bridging of matrix cracks by the fibers, and tough composite behavior. The stress-strain curve of the 1800 $^{\circ}\text{C}$ heat treated composite displays an initial linear region and no strain capability beyond matrix fracture. The slope of this line is slightly lower than that of the other two.

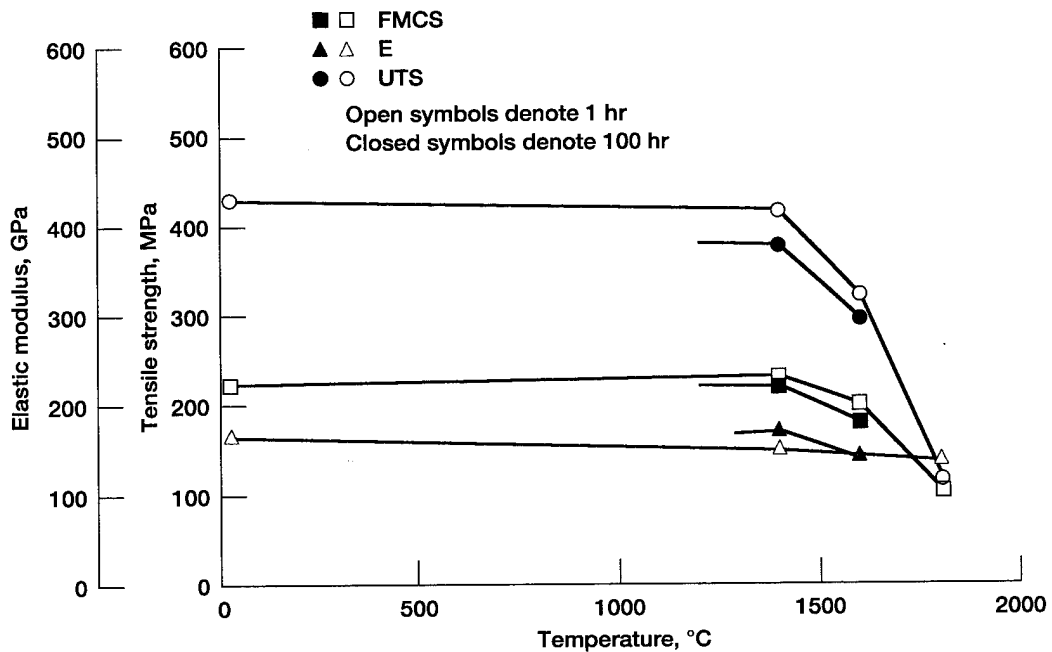
Figure 3.—Effects of heat treatment temperature and time on tensile properties of SiC/RBSN composites.

The effect of 1 and 100 hr heat treatment in nitrogen on primary elastic modulus (E), first matrix cracking stress (FMCS), ultimate tensile strength (UTS) of the composites are illustrated in figure 3. Each data point represents an average of three tests. Since the specimens heat treated at 1800 $^{\circ}\text{C}$ for 100 hr were very weak, their tensile data could not be plotted in figure 3. As seen in the figure, for up to 100 hr of exposure at 1400 $^{\circ}\text{C}$, the composites retained as-fabricated mechanical properties. With increasing temperature of exposure the elastic modulus, the first matrix cracking strength, and the ultimate tensile strength decreased, but the ultimate tensile strength showed greater loss with exposure temperature than did the matrix fracture strength or the elastic modulus.

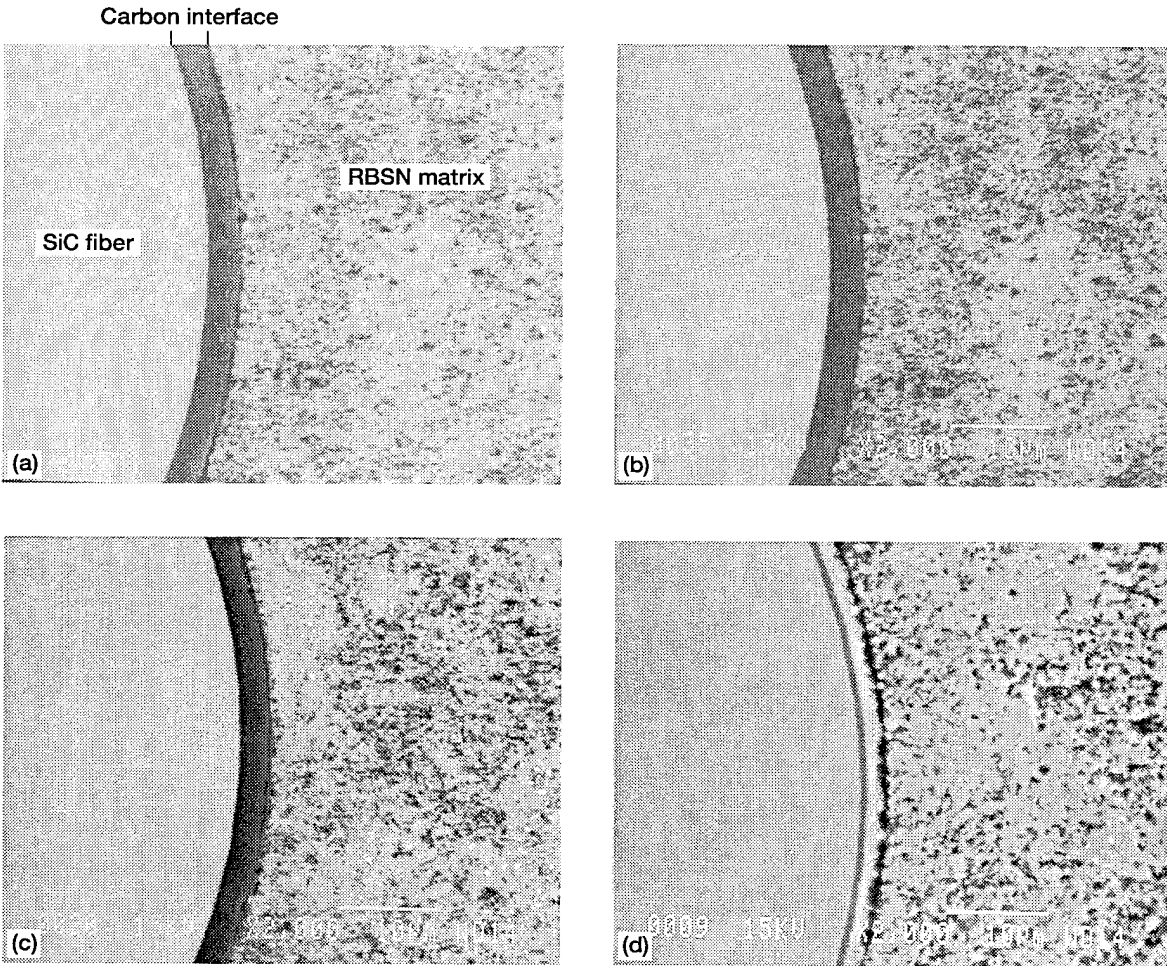
Figure 4.—Influence of one-hr heat treatment in nitrogen on microstructure of SiC/RBSN composite. (a) As-fabricated. (b) 1400 °C. (c) 1600 °C. (d) 1800 °C.

Examination of the cross-sections of the heat treated composites indicates that up to 1600 °C, the RBSN matrix and carbon-rich interface coating remained stable (fig. 4(c)). Beyond this temperature, the carbon-rich interface coating reacted with the RBSN matrix (fig. 4(d)). As a consequence, the thickness of the carbon coating is ~ half that of the as-fabricated composite. In addition, the size of the matrix pores has increased. Limited x-ray measurements performed on composites heat treated at 1800 °C showed increasing amounts of silicon in the RBSN matrix with increasing exposure time. Increasing amounts of silicon in the RBSN matrix indicates dissociation of silicon nitride to silicon and nitrogen. In fact, it is known that silicon nitride dissociates at ~ 1800 °C in 0.1 MPa nitrogen (ref. 11). Composites heat treated for 1 hr at and beyond 1600 °C also showed fiber degradation. A diffusion zone started emanating from the outer surface of the SiC fiber adjacent to the carbon-rich surface coating. The thickness of this zone increased with increasing temperature of exposure or with increasing time of exposure at a given temperature. A photomicrograph of the cross section of the composite heat treated at 1800 °C for 1 hr showing the growth of the zone is shown in figure 5. The growth of the diffusion zone at the interface of the carbon coating and the SiC sheath is similar to that observed in the individual SiC fibers heat treated beyond 1500 °C for 1 hr in an argon environment (ref. 12), but the thickness of the zone in the composite is smaller than that in the individual fibers. It has been shown by TEM analysis of heat treated SiC fibers that the diffusion zone consists of equiaxed recrystallized SiC grains (ref. 12). This study showed that strength degradation in this fiber is due to recrystallization and growth of SiC grains and that a relationship exists between the strength of the heat treated fibers and the thickness of the recrystallization zone.

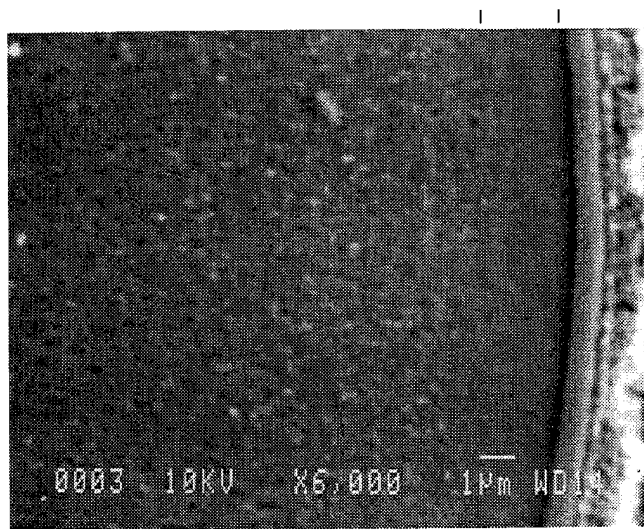
Recrystallization zone

Figure 5.—Photomicrograph of cross-section of SiC/RBSN composite heat treated at 1800 °C for 1 hr showing growth of diffuse zone at interface of carbon coating and SiC sheath of SiC fiber.
