NASA CR-134712
PWA™-5022

IMPACT RESISTANCE OF HYBRID COMPOSITE FAN BLADE MATERIALS

Pratt & Whitney Aircraft
Division of United Aircraft Corporation

Contract NAS3-17789

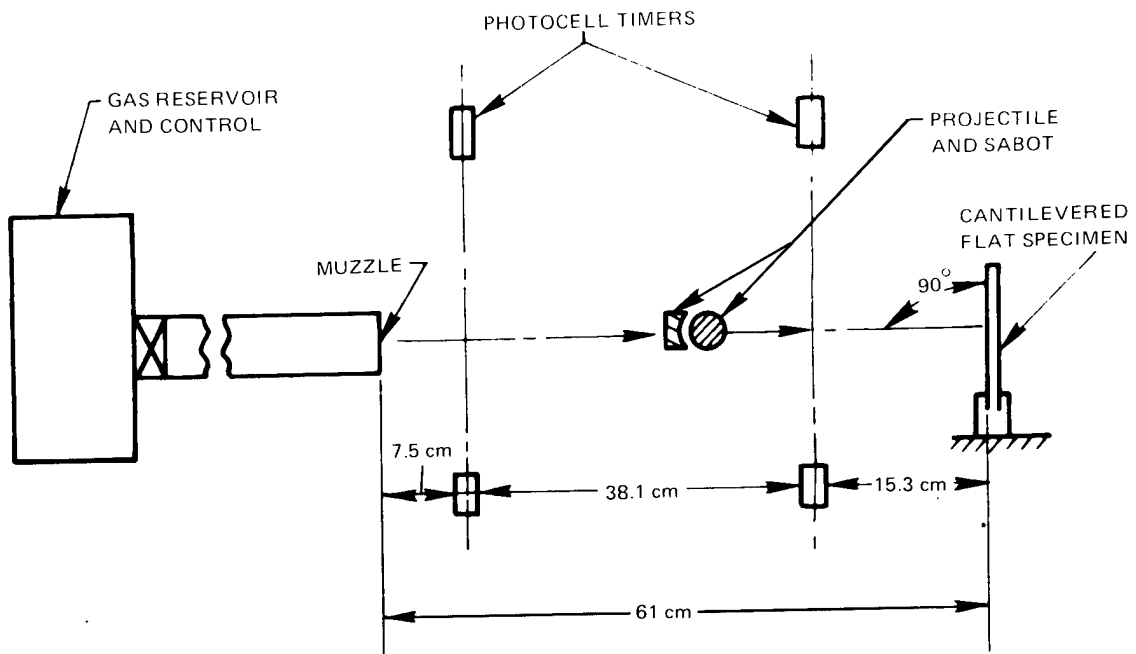
Figure 1 Schematic of Ballistic Impact Test for Flat Panels

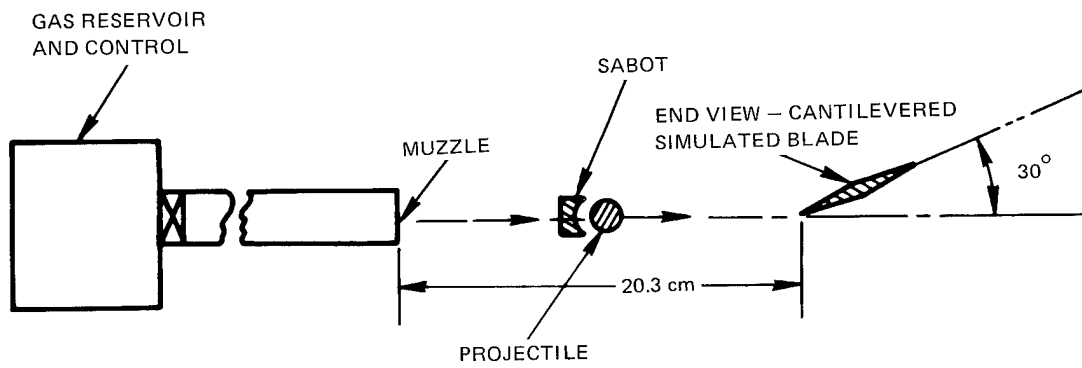
Figure 13 Schematic of Ballistic Test for Blade Specimens

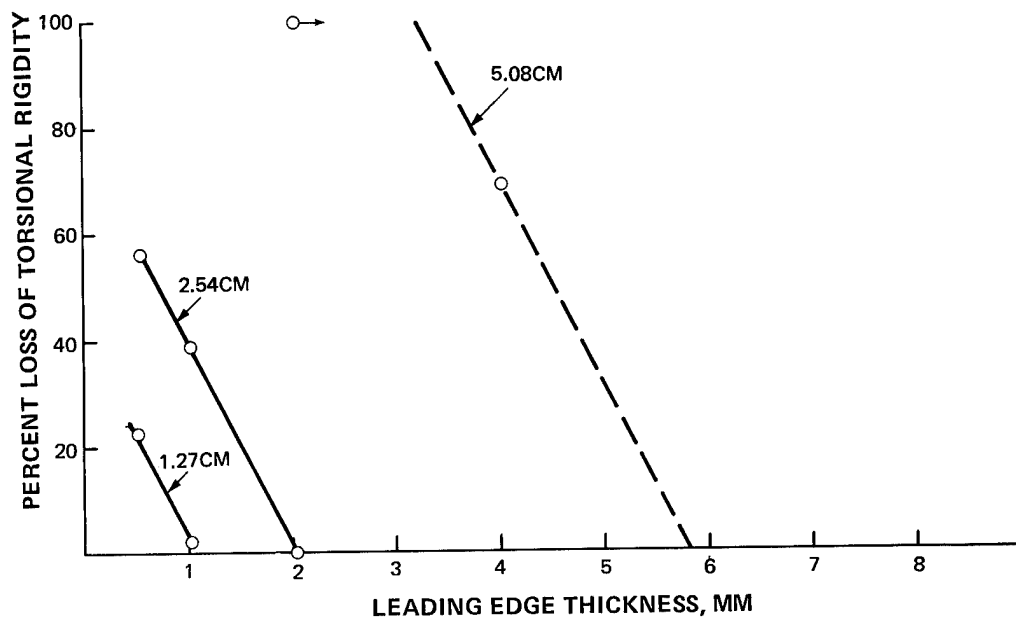
Figure 22 Blade Damage vs. Blade Thickness for Gelatin Projectile Impacts at 275 m/sec on S-Glass + Graphite/Epoxy Blades

The results of the torsional testing are shown in Figure 22. The testing of three different thicknesses of blade specimen with 2.54 cm diameter gelatin projectiles resulted in an excellent correlation with loss of torsional stiffness. The test results from the 1.27 cm diameter gelatin projectile impacts plotted parallel to the 2.54 cm diameter plot (Figure 22). These test results provided a degree of confidence in the use of the loss of torsional rigidity as a quantitative measure of ballistic damage. The damage caused by 5.08 cm diameter gelatin projectiles (at a slightly lower velocity) is represented by two data points. Since one of the points is representative of the total loss of specimen rigidity, the relationship between the loss of torsion rigidity and specimen thickness was approximated by drawing a line parallel to the 1.27 cm and 2.54 cm diameter projectile lines through the data point where less than total destruction of the specimen occurred.

Extrapolating the plots of loss of torsional rigidity vs. blade thickness (Figure 22) zero loss of torsional rigidity results in a blade leading edge thickness of 0.11 cm to withstand a 1.27 cm diameter gelatin projectile impact; of 0.20 cm to withstand a 2.54 cm diameter gelatin projectile impact; and of 0.58 cm to withstand a 5.08 cm gelatin projectile impact under the given test condition. The first two points were well supported by the test data while the blade thickness to resist the 5.08 cm diameter gelatin projectile impact is based on a single data point.

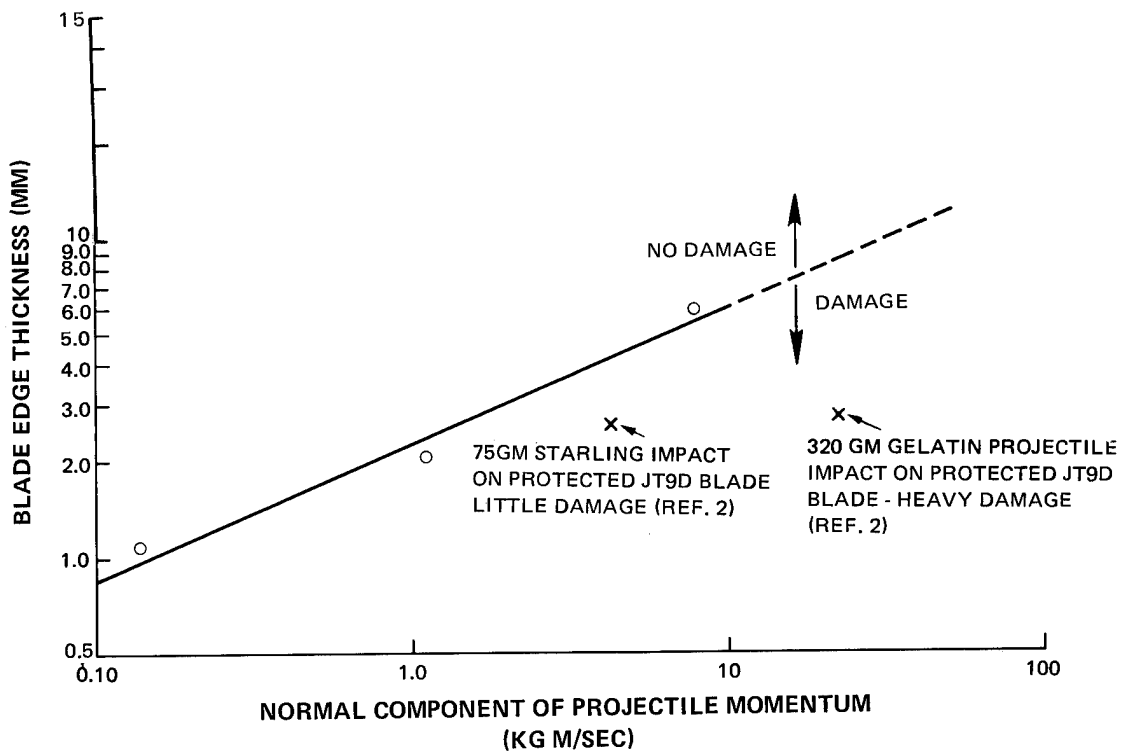
Figure 23 Hybrid Blade Thickness Required to Prevent Impact Damage as a Function of Normal Component of Foreign Object Momentum

Two points are plotted in Figure 23 from the testing of JT9D fan blades (Reference 2). The point shown for the stalling impact which caused very little blade damage lies close to the "no damage" zone of the plot while the second point representing impact by a 8.4 cm gelatin projectile which caused severe blade damage lies well in the "damage" zone of the plot.

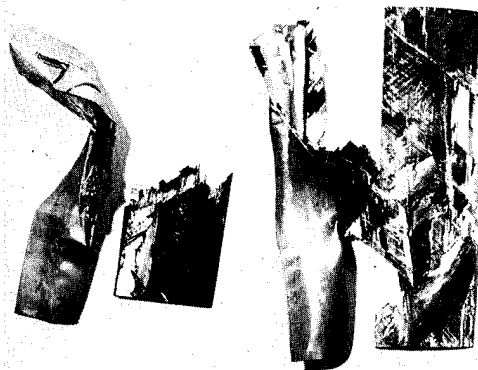
1.27 CM GELATIN
PROJECTILE

2.54 CM GELATIN
PROJECTILE

5.08 CM GELATIN
PROJECTILE

Visual examination of the impact tested specimens (Figure 25) indicated that for the 1.27 cm and 2.54 cm diameter gelatin projectile impacts, the leading edge protection afforded protection to both the all-graphite and the hybrid composite blade specimens. The extent of damage was comparable to that incurred by the titanium alloy blade specimen. The metal leading edge remained completely bonded to the composite material in all cases.

Impacting with the 5.08 cm (66 gm) gelatin projectile resulted in severe damage to all specimens including the titanium alloy blade specimen. The leading edge shields became separated from the composite specimen. The hybrid composite specimen exhibited less damage than the all-graphite specimen indicating some improvement in impact performance through the incorporation of the fiberglass material.
