**NASA CR-2549**

**DESIGN AND FABRICATION  
OF COMPOSITE WING PANELS  
CONTAINING A PRODUCTION SPLICE**

*Prepared by*  
**GENERAL DYNAMICS**  
Fort Worth, Texas  
*for Langley Research Center*

**NATIONAL AERONAUTICS AND SPACE ADMINISTRATION • WASHINGTON, D. C. • AUGUST 1975**

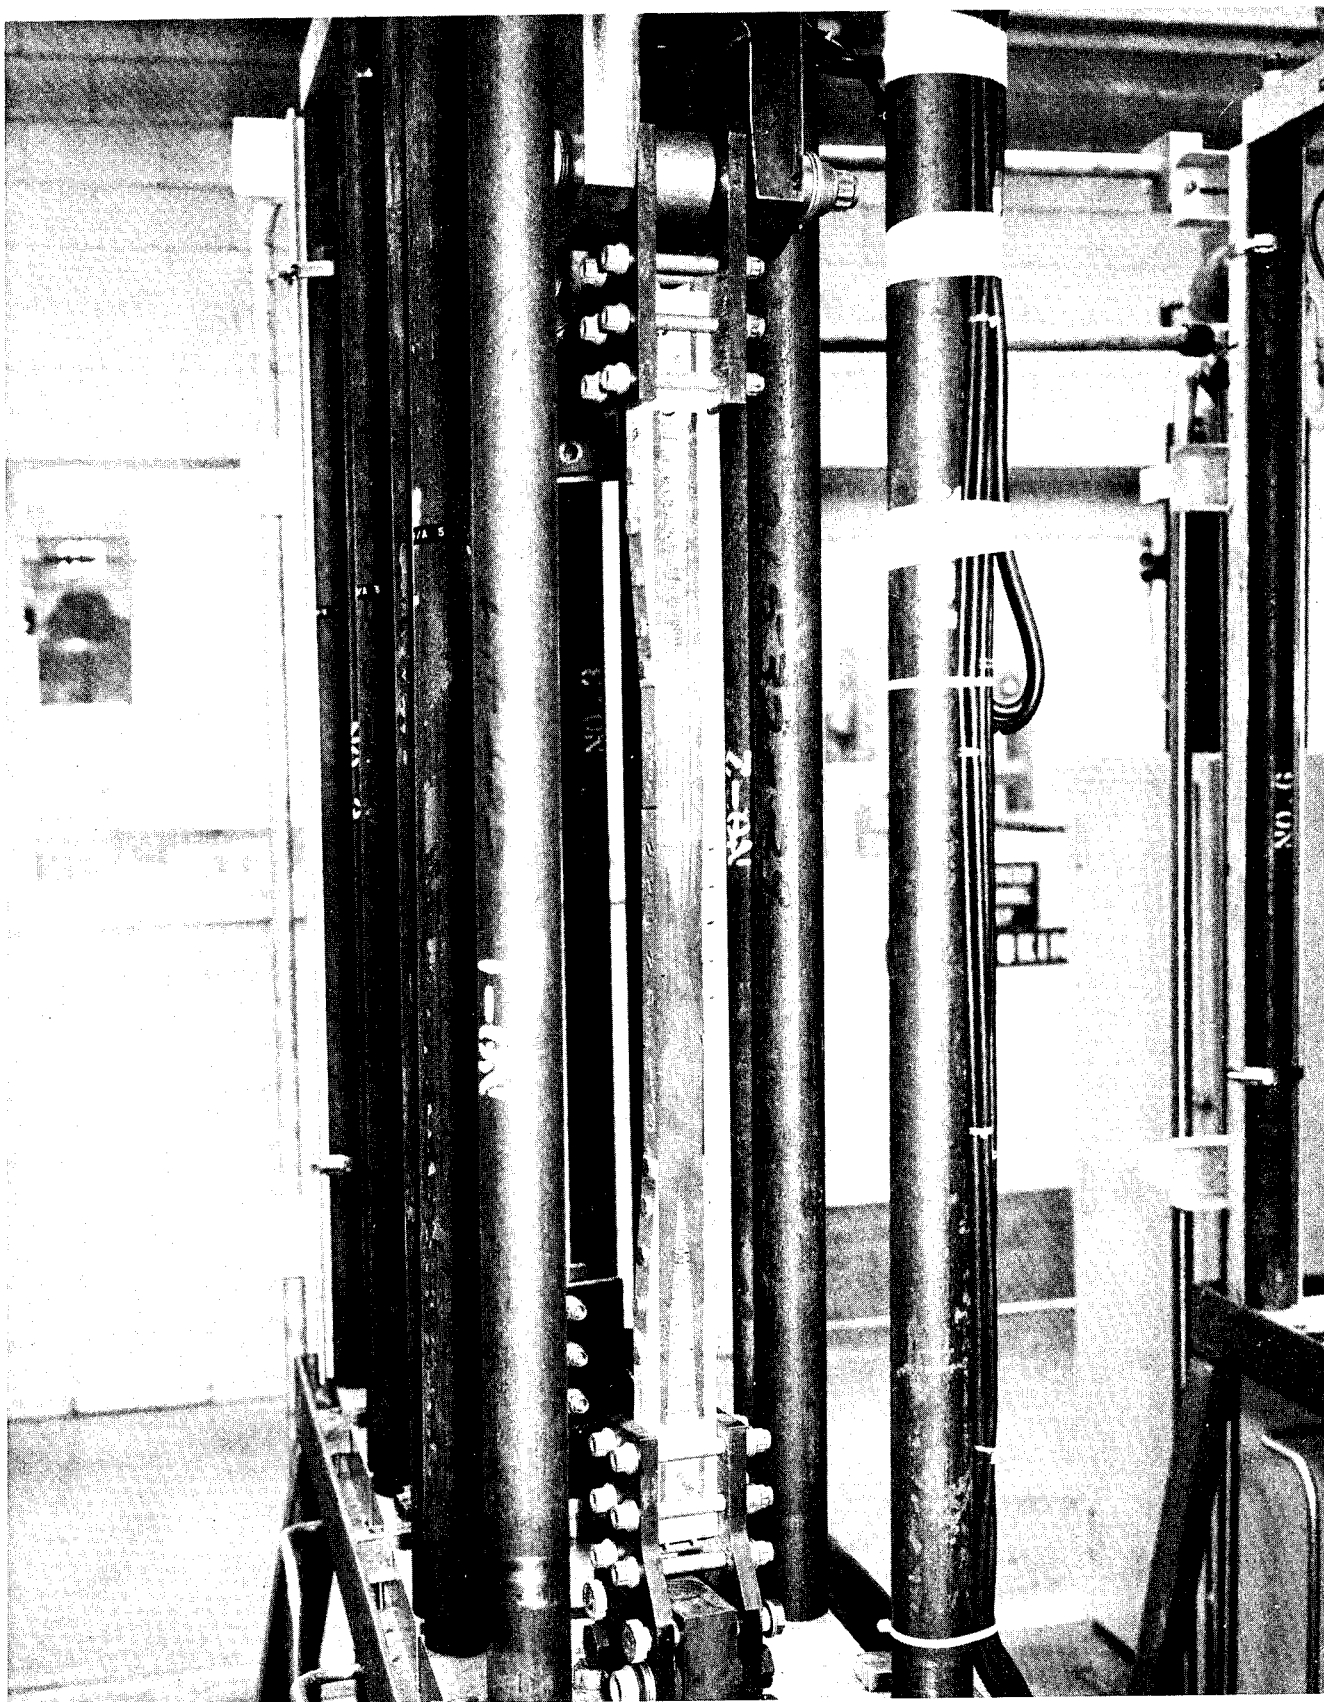
Figure 14 Test Fixture

Five test fixtures were fabricated for the static and fatigue tests of the splice test specimens. Figure 14 shows one of the compression test specimens installed in one of the loading fixtures. Each of the test fixtures was controlled with separate load control systems from a single computer

generated signal. The loads were introduced through bolted, serrated steel plates at each end of the specimen. The specimen was attached to the load cell by a steel clevis to minimize loads caused by misalignment. This load cell provides the feedback signal to close the testing loop. Aluminum side plates were used to stabilize the compression specimens during testing. These were not required for the tension specimens even though compression loads occurred during the GAG cycles.

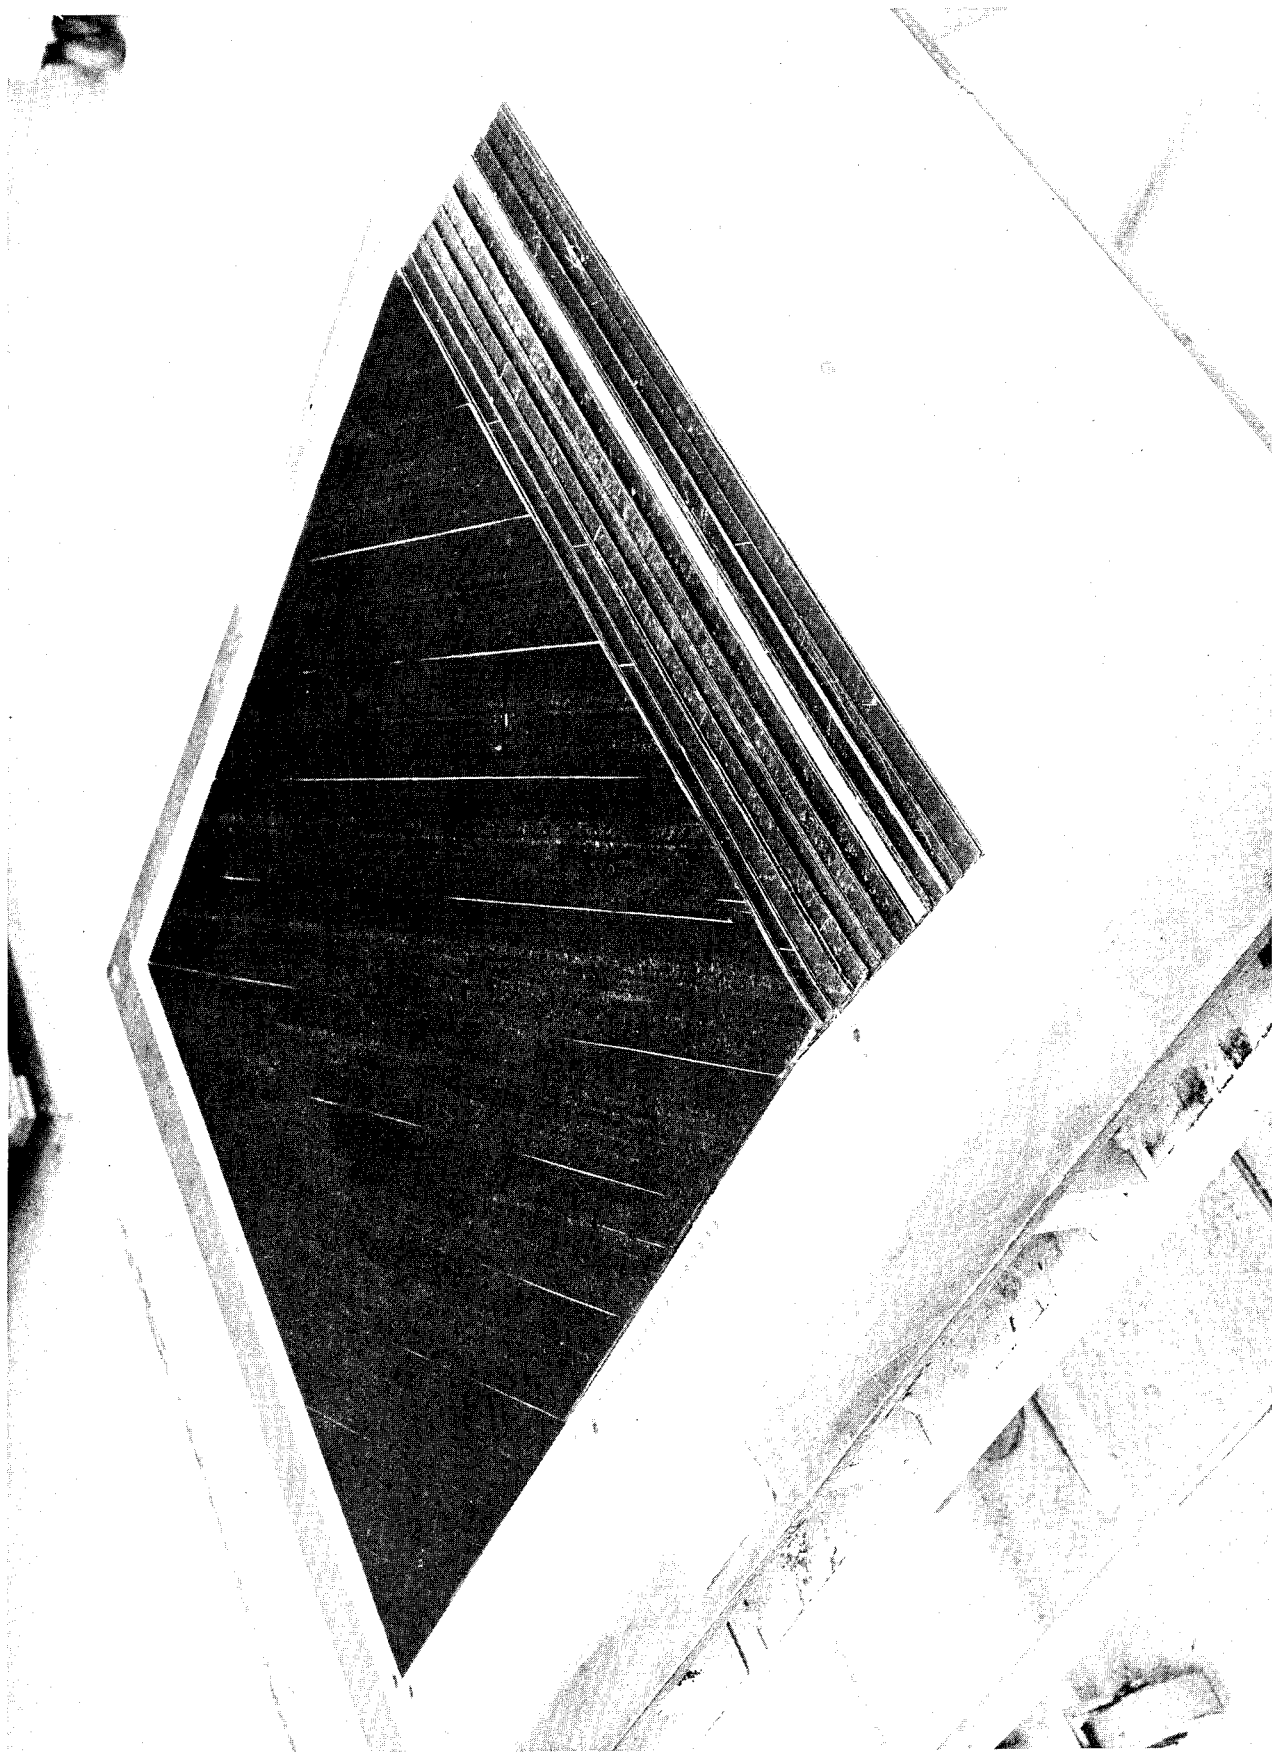
Figure 36 Completed Layup Before Cure

not completely eliminate the depression. Figure 36 shows a completed assembly before curing. After curing, pre-cured fiberglass end tabs were bonded to both sides of the panel in the grip area and the panel was cut into specimen and panel widths. Figure 37 shows a 30.48 cm (12.0 inch) wide panel and 10, 2.54 cm (1.0 inch) wide specimens that were cut from one of the wide panels. Next, the sides of the specimens, the scarf surfaces, and the fiberglass end tabs were machined. The specimen halves were then clamped together, the holes were drilled and countersunk, and the bolts were installed. Figure 38 shows a completed tension and compression joint specimen.
