NASA TN D-2741

# PRELIMINARY INVESTIGATION OF FILAMENT-WOUND GLASS-REINFORCED PLASTICS AND LINERS FOR CRYOGENIC PRESSURE VESSELS

*by Morgan P. Hanson, Hadley T. Richards,  
and Robert O. Hickel*

*Lewis Research Center  
Cleveland, Ohio*

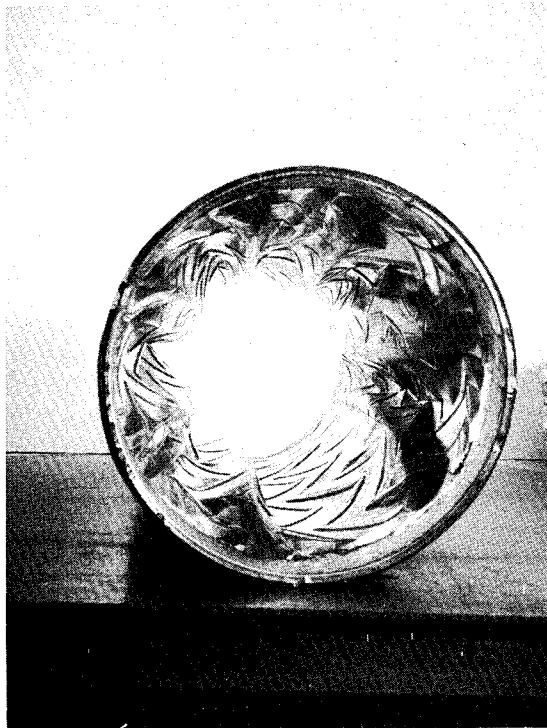
(a) Single spiral (5 cycles).

(b) Double spiral (1 cycle).

(c) Zig-zag (5 cycles).

(d) Sinusoidal (18 cycles).

The results of cyclically straining and extending the various liner configurations under pressure loads that resulted in a strain of  $2\frac{1}{2}$  percent in the test cylinders is given in table II. The liner with single spiral convolutions (fig. 11(a)) was investigated first and was found to have a life of 5 cycles; although this was an improvement over that of the plain aluminum liner, it was not as good as that for the plain stainless-steel liner. A photograph of the failed spiral liner is shown in figure 12(a). A number of buckled regions at approximate right angles to the spiral convolutions are visible in addition to some randomly buckled regions. The failures in the liner appeared to originate in the ridges of the convolutions where strain components that were essentially parallel to the ridges apparently caused the aluminum foil to exceed its elastic limit. After several cycles, some of these regions where plastic flow had occurred apparently began to pinhole and then develop into a small tear causing the liner to leak excessively.

It was thought that perhaps a liner that was essentially a double spiral with the second group of spirals being at right angles to the first set might offer some improvement in cyclic life; this type of pattern results in the waffle configuration shown in figure 11(b). As shown in table II, this configuration operated successfully for only 1 cycle. Its mode of failure (shown in fig. 12(b)) was similar to that of the spiral convolution configuration in that the failures within the liner appeared to originate in regions where excessive plastic strain occurred in the ridges of the convolutions.

With this sinusoidal configuration, a maximum of 18 cycles were completed before failure occurred. This liner was formed within a previous sinusoidal liner that had failed because of excessive stretching of the aluminum foil over the backup wires during pressurization. The first liner created a fillet at the juncture of the wires and the FRP tank inner wall and allowed the second liner to form without exceeding the maximum elongation capability of the aluminum foil. A cross section of this configuration is shown in figure 11(d). Figure 12(d) shows the liner at the completion of the test. Actually the failure of this liner was in the seam region and in several places where the liner was forced into a severely sharp radius at the junction of the backup wire with the wall of the reinforced plastic tank. It appears that the elimination of essentially straight and long ridges and sharp corners in the ridges improves the cyclic life of the liner.
