**USAAMRDL TECHNICAL REPORT 72-47**

**EXPENDABLE MAIN ROTOR BLADE STUDY**

CONTRACT DAAJ02-71-C-0046  
SIKORSKY AIRCRAFT  
DIVISION OF UNITED AIRCRAFT CORPORATION  
STRATFORD, CONNECTICUT

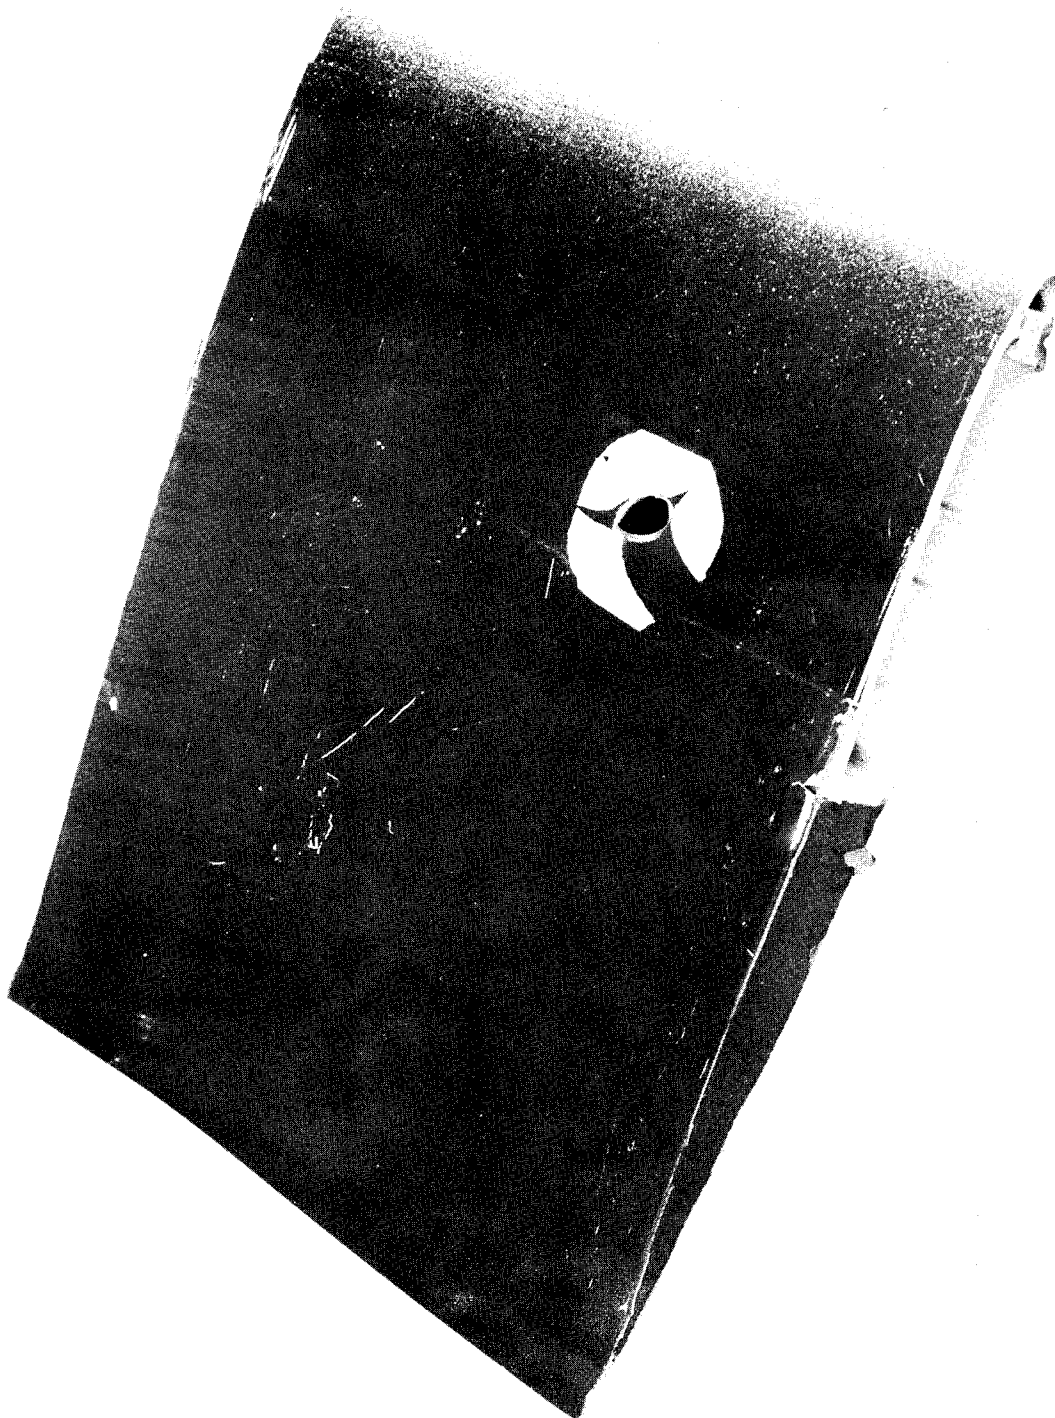
Figure 46. .50-Caliber Hit Sikorsky Main Blade.

Ballistic damage to the blade spars in all the design concepts is considered survivable. Service experience with aluminum spar blades has shown that up to .50-caliber bullet holes in various locations on the spar are survivable. Figures 46 and 47 are photos of actual in-flight ballistic damage sustained by Sikorsky main blades. The blade in Figure 46 was actually flown on a subsequent mission after the .50-caliber hole was "repaired" with aluminum foil tape. Although no service experience is available on composite blade spars, we expect that the composite blades will be even more damage tolerant than the present metal ones. The very large amount of reserve strength present in the twin beam composite spar, as shown in the analysis of both the damaged and undamaged rotor blades, makes this very probable.

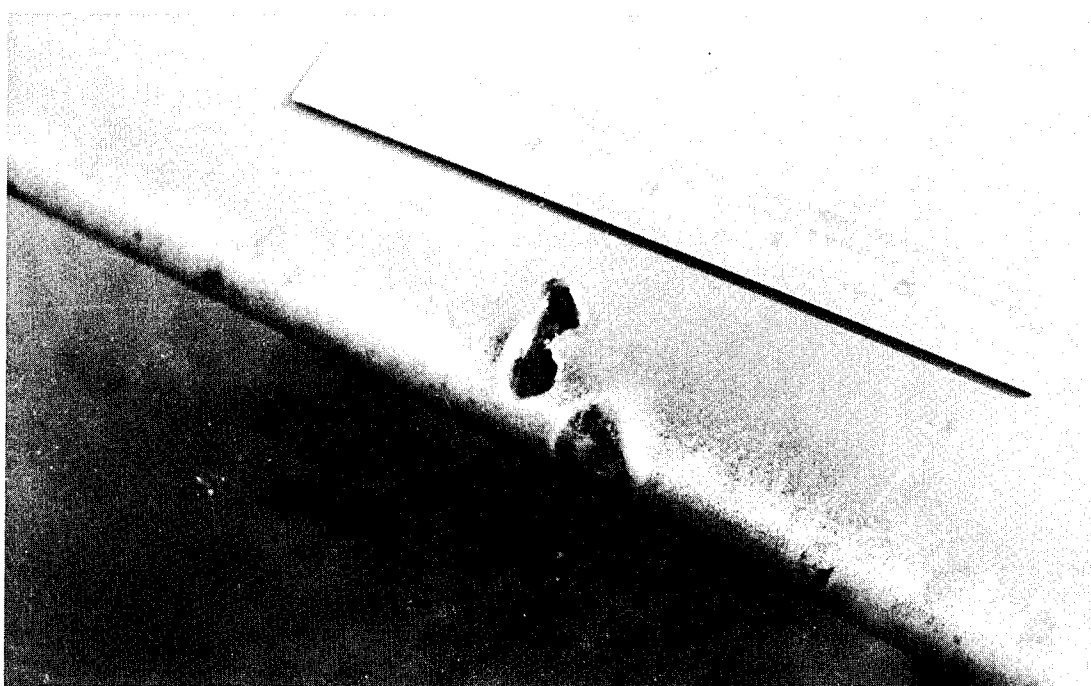
Figure 51. Blade Dent Damage.

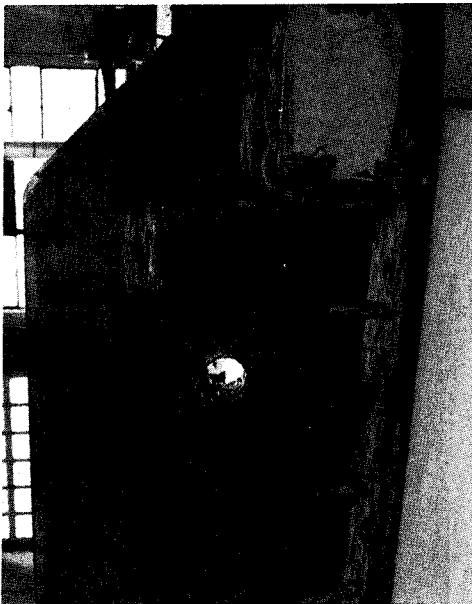
Figure 73. Damaged Blade.

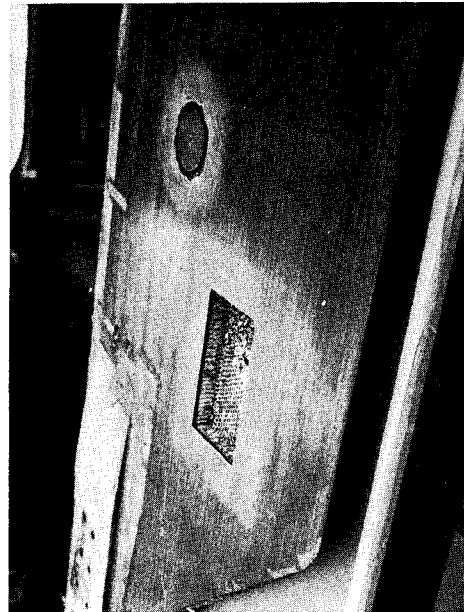
Figure 76. Plug in Place.

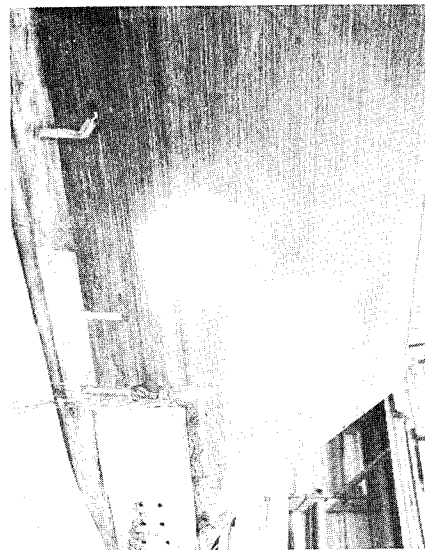
Figure 84. Finished Repair.
