**NO FURTHER ACTION UNDER  
COMPREHENSIVE ENVIRONMENTAL  
RESPONSE, COMPENSATION,  
AND LIABILITY ACT  
STUDY AREA P19  
CLEARING, TRACKED ROAD**

**FINAL DOCUMENT**

1. AGENCY USE ONLY (Leave blank)		2. REPORT DATE 4/12/95	3. REPORT TYPE AND DATES COVERED Final No Further Action Decision Document	
4. TITLE AND SUBTITLE No Further Action Decision Document for Study Area P19, Clearing, Tracked Road, Fort Devens Sudbury Training Annex			5. FUNDING NUMBERS  C

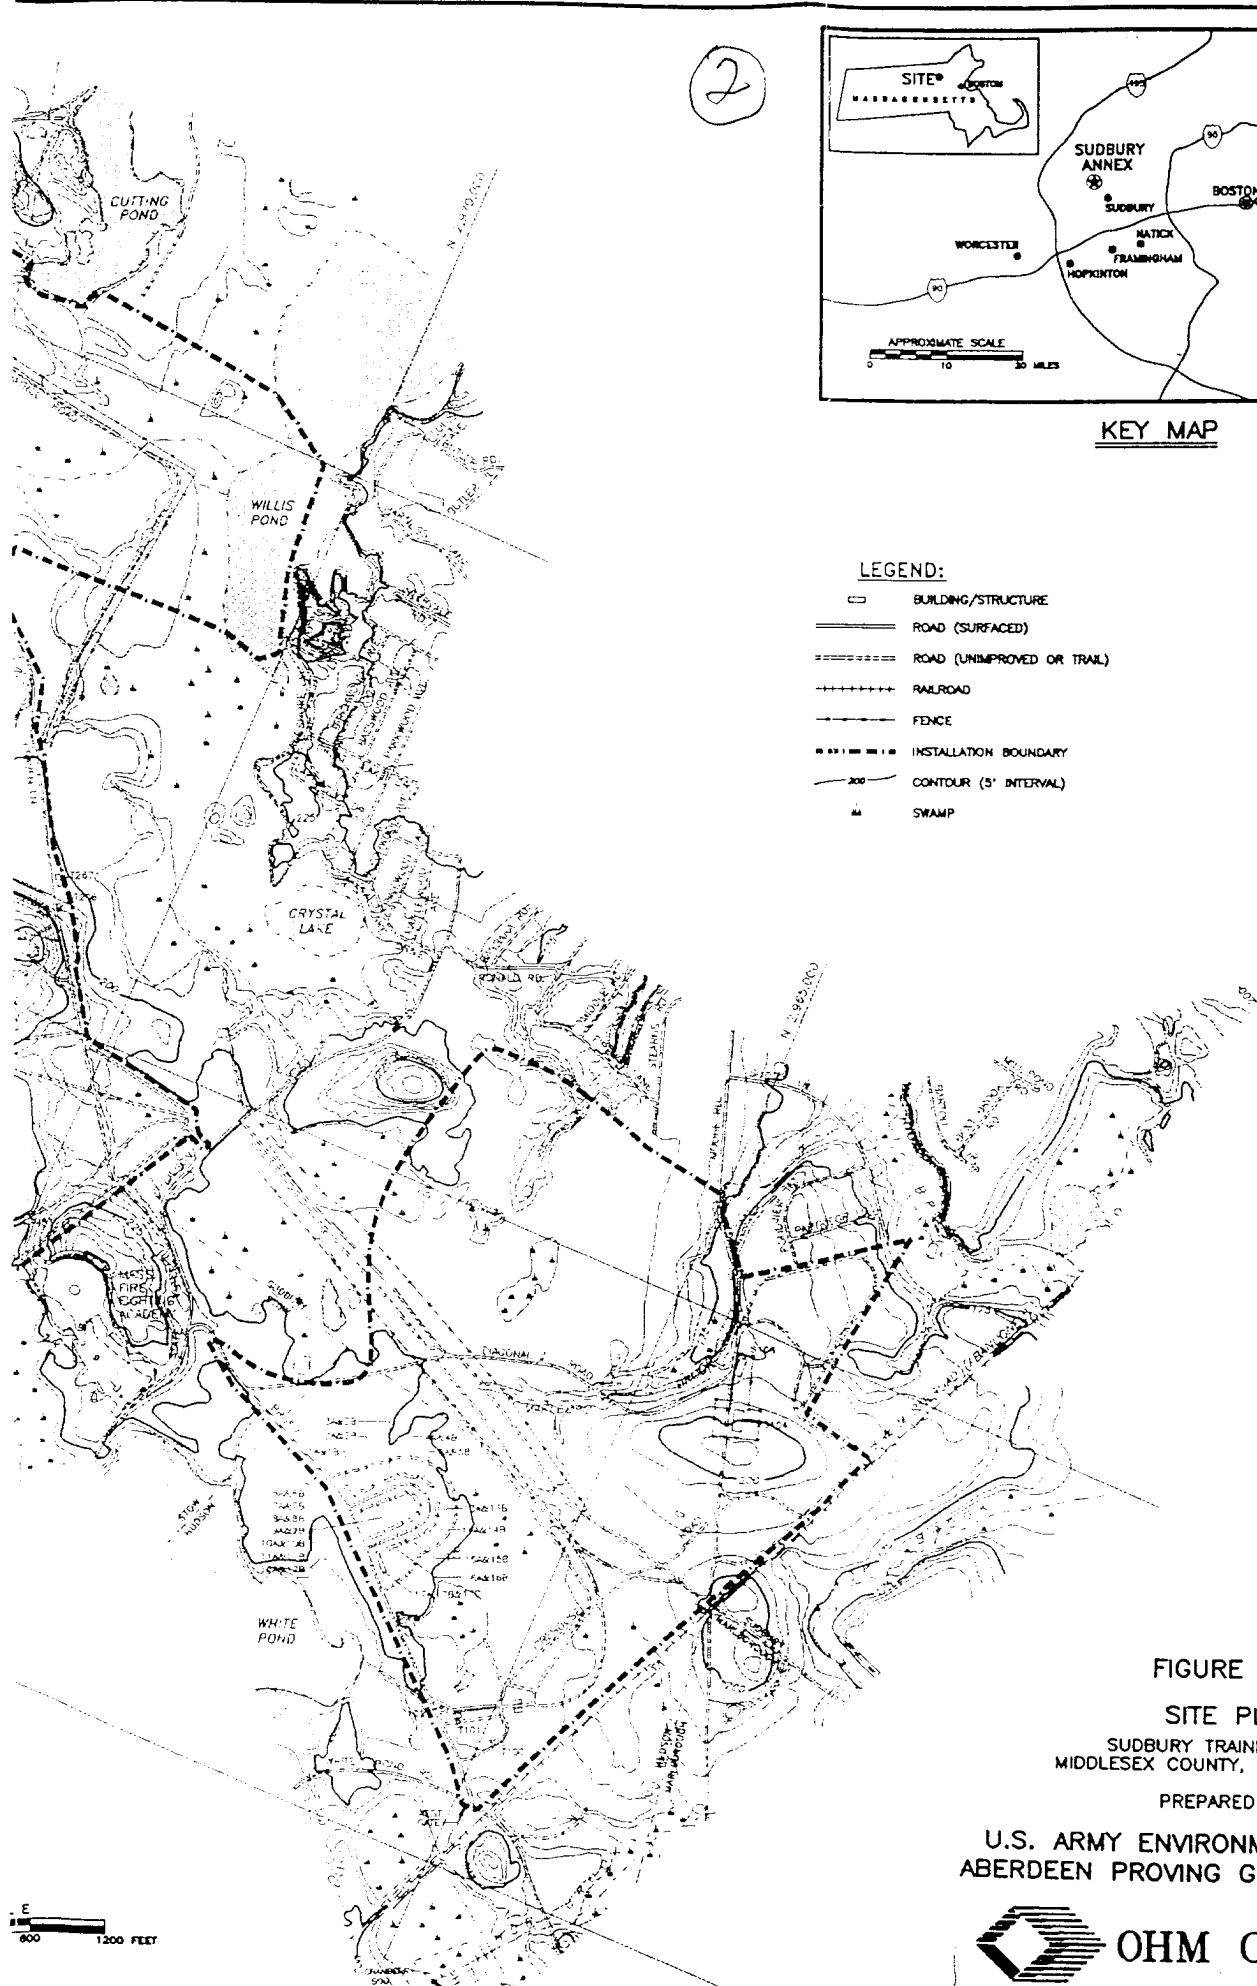
FIGURE 2-1  
 SITE PLAN  
 SUDBURY TRAINING ANNEX  
 MIDDLESEX COUNTY, MASSACHUSETTS

The Sudbury Training Annex is located 20 miles west of Boston, 12 miles northwest of Natick, Massachusetts and 2 miles northwest of the town of Sudbury in Middlesex County, Massachusetts. The installation is located in the Maynard, Massachusetts 7½-minute United States Geological Survey (USGS) quadrangle map. Figure 2-1 presents the site map.

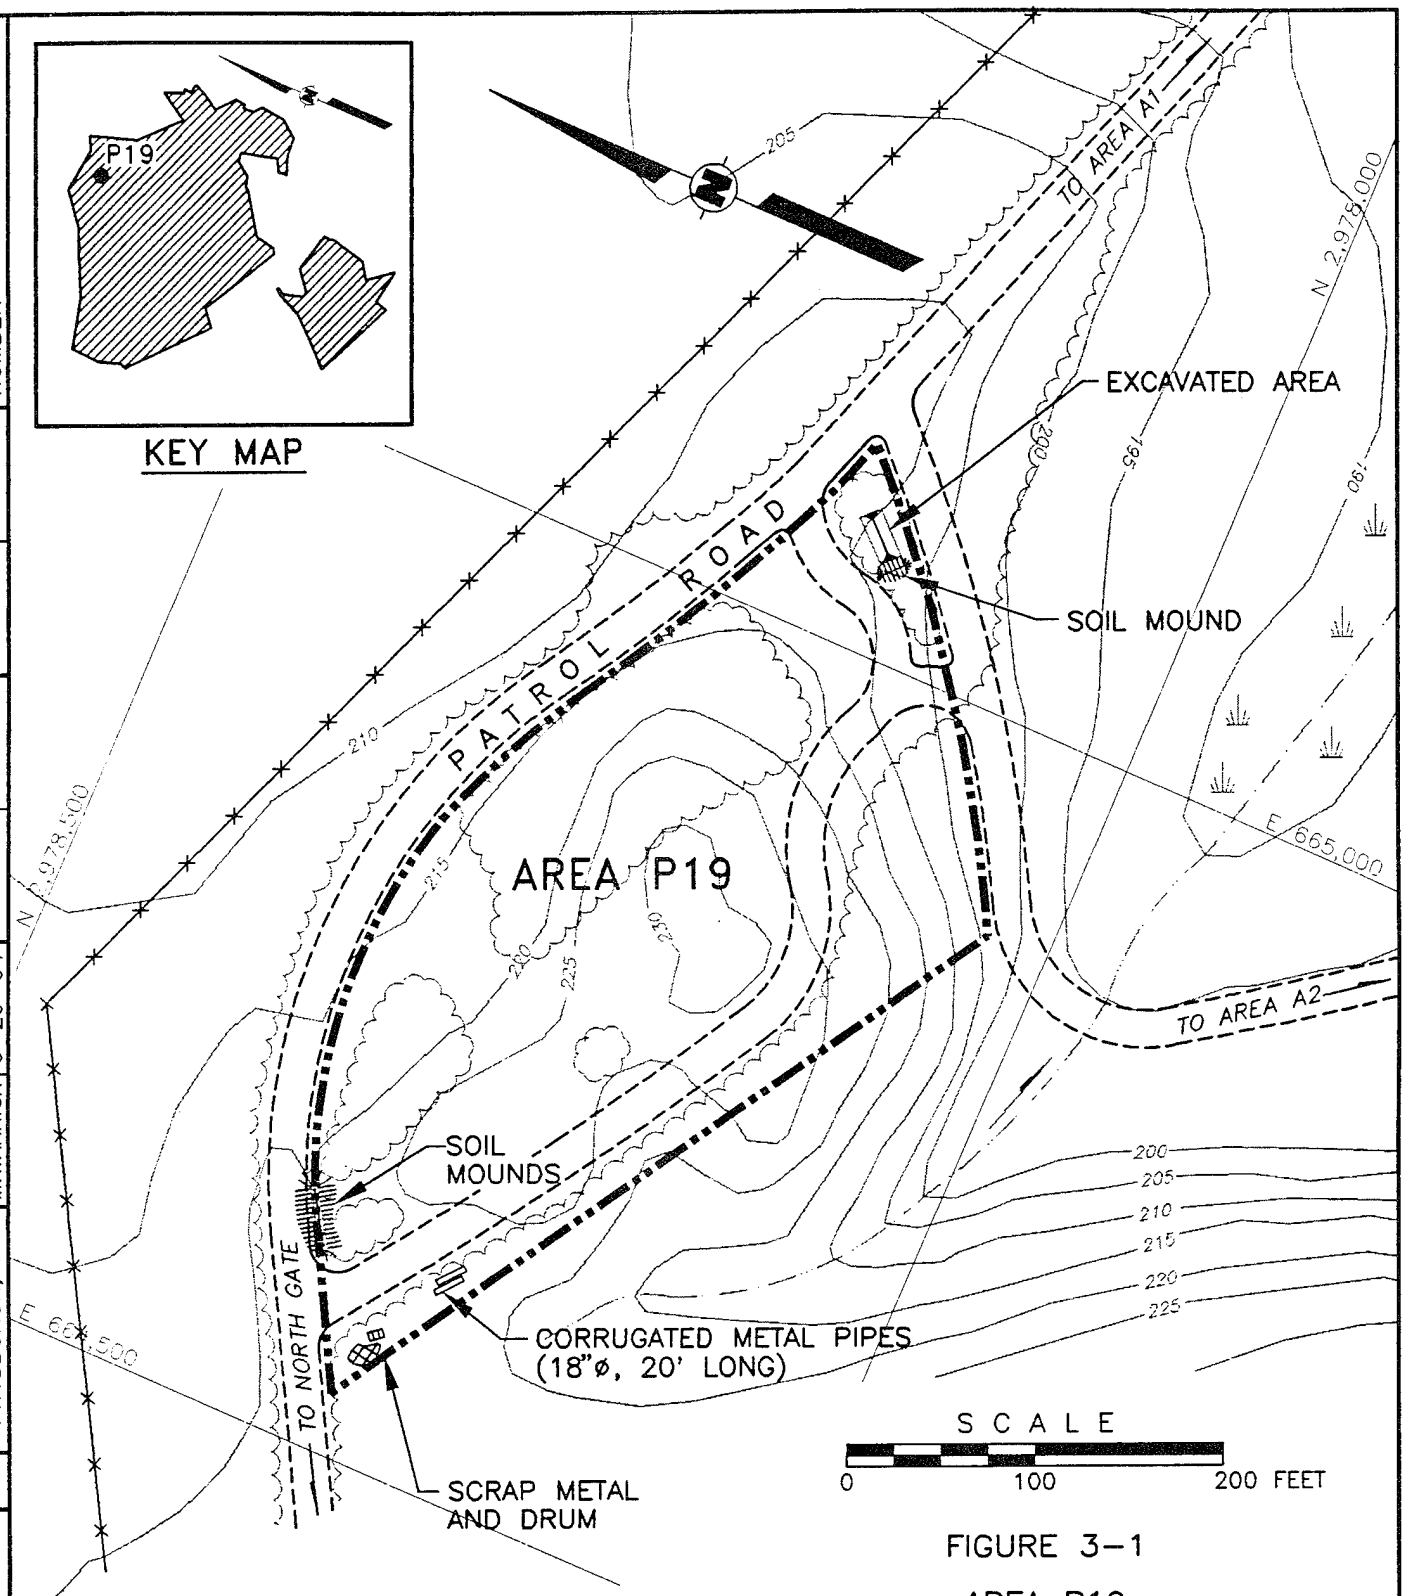
FIGURE 3-1  
 AREA P19  
 SITE MAP  
 SUDBURY TRAINING ANNEX  
 MIDDLESEX COUNTY, MASSACHUSETTS

Area P19 is located near the northern border of the installation on the south side of Patrol Road. The area is 500 feet north of Area A2 and 1,500 feet northeast of the North Gate. Figure 3-1 presents a map of the area. The surficial geology of this area has been classified as ground moraine (Hansen,1956). The area is a wide clearing situated on a small hill. The clearing is visible on aerial photographs.

Several small mounds, trenches, and pits were noted in the area which were believed to be the remains of fighting positions left by military training units. Record searches do not indicate disposal activities in this area.
