**FATIGUE RESPONSE OF CRACKED ALUMINUM
PANEL WITH PARTIALLY BONDED
COMPOSITE PATCH**

THESIS

Jason J. Denney, Captain, USAF

AFIT/GAE/ENY/95D-7

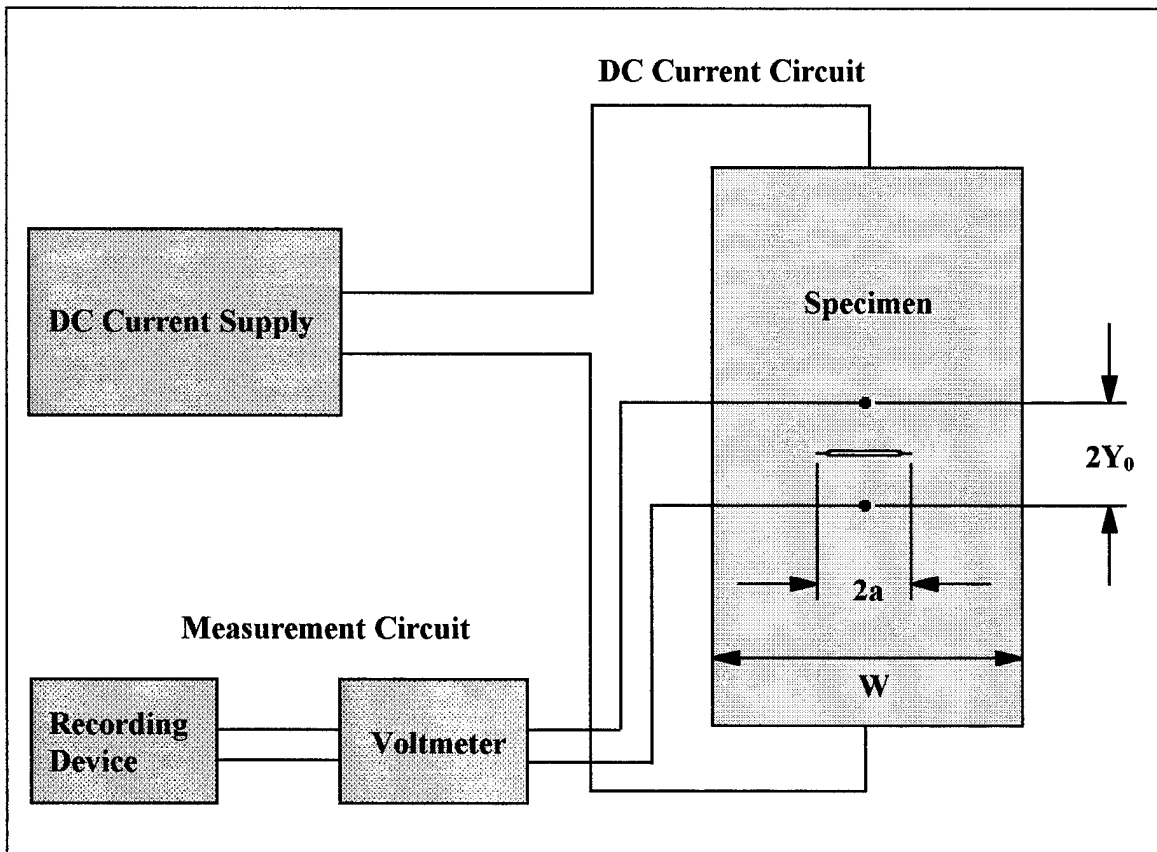
Figure 19. EPD Circuit Set-up

where a is the crack size, a_r is the reference crack size, W is the specimen width, V is the measured EPD voltage, V_r is voltage corresponding to a_r , and Y_0 is the voltage measurement lead distance from the crack plane. Note that a_r and V_r are based on an alternate method, optical in this case, of determining a_r (5:695-698).

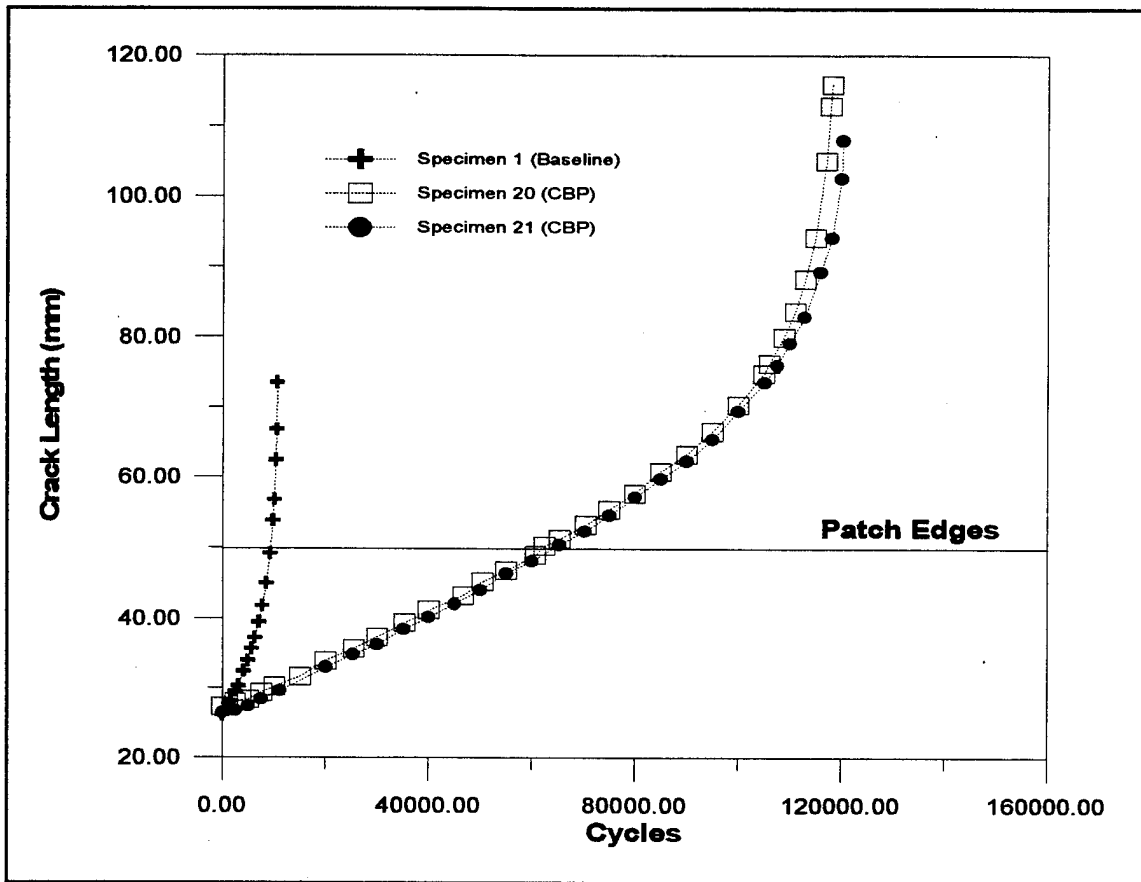
Figure 24. Baseline vs. CBP Crack Growth

Figure 24 shows the comparison between the crack length versus cycles curve for the baseline and two CBP specimens. At first glance, Figure 24 looks like a typical collection of fatigue life curves, however, it really tells the story about the mechanics and efficiency of bonded repairs. The first, and most important, feature of Figure 24 is that the crack growth rate, da/dN , was relatively constant within the domain of the patch repair. This is also shown by examining Figure 25 in which a three-point least squares method (37) was used to calculate the crack growth rate, da/dN . As shown in Figure 25, the crack growth rate was constant within the patch repair. In agreement with Rose (33) and Baker(8), the crack growth rate, and therefore, the repaired stress intensity factor range, ΔK_R , were constant inside the patch. Actually, not until the crack has extended beyond each edge of the patch does the crack growth curve change from linear to the more recognizable parabolic shape characteristic of metal fatigue. The initial stress intensity factor, K , for the baseline test was $24.26 \text{ MPa}\sqrt{\text{m}}$ and the average initial repaired stress intensity factor, K_R , for the two CBP specimens was $5.43 \text{ MPa}\sqrt{\text{m}}$. K_R was calculated using the Rose model (33, 34, 35). This significant reduction in the stress intensity

factor with repair was the result of: (1) load sharing by the patch; and (2) crack bridging which reduced the crack opening displacement. The second insight gained from Figure 24 and also shown in Figure 26, for the first 20,000 cycles of both CBP specimens, is that no retardation in the crack growth rate occurred during the earlier portion of crack growth inside the patch. Again, this is in agreement with Baker (6, 7, 8) and with Figure 6. The use of the elevated cure temperature film adhesive, AF-163-2, allowed the beneficial compressive stresses in the crack tip plastic zone to be annealed out during bonding of the boron/epoxy patch to the aluminum panel, eliminating retardation in the earlier portion of

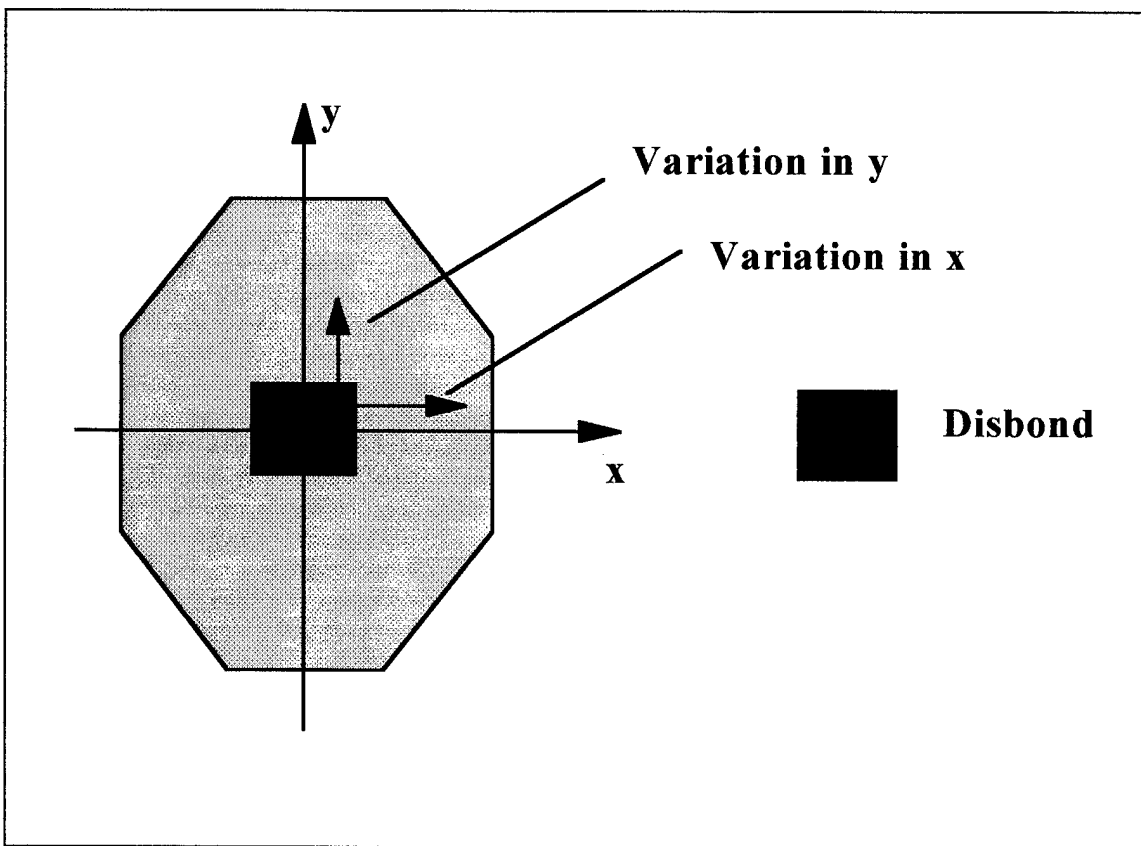
Figure 52. Disbond Size Variation

Effects of Disbond Size. This subsection is divided into two parts: (1) full width disbond (FWD) size effects; and (2) center disbond (CD) size effects. The size effects in these two parts differ by varying the disbond size relative to the x and y-directions as shown in Figure 52. FWD specimens demonstrate y-direction effects and CD specimens
