WINDOWS FOR EXTERNAL OR INTERNAL  
HYDROSTATIC PRESSURE VESSELS

Part I — Conical Acrylic Windows Under  
Short-Term Pressure Application

U. S. NAVAL CIVIL ENGINEERING LABORATORY  
Port Hueneme, California

Technical Report R-512

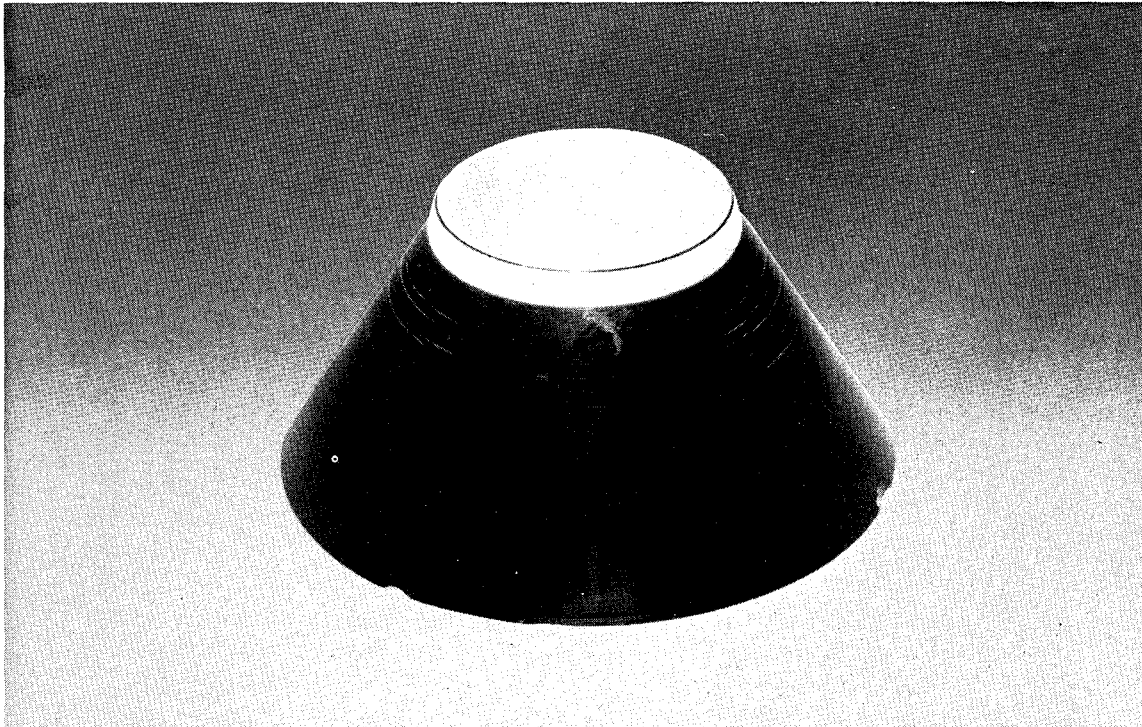
Figure B-8. Arrested failure of 1-inch-diameter,  $60^\circ$ , 1.0 t/D ratio window at 22,000 psi, low-pressure face. (Phase 1 of deformation.)

Figure B-9. Arrested failure of 1-inch-diameter,  $60^\circ$ , 1.0 t/D ratio window at 22,000 psi, high-pressure face. (Phase 1 of deformation.)

Figure B-10. Arrested failure of 1-inch-diameter,  $60^\circ$ , 1.0 t/D ratio window at 28,000 psi, low-pressure face. (Phase 2 of deformation.)

Figure B-11. Arrested failure of 1-inch-diameter,  $60^\circ$ , 1.0 t/D ratio window at 28,000 psi, high-pressure face. (Phase 2 of deformation.)

When the 60° windows with high t/D ratios were observed during tests, it was found they behaved in a manner similar to the low and intermediate t/D ratio windows except that no pieces of window remained in the flange after testing. The cold flow, of course, would be more pronounced than in either the low or intermediate ratio windows, as the proportions of the window were such that a cold flow had to occur before a conical fracture on the low-pressure face could be initiated. Even windows pressurized to 30% to 50% below the critical pressure showed considerable extrusion into the cylindrical cavity of the mounting flange (Figure B-8). When the large amount of cold flow on the low-pressure face of the high t/D ratio (1.0) window (Figure B-8) was compared with the small amount of cold flow on the high-pressure face (Figure B-9), the tentative conclusion was reached that the high t/D ratio, 60° window underwent three phases of deformation. The first phase was characterized by the uniform radial compression of the window caused by hydrostatic pressure forcing the acrylic plastic into the cylindrical cavity, resulting in the large amount of extrusion there. Very little, or no cold flow occurred on the high-pressure face of the window during that phase, as the face still remained essentially flat without noticeable crater. The duration of the first phase was probably to 50% of the critical pressure of the window.

The second phase, lasting from approximately 50% of critical pressure to just below the critical pressure, was characterized by extensive cold flow on the low-pressure face (Figure B-10), while the crater on the high-pressure face became noticeable (Figure B-11). Considerable cracking of the window body occurred in the transition zone between the conical and cylindrical sections of the window, as well as on the low-pressure face. The cracks in the transition zone (Figure B-10) extended at an angle from the bearing surface of the window into its interior, forming the incipient conical fracture surface. The cracks on the low-pressure face, on the other hand, extended along the circumference of the face, forming several continuous-crack circles.

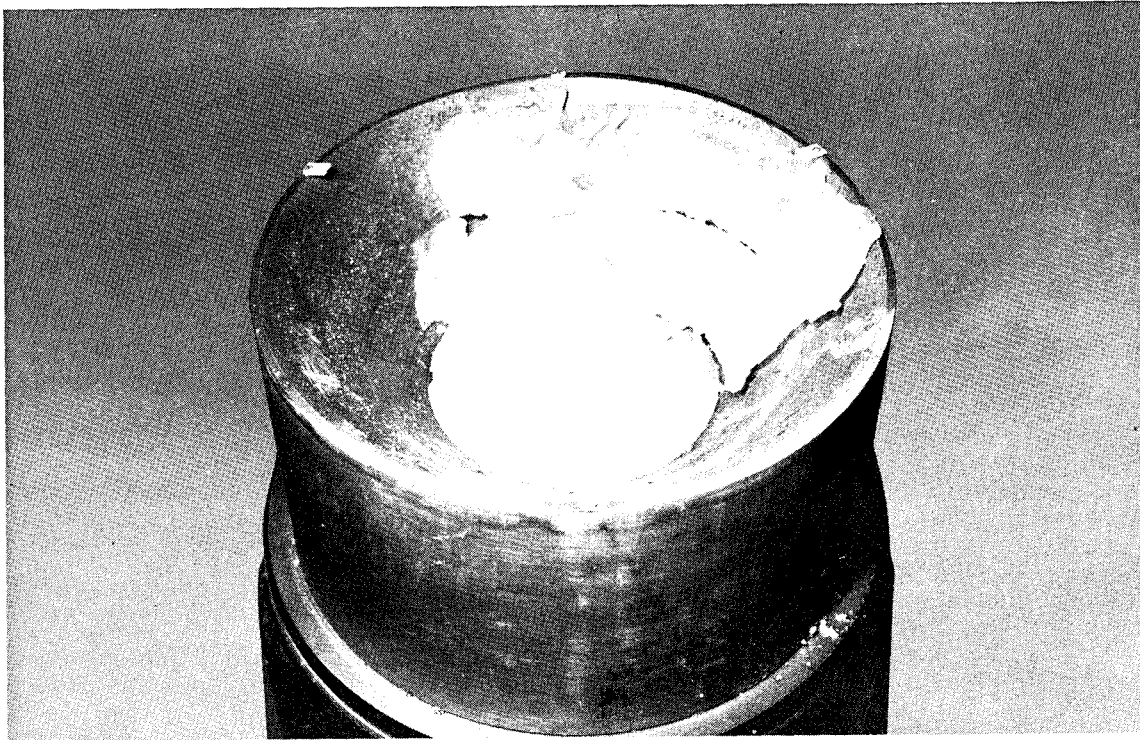
When the 8-inch-diameter, 4-inch-thick conical window with  $90^\circ$  included angle was subjected to increasing hydrostatic pressure, it failed by fracturing (Figure B-45) in a manner similar to 1-inch-diameter windows of the same t/D ratio (0.5) and included angle. The failure of the two types of windows at the same critical pressure lends considerable affirmation to the postulate that the critical pressure data obtained with 1-inch-diameter conical windows is applicable to larger conical windows provided they have the same included angle and t/D ratio.

Figure B-45. Failed 8-inch-diameter, 90°, 0.5 t/D ratio window, high-pressure face, shown in mounting flange.
