NASA CR-134521  
HSER 6241

**IMPACT RESISTANCE OF SPAR-SHELL COMPOSITE FAN BLADES**

**HAMILTON STANDARD DIVISION  
UNITED AIRCRAFT  
WINDSOR LOCKS, CONNECTICUT 06096**

**CONTRACT NAS3-16778**

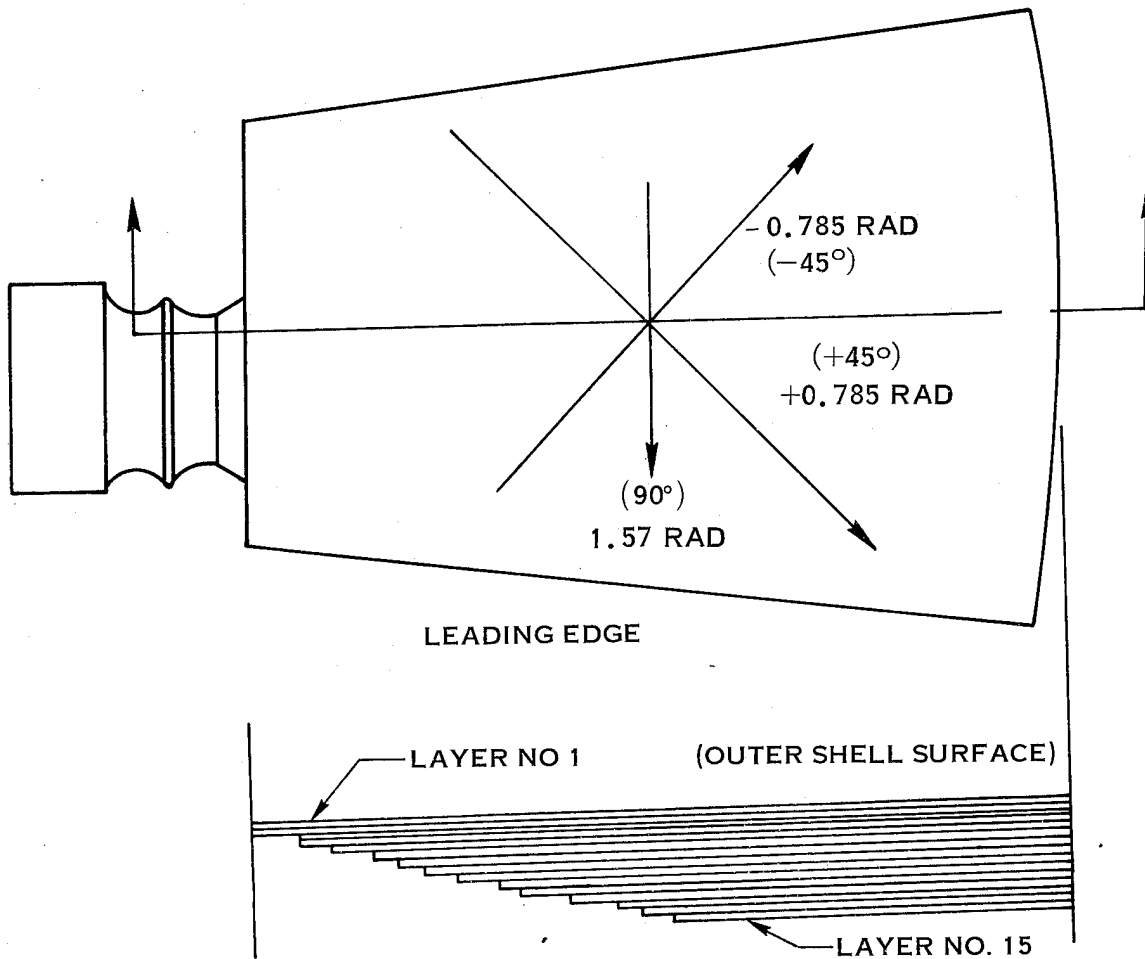
FIGURE 2. SHELL DETAILS - ORIENTATION AND CURING CONDITION

LAYER NO.	1	2	3	4	5	6	7	8	9	10	11	12	13	14	15
ORIENTATION DEGREES	+45°	-45°	+45°	-45°	90°	90°	+45°	90°	90°	-45°	90°	90°	+45°	90°	90°
RADIANS	+.785	-.785	+.785	-.785	1.57	1.57	+.785	1.57	1.57	-.785	1.57	1.57	+.785	1.57	1.57

MATERIAL: 3M PRODUCT TYPE SP-292 (5, 6) BORON-EPOXY  
PREPREG TAPE

AUTOCCLAVE PROCESS 586 KN-M<sup>2</sup> - 655 KN-M<sup>2</sup> (85 - 95 PSI) CURE 440 - 456° K  
(340 - 360° F) FOR 80 - 90 MINUTES, COOL AND POSTCURE SHELL IN OVEN  
FOR 4 - 6 HRS. AT 440° - 456° K (340 - 360° F)

The face and camber halves of the shell consist of 15 layers of material oriented as listed in Figure 2. Each shell half is laid up by hand on a female die half and cured in an auto-clave, to the cycle given in Figure 2.

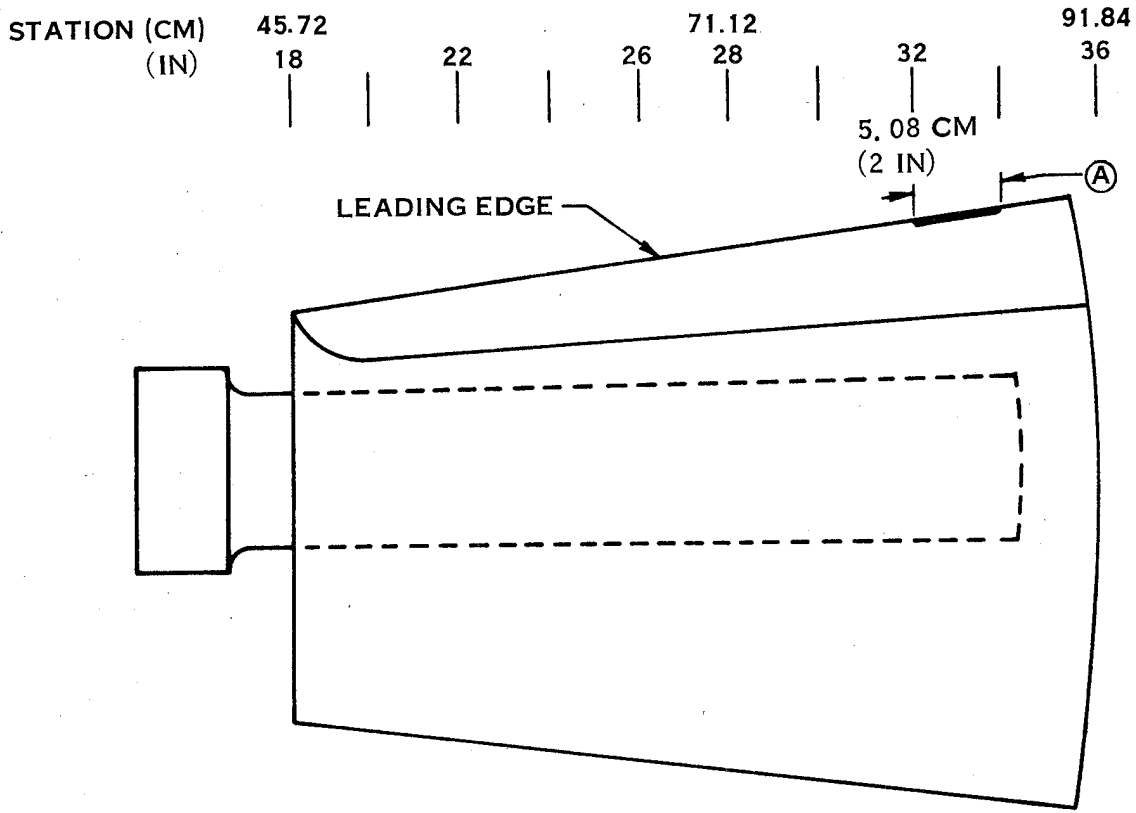
FIGURE 14. ICE BALL IMPACT LOCATION — BLADE B-2

IMPACT MEDIA 5.08 CM (2 IN) ICE BALLS—STRUCK  
WITH 2 BALLS (APPROX. 56 GM EACH)

- (A) LEAD EDGE OVER 5.08 CM (2 IN) LENGTH BENT SLIGHTLY  
TOWARD CAMBER 0.10 CM (0.040 IN) AT MAX DEFLECTION

This blade was impacted by a 5.08 cm (2.0 inch) diameter iceball in each of two tests. Specific characteristics of this media are shown in Table III. The blade struck about 25% of the first iceball and 100% of the second. There was no internal structural damage. A drop in the second flatwise static frequency of 2.8% coupled with minor change in the first flatwise mode and the first torsion mode were not considered significant since the displacement of the leading edge is expected to modify the blade resonance slightly in this direction. Frequency data is presented in Table V.

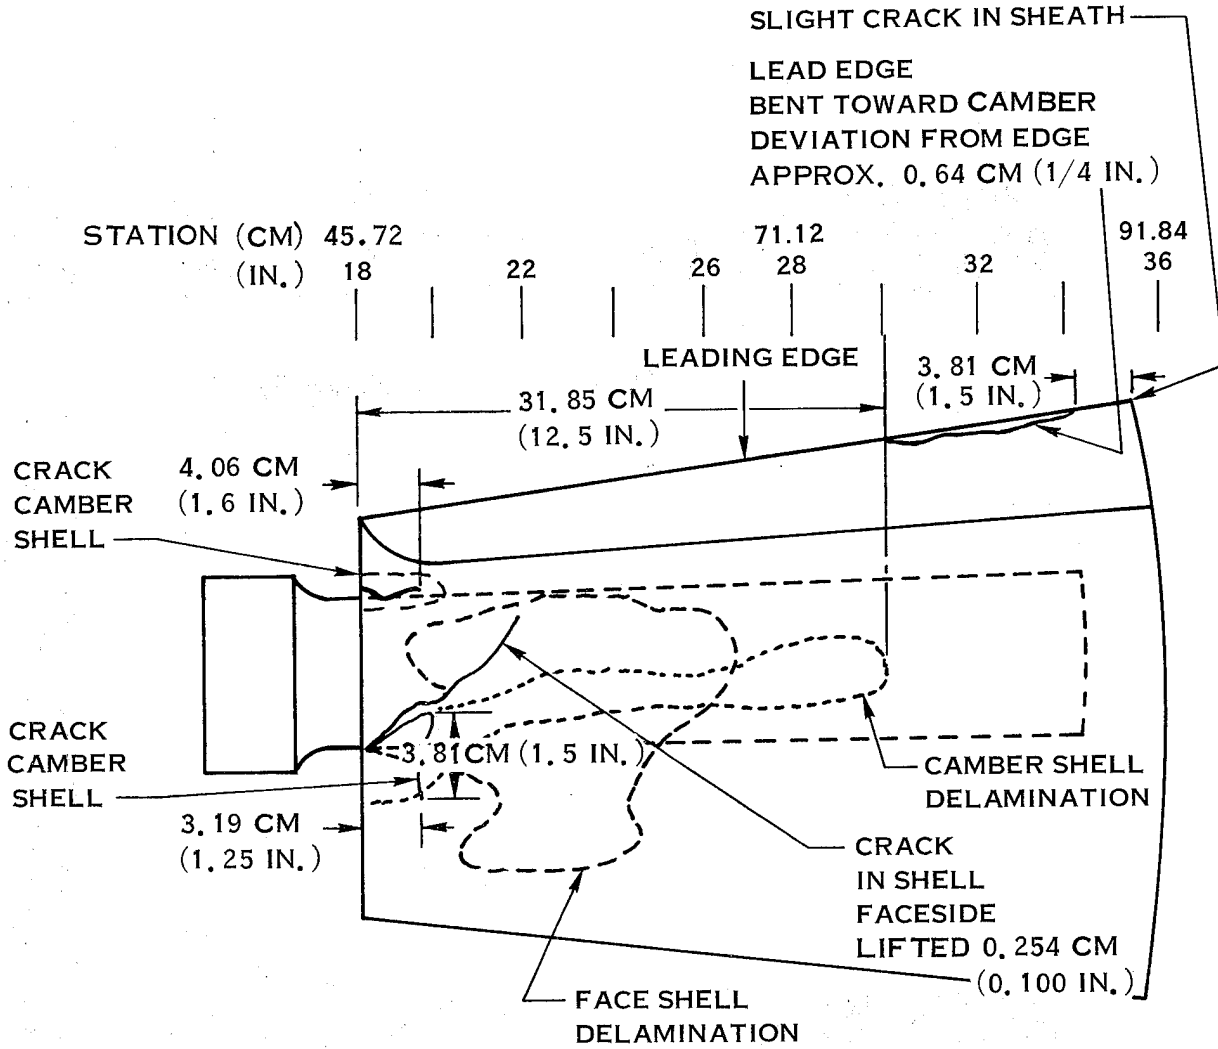
FIGURE 17. POST TEST CONDITION - BLADE B-3

IMPACT MEDIA 454 GM (1 LB) SIMULATED BIRD - 56% HIT

This blade was impacted by a 454 gram (1 pound) simulated gelatin bird. The slice removed by the blade as the result of the impact was 249 grams (0.55 pound). Visual examination of the blade after impact revealed sheath deformation in the impact region and shell fractures in the inboard area of the blade on both sides. Figures 15 and 16 show this damage. Tap and other visual indications are presented in Figure 17. Some reduction in frequencies were observed as the result of impact. These are shown in Table V. A drop of 5% in a frequency was considered evidence of structural damage to the blade. As indicated in the table, the first torsional frequency was especially effected, dropping 16.1%.
