## STRUCTURAL TECHNIQUES FOR JOINING FILAMENTARY COMPOSITES

G. A. CLARK and K. I. CLAYTON  
North American Rockwell Corporation  
Columbus, Ohio

AIAA Paper  
No. 68-1038

# AIAA 5th Annual Meeting and Technical Display

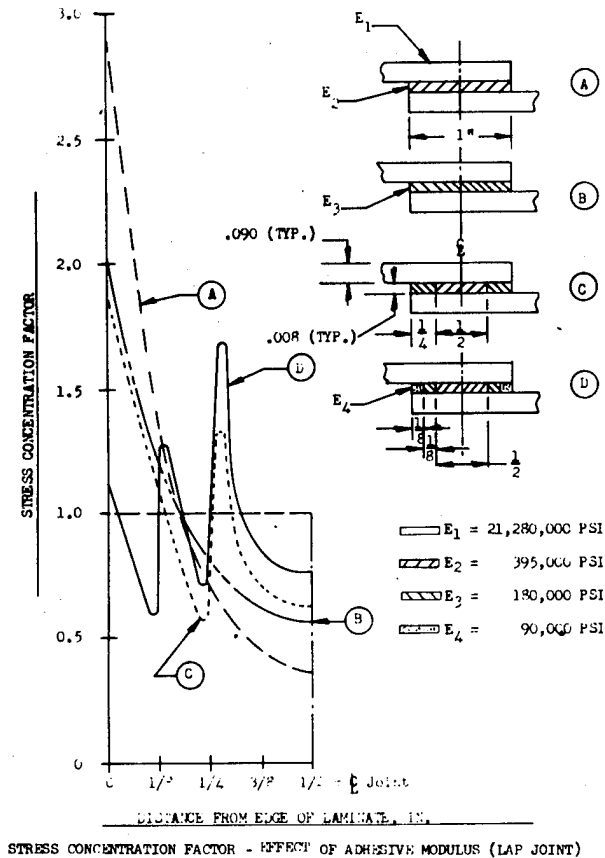
FIGURE 1

The effect of adhesive modulus on joint efficiency was calculated as shear stress concentration factor throughout the adhesive bond. Data plotted as Figure 1 show that the peak stresses encountered at the ends of a lap shear specimen can be reduced, thus raising the average shear strength, by incorporating a lower modulus adhesive for some distance at the end of the lap. Plot "A" uses HT424 adhesive throughout the joint, resulting in the most severe edge stress concentration of any of the

candidate joints. Plot "B" uses AF31 adhesive throughout the joint, resulting in a 32% reduction of the HT424 peak stress. It may be seen from curves "C" and "D" that the stresses vary abruptly, introducing secondary peaks, in the regions of adhesive modulus variation. However, combining a more flexible adhesive at the joint edge with a more rigid adhesive across the center of the joint does not create any stress risers as severe as when bonding with only one adhesive; therefore an orientation of variable modulus adhesives within the bond line significantly improved the joint efficiency.

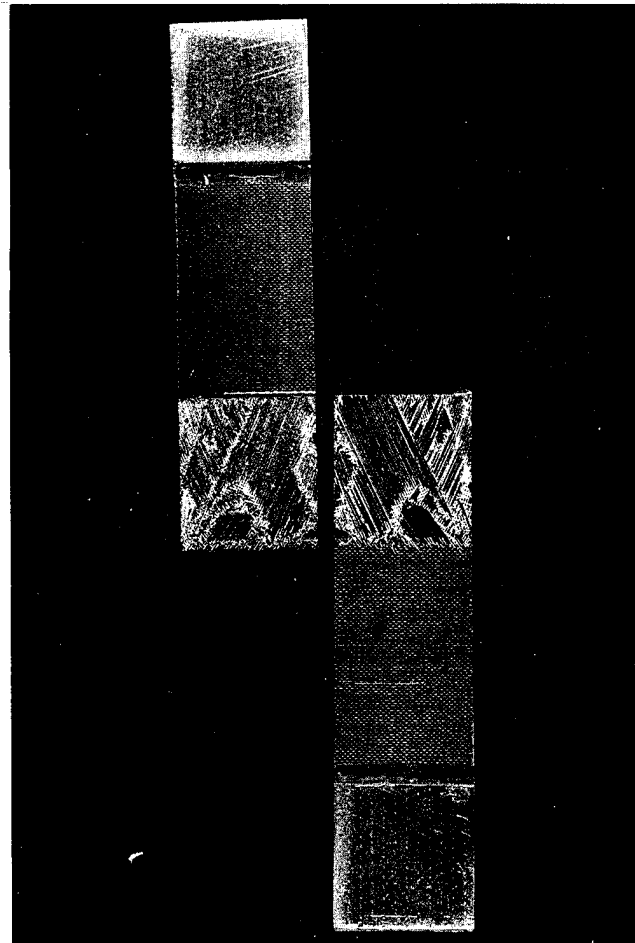
FIGURE 2. BONDED LAP JOINT-TYPICAL INTERLAMINAR SHEAR FAILURE

Bonded single lap shear specimens were fabricated and tested in an initial attempt to verify the analytical study of the lap type joints. The 3M Company's boron prepreg tape, "Scotchply" SP272, was selected for the experimental effort. This material is a three inch wide unidirectional boron tape of .005 inches thickness, having 210 filaments per inch, and carried on style 104 glass scrim. The results of all AF31-HT424 systems were comparable since all failures took place within the boron laminate structure itself and not in the adhesive bond. Apparently failure was induced by a peeling of the outer plies ( $\pm 35^\circ$ ) of boron fibers from the composite adherend as shown in Figure 2. Experimental results of additional lap shear test specimens, reversing the order of laminate layup, showed an increase in strength when a zero degree

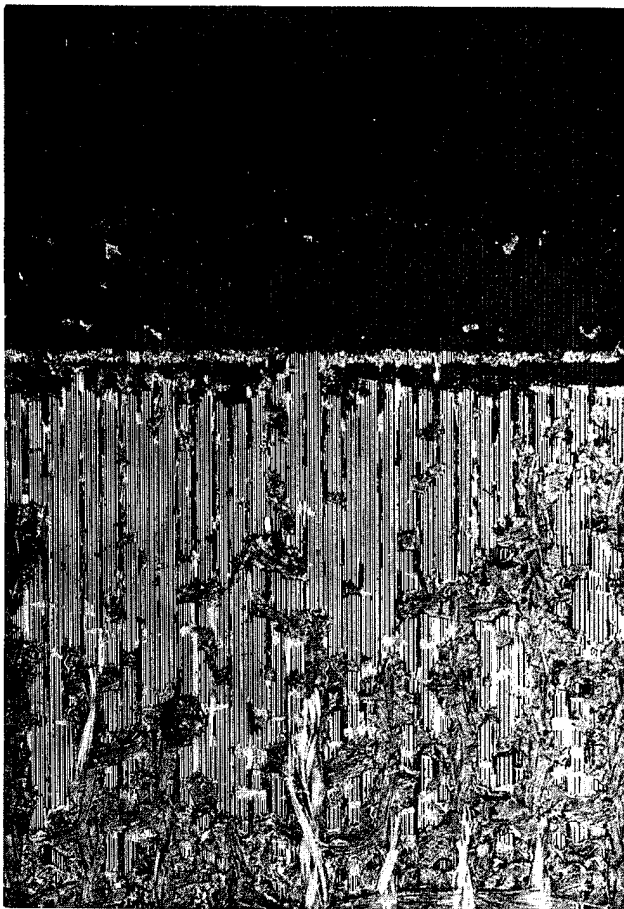
FIGURE 3. DETAIL OF SURFACE FAILURE-LAP SHEAR SPECIMEN

oriented boron layer is placed on the surface next to the bond line. Failure of the adhesive bond was initiated where the laminating resin was separated from the boron filament as shown in Figure 3. Double lap shear test results on metal adherends confirmed that the low modulus adhesive which has considerable plastic behavior, is far superior at room temperature to the high modulus adhesive but only slightly better than the marriage of the two. This latter situation may not be true if the effects of fatigue, creep, or moderately elevated temperature are considered. Test data of multidirectional boron laminates infers that the structural potential of an adhesive bond cannot be fully utilized until the interlaminar shear and/or laminating resin to boron filament integrity is improved.

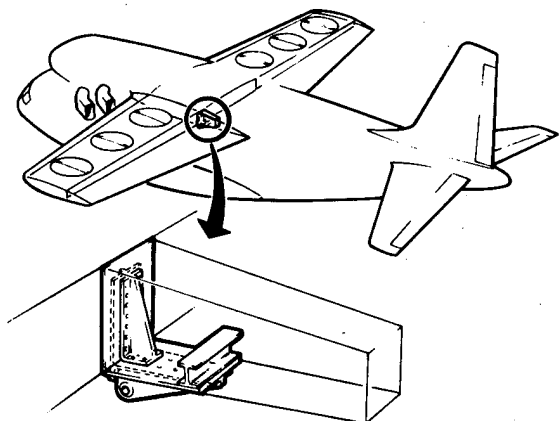
FIGURE 4

The wing is mated to the fuselage through fittings attached to the wing at each main spar location. The fittings at the forward spar, forward intermediate spar and the rear spar are designed to resist both vertical and side loads while the fitting at the rear intermediate spar is designed to resist vertical and drag loads. All wing to fuselage attach fittings are bolted to the spar and the lower wing-skin sandwich panels. Major effort was directed toward the design, analysis, fabrication and testing of the forward wing to fuselage attach fitting (aft torque box) which had been selected as the full-scale demonstration article under study (Figure 4).

### CX-6 WING TO FUSELAGE ATTACHMENT

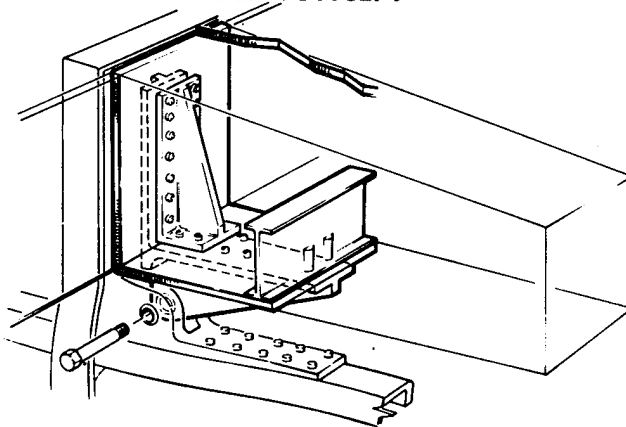
FIGURE 5

utilizes a conventional approach to designing with composite materials, as a first generation article, where a metallic doubler-fitting is bolted to the composite assembly (Figure 5).

### COMPOSITE DESIGN (BORON/EPOXY) CONVENTIONAL CONCEPT

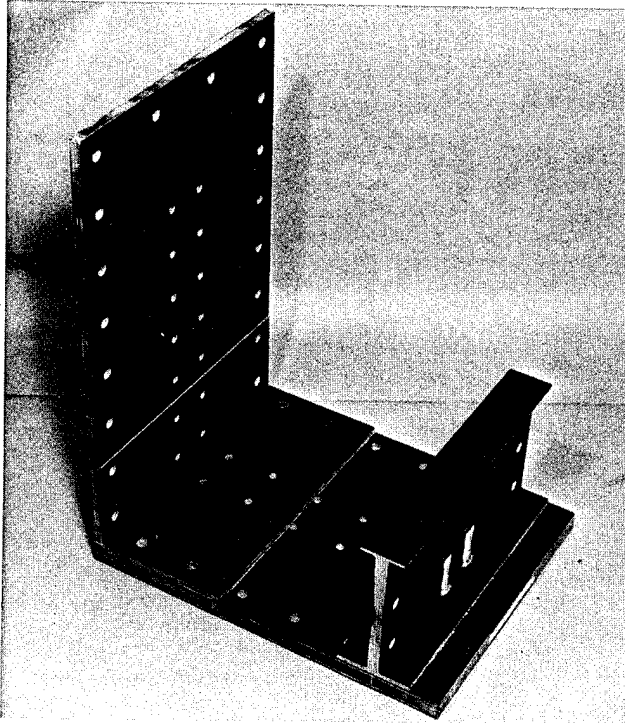
The Demonstration Article is a major assembly composed of three basic assemblies (Figure 6). These are the spar, wing skin and intercostal and in production drawings they would be shown as individual parts. Fabrication on each can run concurrently to expedite fabrication with a minimum of tools.

FIGURE 6. WING TO FUSELAGE  
ATTACHMENT-CONVENTIONAL CONCEPT

All details were precured and pre-machined prior to assembly. The wing skin panel consists of boron skins oriented at  $0^\circ$ ,  $\pm 10^\circ$ ,  $\pm 20^\circ$ ,  $\pm 25^\circ$ ,  $\pm 35^\circ$ , glass inserts and an aluminum honeycomb core. The 0.180 inch facings were laid up using SP272 boron tape to the required configuration as one unit on the skin tool, autoclave molded and cured. Details were machined to final dimension using diamond impregnated cutting tools. The solid glass inserts were fabricated from Type 181, E glass fabric.

The honeycomb core was machined to thickness in the unexpanded (HOBE) condition, expanded and cut to size. Where bolts were to be inserted into the assembly, 0.625 inch holes were cut through the core and this area potted with a filled epoxy compound catalyzed for room temperature cure. Assembly was accomplished by applying HT424 to the faying surfaces of all details except a bead of foaming type HT424D was placed in the edge "V" groove of the inserts. Bonding was accomplished with vacuum bag pressure.

The spar assembly consists of cap angles, skins oriented at  $\pm 45^\circ$ , doublers, insert, and core. The doublers, core and insert were fabricated using the same process as the respective counterparts in the wing skin.

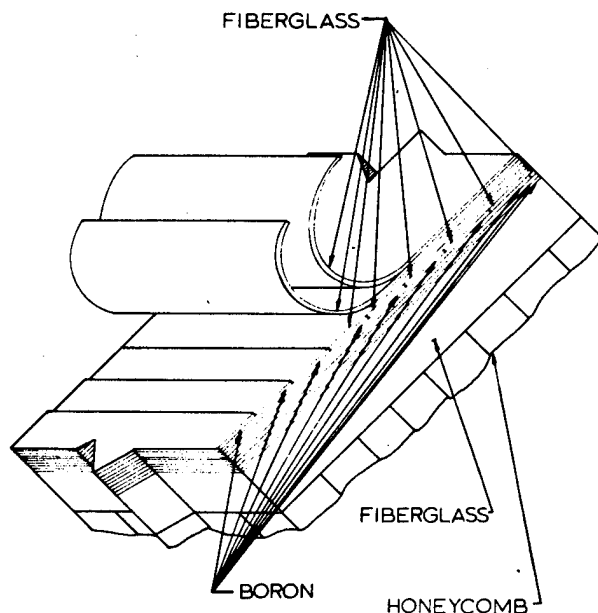
A rather complex glass transition area, shown in Figure 7, was required for forming a  $90^\circ$  flange integral with the skin.

FIGURE 7. LAY-UP OF BORON-GLASS TRANSITION

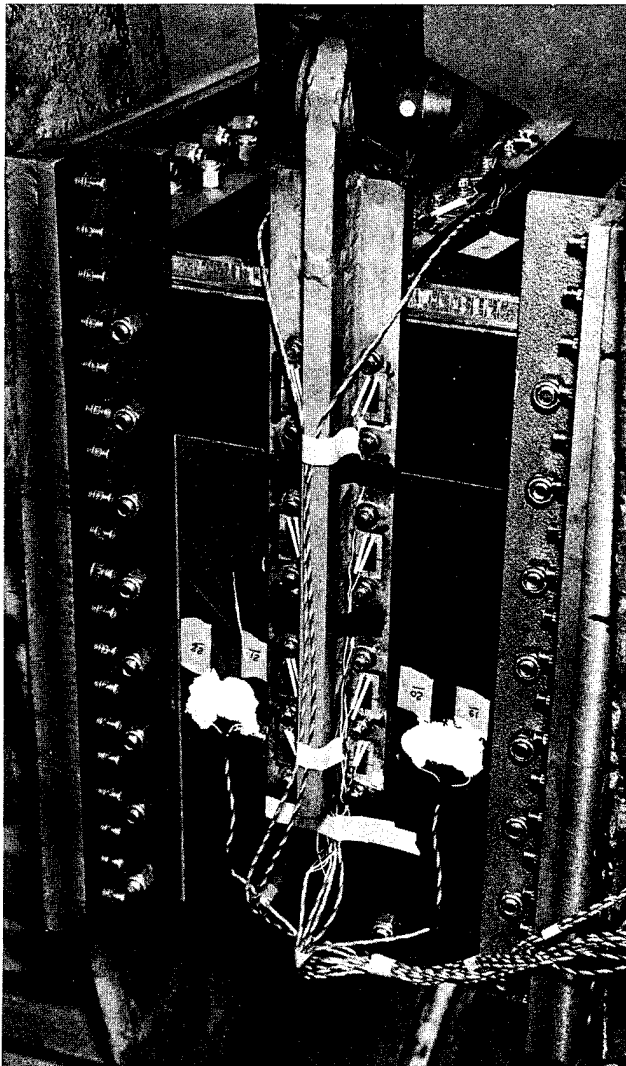
The specimen was mounted to a steel fitting and to a rigid fixture for testing (Figure 8). Test loads were applied by calibrated hydraulic struts through utilization of a Marginator pressure proportioning unit which controls the ratio of constant and variable pressure applied to the struts. Calibrated load cells were also installed in series with the loading struts as part of the test setup. Deflection was measured by Ames dials while strain gage data were recorded on a Gilmore Strain Recorder, providing an immediate plot of test data and a continuous check on possible yield. Test loadings were applied in increments of design limit load with strain gage readings recorded at every 20% D.L.L. up to 100% D.L.L. and then at every 10% D.L.L. up to failure.

FIGURE 8. TEST FIXTURE FOR ARTICLE #1-LOOKING AFT

Run No. 1 was conducted to 166% design limit load (D.L.L.) or 110% ultimate after which the fitting was removed and the fastener holes inspected. No damage to the specimen was found. Run No. 2 was conducted to 200% ultimate without failure. At this time it was proposed to resume testing of Demonstration Article No. 1, to failure, incorporating a change to the test setup. The design of the cover skin sandwich panel influenced the distribution of loads between the spar and skin components. In order to better simulate the edge fixity of the wing skin panel, the jig bolts which prohibit the normal deflection that this panel would experience due to spanwise bending of the aircraft wing were omitted. Run No. 3 was then conducted at which time failure of the spar to fitting attachment occurred at 163% ultimate or at a resultant load of 103,500 pounds, demonstrating the strength of a conventional bolted assembly. Edge-wise shear failure of the .050 boron spar facings along the edge of the glass doubler was the primary cause of failure.

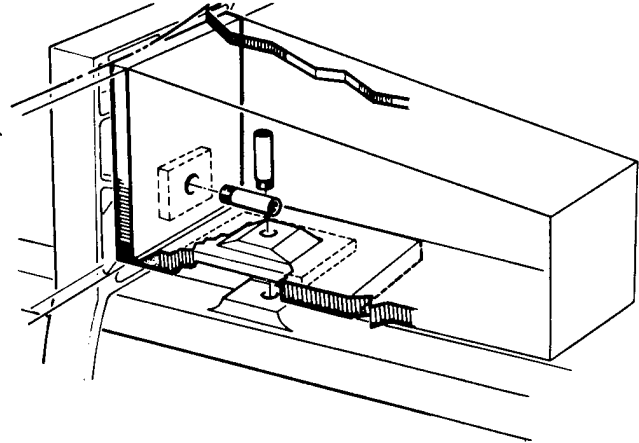
FIGURE 9

spars, reducing the number of attach fittings from ten to six. Consequently, an all bonded design which incorporates an integral spherical bearing has been generated as the advanced concept, Item No. 1, to resist ultimate loads of 54,000 pounds vertical and 17,000 pounds drag (Figure 9).

### COMPOSITE DESIGN (BORON/EPOXY) ADVANCED CONCEPT

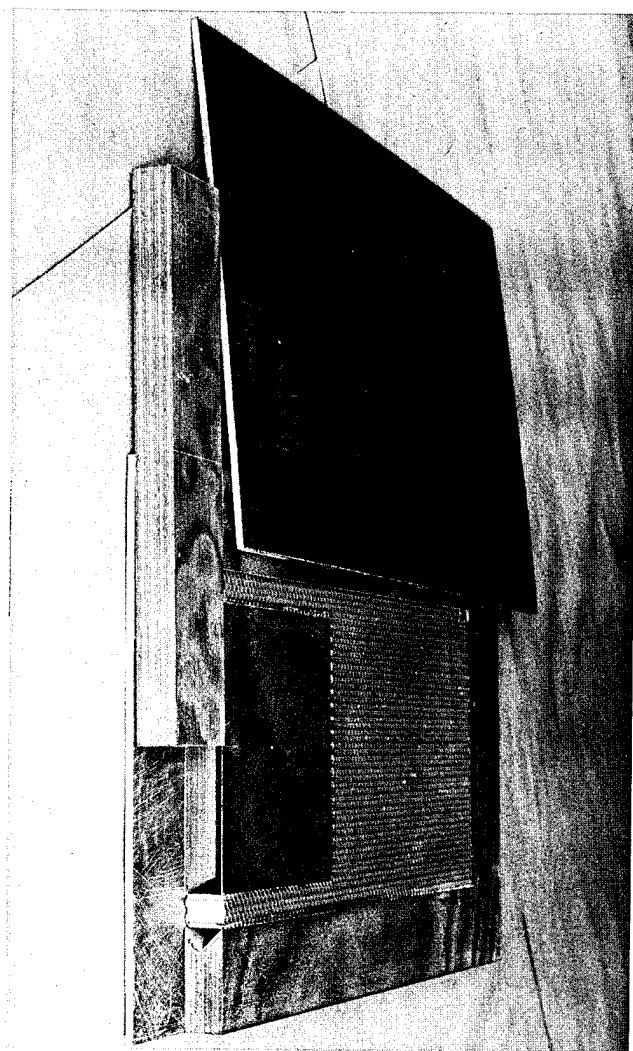
The oriented boron facings for both the spars and skins were laid up at  $\pm 45^\circ$  using a tool similar to the one used in the conventional concept. The same bagging, pressure application and curing techniques were used for these components and assembly. The only deviations or improvements over previous techniques were: (1) inserts were made oversize and machined to the required tolerance except for the wing skin laminated insert. This was machined undersize in order that continuous laminations could be placed over the flat and angled surfaces to eliminate the possibility of shearing off the area of increased thickness, (2) when the large boron skin to doubler bond was made, small (0.040 inches) holes were drilled through the doubler on 2 inch centers to permit excess adhesive to escape from the bond line. This technique reduces the pillowing effect which sometime occurs when thin materials are bonded using only vacuum bag pressures. Figures 10 and 11 show the details of the

FIGURE 10. DETAILS-SPAR ASSEMBLY (ADVANCED CONCEPT)

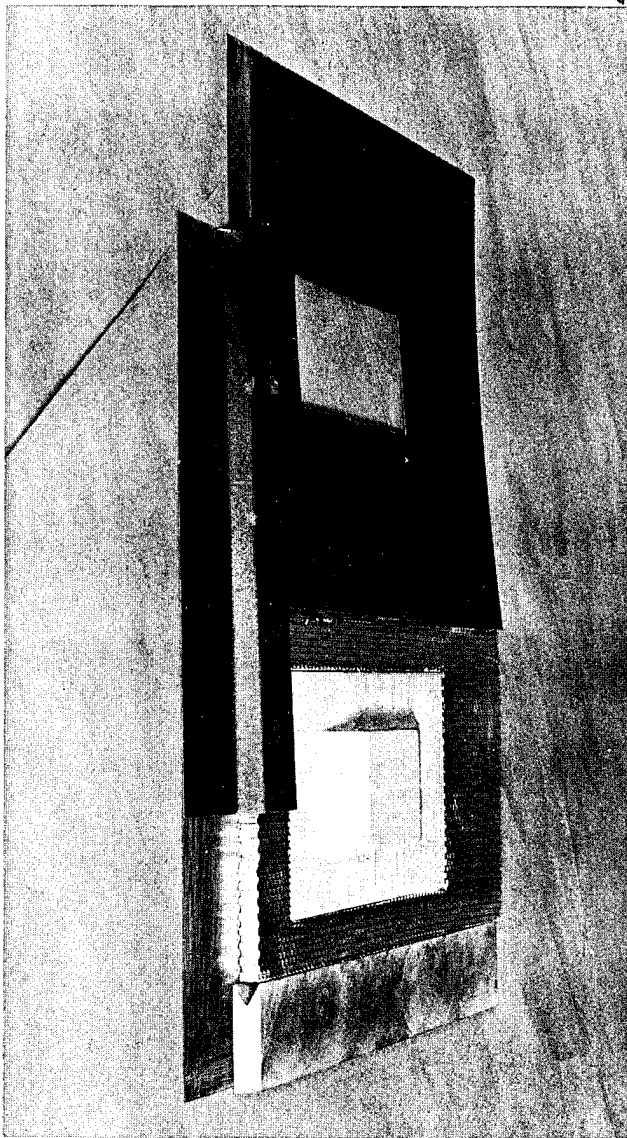
FIGURE 11. DETAILS-WING SKIN ASSEMBLY (ADVANCED CONCEPT)

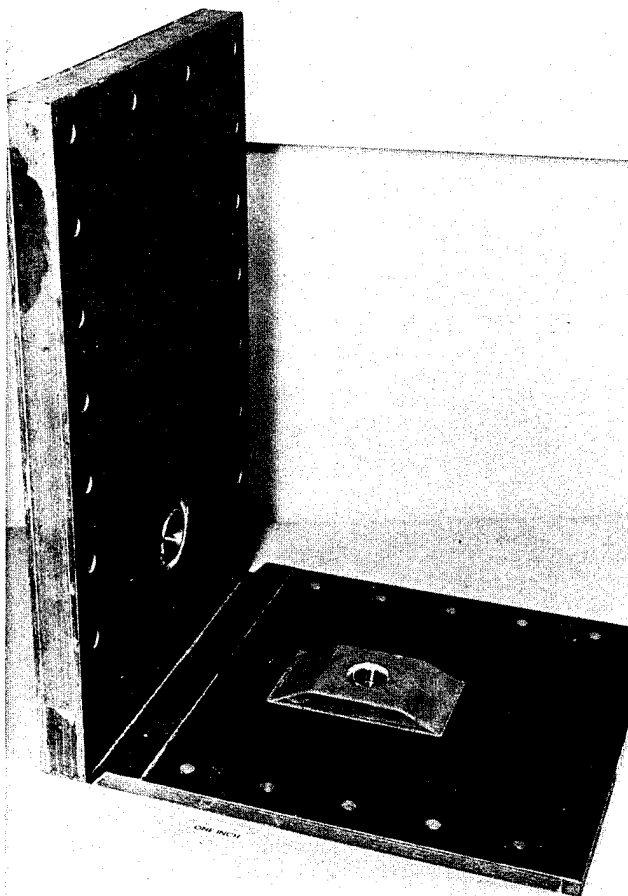
All of the 1/2 inch mounting holes around the periphery of both the spar and wing skin were drilled using the ultrasonic silicon carbide slurry (Cavitron) method. The resulting holes were very satisfactory with very close tolerance, smooth surfaces and no delamination or fracturing of the surface on the back side. The tool life is virtually unlimited. Figure 12 shows the completed advanced concept assembly.

FIGURE 12. COMPLETED ASSEMBLY  
ADVANCED CONCEPT

A static test was conducted to verify the structural integrity and fabrication quality of the advanced concept demonstration article. Run No. 1 was conducted to 98% design limit load (D.L.L.) at which time a cracking sound was heard and the load dumped. After 60% D.L.L. of Run No. 2, a chamfer, approximately .060 x 45°, was cut on the corner of the joint at the intersection of the spar and skin panels to eliminate interference between the specimen and loading jig. Run No. 3 and Run No. 4 were prematurely dumped after 100% D.L.L. and 75% D.L.L., respectively, when sounds were again heard. Run No. 5 was then conducted to failure which occurred

An adhesive bond failure between the glass insert housing the spherical bearing and the glass doubler which reinforces the boron spar facings was the primary cause of failure. The non-linearity of dial gages and axial strain gages located in the area of the spar spherical bearing insert showed the yielding of the failed bond from 80%-100% D.L.L. to failure at 160% D.L.L. The spar panel was disassembled after failure revealing a poor bond over the area inside the attaching doublers and to some degree over the doublers themselves. The poor bond was apparently caused by excessive use of the foaming type HT424D for a shear tie between the core and inserts. This can be eliminated by (1) using a non-foaming type shear tie or (2) by assembly of the core-insert blanket then bonding to the skin-doubler facings.

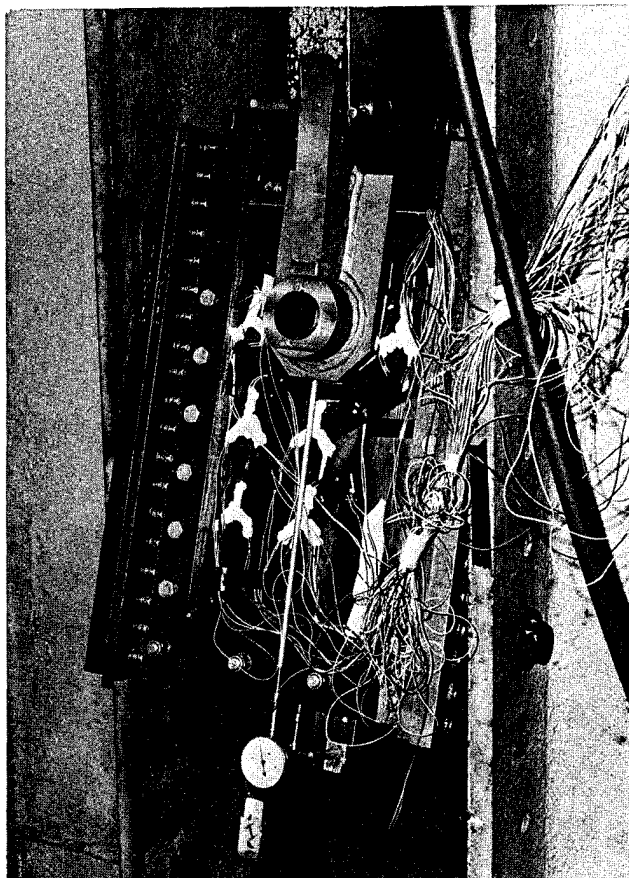
The specimen was mounted to a steel loading fitting and to a rigid fixture for testing (Figure 13). A vertical shear load of 54,000 pounds ultimate and a drag load of 17,000 pounds ultimate, for the spar and outer skin panel respectively, were introduced through an integral fitting rather than through the two separate Item #1 loading straps. Such a load introduction provides a more typical aircraft application rather than a limited test configuration.

FIGURE 13. TEST FIXTURE-ADVANCED CONCEPT, ITEM #2

Run No. 1 was conducted to 100% D.L.L. at which time the load was reduced to 20% to check data. A predicted stress distribution for the Item #2 spar showed the highest shear stress, 45,200 psi, at ultimate load, is located 3.85

inches from centerline, in line with the spherical bearing. An examination of the monitor strain gage plot, revealed good linearity up to  $1740 \mu\text{in}/\text{in}$  at 100% D.L.L. Using a modulus of  $17.2 \times 10^6$  psi for  $0^\circ$  -  $90^\circ$  oriented SP272 boron, since the strain gage is applied parallel to the filaments on the  $\pm 45^\circ$  boron facing, the measured stress level at 100% D.L.L. =  $E\epsilon = (17.2 \times 10^6) (1740 \times 10^{-6}) = 29,900$  psi or projected to 150% D.L.L. = 44,900 psi compared to the 45,200 psi predicted. Based on this excellent agreement, coupled with the absence of any appreciable yield, it was decided to resume testing and continue Run No. 2 to failure which occurred at 140% D.L.L. or 93.3% ultimate. Non-linearity of strain gage readings started between 100-120%, reflecting yielding in the area of the spar spherical bearing insert and continued to failure.

An adhesive bond failure between the glass insert housing the spherical bearing and the doubler which reinforces the boron spar facings, along with interlaminar shear failure within the glass insert itself, were the primary cause of failure leading to subsequent edgewise shear failure of the .021 boron spar facings along the previously discussed transition line, 3.85 inches from centerline. As in prior testing, the fitting to wing cover skin panel was not critical.
