# IMPACT RESISTANCE OF COMPOSITE FAN BLADES

GENERAL ELECTRIC COMPANY  
AIRCRAFT ENGINE GROUP  
Cincinnati, Ohio 45215

NATIONAL AERONAUTICS AND SPACE ADMINISTRATION  
NASA-LEWIS RESEARCH CENTER

| 1. Report No.<br>NASA CR-134707 | | 2. Government Accession No. | | 3. Recipient's Catalog No. | |

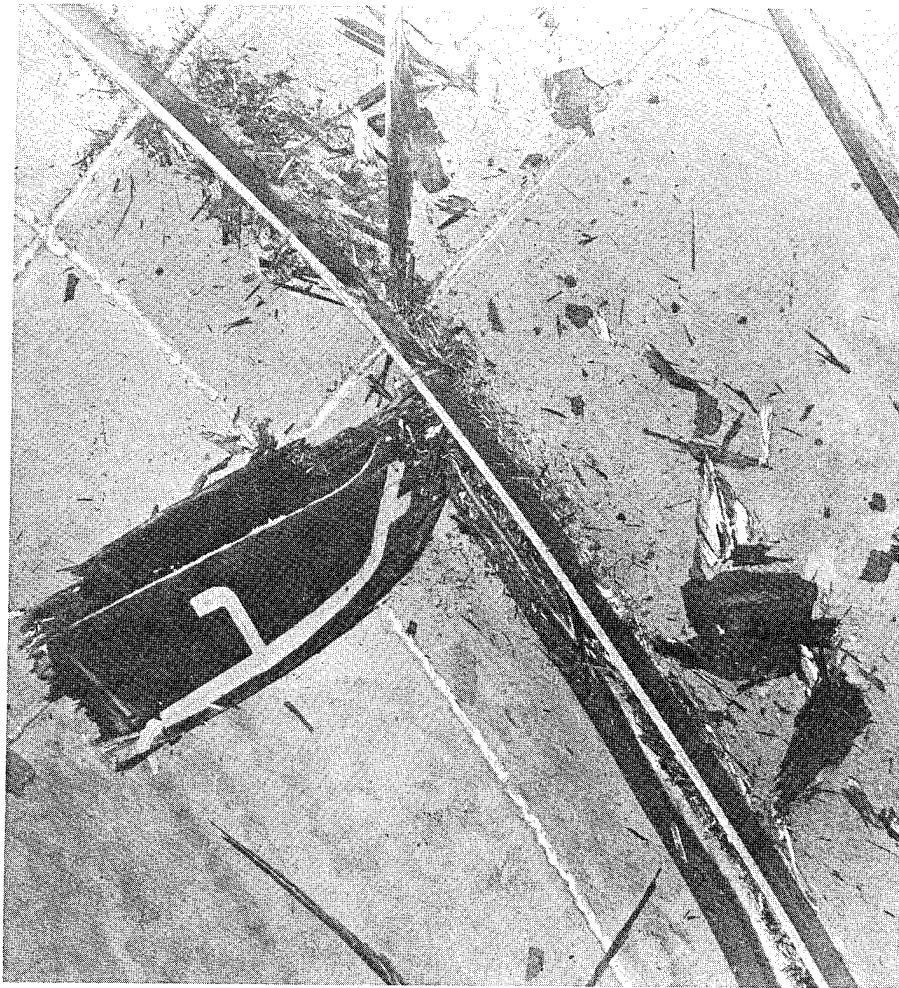
NASA-FOD Impact Resistance Test  
 Blade S/N NG3  
 Graphite/Epoxy  
 Tip Speed: 244 m/sec (800 ft/sec)  
 794 g (28 oz) RTV Bird  
 340 g (12 oz) Slice  
 0.384 Radians (22°) Incidence Angle

Figure 34. Blade S/N NG3 after Impact.

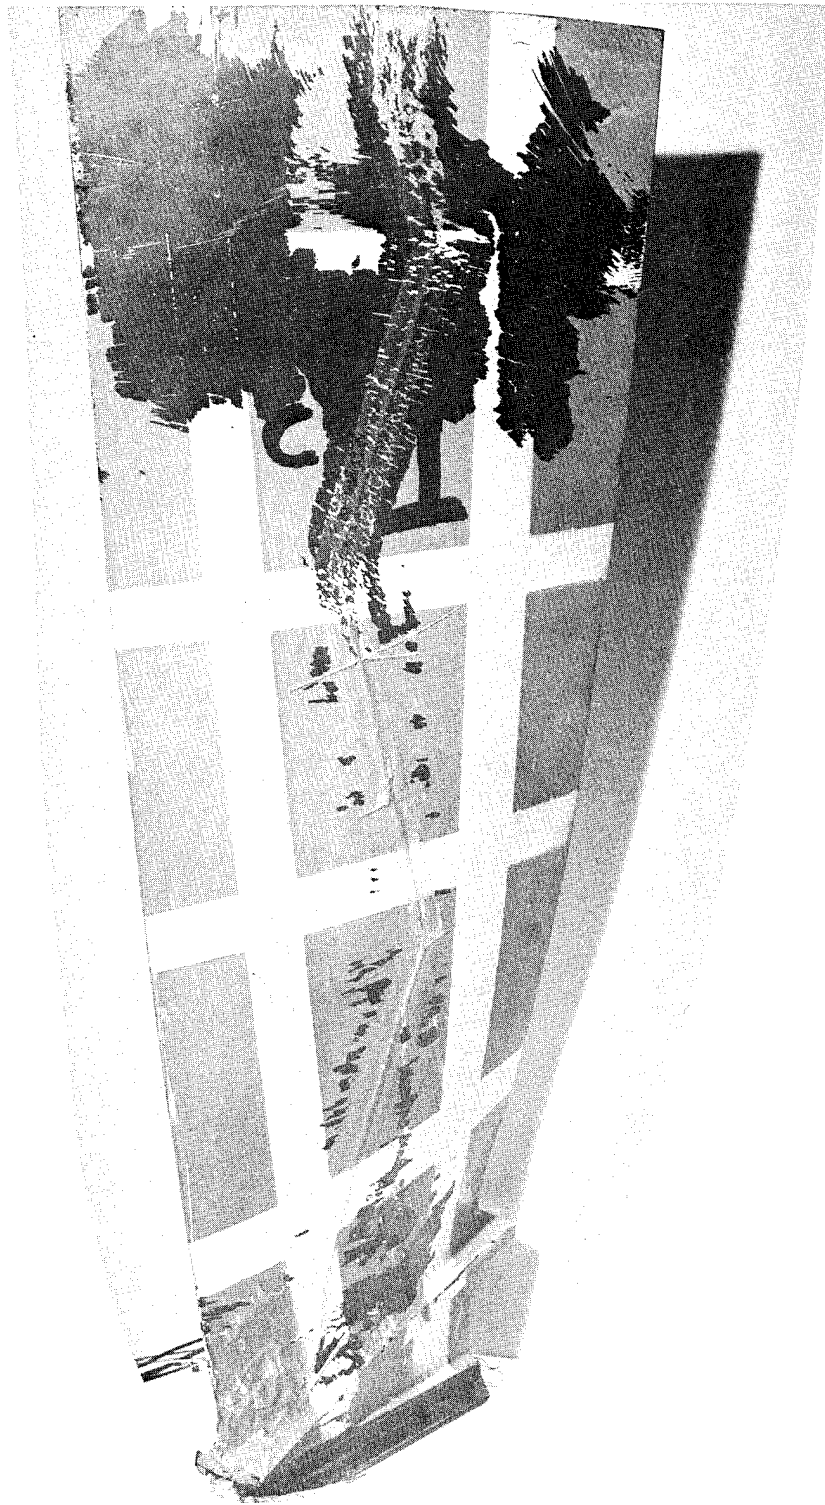
Figure 42. Titanium Blade after Impact  
(Convex Surface), Test No.  
STOL 3.

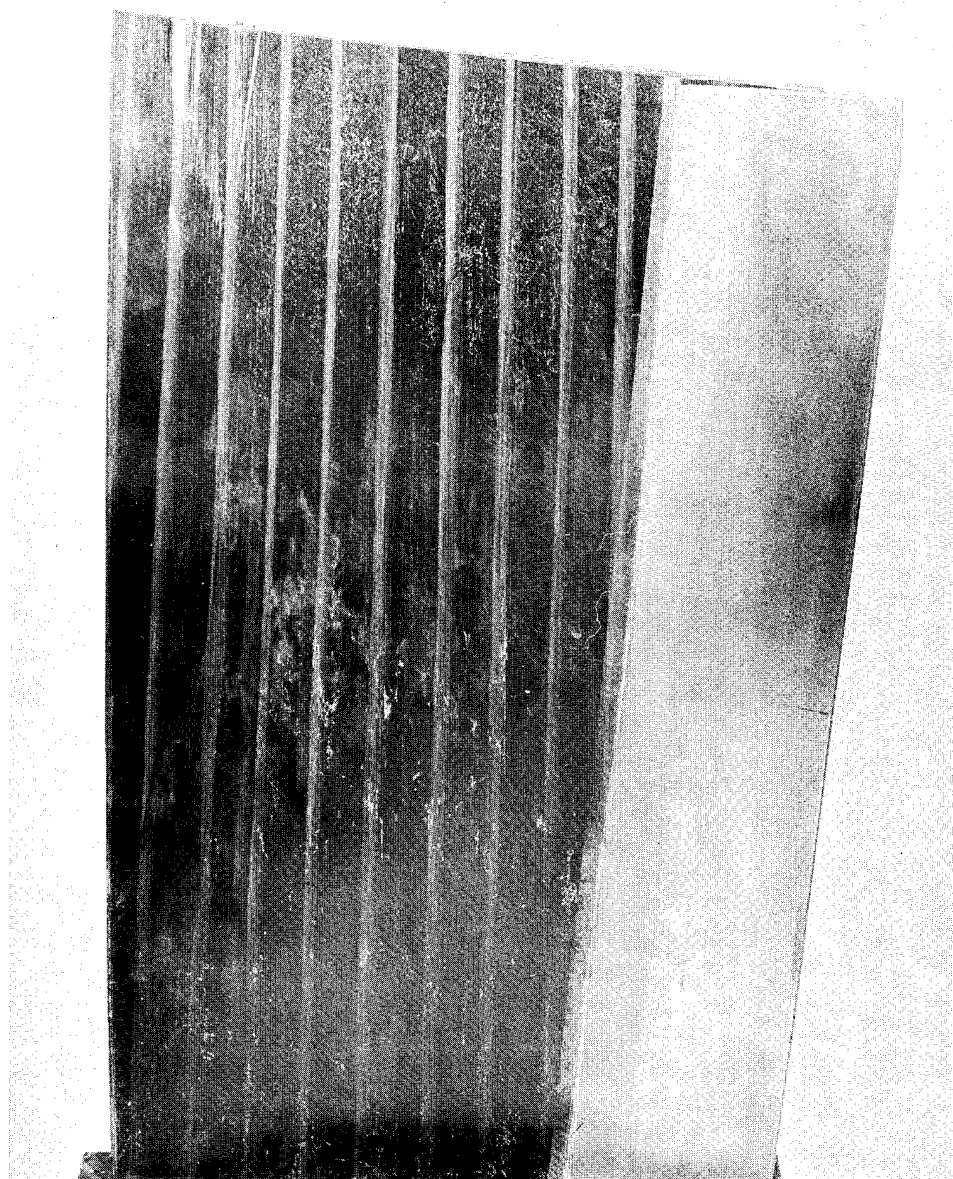
NASA-FOD Program  
Panel S/N 2  
PR 288/80% AU/20% S-Glass  
RTV Simulated Bird  
Bird Size: 227 g (8 oz)  
Half Bite  
Impact Velocity: 215 m/sec (707 ft/sec)  
Incidence Angle: 0.384 Radians (22°)

Figure 51. Panel S/N 2 After Impact.

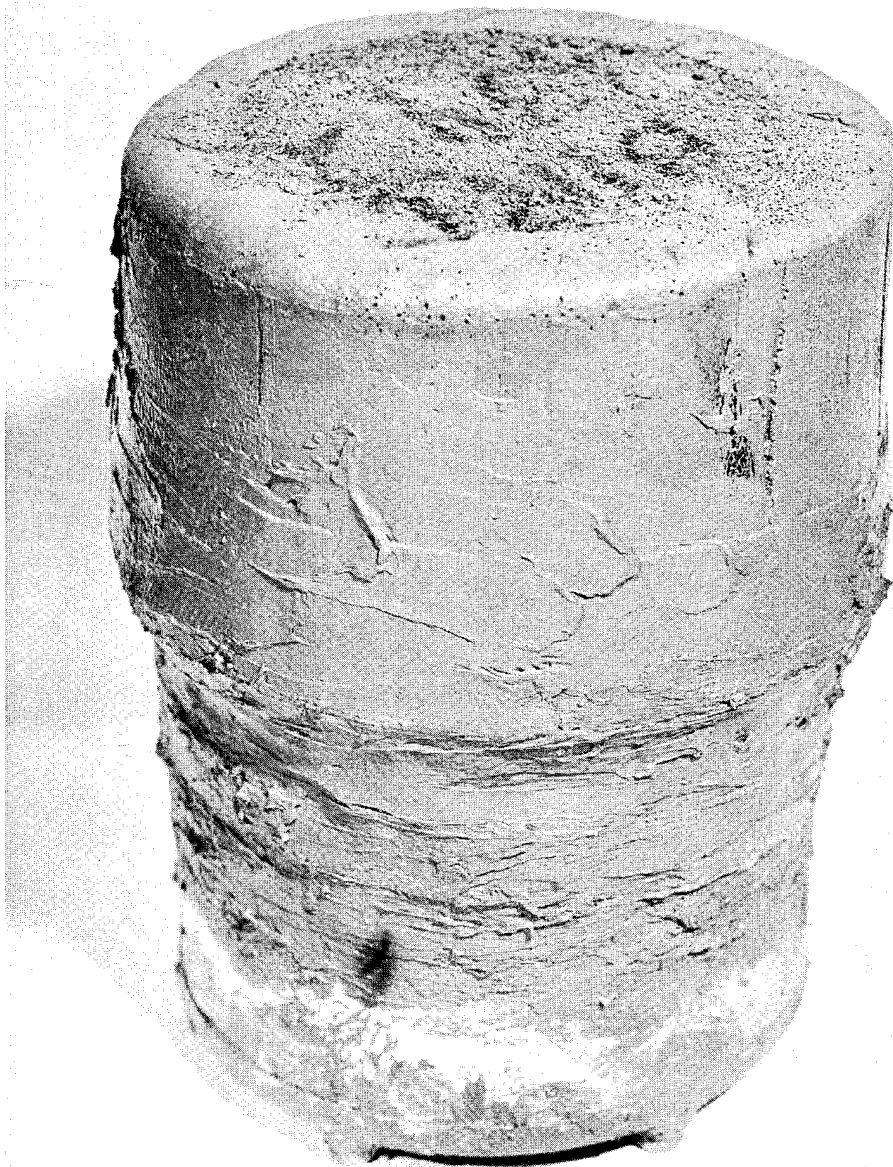
Figure 54. Typical RTV Simulated Bird Before Test.

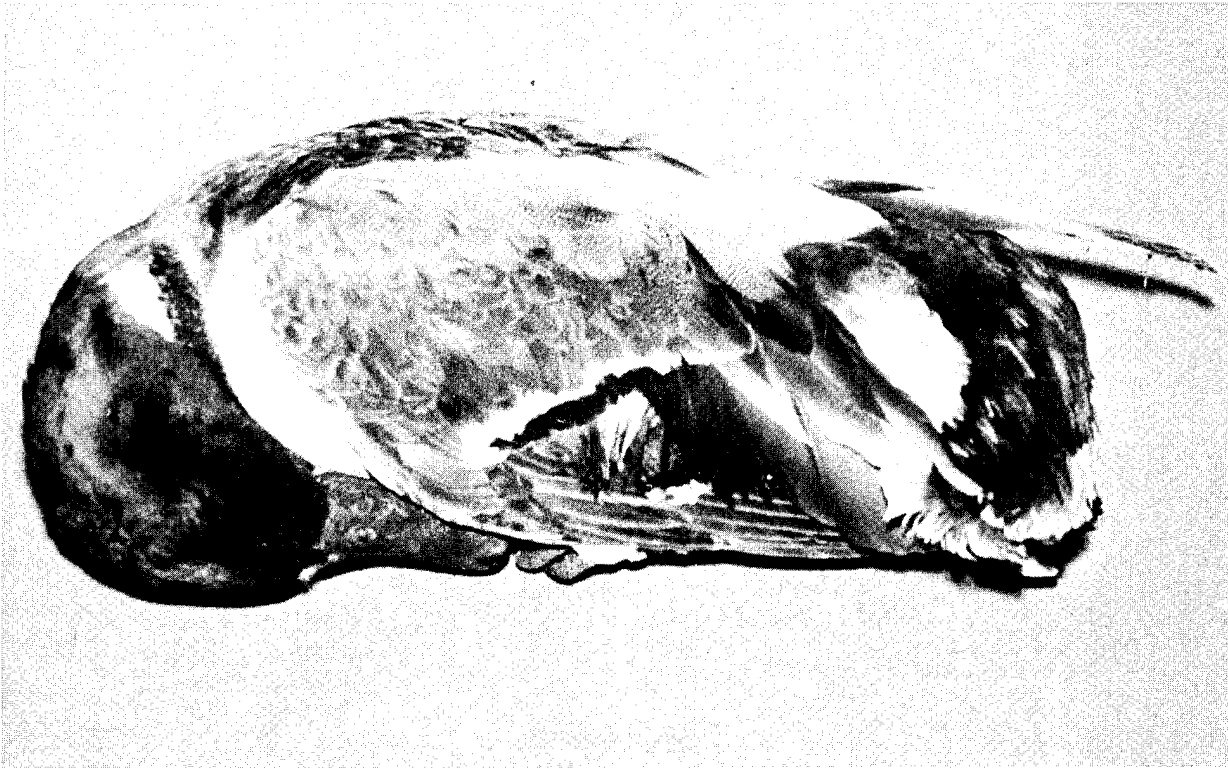
Figure 55. Wild Mallard Duck Used in Hybrid/Epoxy Blade Tests.

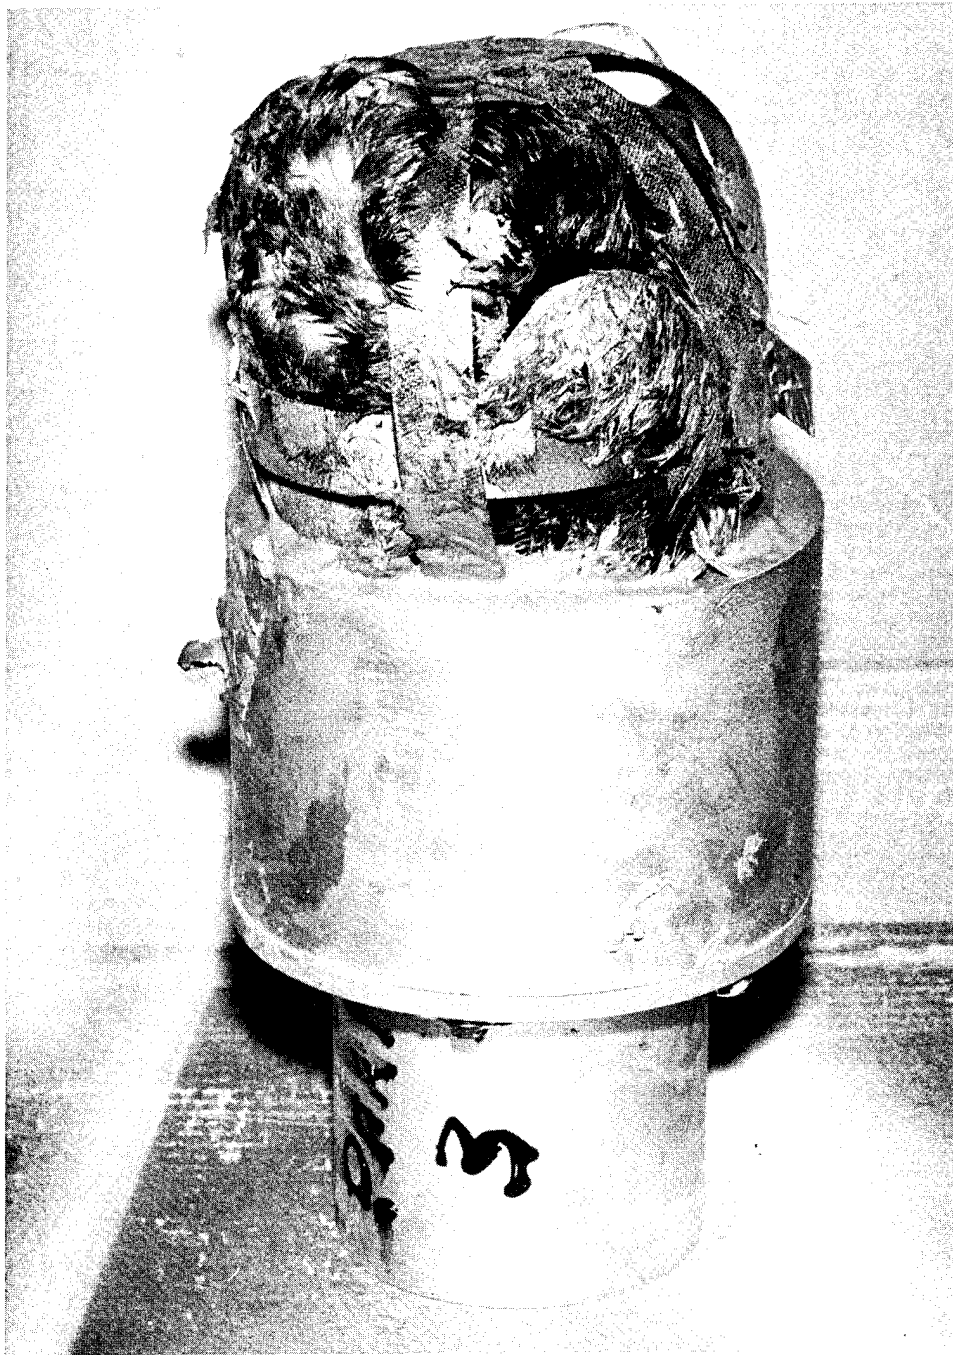
Figure 56. Mallard Duck Positioned for Impact in Whirligig Test Facility.
