A STUDY OF STIFFNESS, RESIDUAL STRENGTH AND FATIGUE  
LIFE RELATIONSHIPS FOR COMPOSITE LAMINATES

Lockheed-California Company  
Burbank, CA

## **NASA Contract Report CR-172211**

Contract NAS1-16406  
October, 1983

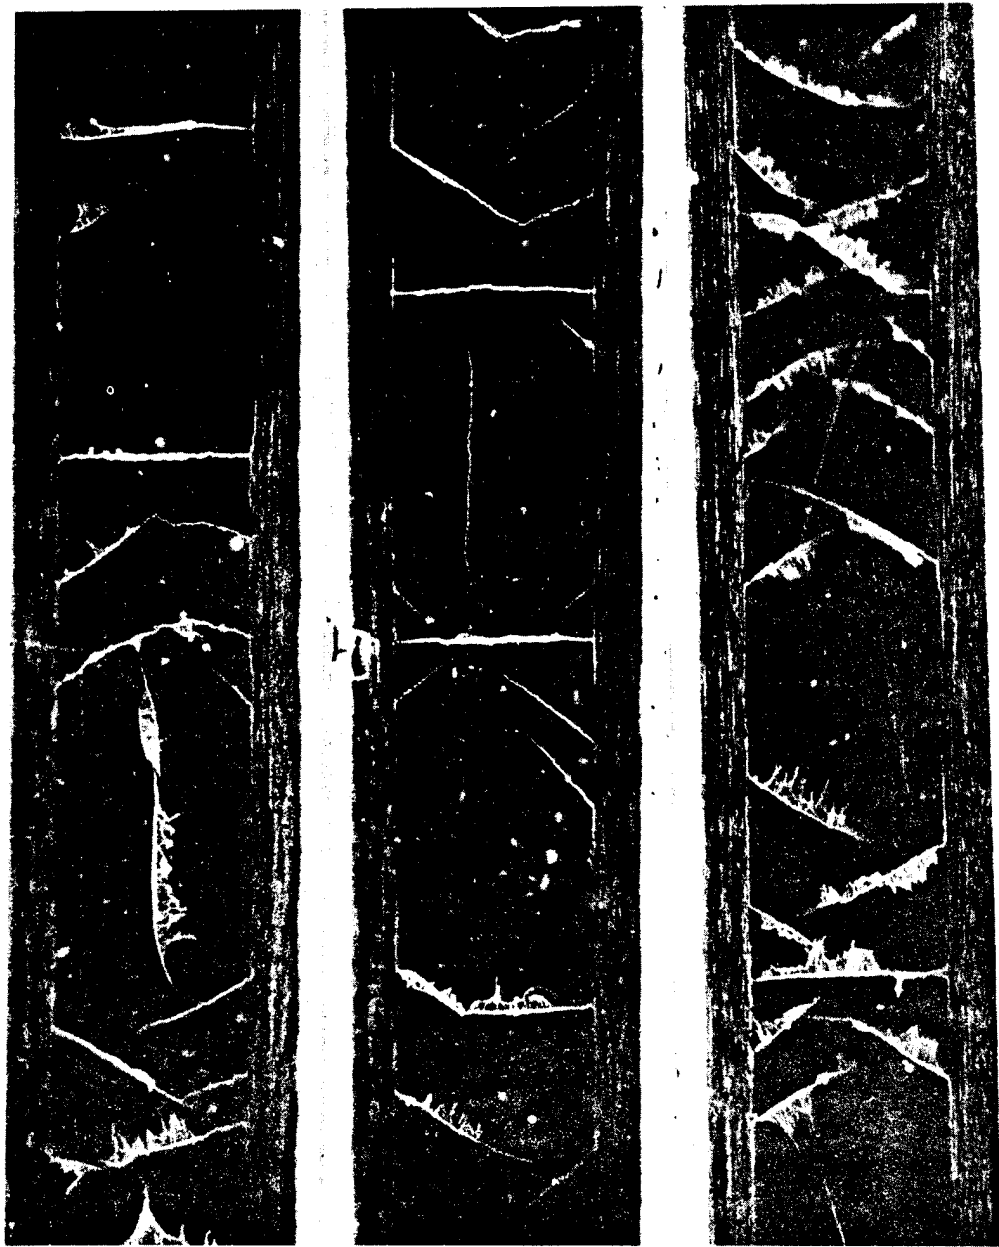
Figure 36: Transverse matrix crack patterns found in Coupon A3 at 0.00975 strain.

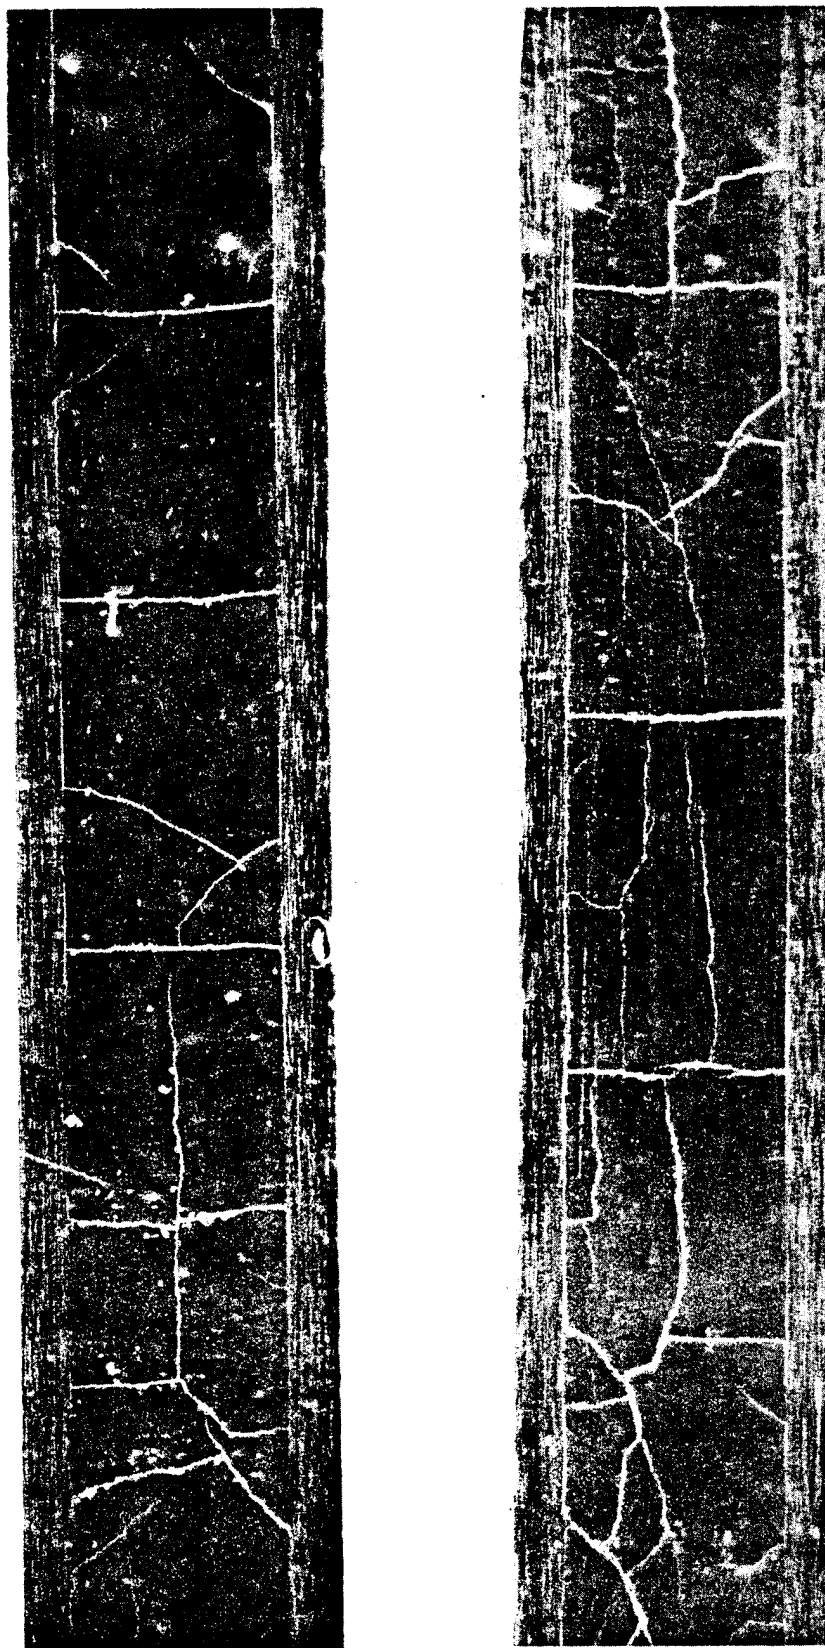
Figure 37: Edge delamination regions found on  $(0_2/90_4)_s$  coupon A8 after 50 000 fatigue cycles.

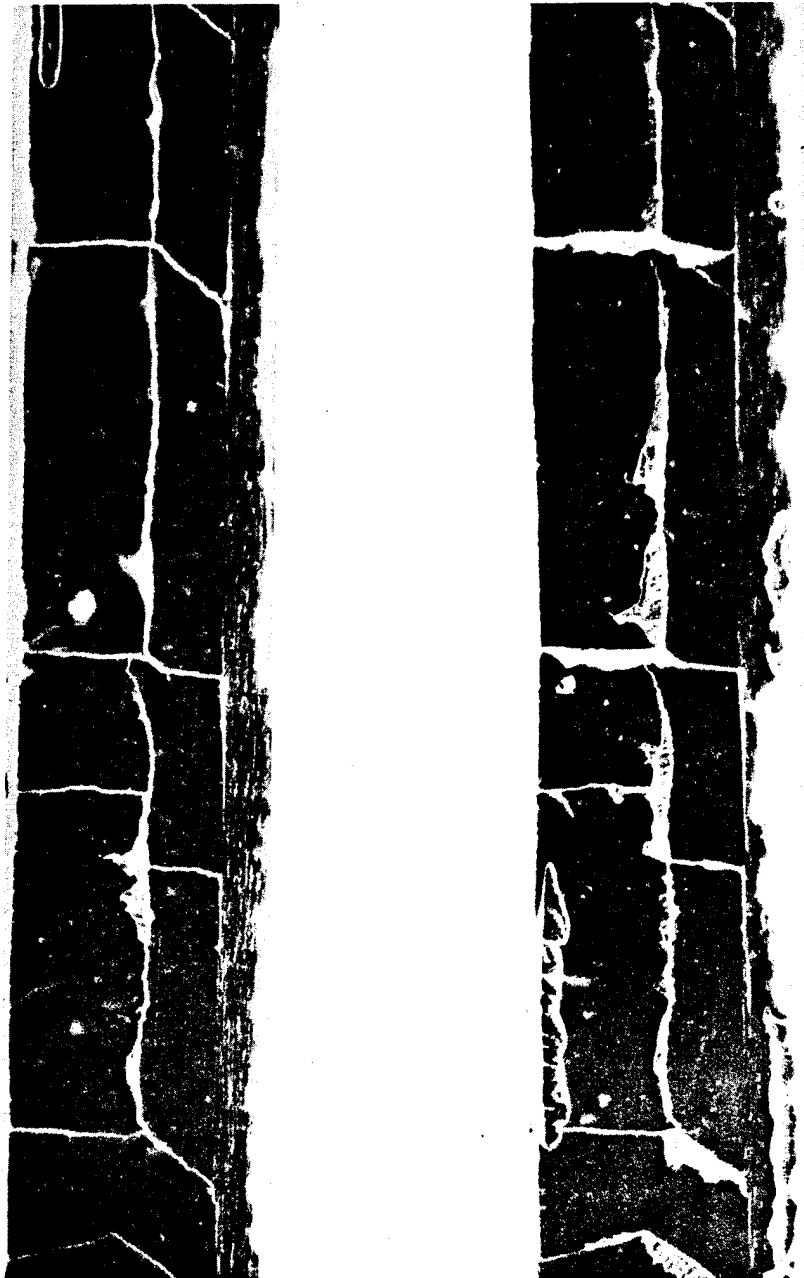
Figure 38: Edge replicates of same location of coupon A6 fatigue  
cycled at  $\epsilon_i = 0.006$ .

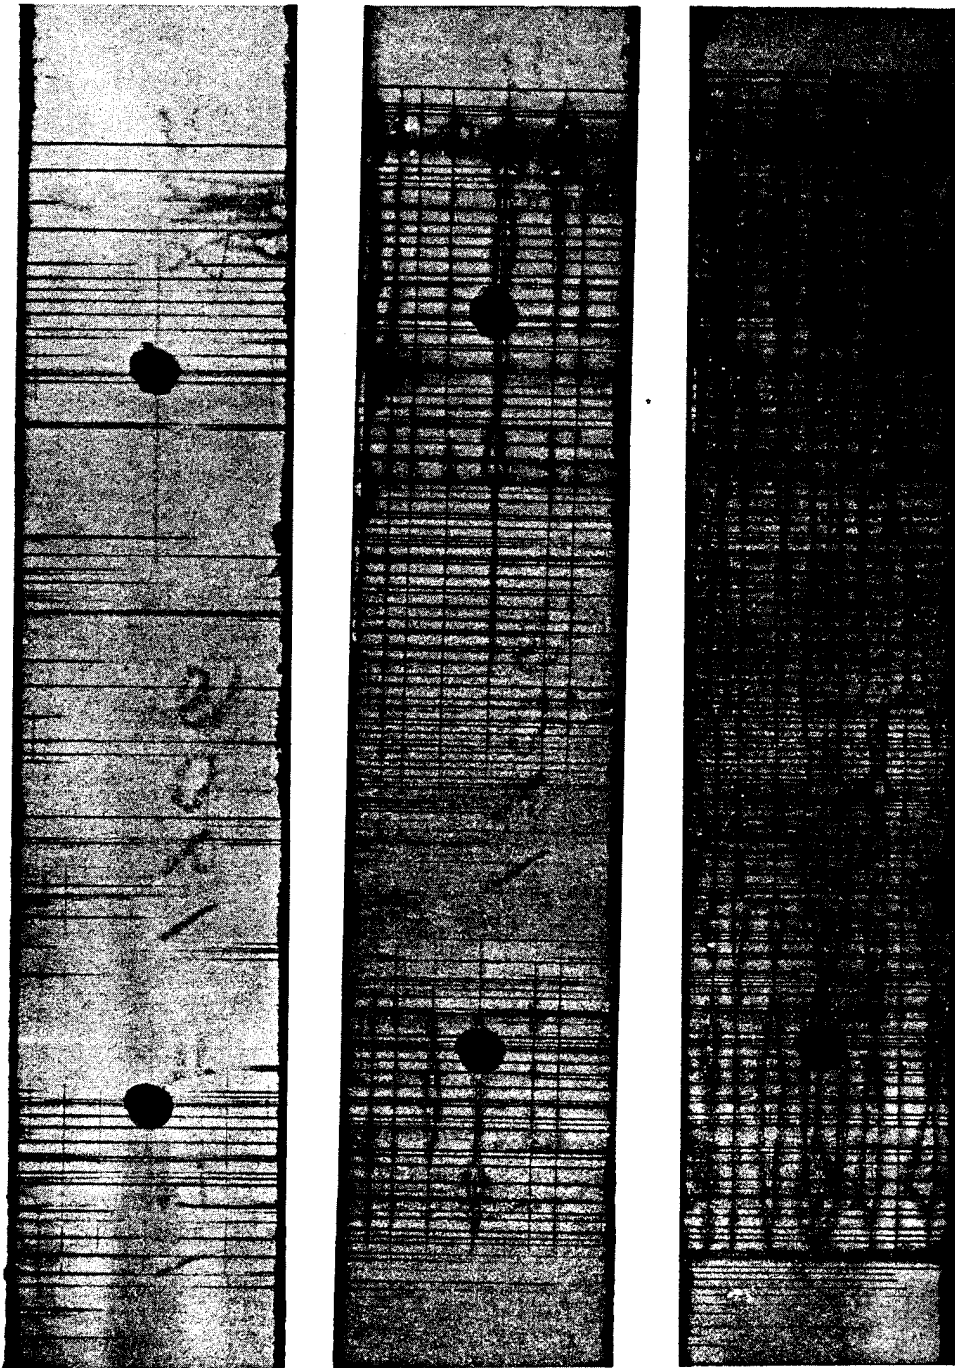
Figure 39: Enhanced x-ray photographs of coupon A6 showing  $90^\circ$  matrix cracking,  $0^\circ$  splits, and delamination; Initial  $\epsilon = 0.006$ .
