Report No. CG-D-05-96

Ohmsett Tests of:

**The CANFLEX "Sea Slug" Temporary Storage Device
and the DOAS Flotation Collar**

**FINAL REPORT
April 1995**

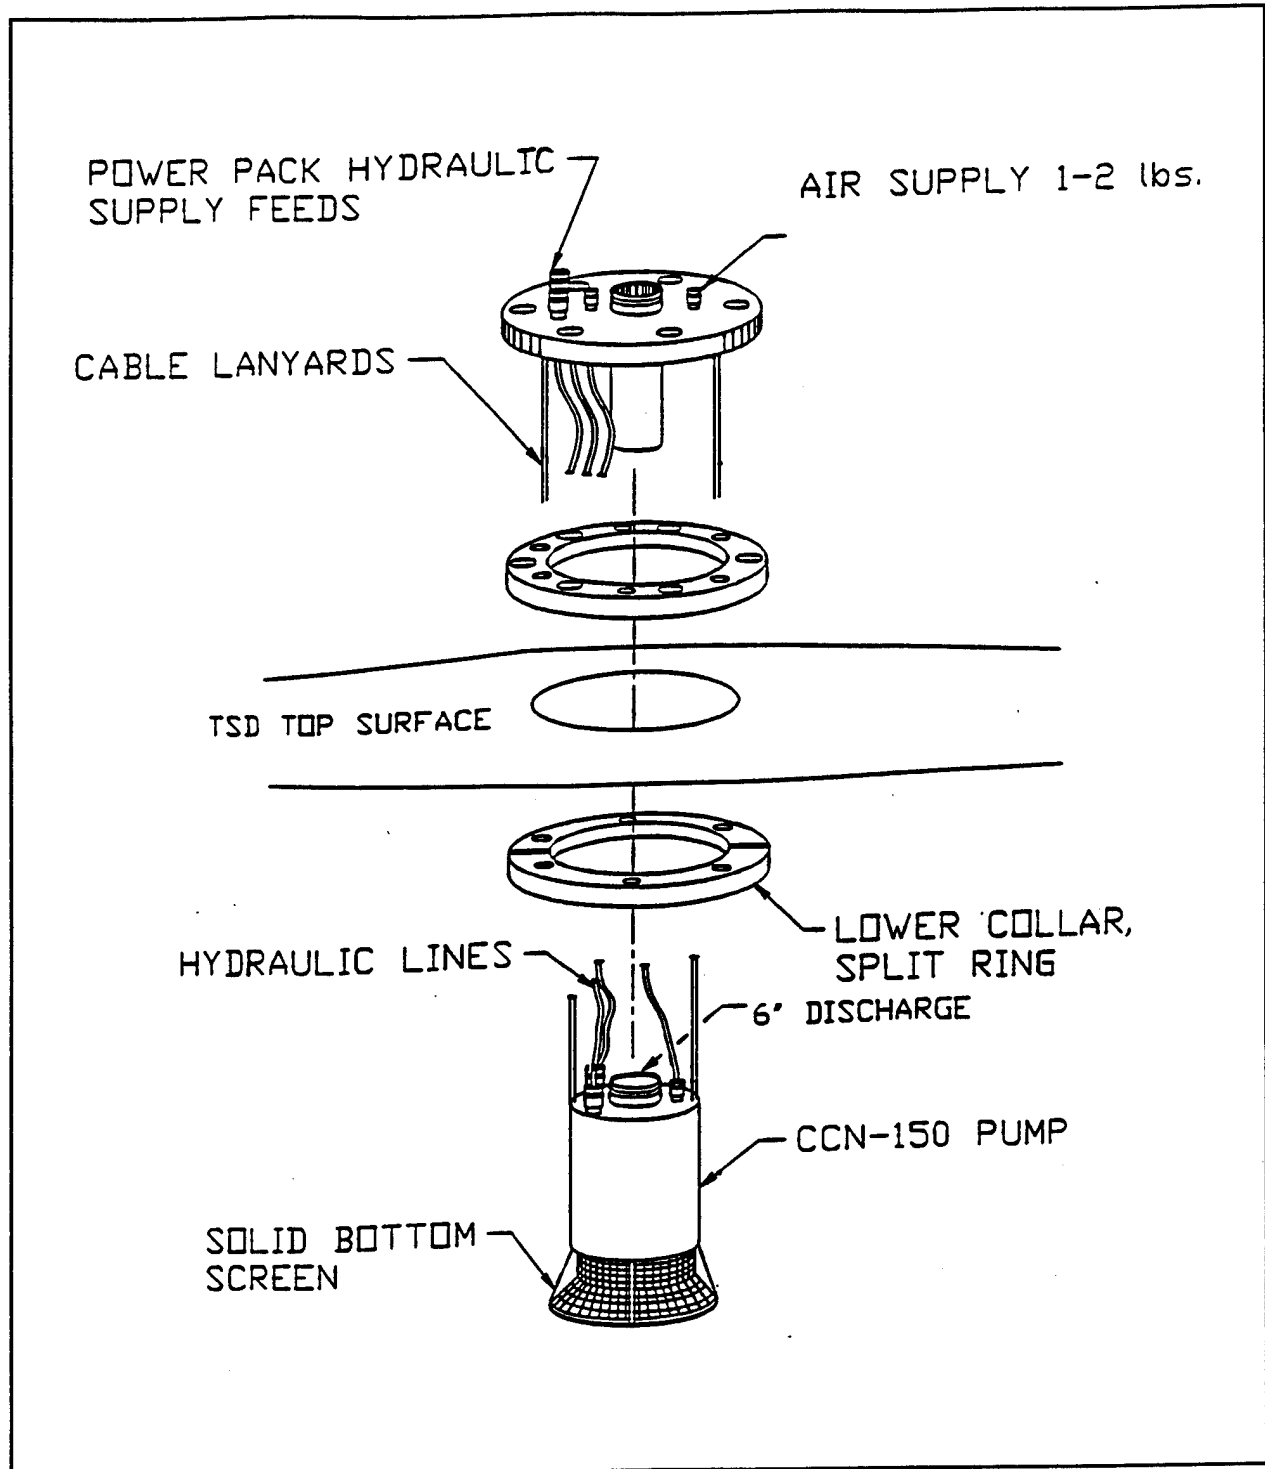
Figure 3 Arrangement for CCN 150 Pump Installation

In the Centrally Located Pump Offloading Tests, the CCN 150 pump was mounted as shown in Figure 3 through the top center opening in the "Sea Slug." The center plate on the top of the TSD was modified for this test. The existing 16 inch diameter ring was replaced by a 20 inch outside diameter, 16 inch inside diameter ring. A support plate was fabricated to bolt on top of the new ring. This support plate had connections for the pump discharge pipe, hydraulic connections and an air supply line for pressurizing the bag. The CCN 150 pump was suspended from this plate by two cable lanyards so that it was just at the bottom of the fully inflated bag.

The pump setup for this test is shown in Figure 3. The intent was to allow the oil to flow from the ends of the TSD to the mid length where the pump was located. The flotation added to the ends of the TSD to improve its towing abilities as a result of the at-sea trials was also expected to benefit this method of offloading by raising the ends of the TSD as fluid was removed. The weight of the centrally located pump was also expected to help by forcing down the middle portion of the TSD. Past experience with similar methods of offloading show that the bag tends to collapse around the pump suction as the bag empties. As a result the bag must be inflated with air to keep the bag away from the pump. The air pressure also assists moving the fluid to the bottom of the TSD. During

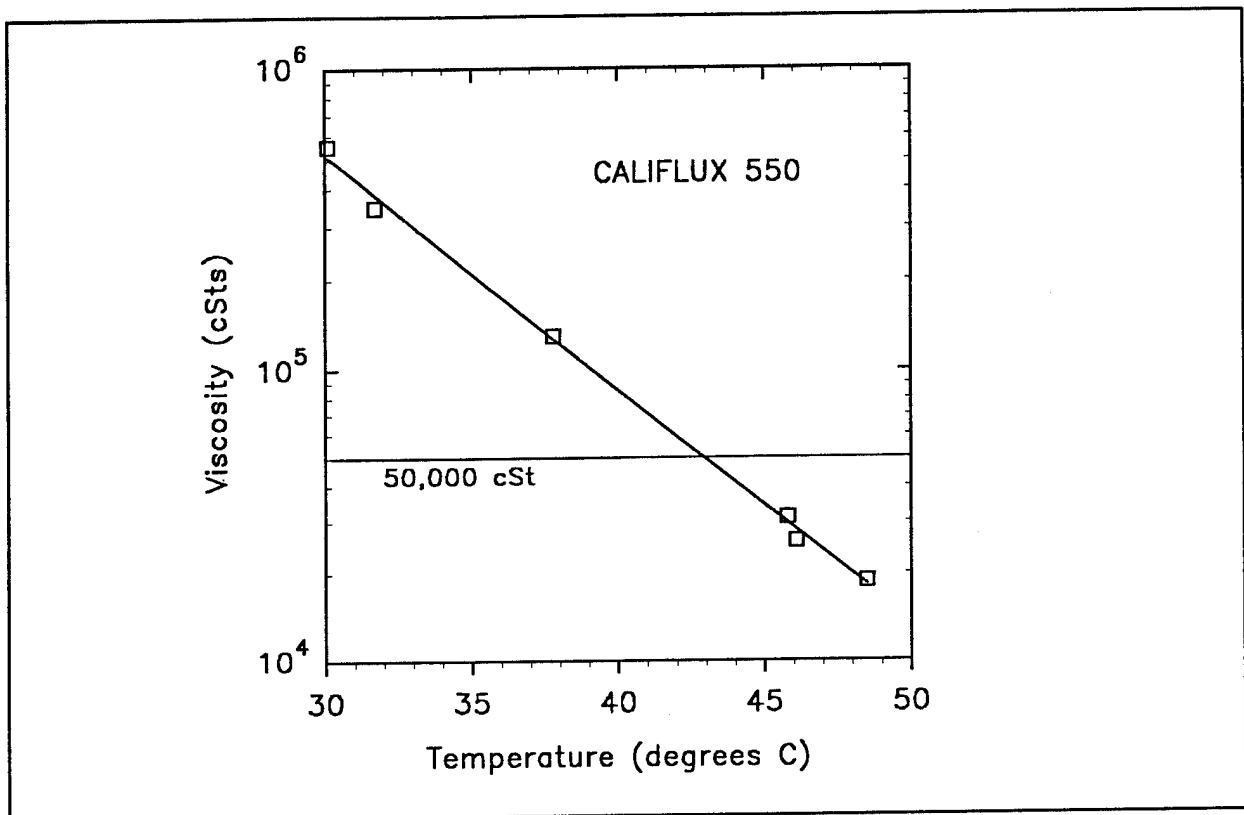
Figure 5 CALIFLUX 550 Viscosity Versus Temperature

The oil used for the DOAS offloading tests was Califlux 550 which has a kinematic viscosity of 50,000 cSts at 42°C. Figure 5 is a plot of the viscosity curve for Califlux 550. The main parameter for the offloading test oil was the viscosity. It was desired that the viscosity be close to 50,000 cSts. The storage tanks were capable of maintaining the oil at an elevated temperature which fluctuated around 42°C (107.5°F).

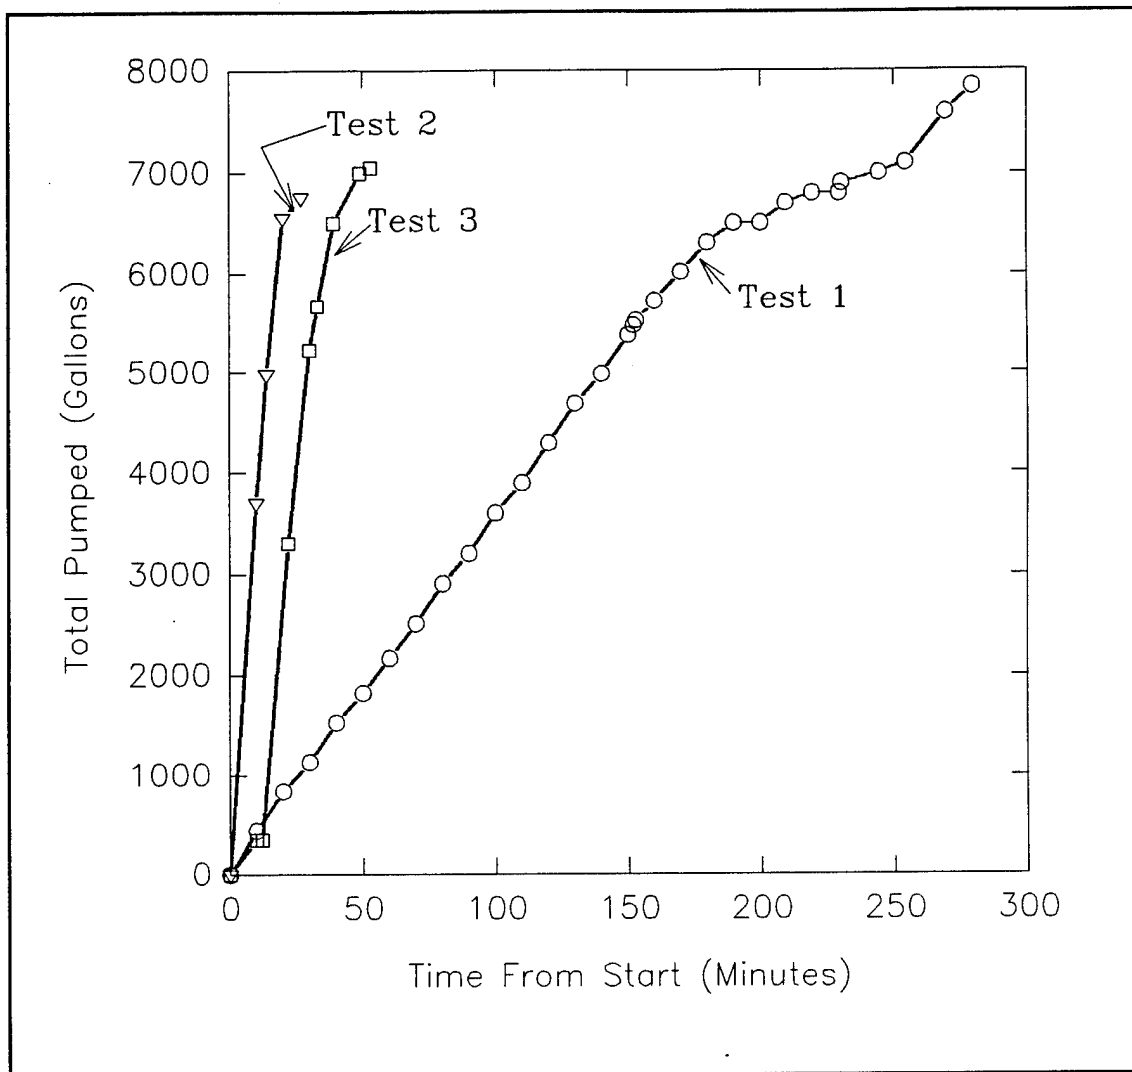
Figure 10 Plot of Discharge Rate for Centrally Located Pump Offloading Tests

Table 3 and Figure 10 show the results of the Centrally Located Pump Offloading Tests. The oil used in these tests was less viscous than that used in the tests with the DOAS pump. Oil viscosity was approximately 2,600 cSt versus 50,000 cSt plus for the DOAS tests. In these tests the TSD was pumped down to between 1,150 to 2,450 gallons remaining. However, these numbers are only approximate. They are based on the oil added versus the oil pumped out. There may have been some additional fluid in TSD after each test. Based on these quantities of fluid remaining, between 91 to 95 percent of the contents could be removed from a fully loaded, 25,000 gallon TSD. The offload rate varied from 20 minutes to offload 6,500 gallons in test 2 to 40 minutes to offload the same amount in test 3. However, the added time in test 3 was due to an initially slow pumping rate possibly caused by a clogged pump suction. This was cleared about 12 minutes into the run and the rate for the remainder of the run was similar to that of test 2. The test 3 rate indicates that a full offload (23,000 gallons) would take 2 hours and 21 minutes. The rate for test 2 indicates only half this time would be needed. The test 2 time is the more accurate barring clogging of the pump.

The results from test 1 of the centrally located pump tests should be disregarded. It was found that the partially detached inner liner of the TSD was blocking the pump suction causing a much lower pumping rate than in tests 2 and 3.

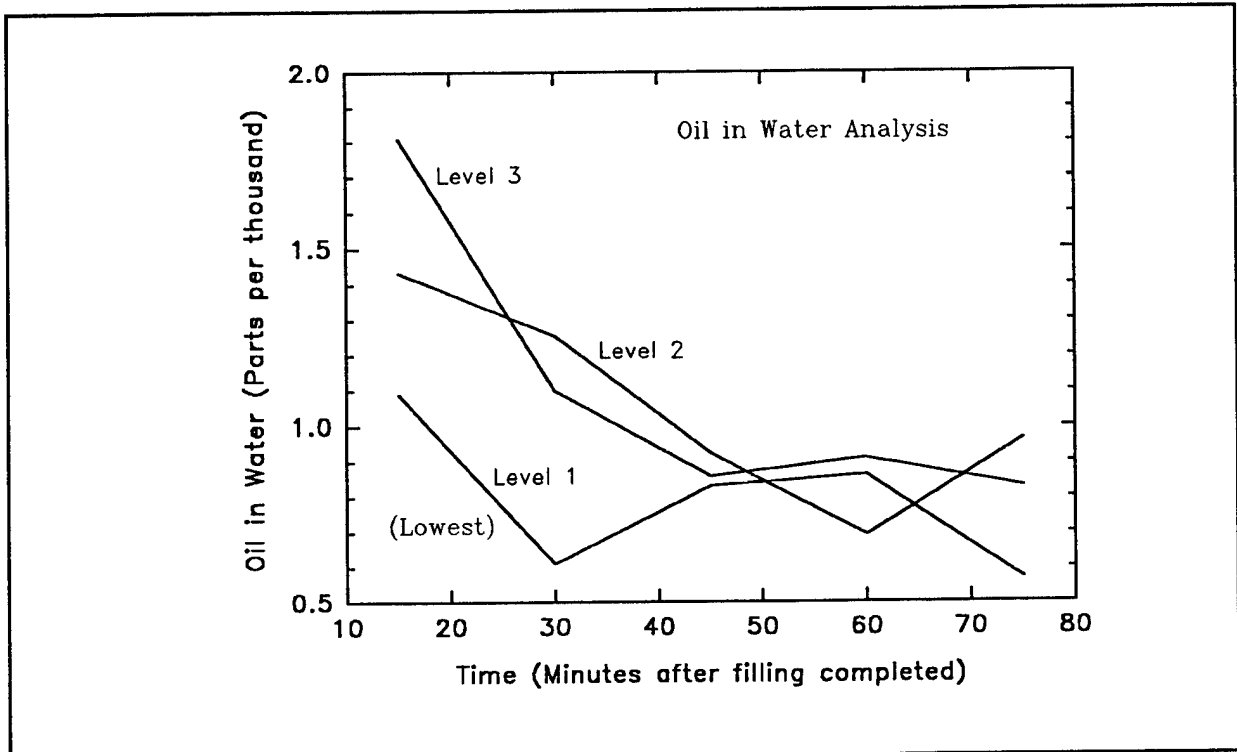
Figure 11 TSD Oil Separation Test - Three Lower Sample Levels

In the decanting test, samples were taken over a five foot vertical range inside the "Sea Slug." The samples were taken one foot apart with the lowest one foot from the bottom and the highest five feet from the bottom. This range represented 57% of the total height.

Each level was monitored five different times, 15 minutes apart. Samples were identified by numbers for heights with 1 being the lowest and 5 the highest. The levels, 1 through 5, represent the following percent of the "Sea Slug's" volume from the bottom when the "Sea Slug" is 100% full.

The lower portion of the liquid in the TSD could be decanted off on site provided that water with 1 part per 1000 of oil can be discharged. There is not a sharp break line between oil and water but the amount of oil in the water below the theoretical break line does fall off very rapidly after a short settling time. The fluid remaining after decanting can be expected to have between 20 to 80 percent water in it. Much of this water may be held in an emulsion with the oil.
