Analysis of Accidents  
Related to Scaffolding and Floor/Wall Openings

John Vincent Heckmann, Jr.

A thesis submitted in partial fulfillment  
of the requirements for the degree of

University of Washington

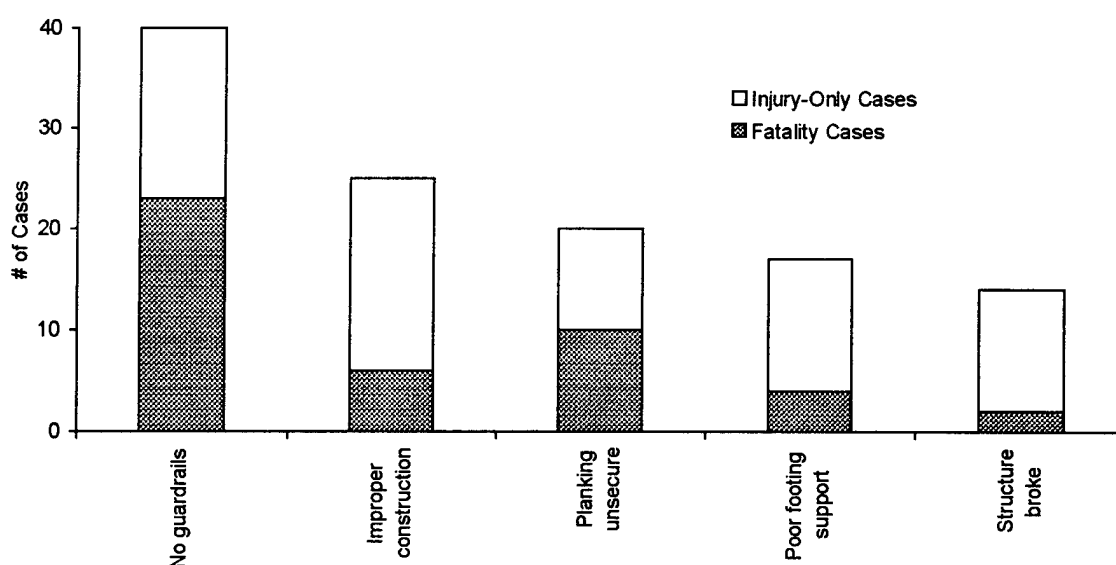
The major causes attributed to tubular welded frame scaffolds focused on the construction of the scaffold (see Figure 54). The 5 most frequent causes involving the construction of the tubular welded frame scaffold accounted for 57% of all cases for this scaffold type. The most surprising fact is that 15.6% of the fatalities are due to not having guardrails installed as required. No complex engineering solution is required to remedy this portion of this scaffold's problem. The equipment simply needs to be utilized as it was designed. Work environment and human causal factors for this scaffold type did not vary from the relative frequencies noticed for all scaffold types reflected in Figures 48 and 49.

Figure 54: Tubular Welded Frame Scaffold Cases by Top 5 Accident Causes
