NASA TECHNICAL NOTE

NASA TN D-2438

FREE-FLIGHT TEST RESULTS ON  
THE PERFORMANCE OF CORK AS  
A THERMAL PROTECTION MATERIAL

*by Randolph A. Graves, Jr., and Thomas E. Walton, Jr.*

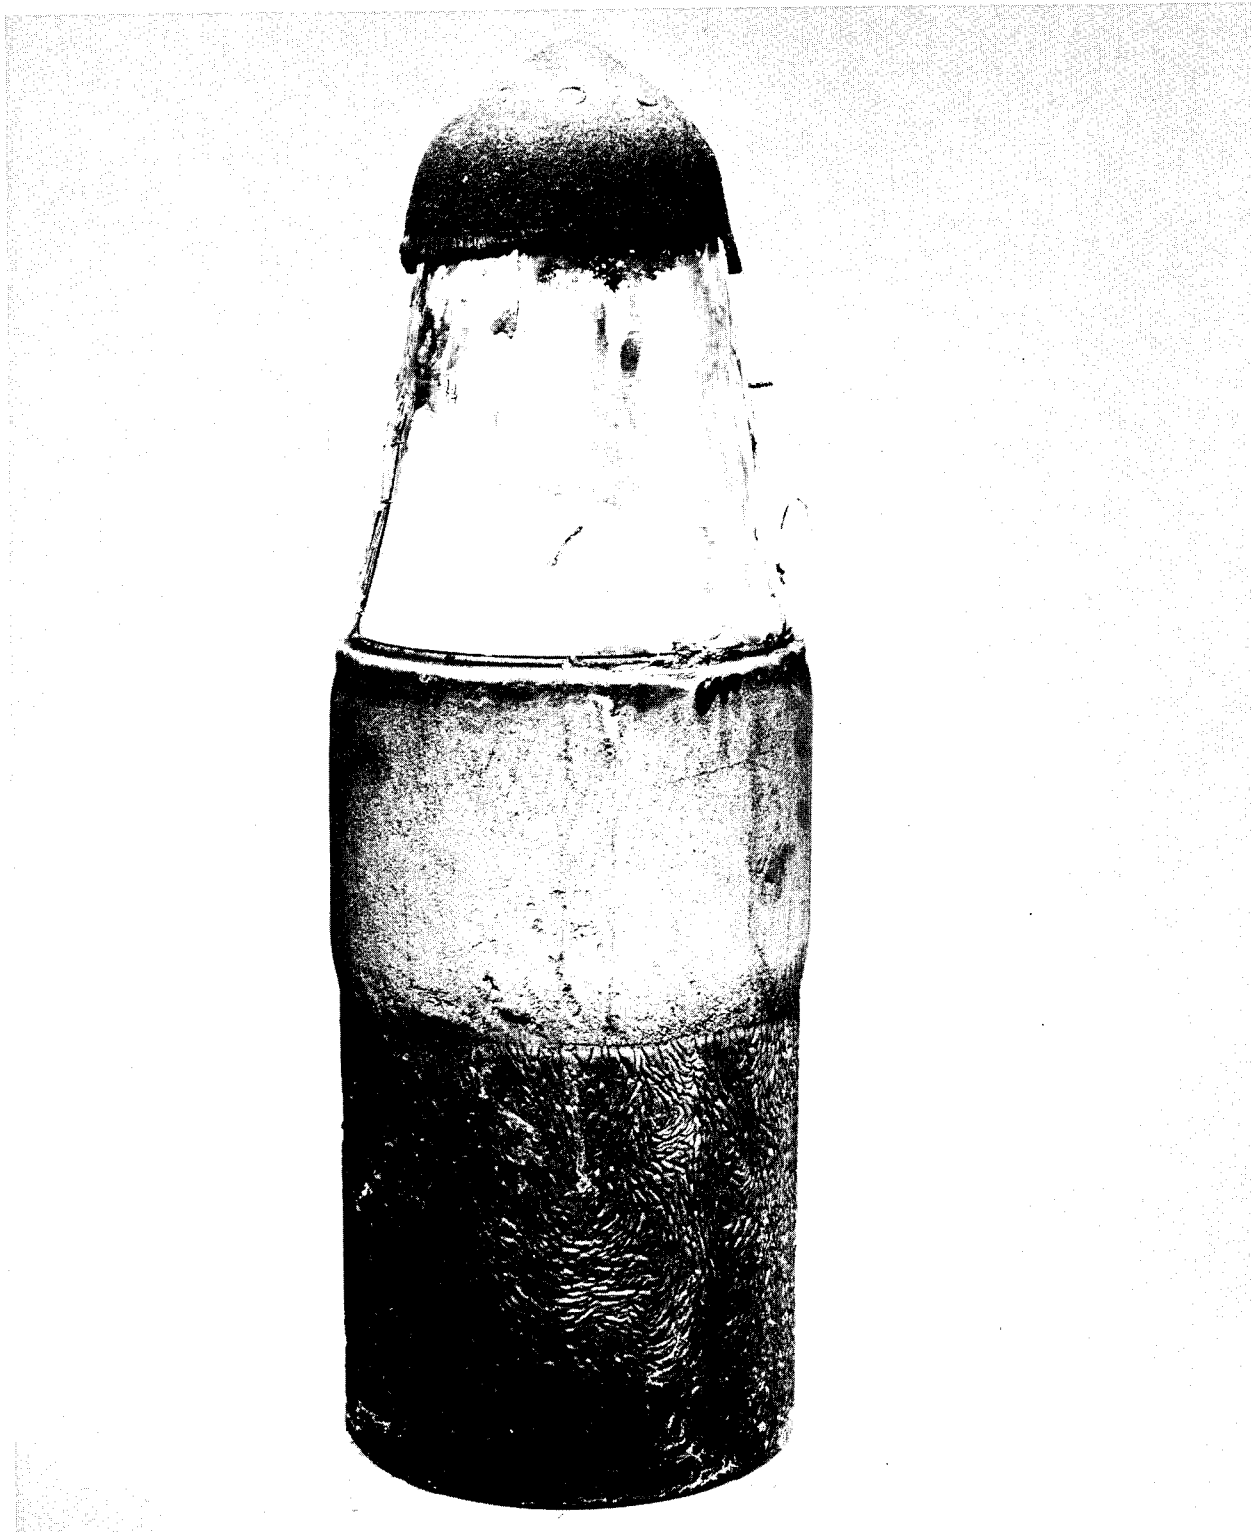
L-63-3991

Figure 29.- Recoverable payload after flight.

A photograph of the recovered payload is shown as figure 29. It can be seen that the hemispherical nose eroded to a conical shape during the reentry.

The epoxy ablation material on the conical afterbody came off during the terminal portion of the flight (about 98 seconds after launch), leaving the cork with a blunted leading edge exposed to the air stream; however, the cork prevented further destruction of the epoxy ablation material on the cylindrical afterbody.
