**Remedial Investigation and Feasibility Study**

**Oliktok Point Radar Installation,  
Alaska**

**ICF Technology Incorporated**

**15 APRIL 1996**

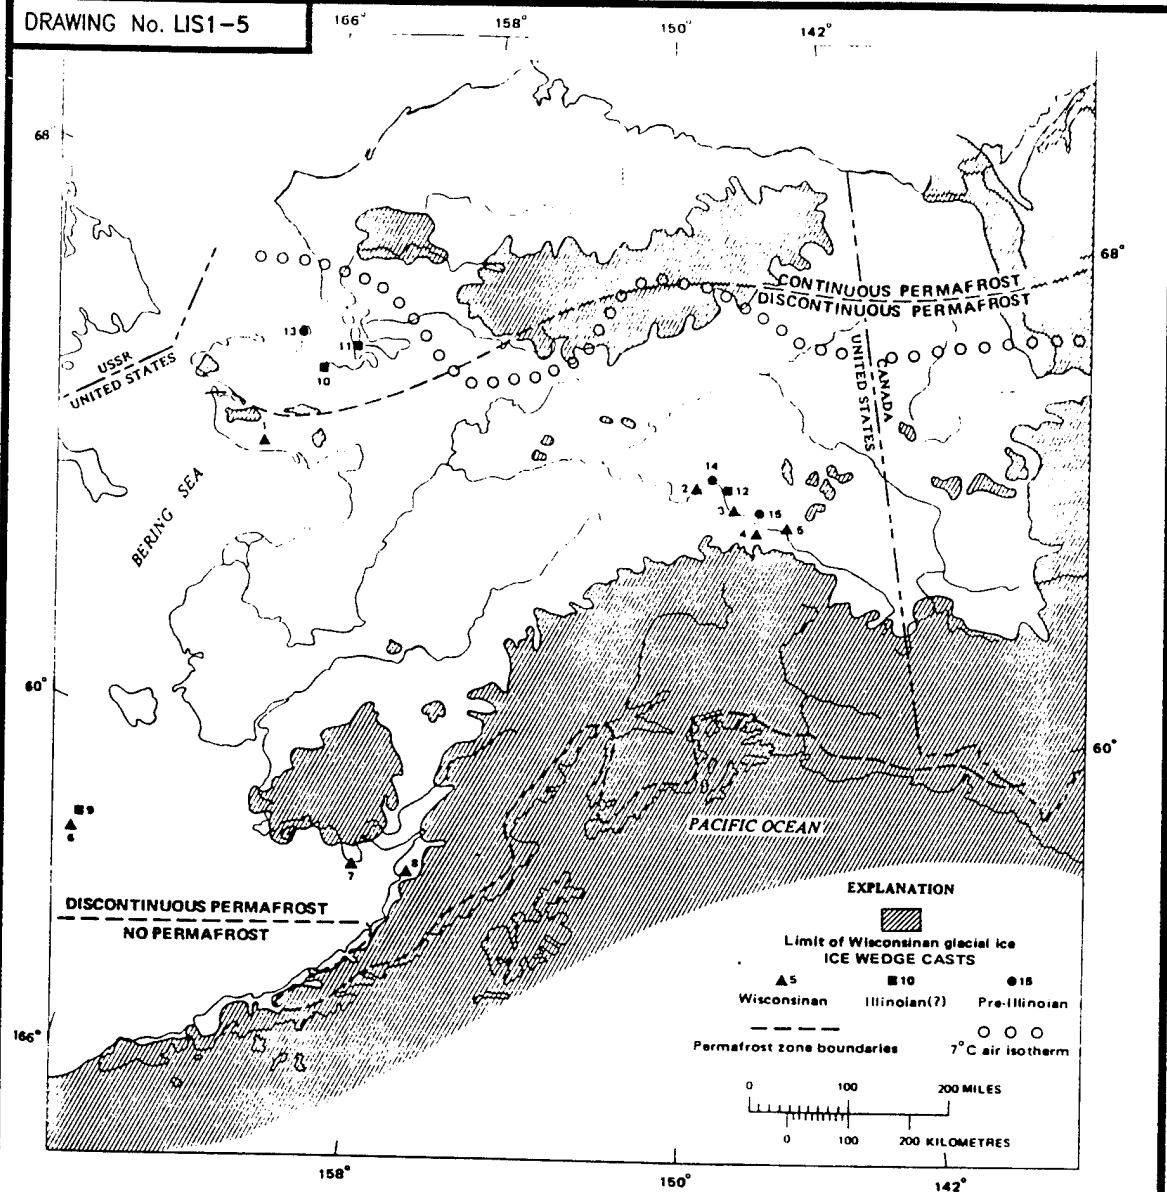
DRAWING No. LIS1-5

PERMAFROST MAP

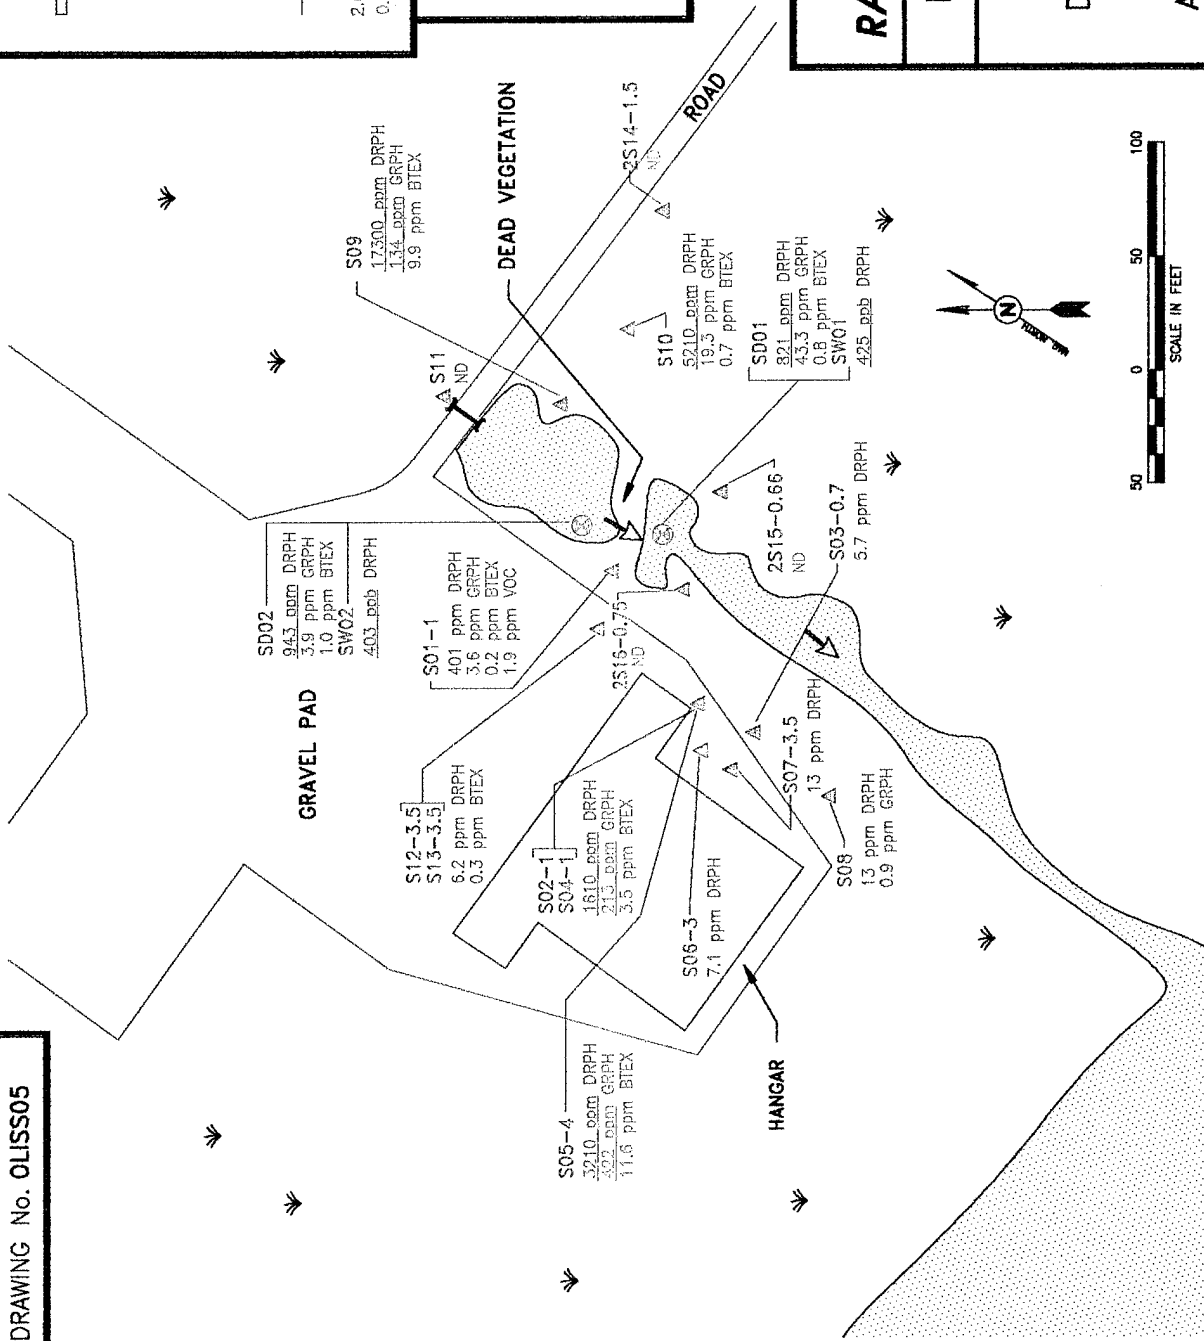
FIGURE NO. 4-1

DIESEL SPILL (SS05)  
SAMPLE LOCATIONS  
AND  
ANALYTICAL RESULTS

Sampling and analyses have determined that the Diesel Spill (SS05) site is contaminated with petroleum compounds [DRPH and gasoline range petroleum hydrocarbons (GRPH)] and volatile organic compounds (VOCs) [including benzene, toluene, ethylbenzene, and xylenes (BTEX)] commonly associated with diesel fuel. The contaminated media at the site include a small portion of the gravel pad east of the hangar and the adjacent tundra northeast of the hangar. The source of contamination is suspected to be spills and/or leaks associated with overfilling of the diesel day tank located near the east wall of the hangar. Analytical data indicate that there is a potential for contaminant migration.

Levels of DRPH, GRPH, and BTEX (total) detected in site soil/sediment, however, exceed ADEC guidance cleanup levels and contaminants may be migrating in the surface water. Therefore, the site is being recommended for remedial action. The contaminated area at the site consists of approximately 237 cubic yards of gravel and 1,111 cubic yards of tundra. The remedial action alternative recommended for all media at the site is enhanced bioremediation. A complete description and evaluation of the remedial alternatives considered for this site are presented in the FS, Section 5.0.

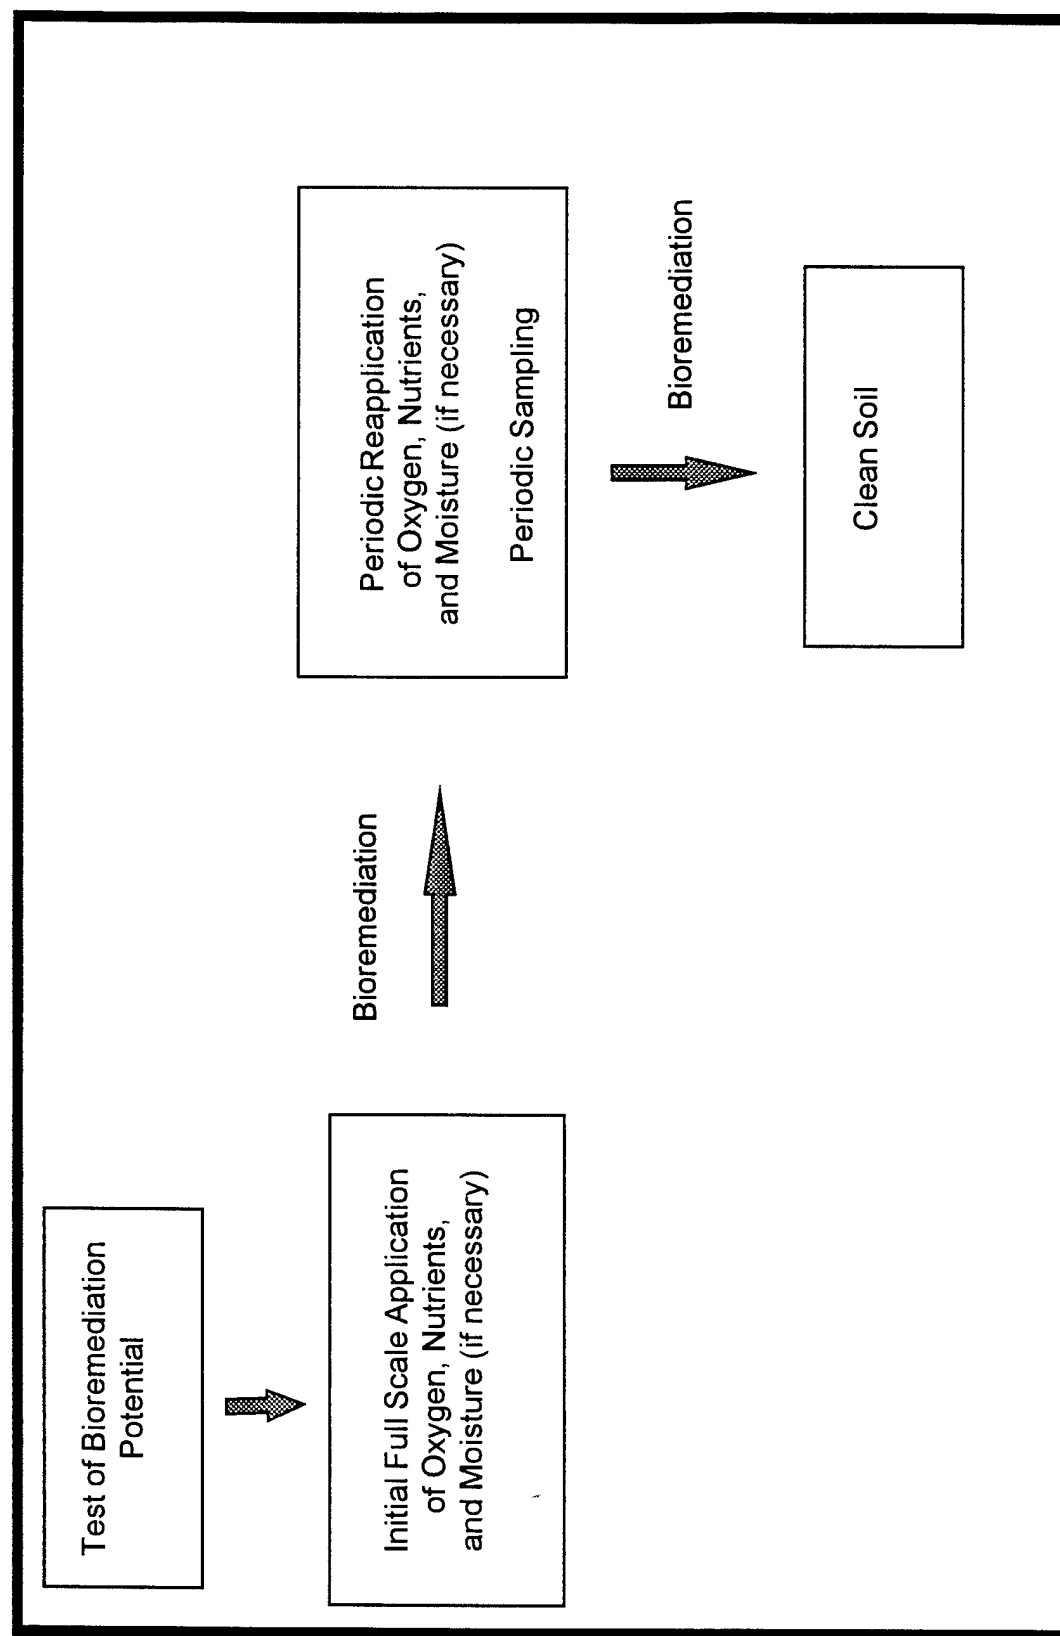
**Figure 5-5: Enhanced Bioremediation Process Flow Diagram**

The remedial action alternative recommended for the tundra at the site is enhanced bioremediation. A complete description and evaluation of the remedial alternatives recommended for this site are presented in the FS, Section 5.0.

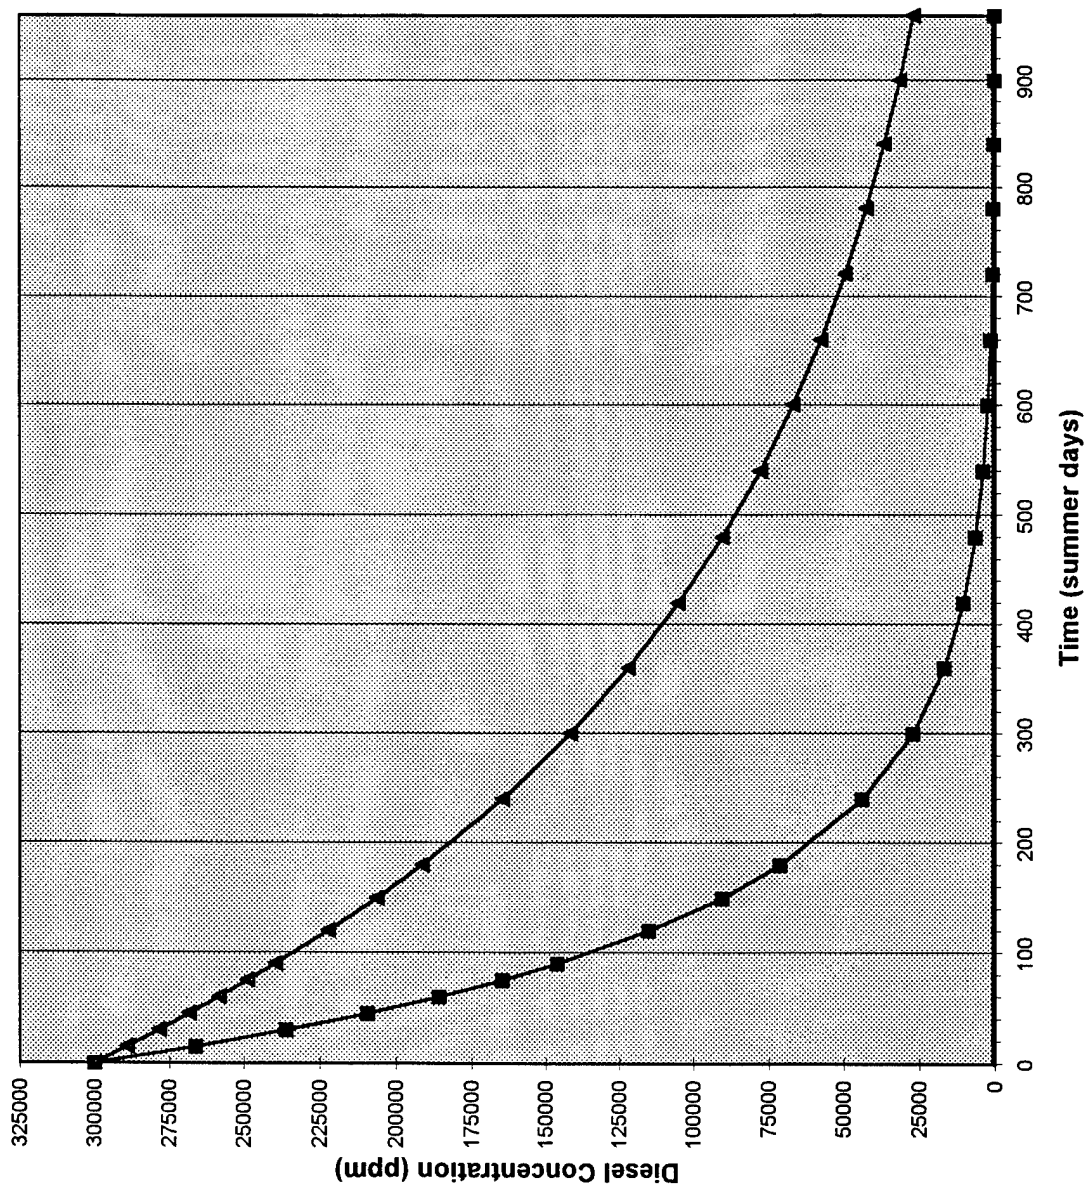
**Figure 5-7. Comparative Biodegradation of Diesel Fuel in Soils**  
 (Basis: Maximum Diesel Concentration of 300,000 at Oliktok Point)

Degradation is modelled by a decay function  $C = C_0 e^{(-kt)}$  with  $k$  in units of (1/day), and  $t$  in units of (day)

Enhanced Bioremediation  $k = 0.008$   
 Natural, Unassisted Bioremediation  $k = 0.0025$

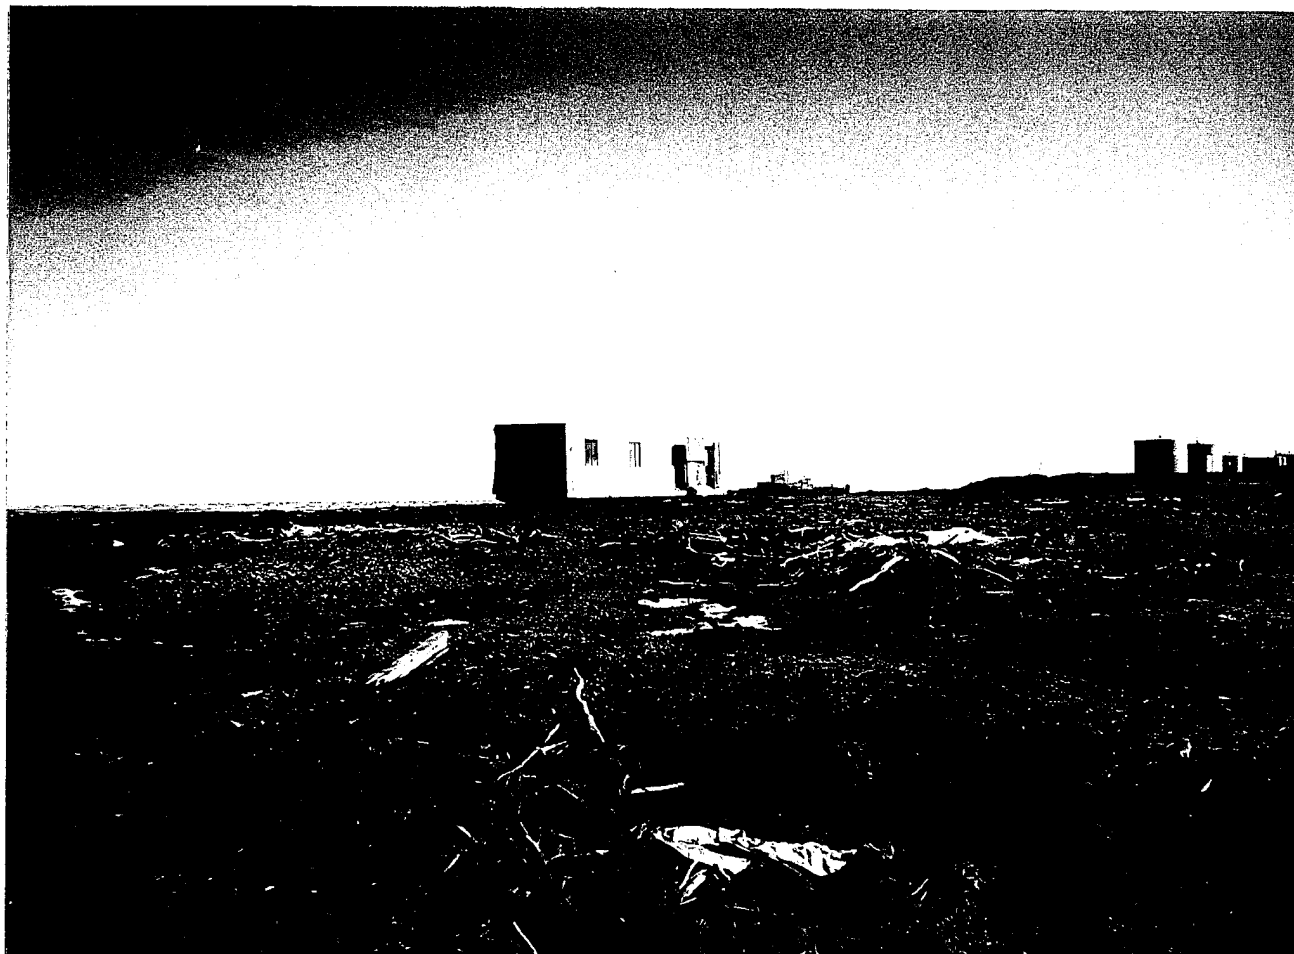
The Old Landfill (LF01) site is the location of the old station dump that received all wastes generated by the station, other than those that were incinerated, from 1956 to approximately 1978. This is a view to the northeast.

or future site uses, remedial action are not warranted at the site. No significant human health or ecological risks were identified at the site. Therefore, the Old Landfill is recommended for no further action.

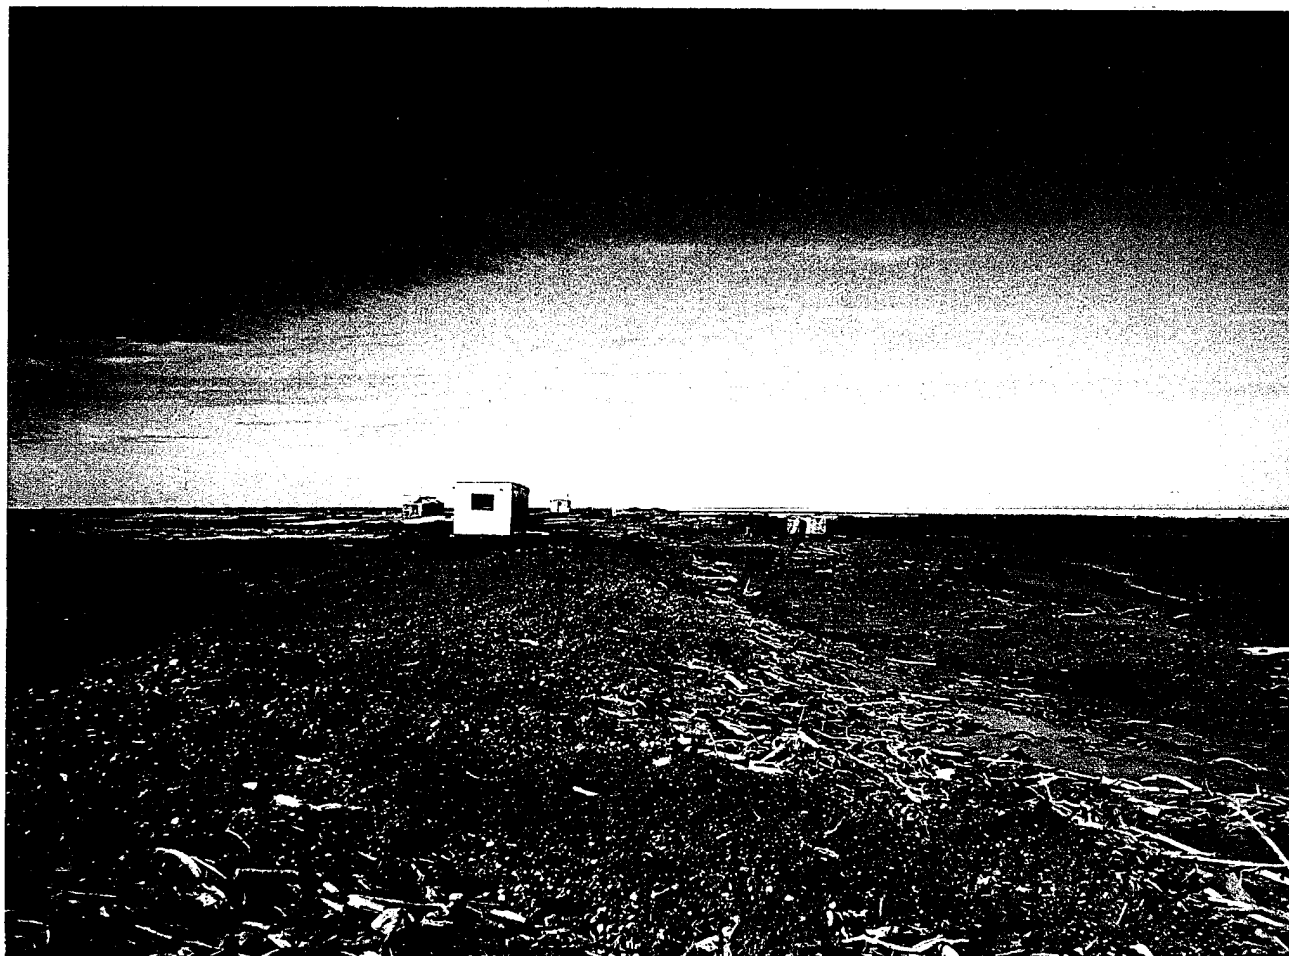
The Dump Site (LF02) site is located east of the Old Landfill (LF01) and north of the Dock Storage Area (ST03). This view is to the west.

Sampling and analyses have determined that the Dump Site (LF02) is not contaminated. Only a very low level of toluene in one soil sample and metals that were not at a level of concern were detected at the site. As no significant contaminants were detected at the site, there appears to be no potential for contaminant migration or risk to human health or ecological receptors. Based on the RI sampling and analyses and risk assessment, the Dump Site (LF02) is recommended for no further action.

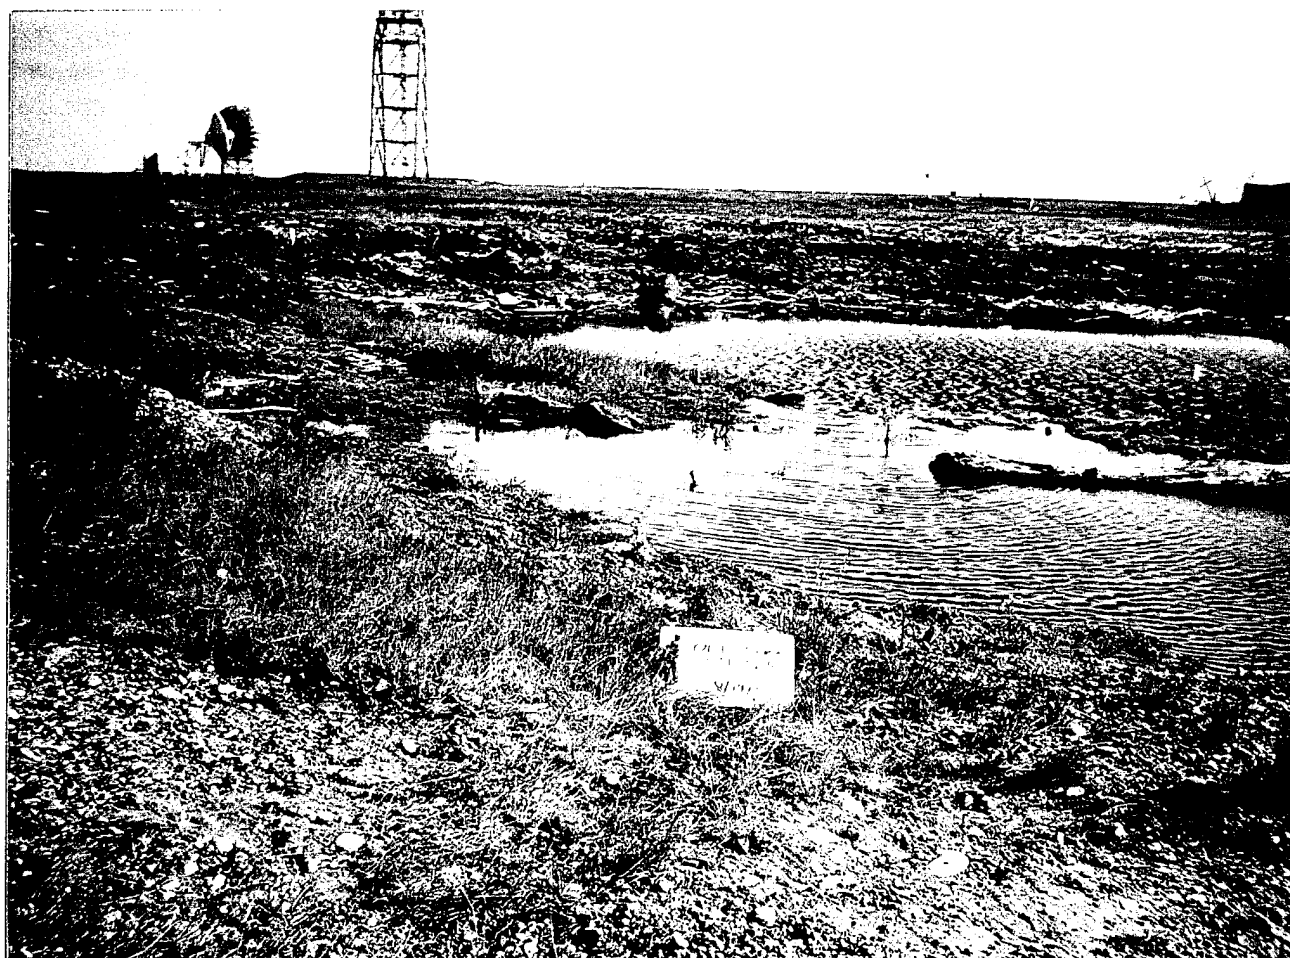
This is a view to the southeast of the Dock Storage Area (ST03) site. Drums were removed from this site prior to 1987.

Sampling and analyses have determined that low levels of contaminants [primarily diesel range petroleum hydrocarbons (DRPH)] were detected at the Dock Storage Area (ST03). Only low levels of contaminants were detected in soil/sediment and surface water. The source, although unknown, is suspected to be migration from spills and/or leaks associated with the Old Sewage Area Petroleum Spill (SS11). It is also possible that isolated spills and/or leaks caused by previous drum storage activities at the site could be a source. The site is presently inactive, so there is no longer a contaminant source at the site. Analytical data indicate that migration of contaminants from the site is minimal.

Based on the RI sampling and analyses and the risk assessment, remedial actions are not warranted at the site. No significant human health or ecological risk was identified at the site. Therefore, the Dock Storage Area (ST03) site is recommended for no further action.

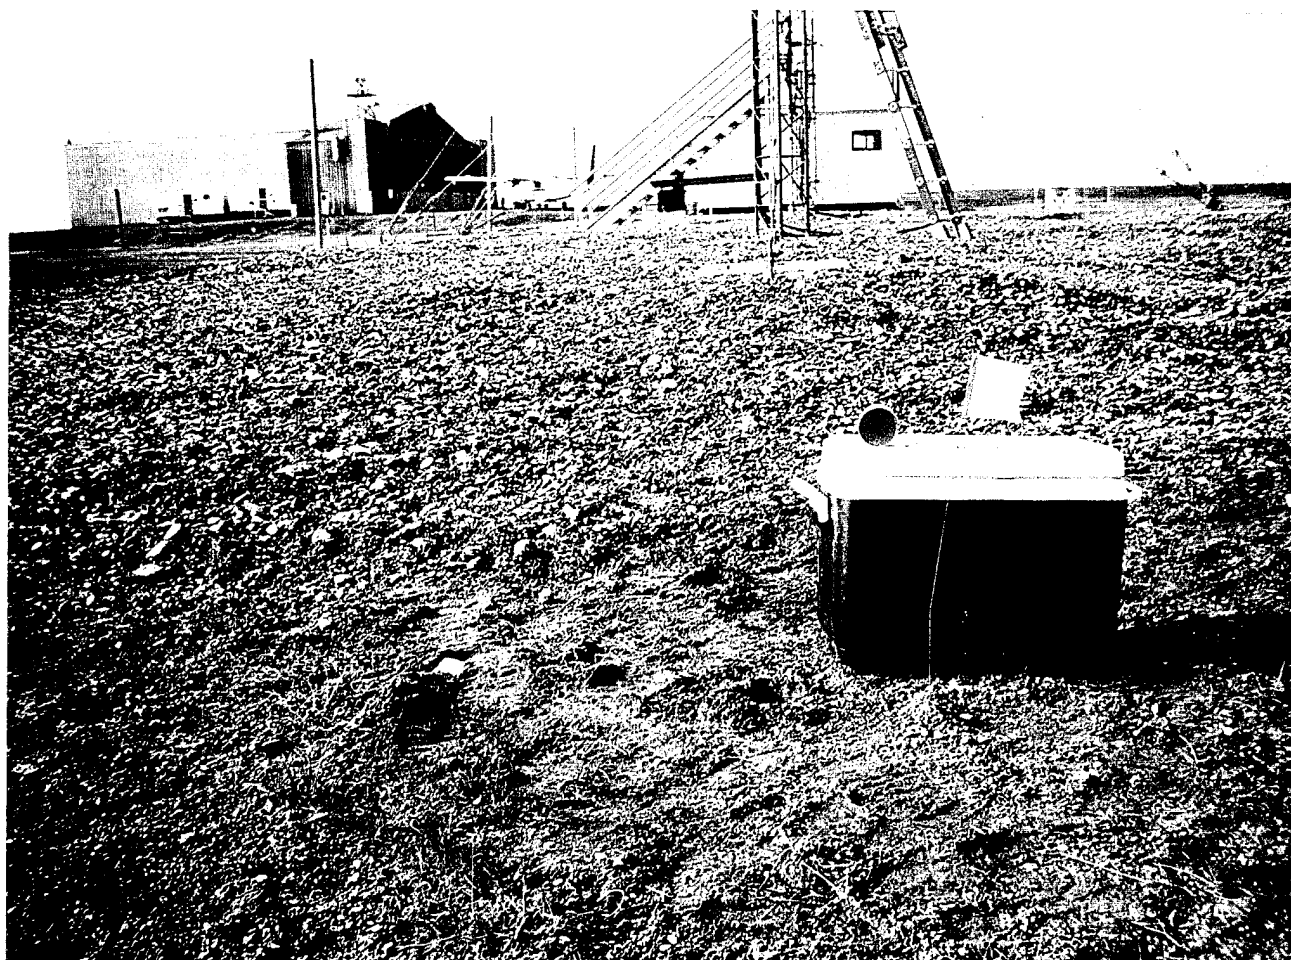
This is a view to the southwest of the POL Storage (ST04) site. The gravel pad area is presently a weather monitoring station. Drums were removed after 1987. The Diesel Spill (SS05) site is located in the upper left corner of the photo.

Sampling and analyses have determined that there is no significant contamination at the POL Storage (ST04) site. Only relatively low levels of contaminants were detected. Their source is suspected to be spills and/or leaks from previous drum storage activities. The POL Storage is presently used as a weather monitoring station; drums are no longer stored at the site.

Based on the RI sampling and analyses, risk assessment, and current or future site uses, remedial actions are not warranted at the site. No significant human health or ecological risks were identified at the site. Therefore, the POL Storage (ST04) site is recommended for no further action.

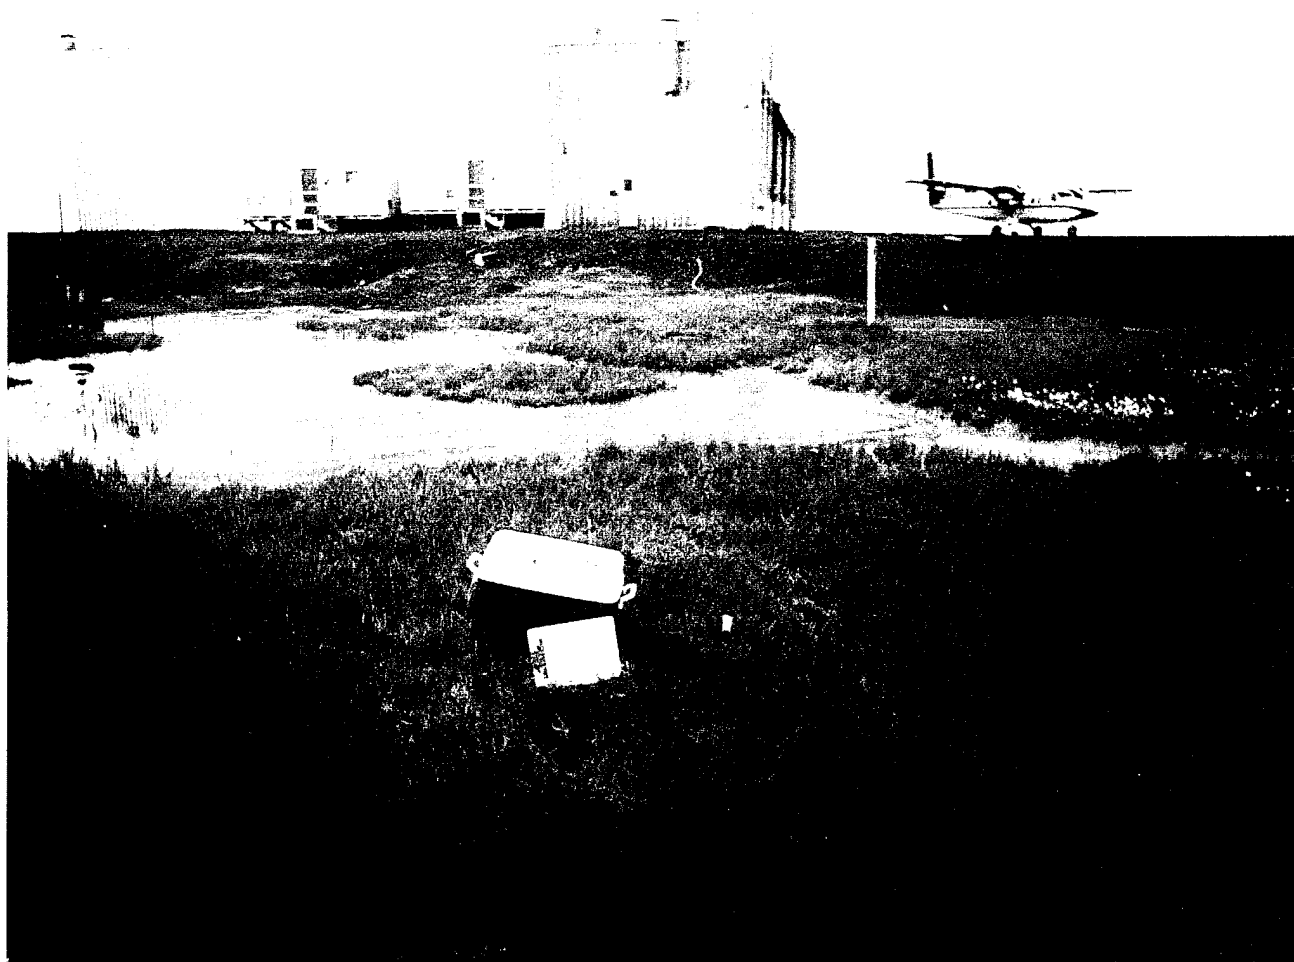
A view to the west of the Diesel Spill (SS05) site. The site is adjacent to the east side of the hangar.

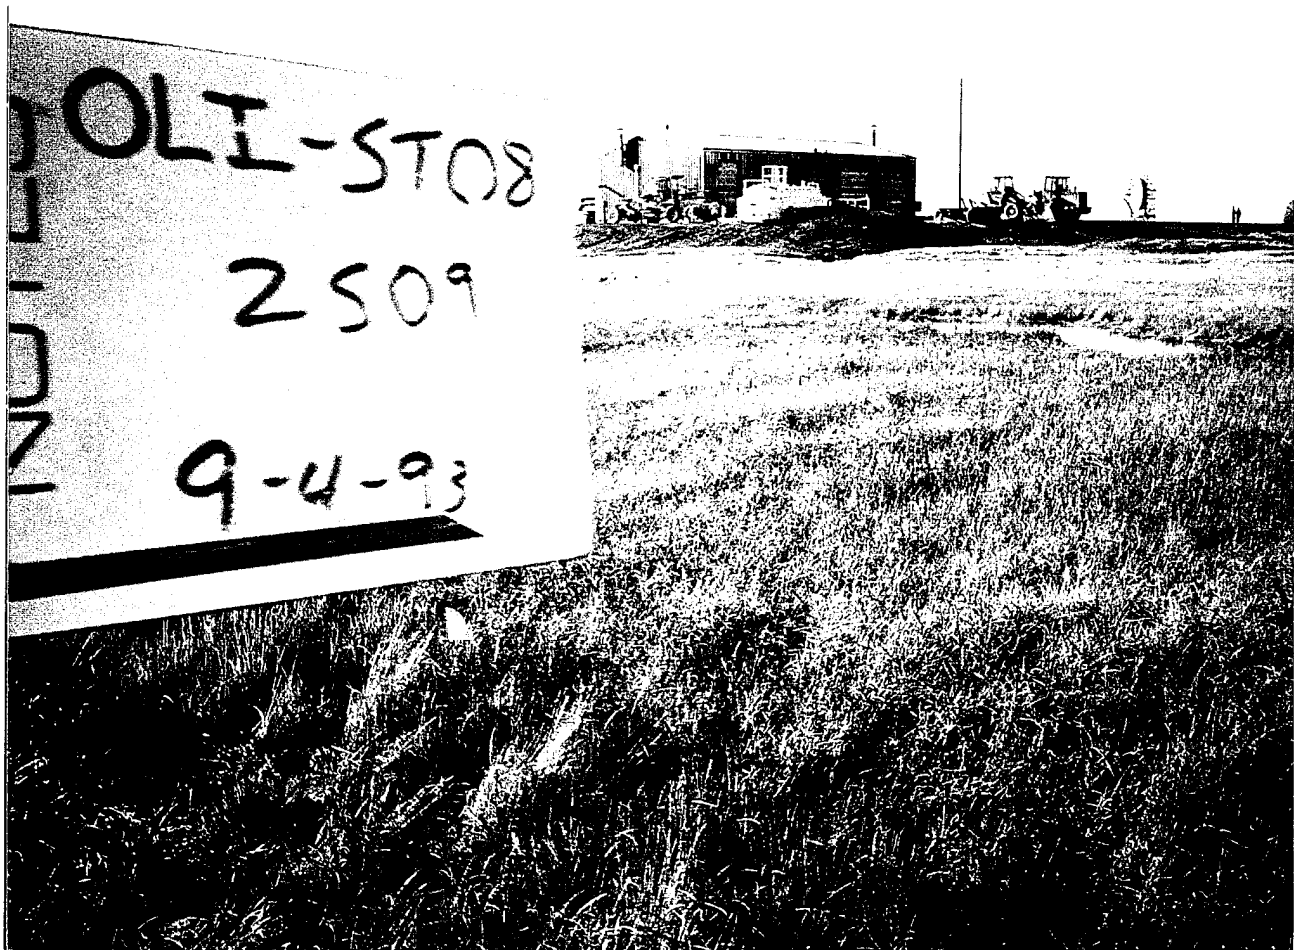
This is a view to the south of the Gasoline Storage Area (ST08) site. Two steel diesel storage tanks were formerly located on the gravel pad in front of the garage. The site extends out into the tundra.

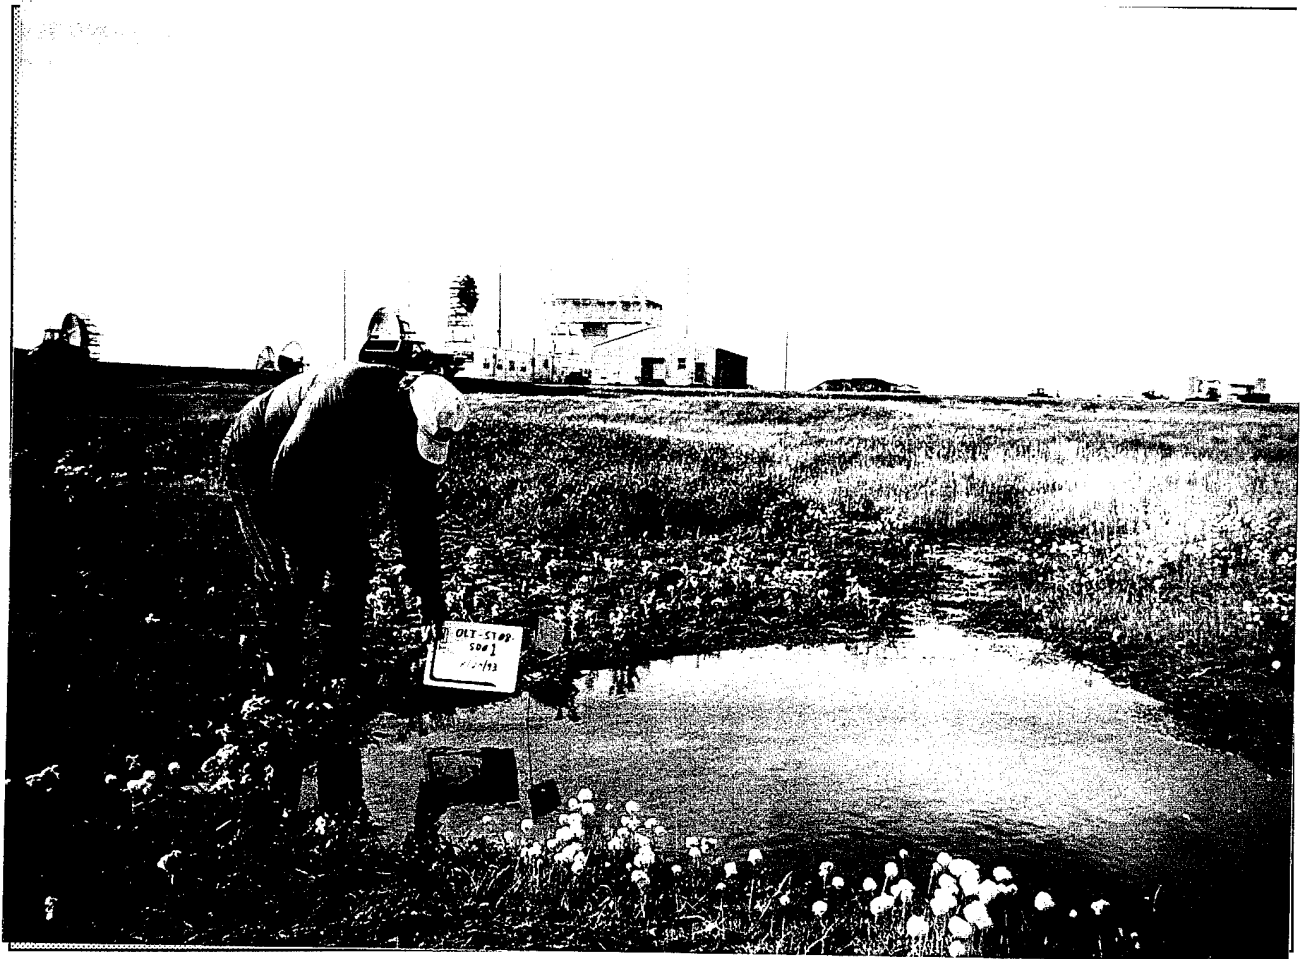
This view is to the southwest of the Gasoline Storage Area (ST08) site. The gravel pad and Garage (SS10) site are located just to the left of this photo.

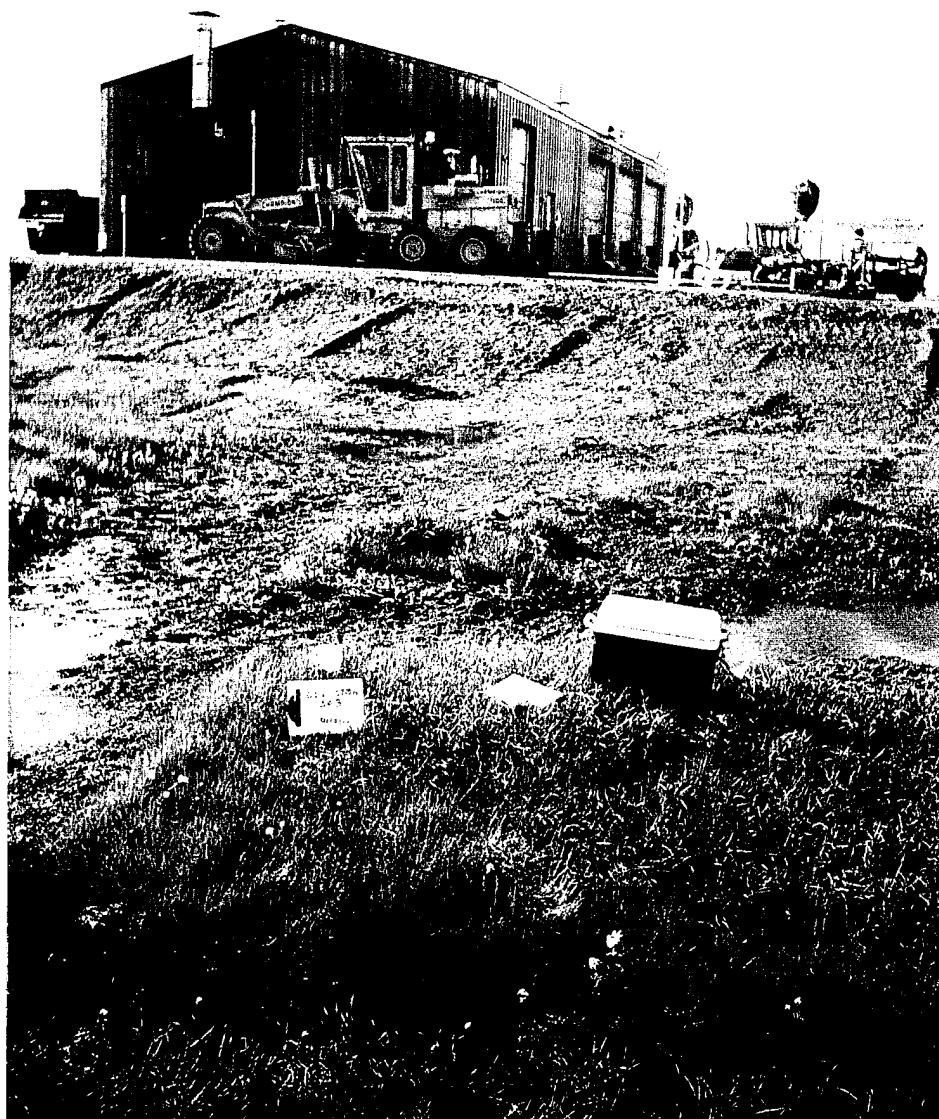
The Garage (SS10) site and the Gasoline Storage Area (ST08) site are adjacent. Samples were collected in the tundra in this photo for the Gasoline Storage Area (ST08) site; the Garage is located on the gravel pad.

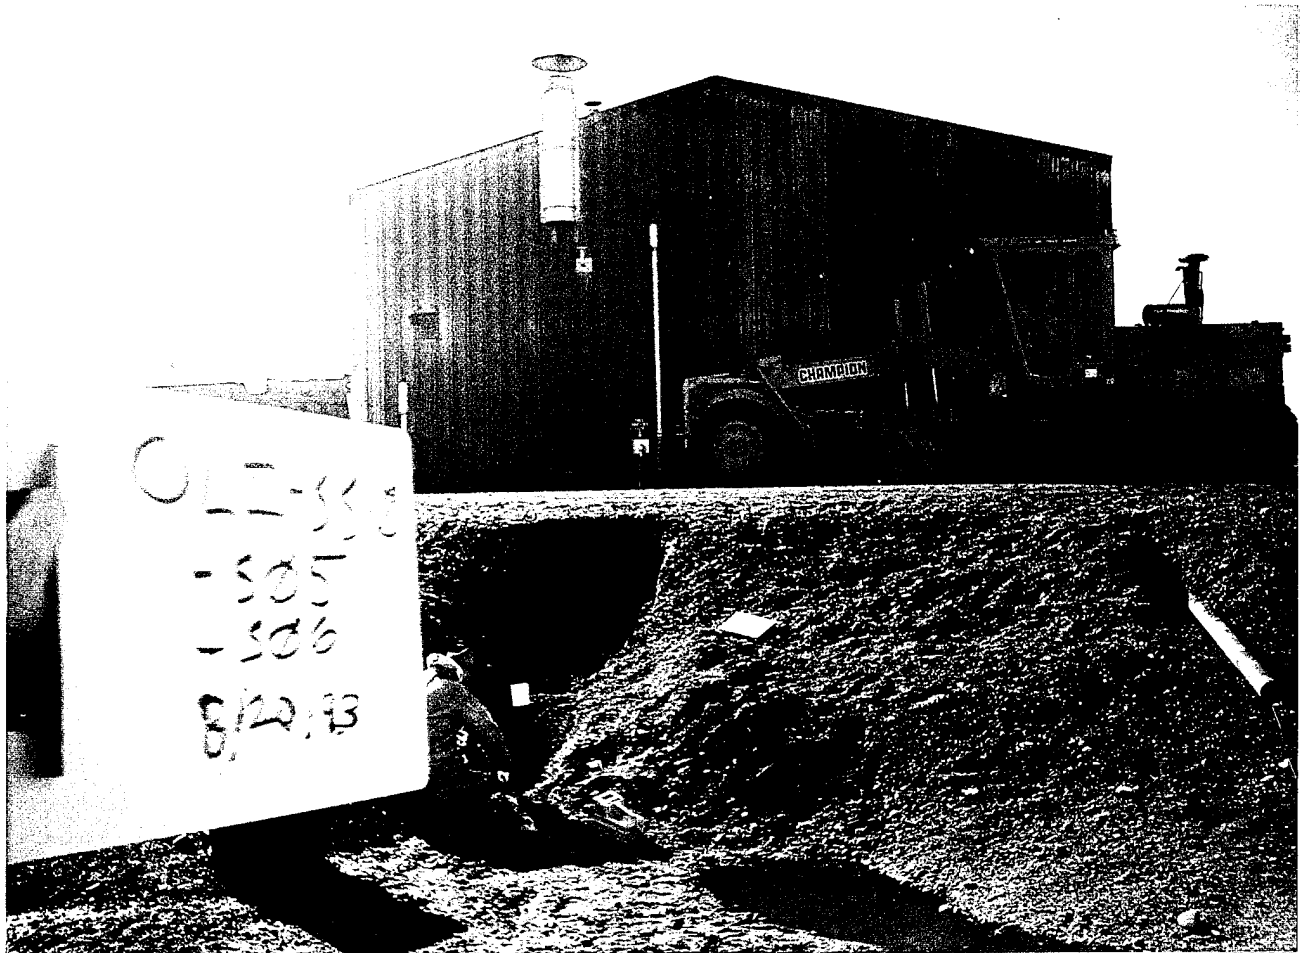
This is a view to the west of the Garage (SS10) site.

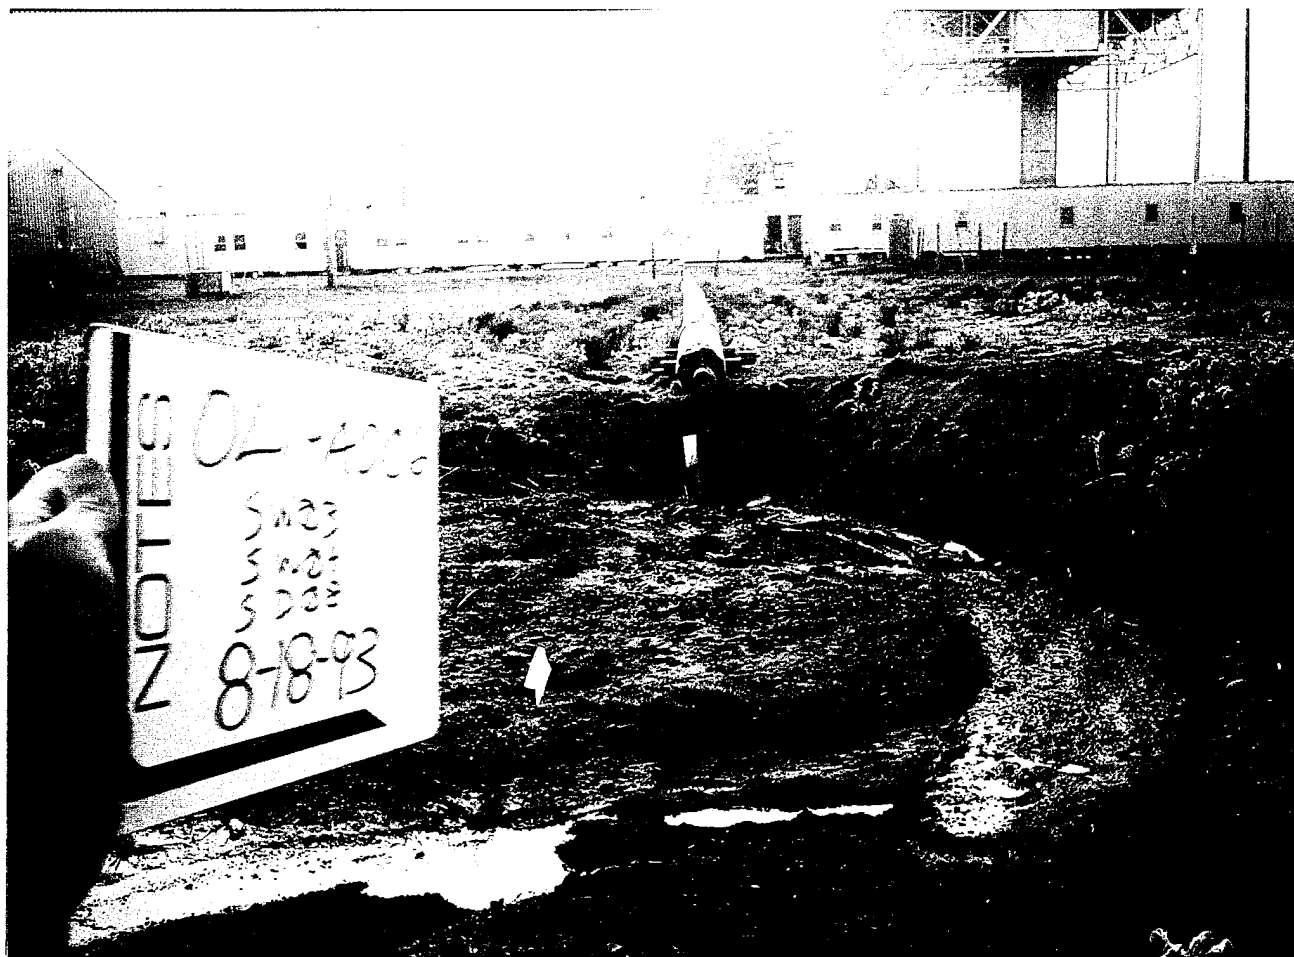
The Old Sewage Area Petroleum Spill (SS11) is located north of the module train.  
This is a view to the south of the inactive sewage outfall pipe.
