TNO-report

96-CMC-R0290

**SHOCK TESTING OF A DRY CHEMICAL  
FIRE EXTINGUISHER inclusive a BRACKET**

TNO Building and  
Construction Research

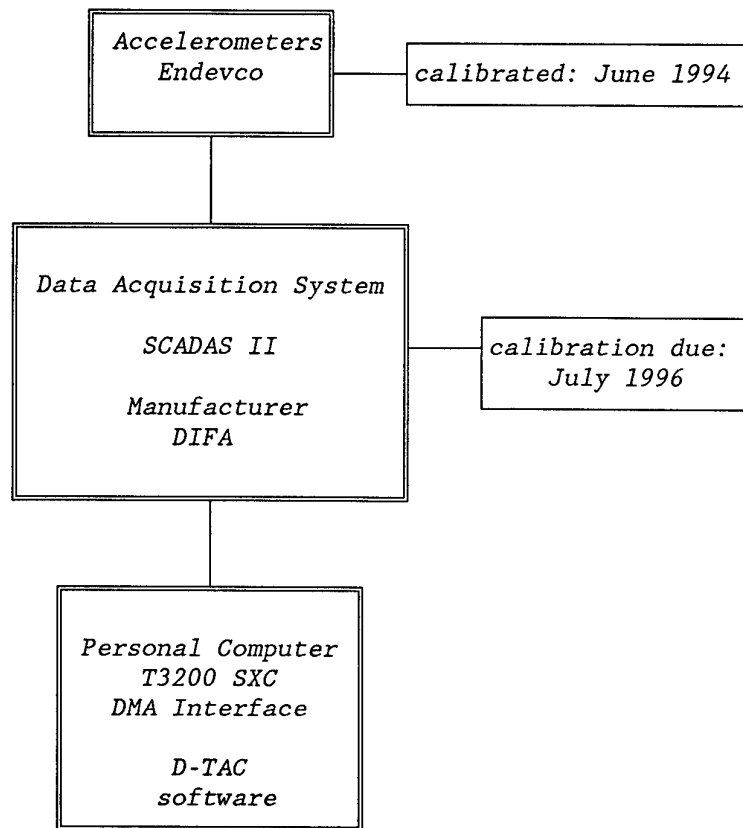
- \* Accelerometers; type 2262/1000; manufacturer Endevco.  
The last calibration of the accelerometers was carried out in May 1996.
- \* Programmable High Speed Data Acquisition System.  
Type SCADAS 212; serial no: 80904002; Manufacturer DIFA.  
Calibrated July 1995; due July 1996.
- \* Personal Computer T3200 SXC.  
DMA interface.  
D\_TAC software. Manufacturer DIFA.

A block diagram of the hardware and the software can be found in figure 4.

Figure 4, Shock measurement system

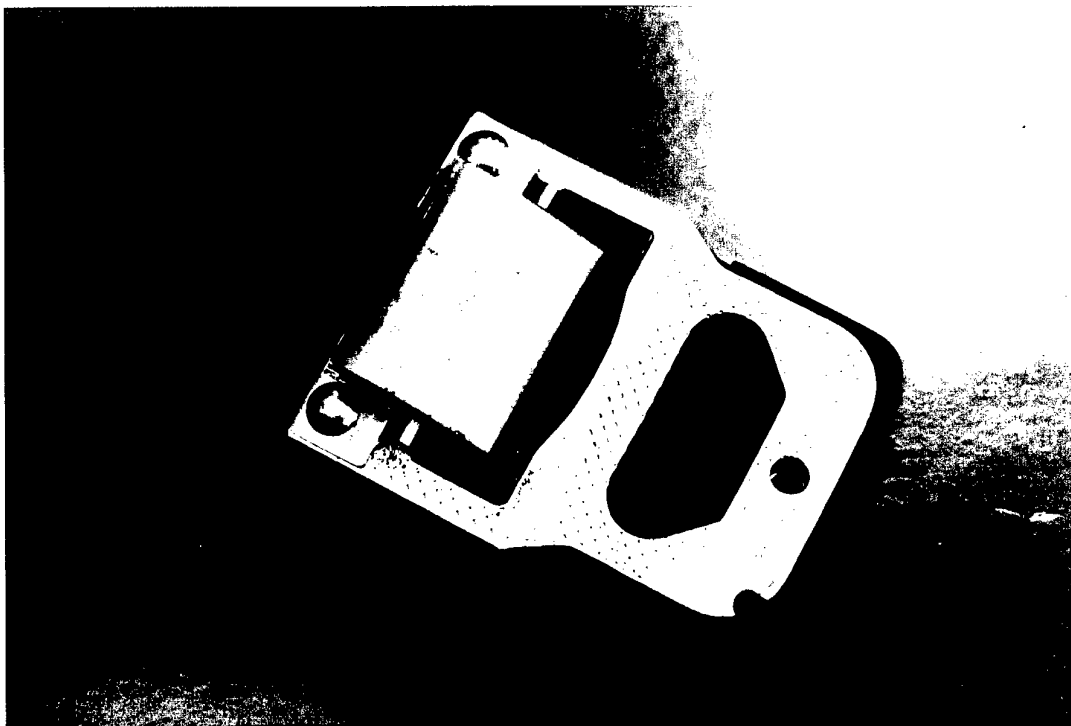
Figure 9, A piece of rubber has been placed on the spring, filling up the gap between the spring and the cover.

06	transverse (X)	An additional piece of rubber was placed between the steel spring and the lock cover to increase the stiffness (figure 9). The previous test was repeated with the modified lock (-X) and the original lock (+X). Both safety belt locks were in good order. Satisfactory result.
07	transverse (X)	For optimization the size of the rubber piece was reduced (figure 10). The shock test was repeated, showing no failures in the locks. Quite some deformation was observed with the bracket base after the four tests in the X-direction, (see figure 11). Satisfactory result.
08	perpendicular (Y)	Satisfactory result.

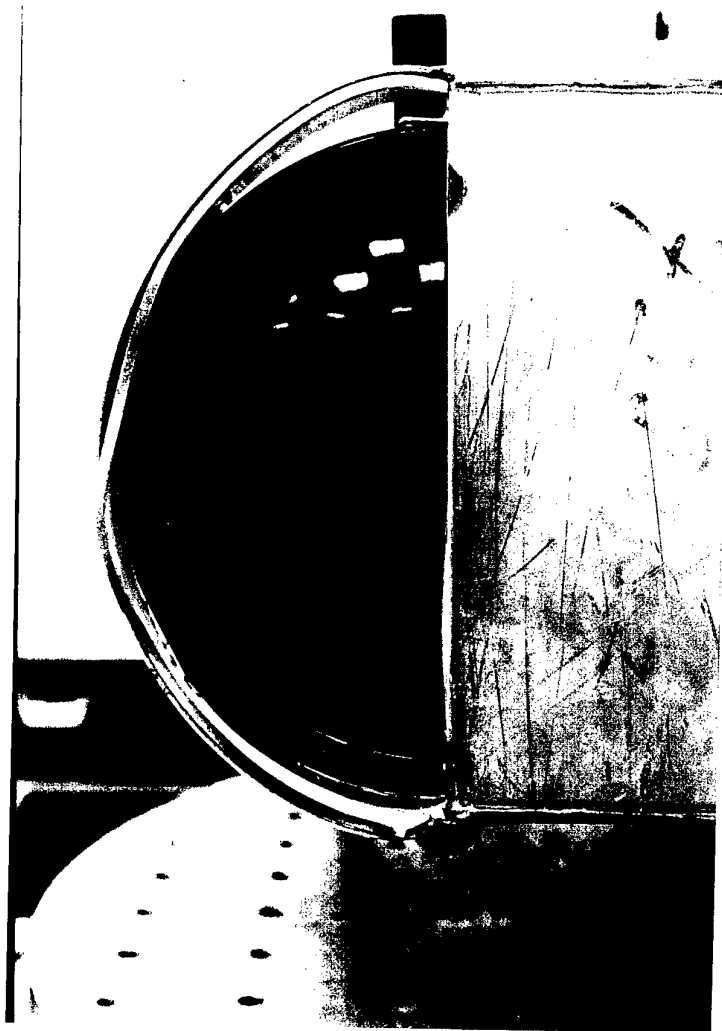
Figure 11, Deformed bracket base support.
