# Ice Action on Riprap

## Small-Scale Tests

Devinder S. Sodhi, Sharon L. Borland and Jesse M. Stanley September 1996

CRREL Report 96-12

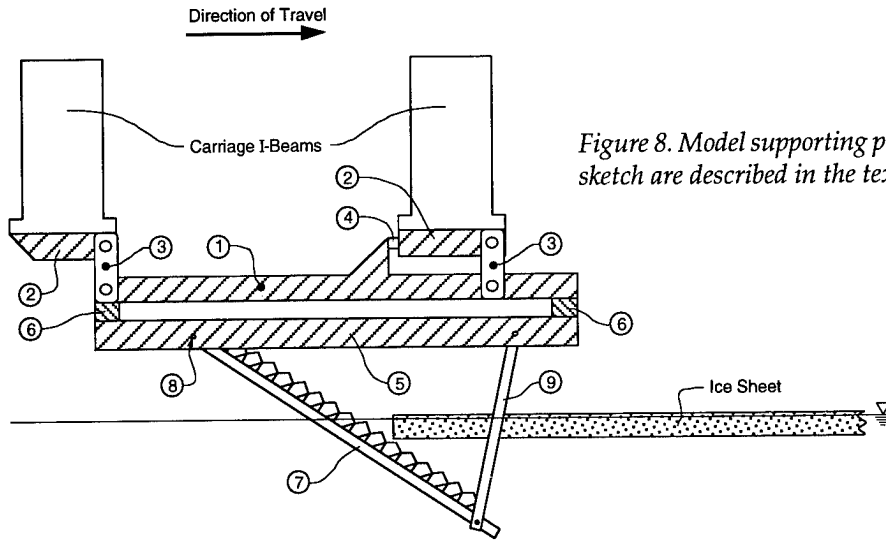
Figure 8. Model supporting platform. Items numbered in this sketch are described in the text.

(9). By adjusting the length of the two steel bars, we could change the slope of the model riprap surface. We could set three slope angles,  $18^\circ$ ,  $27^\circ$ , and  $34^\circ$  from the horizontal, corresponding to vertical to horizontal distance ratios of 1V:3H, 1V:2H, 1V:1.5H, respectively.

The forces on the model during open water test runs (without any ice) were much smaller than those measured during tests with model ice. Figure 21 shows typical time-history plots of the horizontal force, which were obtained by summing the load measured by two load cells (Fig. 8). This

To obtain the total vertical load acting on the model riprap, we summed the output of three load cells placed between the two frames (Fig. 8). Figure 22 shows a typical time-history plot of verti-

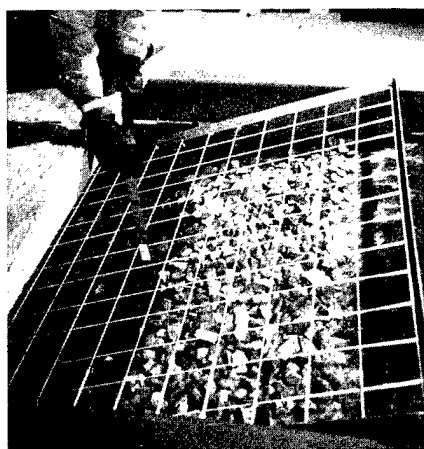
*Figure 13. Measurement of the distance of the riprap surface from the strings at each grid point.*

ice-free test. This technique provided a repeatable means of quantifying the amount of rock moved during a test by ice shoving.

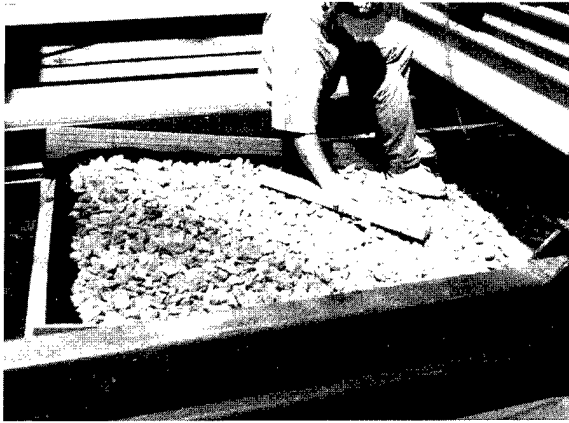
Figure 14. Leveling rocks of model riprap in final preparation prior to each test.

Before each test, we carefully leveled the rocks on the model riprap bank and filled in gaps in the riprap layer where necessary, as shown in Figure 14. The angle of the model bank was adjusted by changing the effective length of the support rods at the front (submerged) end of the model. Prior to freezing an ice sheet, we adjusted the water level in the test basin so that the model was submerged about halfway. We measured the water level relative to the model bank for each test and profiled the rocks using a grid technique explained above. We took photographs of the rocks directly above the model from a fixed vantage point before, dur-

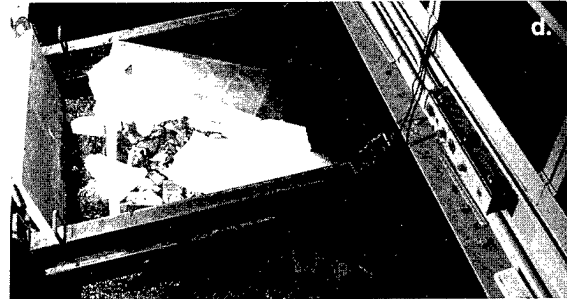
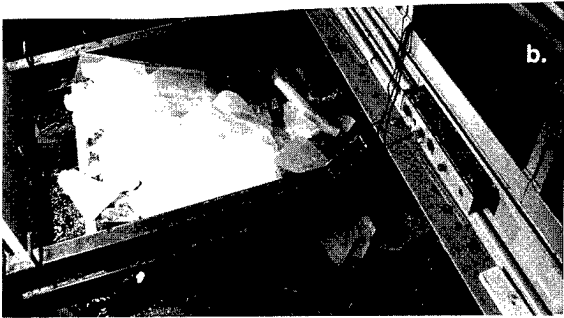
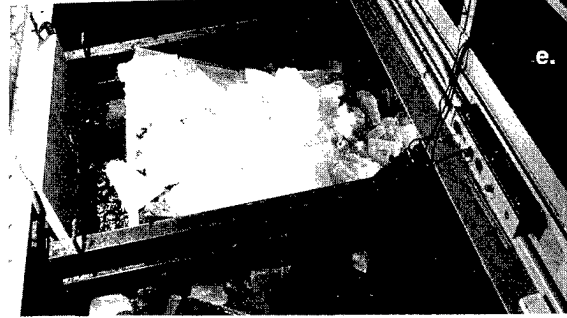
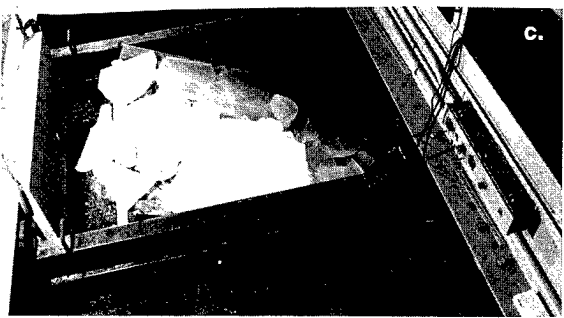
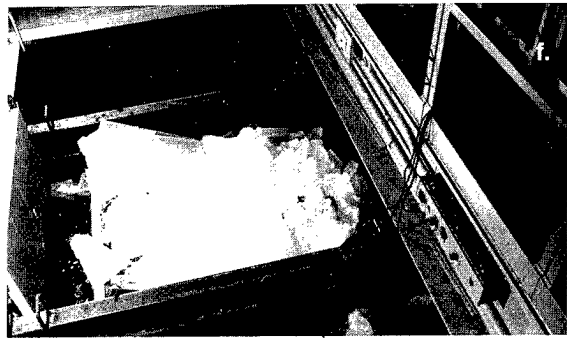
Figure 20. Sequence of ride-up and pileup events for test 20, in which the ice thickness was 53 mm (2.1 in.), and the bank slope was  $27^\circ$  (1V:2H).

mm (2.1 in.). As shown in Figure 20a, the ice sheet broke into roughly rectangular-shaped pieces approximately 25 cm (10 in.) square as soon as the ice sheet contacted the bank above the waterline. Figure 20b shows the broken-up ice sheet going over the top edge of the bank and starting to pile up on one side of the riprap bank. Figure 20c shows the ice sheet riding up and over the top edge of the bank on one side of the model, and beginning to pile up on the other side. As more of the ice sheet continued to shove onto the bank, the ice pieces stacked up on the previously deposited ice

pieces (Fig. 20d). At this stage, no ice was being pushed off at the top edge of the bank because all the ice pieces piled up high, creating a steep incline for the incoming ice sheet. Figure 20e and f show that the ice sheet piled up and crushed into the ice pile. In these last two views, it is possible to see rocks being brought to the surface of the ice pile by the ice sheet. We observed the rocks being transported from the bed to the surface of the ice pile during most of the tests in which the ice piled up on the bank.

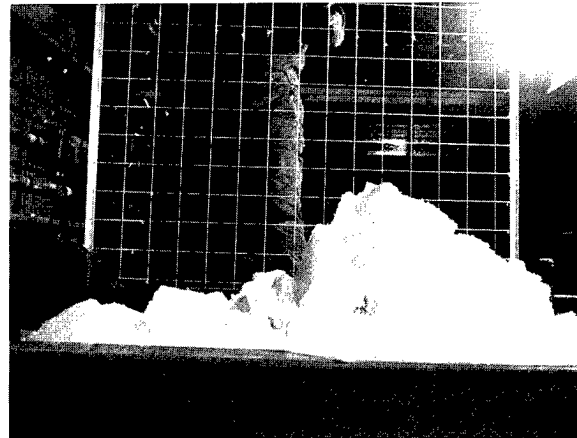
Figure 24. Ice pileup after test 4.

An ice pileup most often caused failure of the riprap when the advancing ice sheet was forced to go between the riprap and the piled up ice. In general, we defined the riprap to have failed if enough rock material was displaced to expose underlying areas of the riprap-protected bank. For example, the ice piled up significantly in test 4, as shown in Figure 24. During that test, the ice gouged away enough riprap to expose large areas of the bank, as shown in Figure 25. In test 5, an ice pileup formed below the water line, as can be seen by the damage to riprap shown in Figure 26. Figures 27a and b show the contour plots of the rock surface, which were generated from the rock profile data taken before and after test 5. Such contour plots help to visualize the total displacement of the riprap during a test. The contour plots

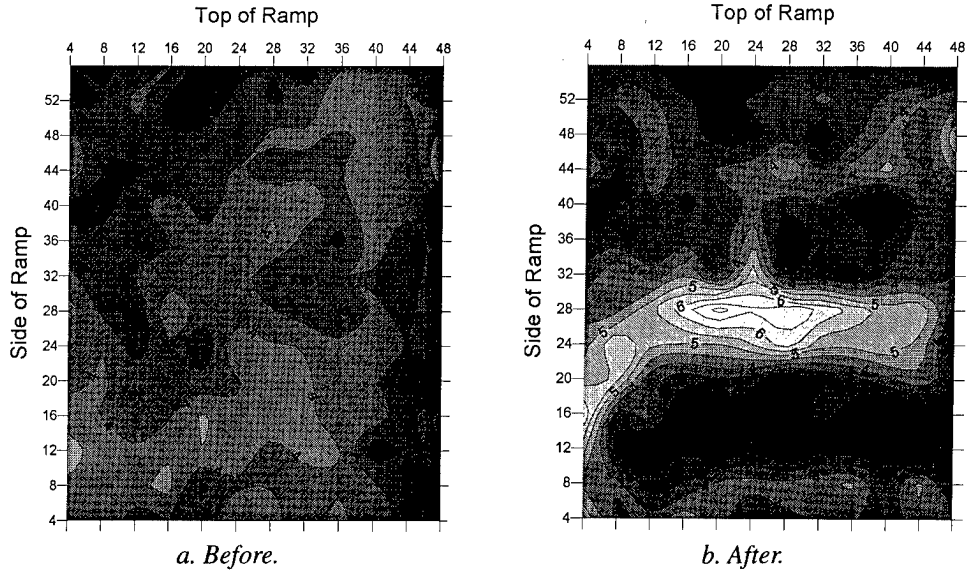
Figure 27. Contour plots of the model riprap before and after test 5. These contour plots show both extent and amount of rock movement during test 5. The numbers along contour lines denote measured distance from the string in the grid frame.
