UNITED STATES ATOMIC ENERGY COMMISSION

ELECTRICAL EQUIPMENT FOR TANKS AND MAGNETS

April 1947

Clinton Engineer Works -  
Tennessee Eastman Corporation  
Oak Ridge, Tennessee

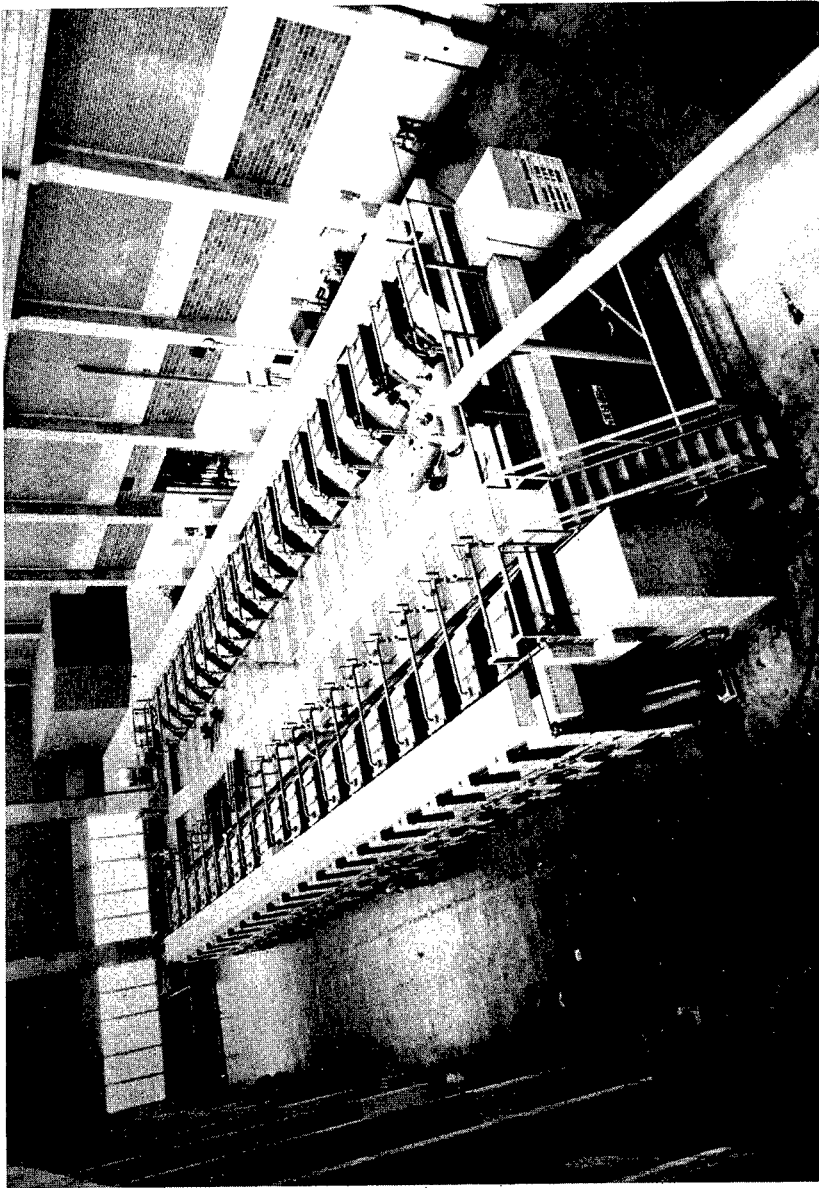
Fig. 18.3 — View of Beta magnet.
