RESULTS OF 1959 NUCLEAR POWER PLANT CONTAINMENT TESTS

by Alf Kolflat
Sargent & Lundy

PREPRINT
PAPER NO. 10

NUCLEAR ENGINEERING
& SCIENCE CONFERENCE

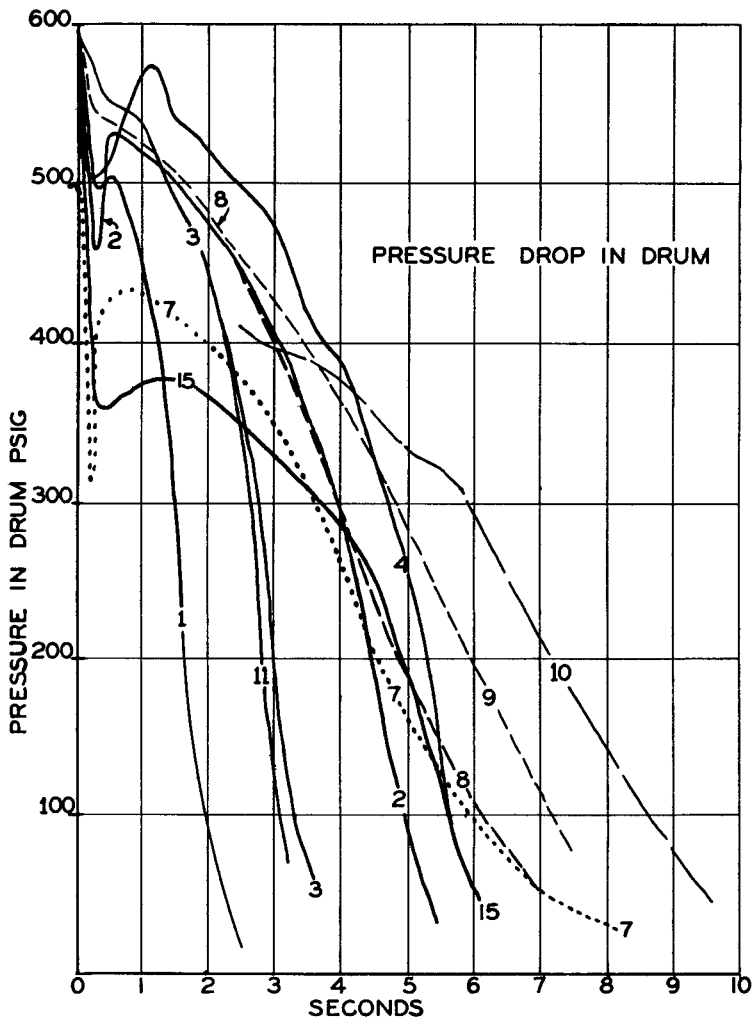
FIGURE NO. 9

One of the experiences gained during these tests was that the quantity of water discharged per second through a 12 inch opening was considerably less than expected. The drop in drum pressure after the break was recorded both on a Brush recorder and on ordinary gauges which gave a good agreement. The water level indicator showing the outflow of the water checked fairly well with the pressure reduction. Figure 9 shows the pressure drop in the drum in relation to time after breakage. It will be noted that on Test No. 7, where steam was ejected, that there were rapid pulsations as the drum pressure dropped suddenly from 500 psig to 320 psig within a fraction of a second, but then the pressure rose rapidly to about 440 psig and gradually fell off. This figure also demonstrates the rapid pressure drop which occurs in the drum in Test No. 15, when two diaphragms were broken, as compared to the Test No. 2 where only one diaphragm was broken even though the boiling water quantity in the drum was the same. Table I summarizes the test results shown on this curve.
