THESIS

**POWER PLANT AND
DRIVE TRAIN IMPROVEMENTS
OF THE
NPS *HUMMINGBIRD*
REMOTELY PILOTED HELICOPTER**

MASTER OF SCIENCE IN AERONAUTICAL ENGINEERING

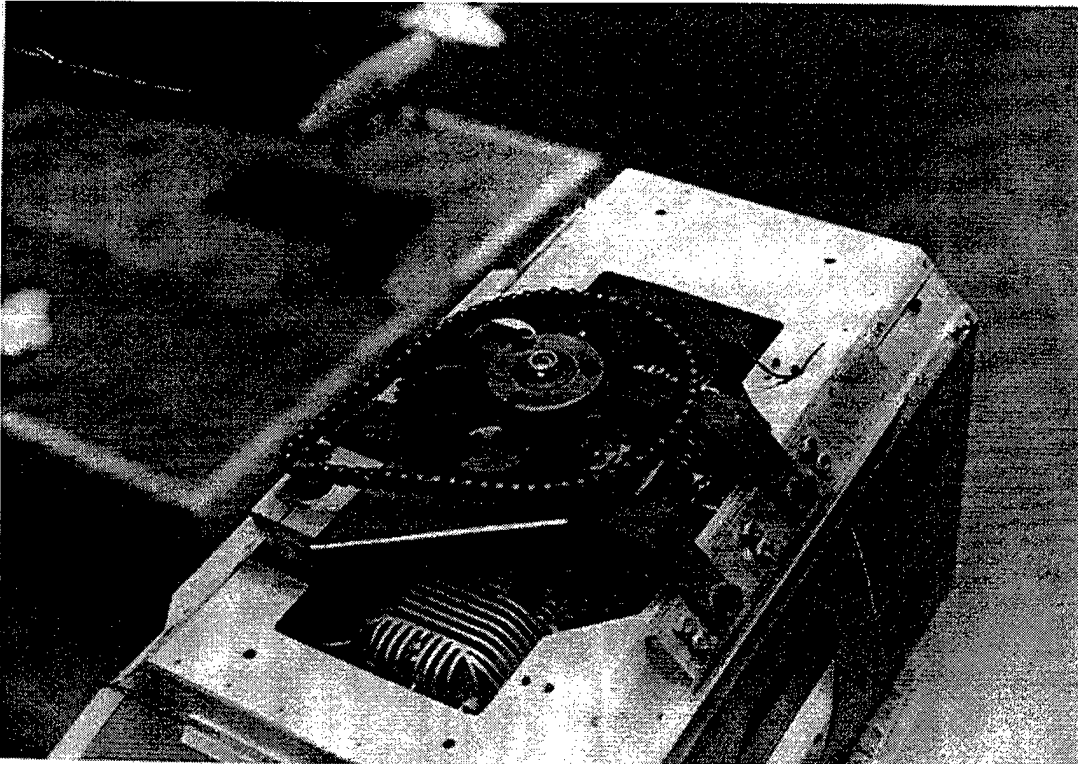
Figure 1. Original Starting System Configuration

The original starter was a permanent attachment to the *Hummingbird*. The starter motor was a 12 volt electrical motor which was hard-mounted to the airframe close to the forward engine cylinder. The starter motor shaft was fitted with a 1 inch diameter sprocket which drove another 7 inch sprocket through a chain drive providing a 7:1 mechanical advantage for the starter motor. A one-way bearing on the 7 inch sprocket provided for starting force in the counterclockwise direction and freewheeling in the clockwise direction as viewed from the top of the RPH. Two DC power cables ran from positive and negative cable receptacles in the left side of the forward fuselage to the starter motor. Figure 1 shows this configuration.

To start the *Hummingbird*, external power cables were hooked up to a 12 volt automobile battery which provided power to the starter motor. Once achieving a starting rpm of approximately 1000 rpm the WAEL 342 cc gasoline engine ran independently. The external power cables then had to be physically pulled out of the receptacles from approximately ten feet away.

The starter motor was found to be under powered. Prior starting attempts required two fully charged 12 volt marine batteries connected in series (24 volts total) for the electric motor to provide enough starting torque to the engine. This configuration ran the risk of burning out the starter motor and causing an electrical fire on the airframe.

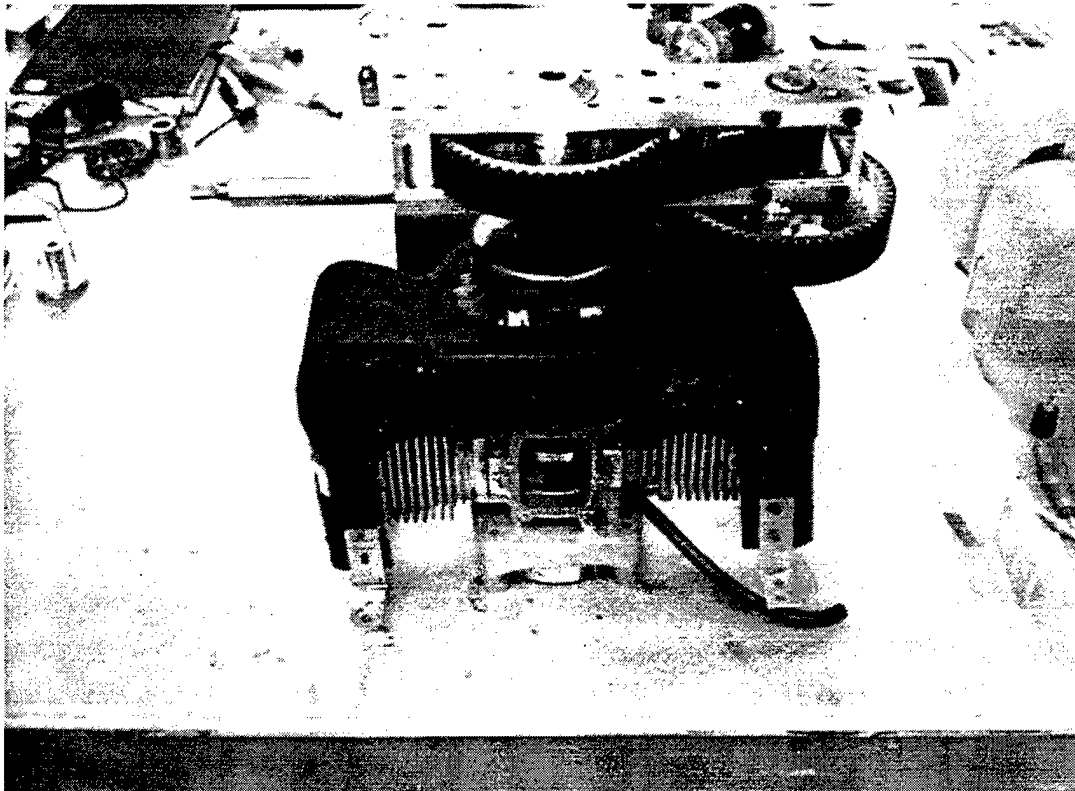
Figure 2. Layout of Engine Cooling Components

The configuration of the engine-cooling system was as follows. A 6 inch diameter vane-axial impeller was mounted to the engine drive shaft which rotated at speeds between 3000 and 7000 rpm. A crudely manufactured cowling was installed over the engine and impeller with the top of the impeller exposed just above the cowling. The cowling was constructed of fiberglass and fit closely around the engine. A make-shift diffuser, similar to those found in smaller scale model helicopter cooling systems, was molded into the top

of the cowling to provide an increase in pressure to reduce losses in the system. The air was directed out the bottom of the fuselage and into the atmosphere. Figure 2 shows the layout of the cooling system components.

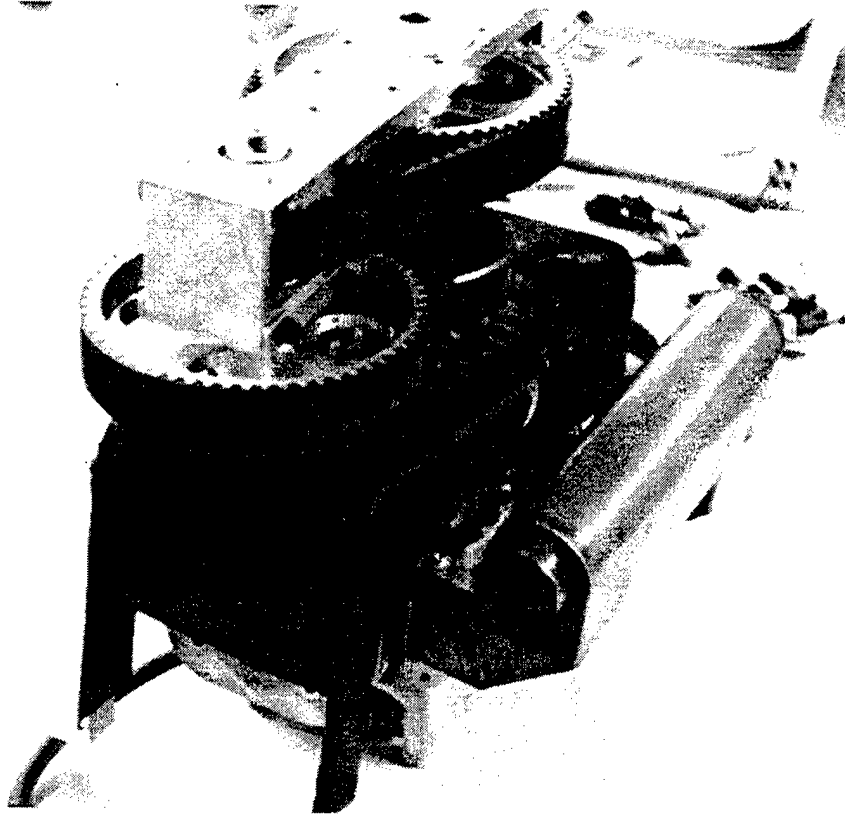
Figure 4. Exhaust Manifold Position

fuselage interior during ground runs aside from an insignificant amount of main rotor wash. The exhaust manifold was also positioned just 2 inches from the intake of the cooling fan as seen in figure 4.

The result was an intake of cooling air with an equal or higher temperature than the maximum cylinder head temperature.

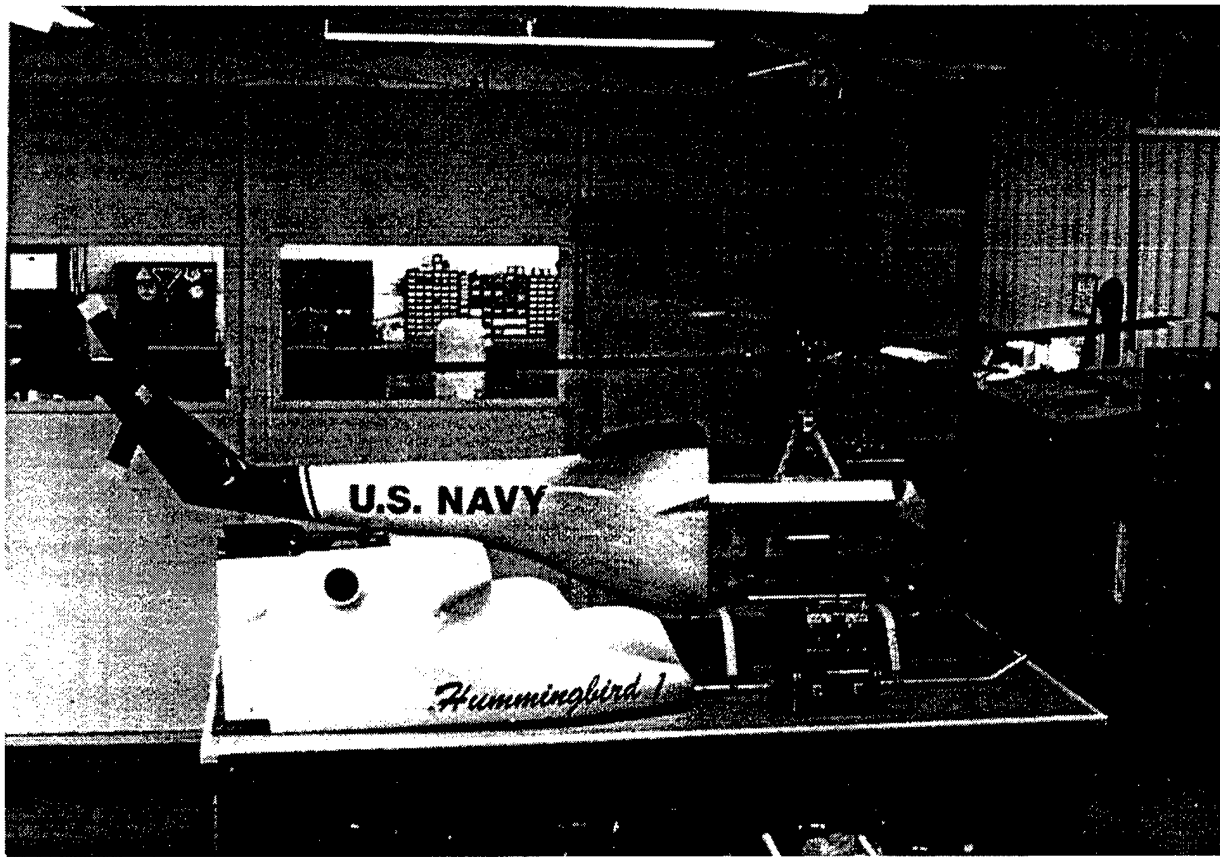
Figure 5. Right Side View of *Hummingbird* Without Ventilation Port body shell and the exhaust manifold's position just inside the fuselage. The solid fiberglass shell on right side allowed a build up of the exhaust manifold temperature which could have further increased the cooling air temperature at the intake of the cooling fan. The object seen in the hole in the fuselage in Figure 6 is the exhaust manifold.

Prior ground tests of the *Hummingbird* at NPS were conducted with the fiberglass front body shell off to allow the maximum heat dissipation and ventilation possible. Photographs of RPH's similar to the *Hummingbird* show ventilation holes cut in both sides of the front body shell. The *Hummingbird*, however, only had one hole cut in the left side. Figure 5 shows a right side view of the RPH with no ventilation hole cut in the fiberglass

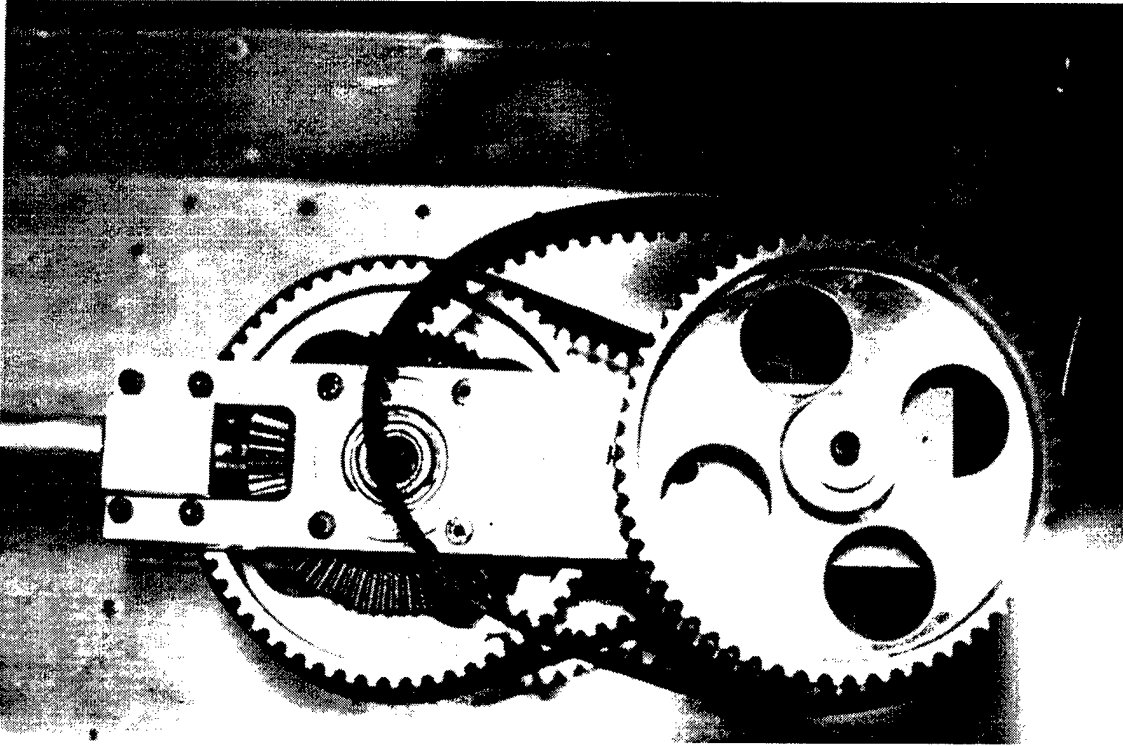
Figure 6. Main Transmission

The drive train begins at the engine drive shaft. The vane-axial cooling fan and centrifugal coupler were mounted on a shaft extension and a drive pulley is attached to the top of the centrifugal coupler. A drive belt connects this pulley to an intermediate shaft to which a sprague clutch is mounted for autorotational capability. Another belt drive is connected to a pulley which is keyed to the main rotor shaft. The tail rotor take-off is driven by bevel gear mounted to this pulley. Total gear reduction is 10:1 from the engine to the main rotor shaft and 3.2:1 to the intermediate shaft. The tail rotor drive shaft turns at 40% of the engine shaft speed. Figure 6 shows the main transmission layout.

As mentioned in the background investigation chapter, massive torque fluctuations due to unsteady idle speeds exist. These torque fluctuations were reported to, however unverified, snap the main rotor shaft of a similar RPH. In any case, fluctuations in engine torque are magnified ten times at the main rotor shaft due to the 10:1 mechanical advantage given by the transmission. With the exception of the hard rubber belts and limited slipping in the centrifugal coupling, there is nothing to absorb any sort of shock caused by torque

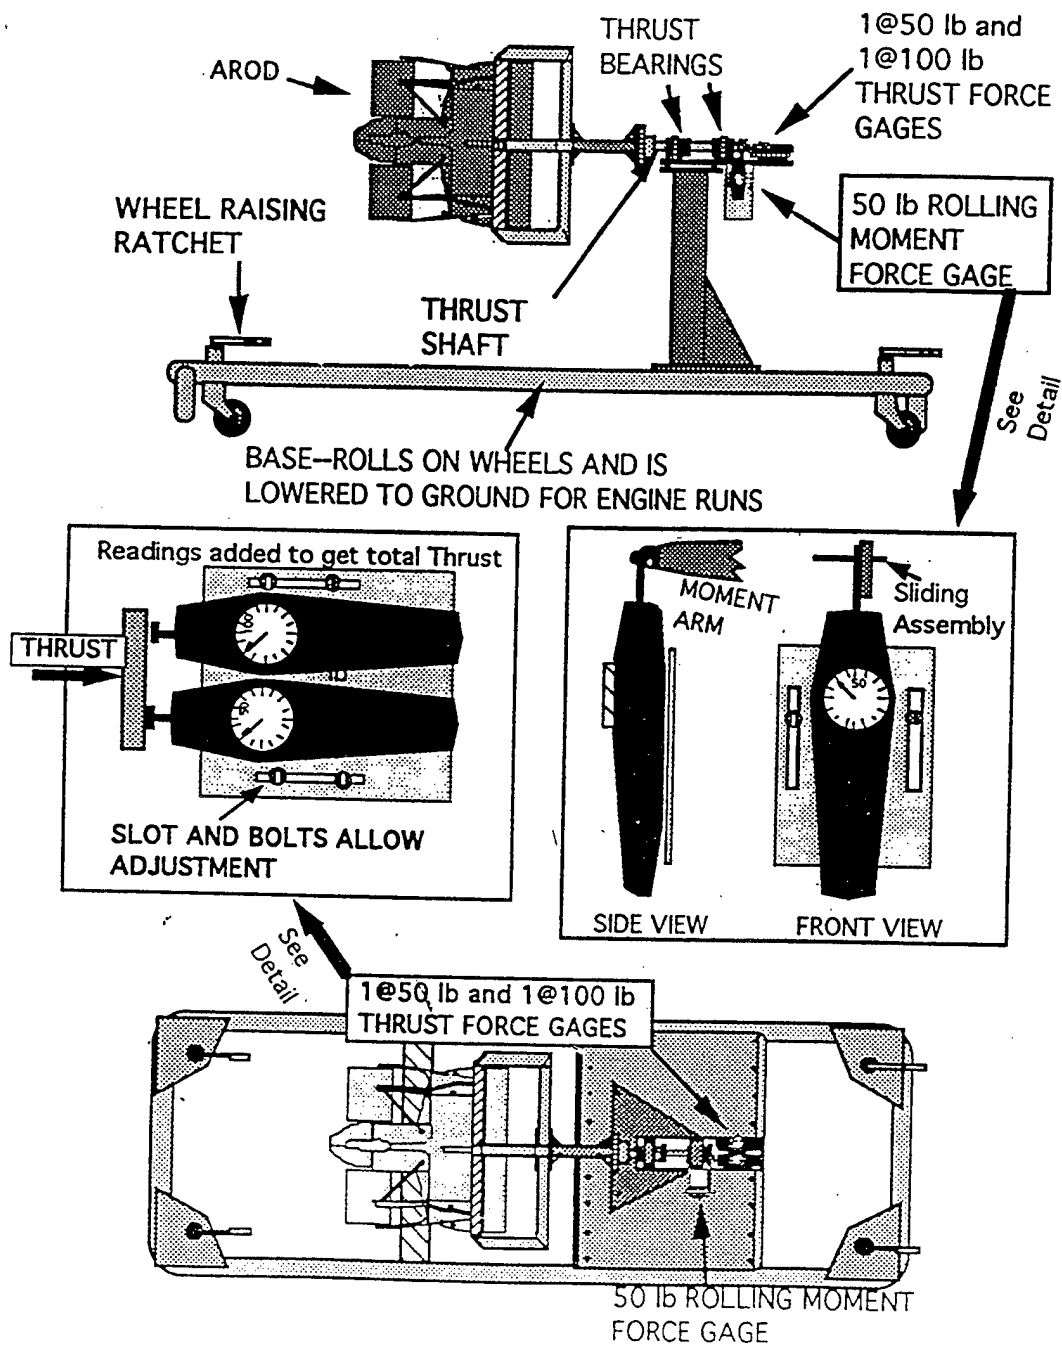
Figure 7. Engine Test Apparatus

The engine was mounted on a test stand designed to measure thrust and rolling moment of the AROD UAV. The rolling moment was the only measurement taken and allowed the determination of engine power. Thrust measurements were not needed for the performance calculations. The moment was computed by reading a force gage which was mounted at the end of a 9 inch moment arm, as seen in Figure 7, and then converted to horsepower after obtaining engine rpm by a strobe tachometer. To provide a working load during the testing and break-in procedures a 30 inch diameter birch propeller (commonly used in ultra light aircraft applications) was installed. Figure 8 shows the engine rigged for testing. The direction of rotation of the engine was opposite to the direction of rotation of

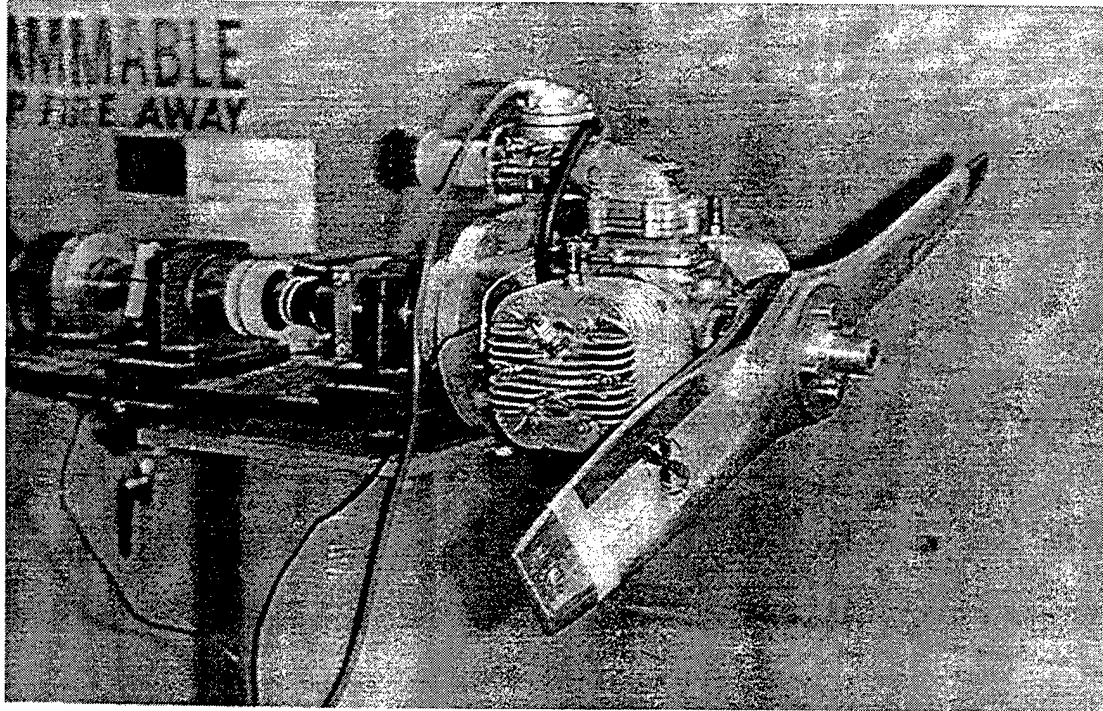
Figure 8. WAEL 342 in the Test Configuration

the propeller. For this reason the propeller had to be mounted backwards. A one gallon fuel tank provided a 25:1 fuel-oil mixture to the engine. As a precaution a 24 inch diameter room fan was placed to direct airflow over the engine. This later proved to be ineffective.

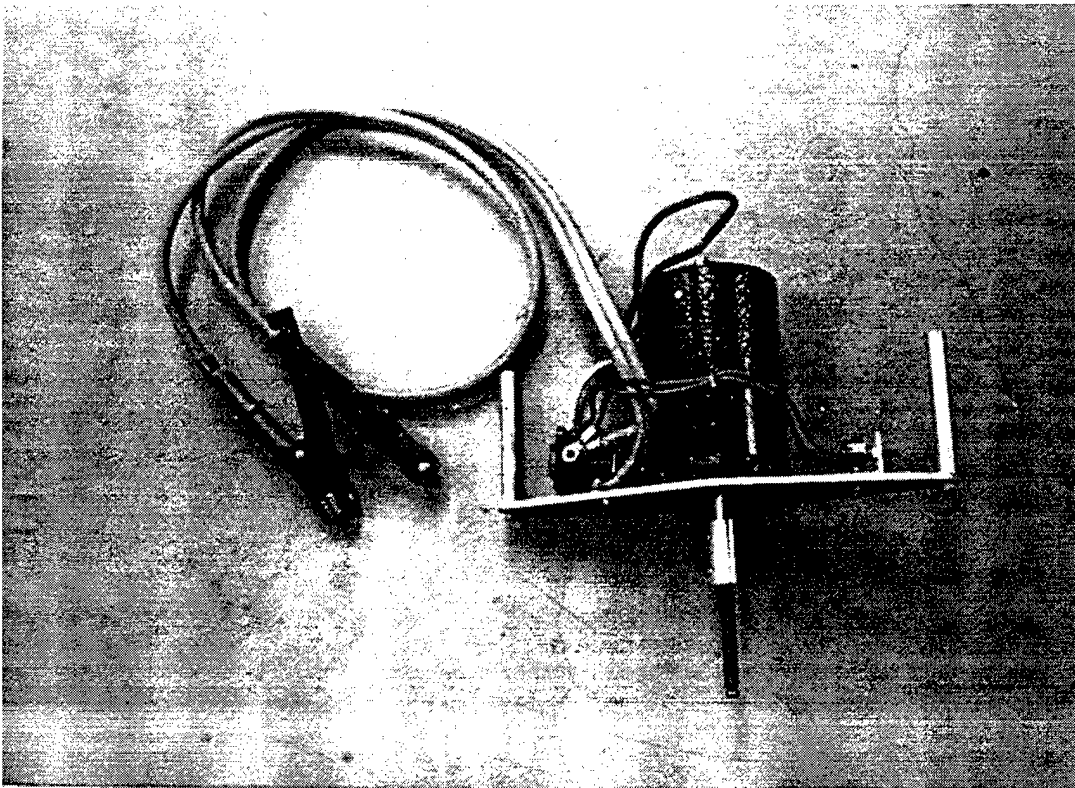
Figure 9. Hand-held Starter

The engine was started by a hand-held starter which contained a new starter motor shown in figure 9. With the need to start the engine in a counter-clockwise viewing the engine from the rear on the test stand, a starter with this rotation was sought. Also at this

stage of the research the direction of rotation of the external starter design had not yet been decided. Therefore a starter with the capability of providing adequate torque in both directions was prudent. The Prestolite MBJ-4407 winch motor was chosen for its availability, power and dual directional capability. The performance specifications for this motor can be found in appendix C.

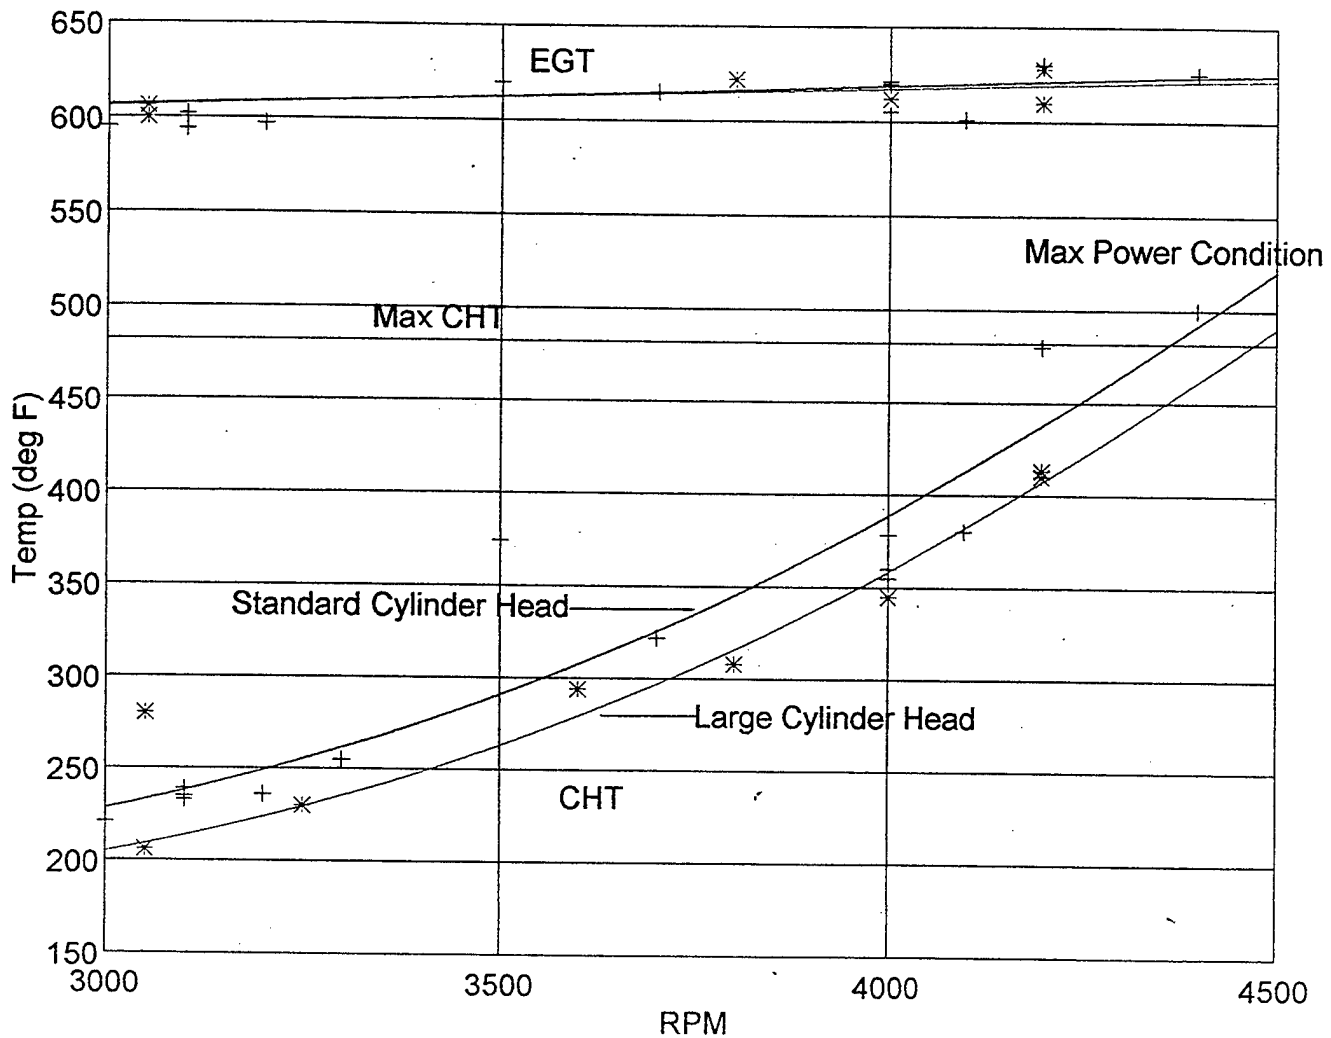
Figure 10. CHT Comparison for Large and Small Cylinder Heads

The engine was again tested in static air conditions. Runs initially at idle power settings showed an approximate 25°F decrease in CHT and, as expected, no change in EGT. Runs at maximum throttle showed a maximum CHT of 435°F. The effect of the increased

area of the cylinder head reduced the maximum CHT by over 47°F in static conditions. A comparison of the EGT and CHT observed with the two sizes of cylinder heads is shown in Figure 10.

This determination moved the cooling system design away from a high mass flow system to an interior ventilation or low mass flow system in which the induced air flow velocities over the engine on the test stand would be matched or increased inside the fuselage.

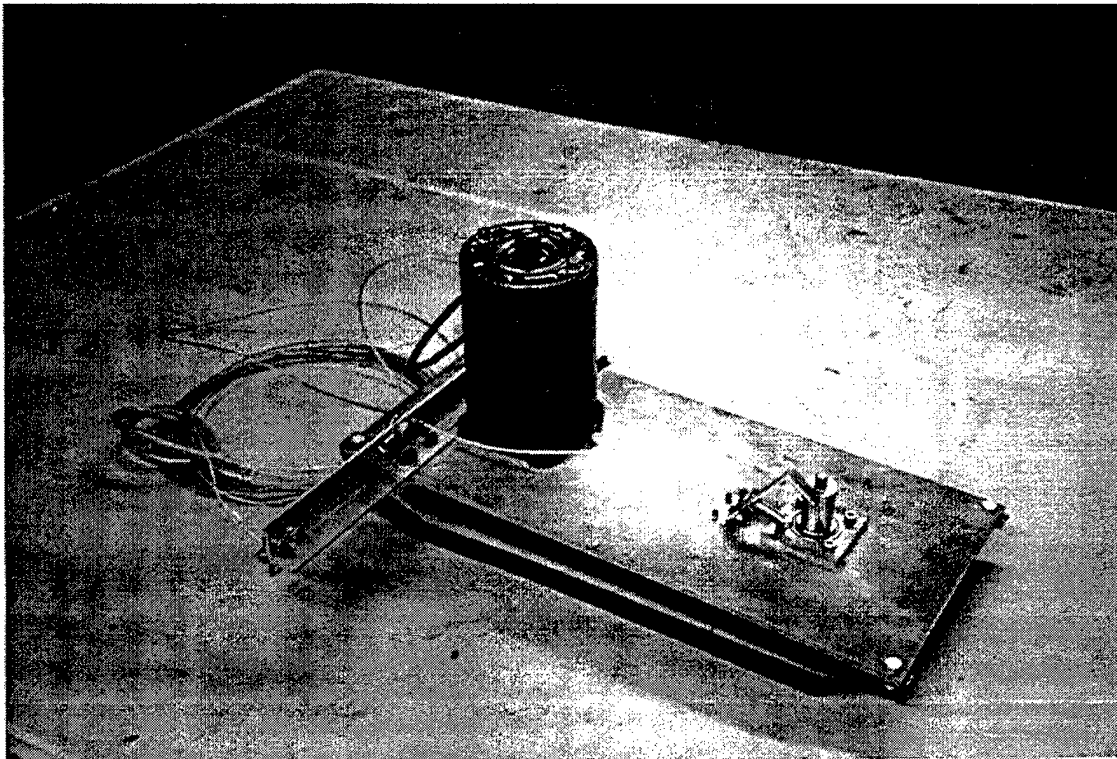
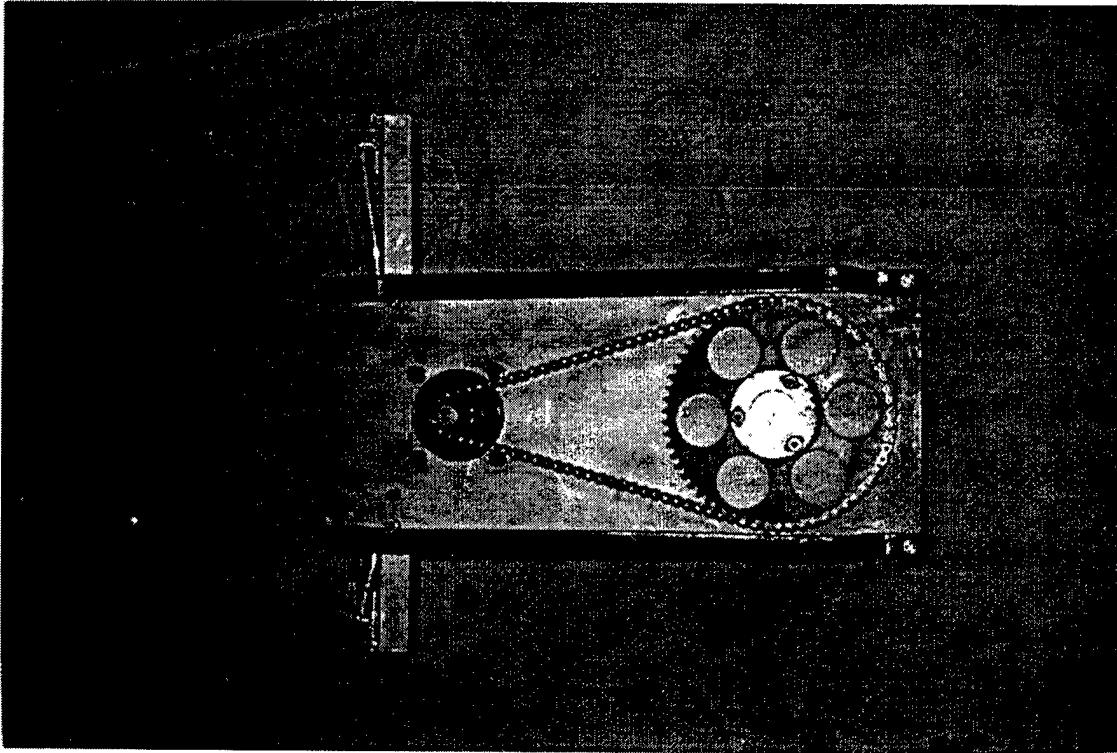
The starter assembly's final design is as shown in Figures 11 and 12. It consists of a 0.25" x 9" x 20" base plate to which the driving components are mounted. The starter motor is the 12 volt Prestolite MBJ-4407 winch motor used in the hand held starter. A 1:1 drive ratio was proven effective by the hand held starter during the engine tests. Originally

the motor was mounted as follows. The starter motor mounts to the plate with the drive shaft passing through the plate from top to bottom. A 7 inch sprocket taken from the spare *Hummingbird* parts is mounted to the end of the shaft. An insert for the sprocket had to be designed and manufactured to replace a one-way bearing of the original design to eliminate any slippage. A chain drives another 7 inch sprocket which is mounted to the engine starting drive shaft. This sprocket contains a one way bearing which allows for torque application during start and freewheeling when the engine rpm exceeds the starter rpm. The original insert for the one way bearing was designed for the tapered shaft that mounted to the bottom of the engine by means of friction only which caused some damage due to metal-to-metal

slippage. A new piece was designed and manufactured to accommodate a straight shaft and key. The sprocket is attached to the drive shaft which passes upward through the plate. A 3/8 inch hex-ball drive wrench is pressed into an adapter which rides on a thrust bearing to prevent excessive wear of the starter drive shaft components. The ball drive wrench again gives the benefit of allowing small misalignments which occur during engine start and allows the starting assembly to drop free of the structure without jamming in the drive socket. The thin neck of the wrench is also the most convenient place for the starter to structurally fail should normal starting forces be exceeded.

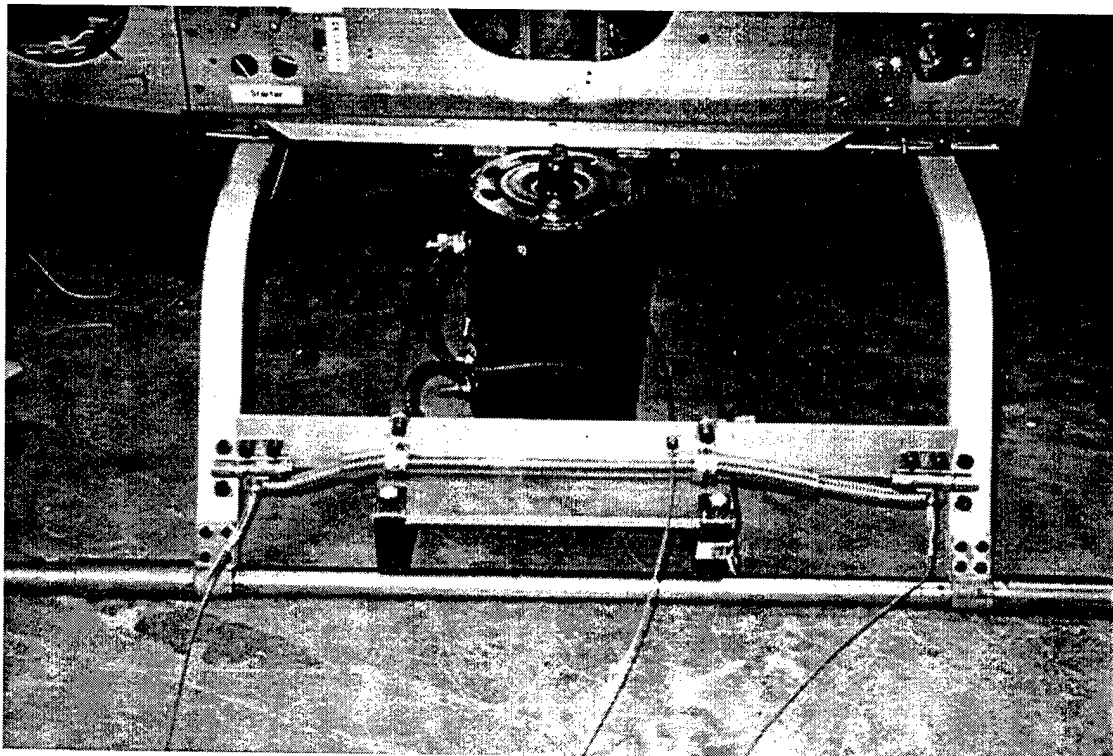
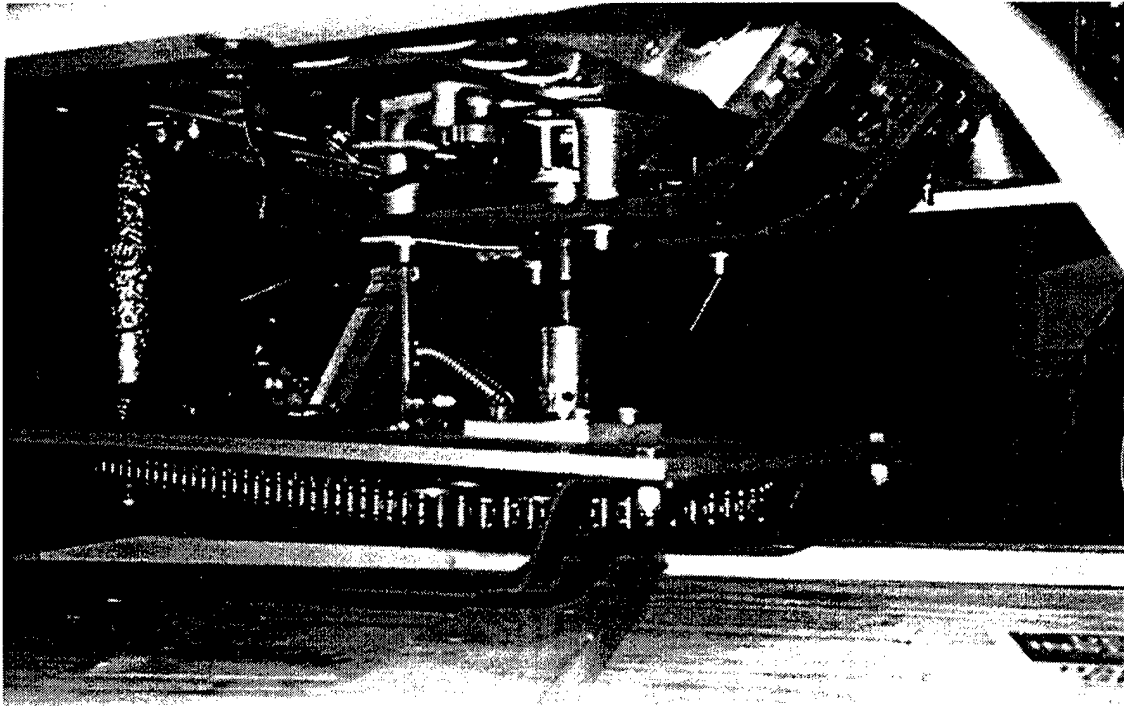
The starter is held in place at four points shown in Figures 13 and 14 keeping entirely off the ground when attached for engine start. The first two are on each landing gear strut. Two pins and mechanical stops prevent fore and aft as well as lateral movement. These two

pins are connected by a spring so that both pins release after an over-the-center lock is cleared. The third point is the 3/8 inch hex ball socket which limits horizontal planar movement when coupled to the engine. The fourth point is a spring-loaded latch assembly connected to a cross bar under the engine which keeps the starter coupled to the engine during start. Two 30 foot lengths of small diameter cable are connected to the assembly which allows starter disengagement and towing the assembly clear of the operating area. Skids are installed to pull the assembly clear. The skids are formed with a semi-circular protrusion on the front. This feature unloads the 20 pound weight on the pins that hold the

starter assembly to the landing gear skids when the starter is disengaged from the engine to ease in the pin release.

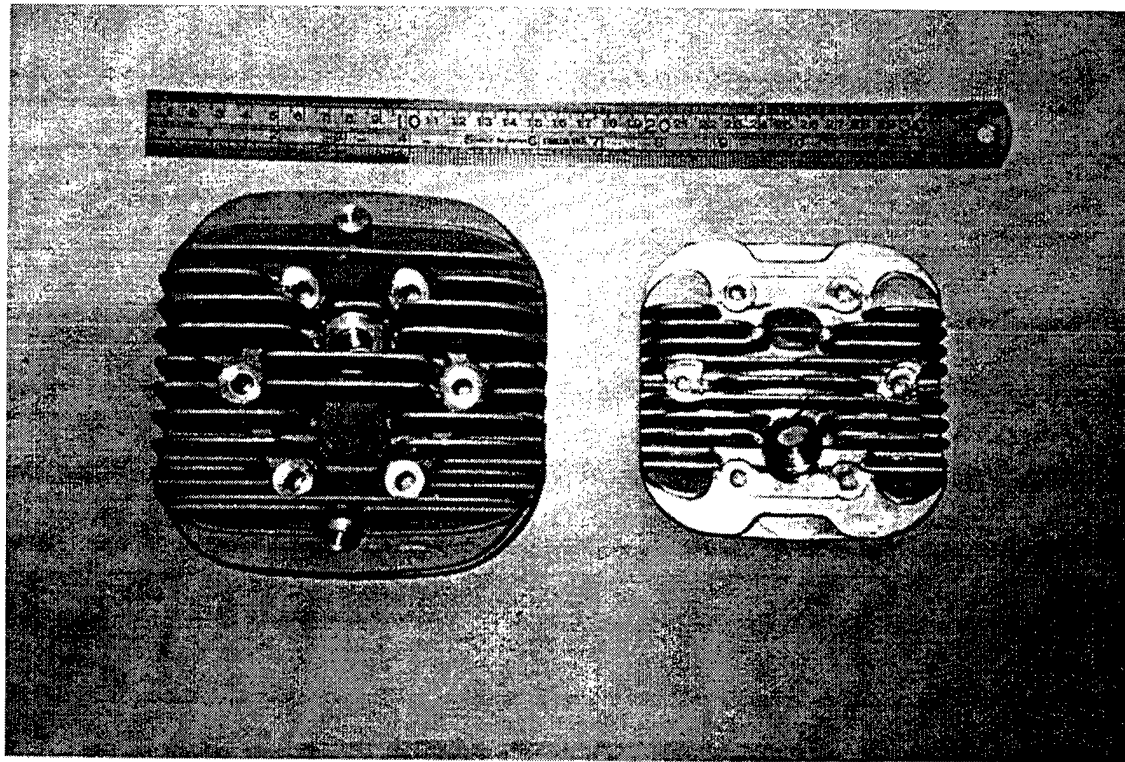
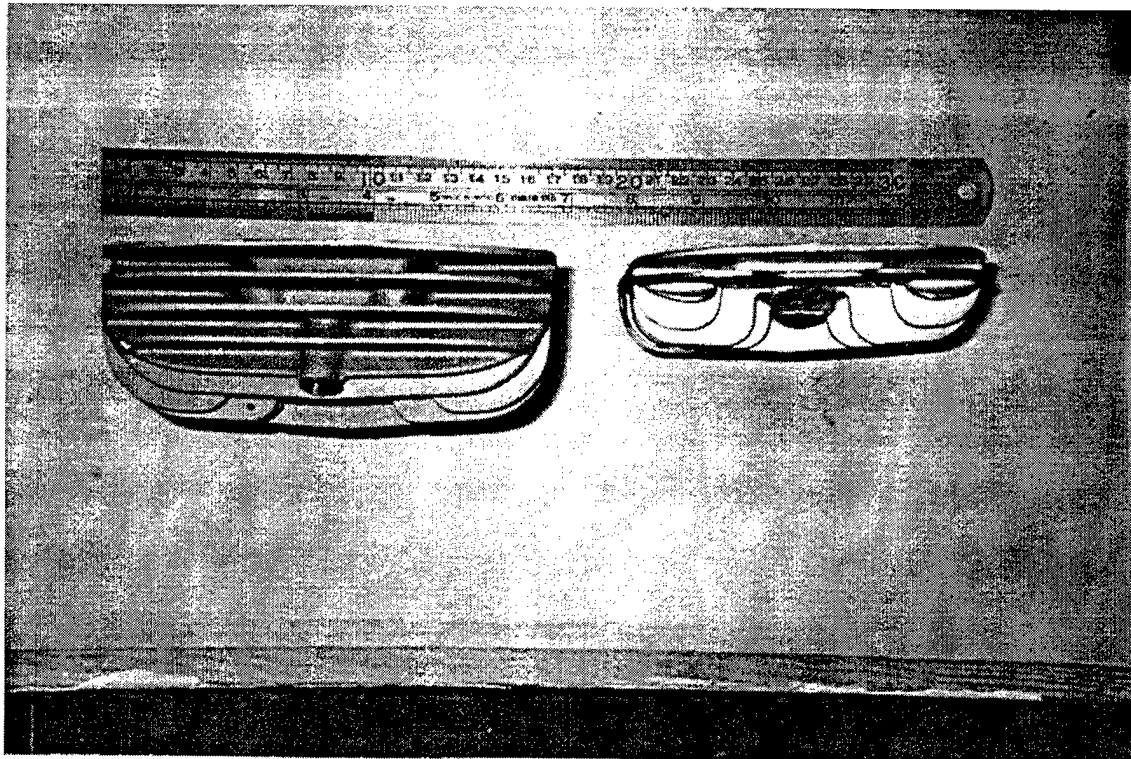
Figure 15. Size Comparison of Cylinder Heads.

As previously stated, the standard cylinder heads which was originally installed on the engine was replaced with the larger cylinder heads and are shown in comparison with each other in Figure 15. The effects of the improved heat dissipation through the significant increase in surface area have already been discussed. The larger heads required a standard size spark plug rather than the short plug used in the standard head. The engine manual called for a Bosch W6 BC spark plug with a 12.7 mm reach. An equivalent substitute plug, Splitfire SF 412C, was used due to the unavailability of the Bosch plug. The Splitfire plug has a smooth ceramic insulator where as other spark plugs have ridged ones. The smoothness caused the spark plug cap to slide off and disconnect during engine operation. To remedy this problem, retaining clips were installed to prevent the caps from working loose.

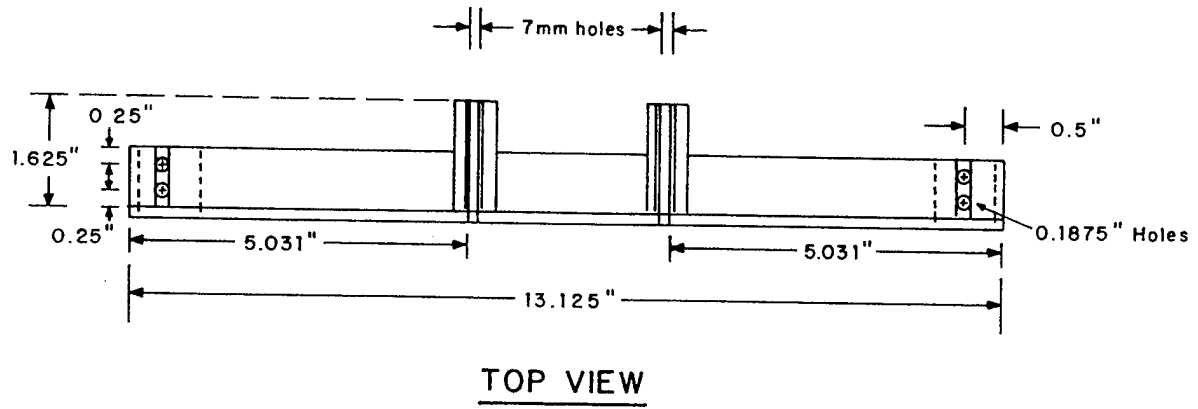
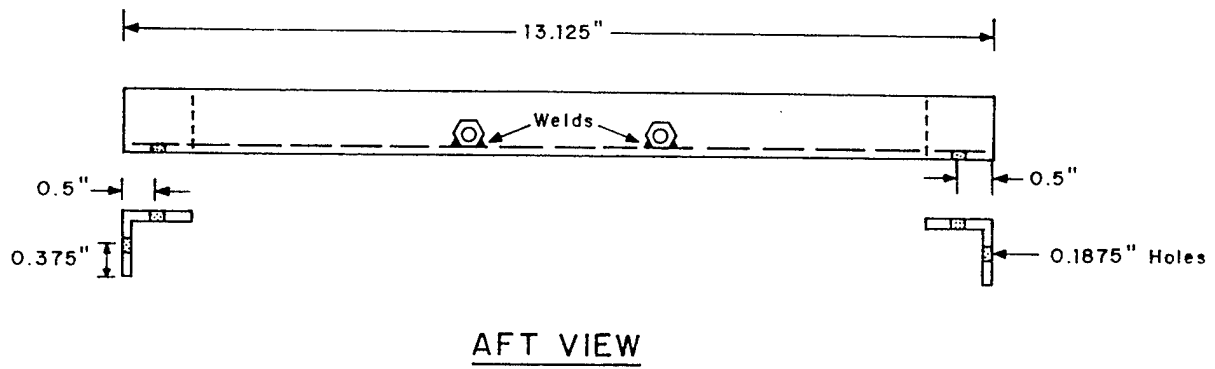
Figure 16. Upper Engine Mount

(1) Upper Engine Mount. As the engine required some minor modification on the test stand, the *Hummingbird* required some airframe modification to accommodate the new enlarged cylinder heads. The four engine mounting points on the bottom of the airframe remained unchanged; however, the upper engine mounting bracket that was installed as a part of LT Greg Fick's [ref. 3] modifications shown in Figure 16 had to be moved aft by at least 1.04 inches due to the difference in the cylinder head thicknesses. The two side stiffening plates were moved aft to provide the necessary airframe support for the bracket's new position.

The bracket modification led to another problem. The upper engine mount braced the engine through two of the six 6 mm cylinder head bolts. The existing cylinder head bolt was not long enough to provide support for the cylinder head and also pass through the upper engine mount. Attempts to find longer bolts and 6mm threaded rod failed as no local supplier carried the longer bolts or metric size threaded rod. As a result, two adapters which acted as a cylinder head bolt, spacer and upper engine mount attachment point were designed to custom fit this application. Figure 17 shows this piece. The cylinder head bolt segment is 6 mm in diameter and includes the correct cylinder head bolt thread length. The spacer was designed to provide a gap between the cylinder head and upper mount brace so there will be no damage inflicted on the cylinder head heat fins while the both the engine and airframe vibrate. The remainder consists of the mounting bracket threads which are also 6 mm in diameter.

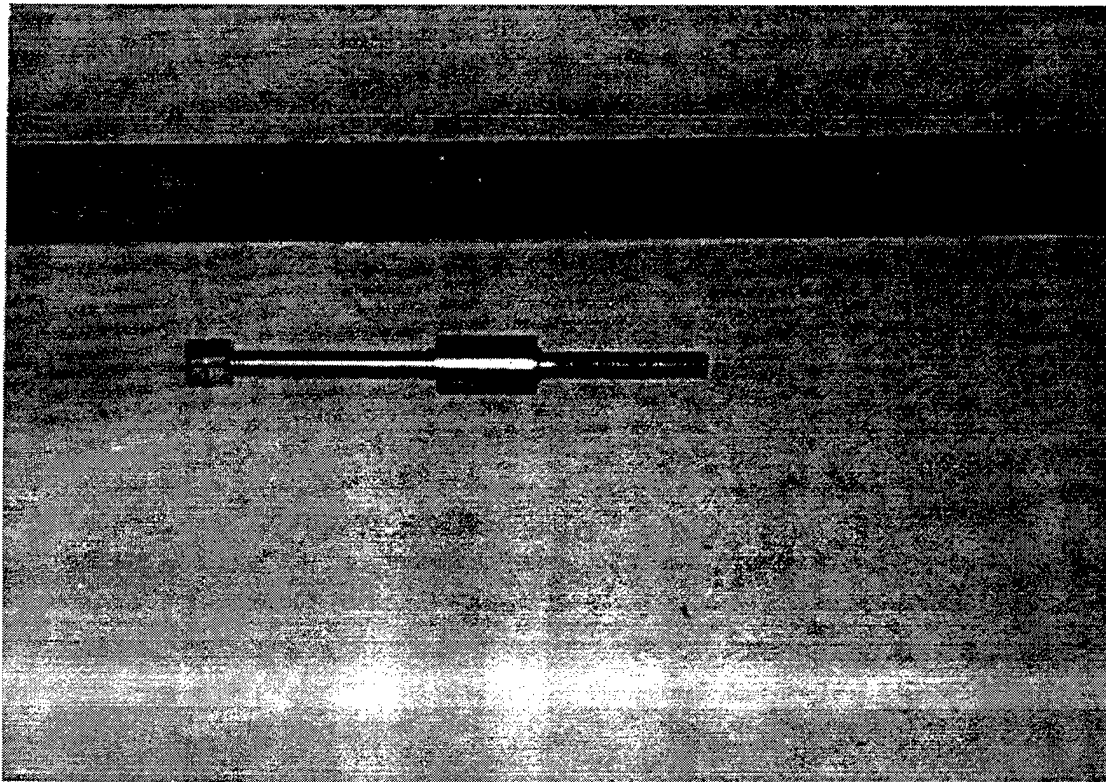
Figure 17. Spacer Bolt

(2) Adapter Installation. To install the adapter the cylinder head bolt portion is first screwed in to place. To accomplish this two nuts must be locked

against each other on the mounting bracket end and then the whole piece torqued to the cylinder head bolt torque specification. The two nuts are then removed and the mounting bracket is then slid over the free end. The mounting bracket is then secured by a two lock washers and nuts.

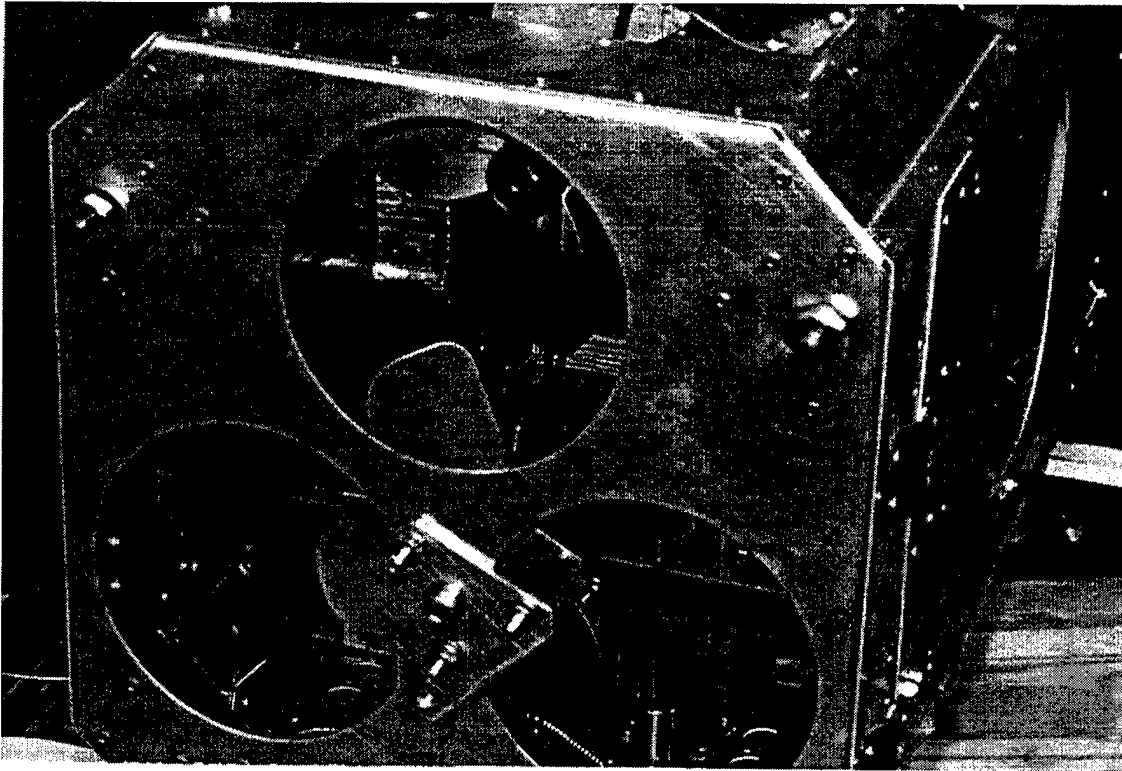
Figure 18. Cooling Fan and Drive Configuration

After considering many options of cooling fans, configurations and suggestions from industry, a simple and reliable design was implemented. The cooling air velocity through the engine compartment was observed during the engine tests and a system to move air through at this speed was introduced. Two air-conditioning condenser fans rated at 500 cfm at 3000 rpm were purchased for less than \$6.00 and mounted to ventilate the new 1.3 cubic foot engine compartment. One fan was modified to fit on the tail rotor drive take-off shaft off the main transmission which rotates at 40 percent of the engine rpm or 1200 to 2800 rpm. The other fan was mounted to the rear wall of the engine compartment. As shown in Figure 20, the lower fan is driven by a belt drive configuration and rotates at the same rpm as the tail rotor drive shaft. The tail rotor shaft mounted fan provides cooling air primarily to the forward cylinder while the belt driven fan provides ventilation to the aft cylinder.

Information on this fan was unavailable. Measurement of the cooling fan air flow at 1500 rpm (approximate fan rpm at engine idle) showed approximately 345 cfm. Assuming a linear increase in air flow with increasing rpm as seen in several other fan

performance charts, the air flow at 2800 rpm is estimated at 480 cfm. Thus the two fans together produce 960 cfm at 7000 engine rpm through the engine compartment which exceeds the air flow pattern seen on the engine test stand.

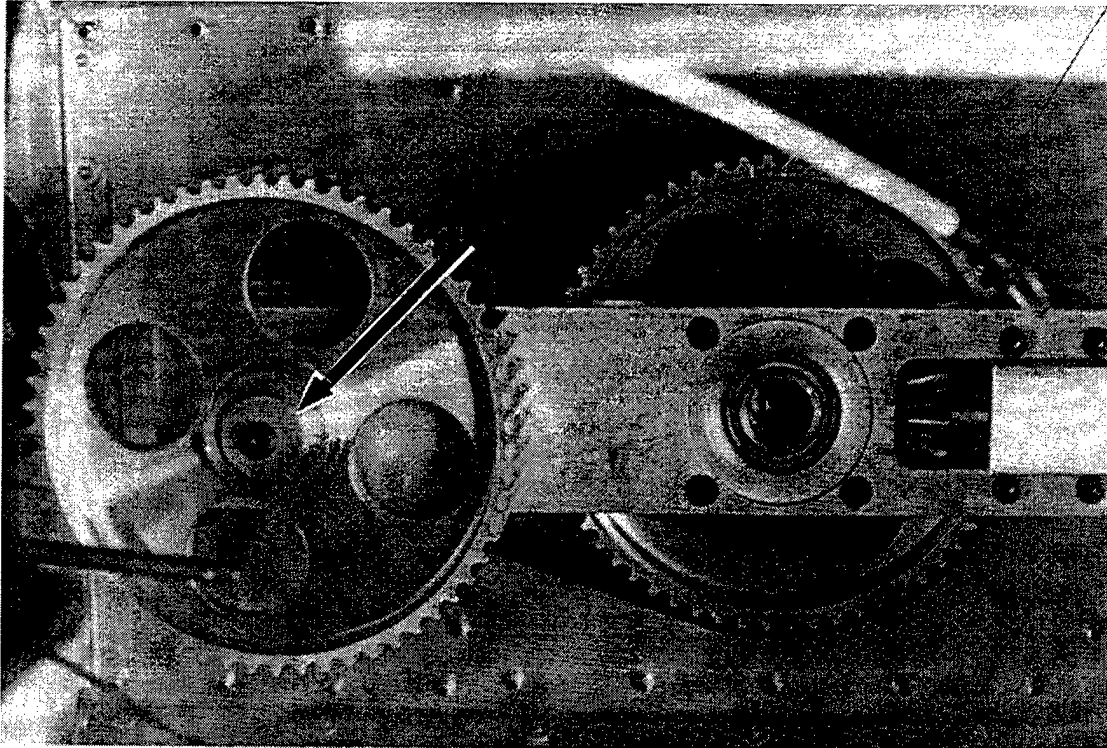
Figure 19. Intermediate Shaft of the Main Transmission

The intermediate shaft on the transmission shown in Figure 19 was selected as the location for the shock absorber assembly. The shock absorber itself is a Metalastik®

Rotoflex® coupling. It consists of a hexagon of rubber with six metal inserts bonded into position. It also contains metal interleaves bonded into the rubber for increased torque capacity when required. The coupling must be able to withstand a 76.8 ft-lb sustained load plus a 32 ft-lb impulse load totaling a maximum load of 108.8 ft-lbs. The 76.8 ft-lb moment was obtained by using the maximum torque rating of 24 ft-lbs and multiplied by 3.2 for the load at the intermediate shaft. . A coupling closest to this specification was ordered. This size coupling gives a safety margin of 1.33 computed for rated maximum torque to estimated

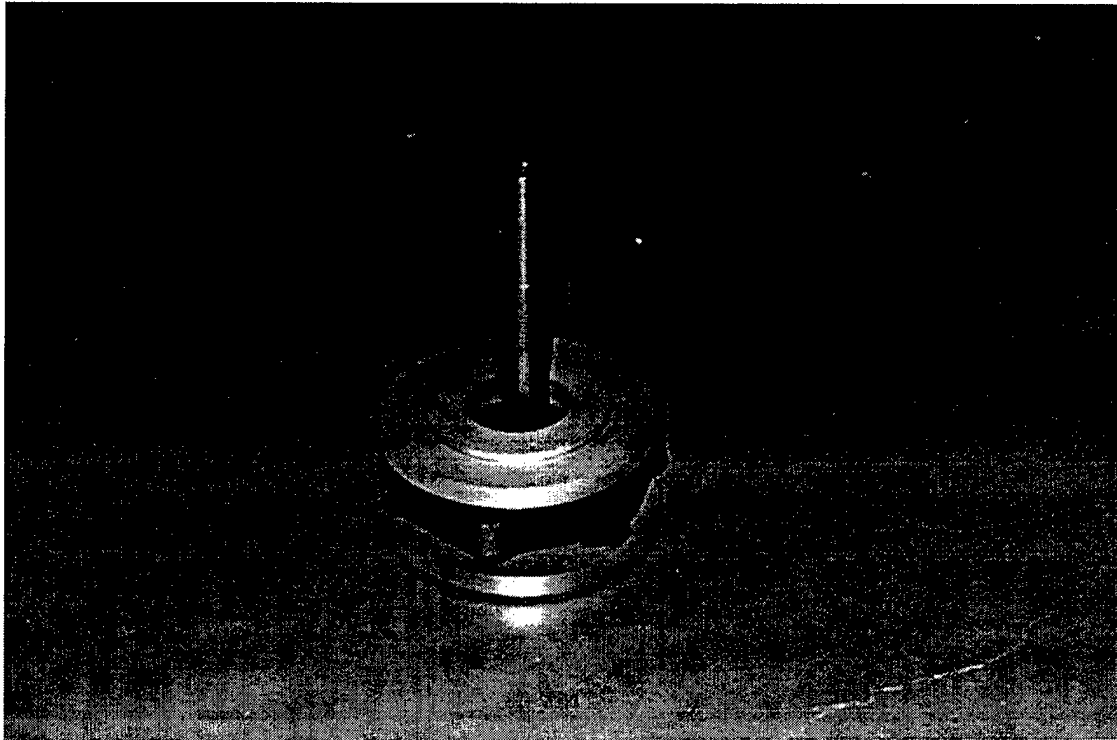
Figure 20. Layout of Shock Absorber Components

unfinished components of the shock absorber system in the position they are to be mounted. The drawings in appendix D show the final form of the upper and lower plates, spacer ring and modified drive shaft.
