THESIS

**POWER PLANT AND
DRIVE TRAIN IMPROVEMENTS
OF THE
NPS *HUMMINGBIRD*
REMOTELY PILOTED HELICOPTER**

MASTER OF SCIENCE IN AERONAUTICAL ENGINEERING

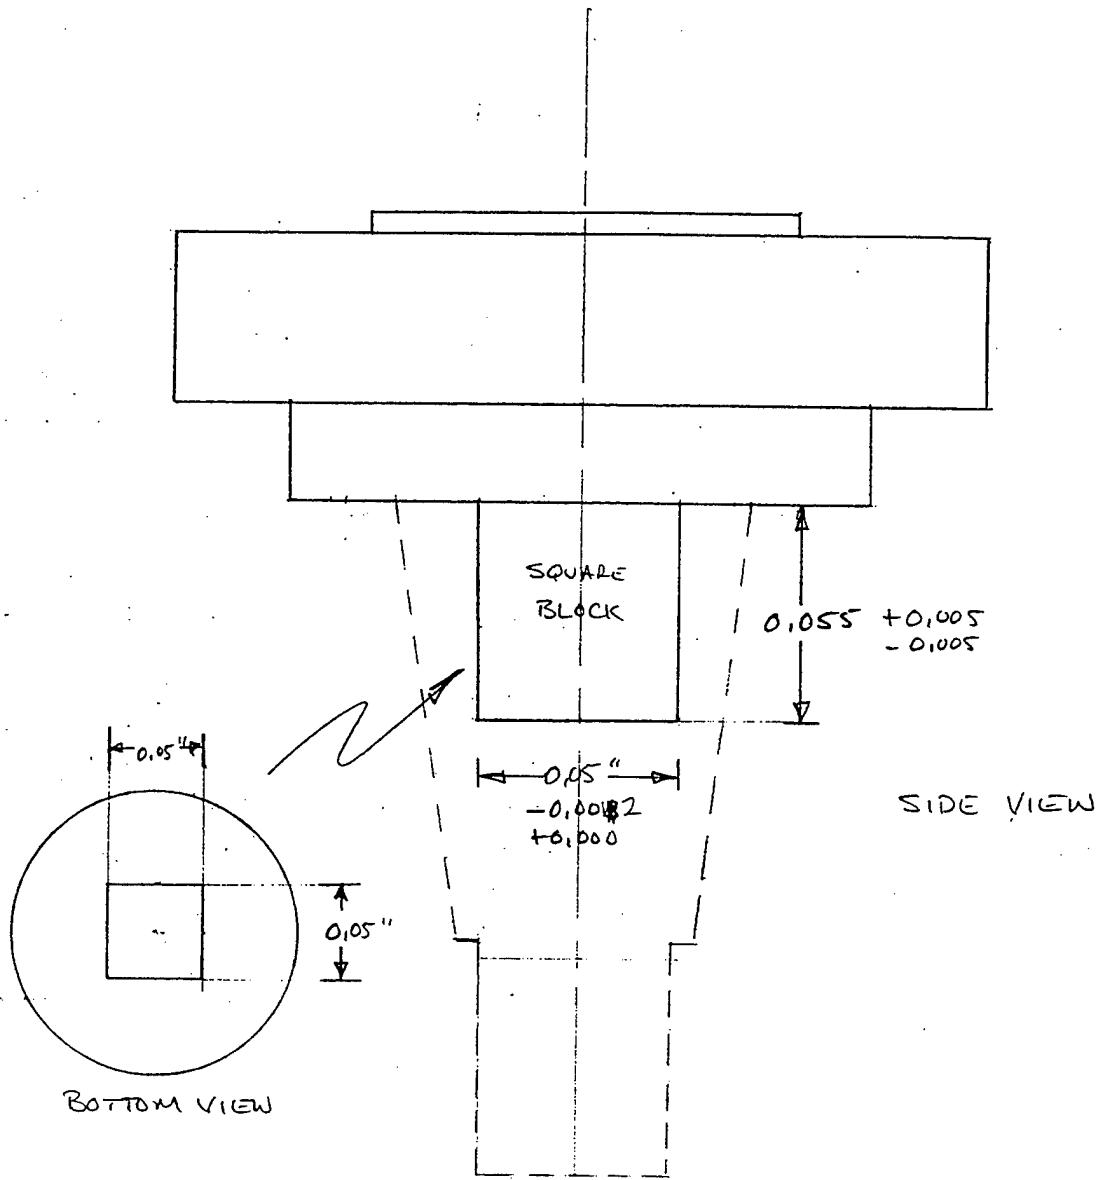
ENGINE SHAFT STARTER MOUNT

NEED EXISTING MATERIAL MILLEY
AWAY TO LEAVE 0.05×0.05 SQUARE

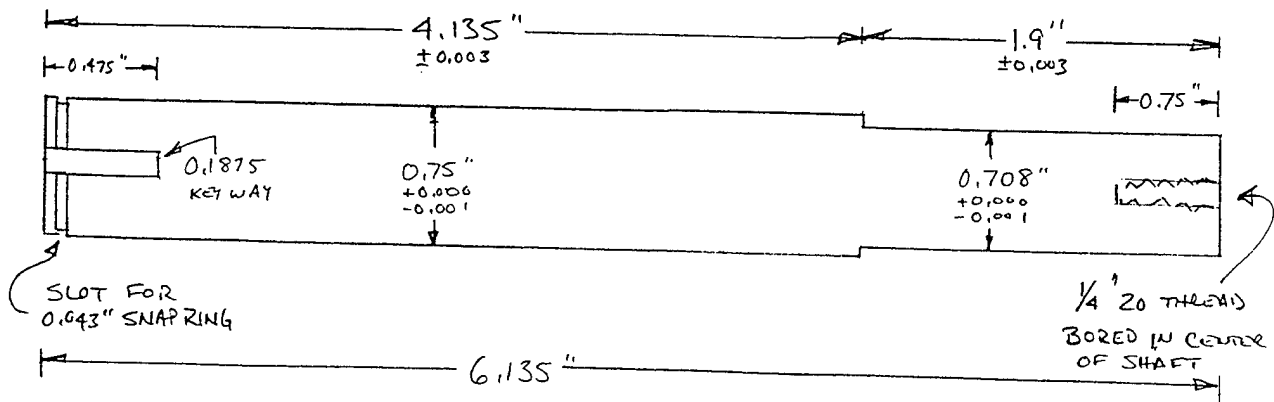
INTERMEDIATE SHAFT

MATL: STEEL

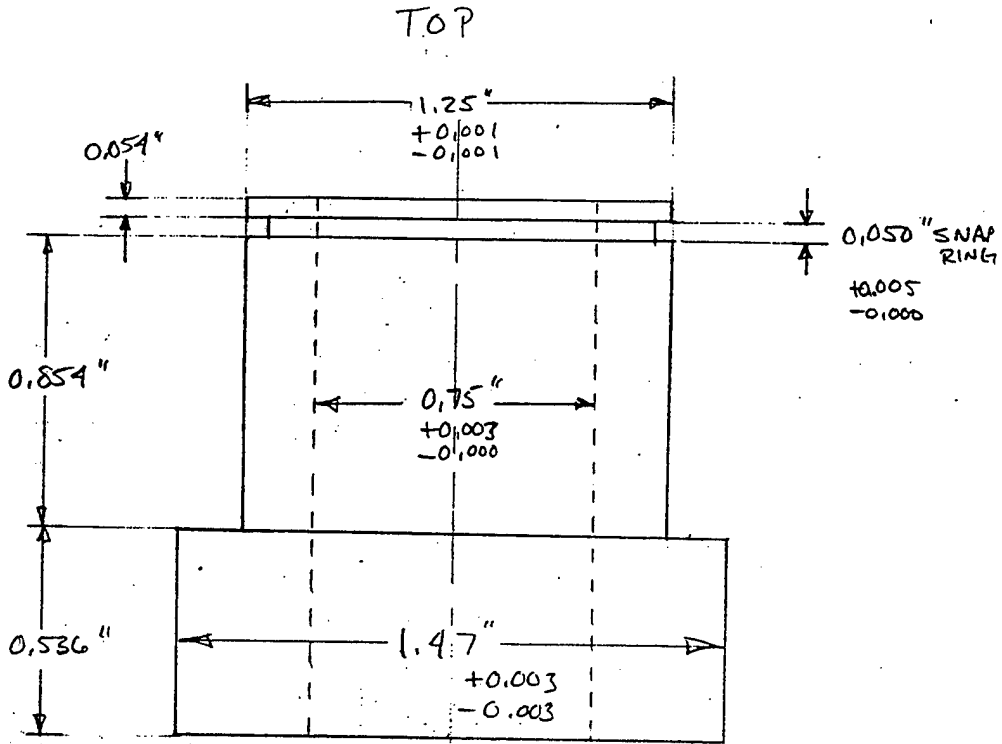
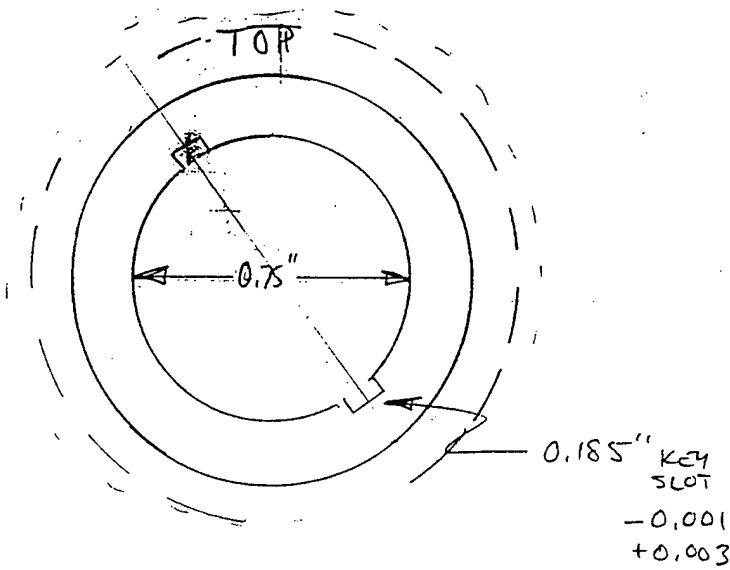
7" SPROCKET INSERT

NEED ENTIRE PIECE MANUFACTURED

MATERIAL: HARDENED STEEL

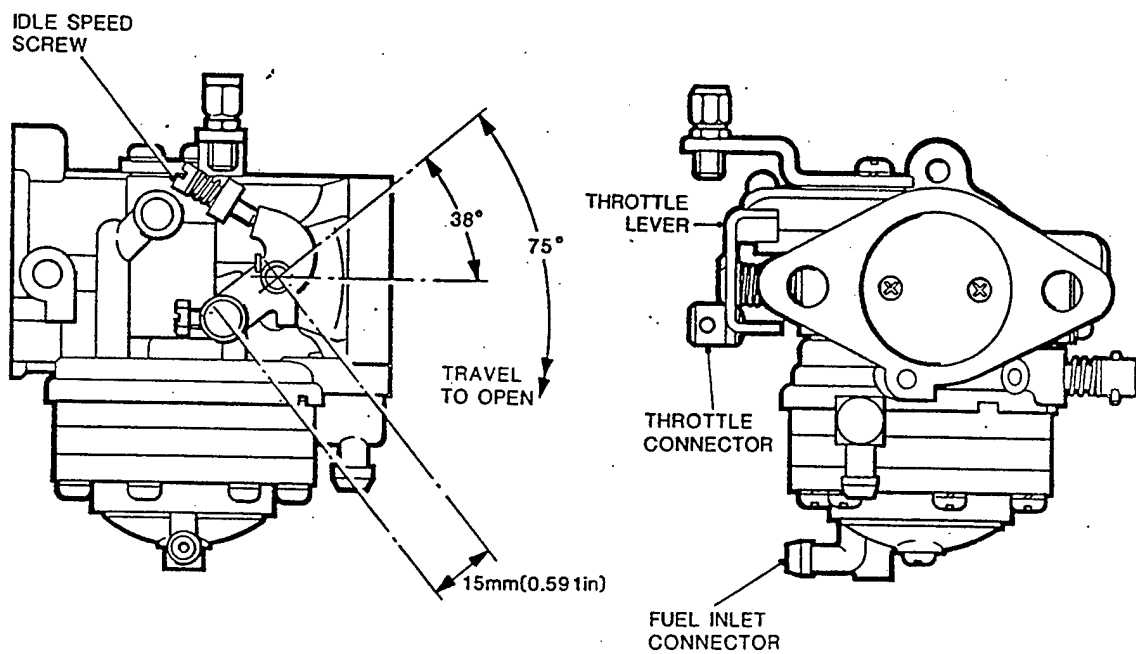
FIGURE 5-1 : CARBURETTOR

- 5.5 Fit 73 mm stub exhaust pipes or installation exhaust system, using gaskets supplied (refer to Installation Drawing) and torque tighten bolts to 6 Nm (53 lbf ins) maximum.
- 5.6 Connect fuel line (customer supply) to carburettor fuel connector (FIGURE 5-1). Ensure a fuel filter 50 microns (0.002 in) is incorporated in fuel line.
- 5.7 Connect throttle cable (customer supply) to carburettor throttle lever (FIGURE 5-1).

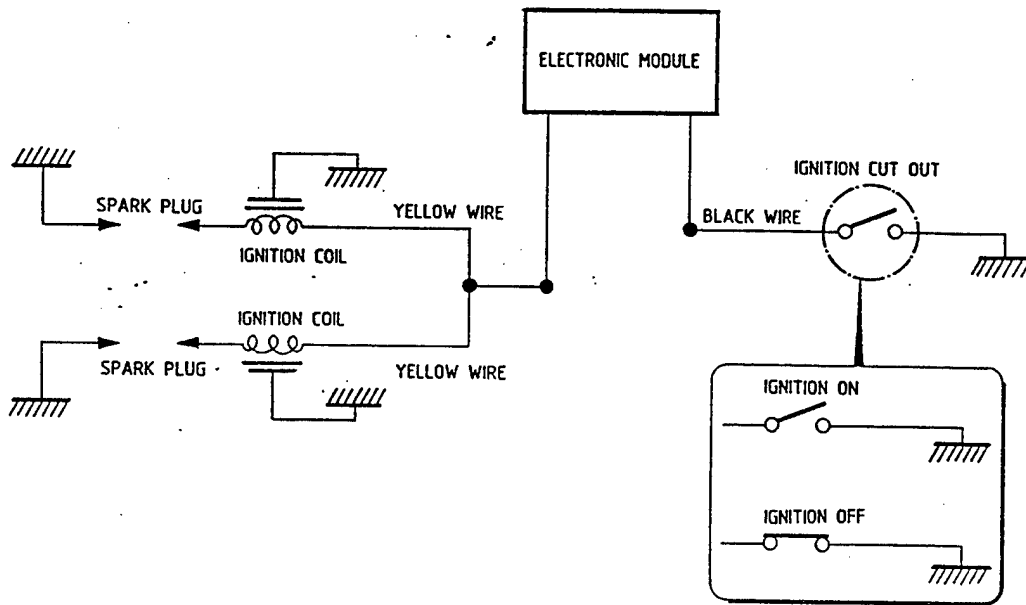
FIGURE 5-2 : IGNITION SYSTEM - CIRCUIT DIAGRAM

- 5.8 Connect ignition cut-out wire to ignition switch (customer supply) (reference FIGURE 5-2).
- 5.9 Remove protection caps from spark plug holes and rotate engine crankshaft 4 - 5 times to clear excess oil from the engine. Check and gap, new spark plugs and install. Torque to 29.80 Nm (22 lbf ft).

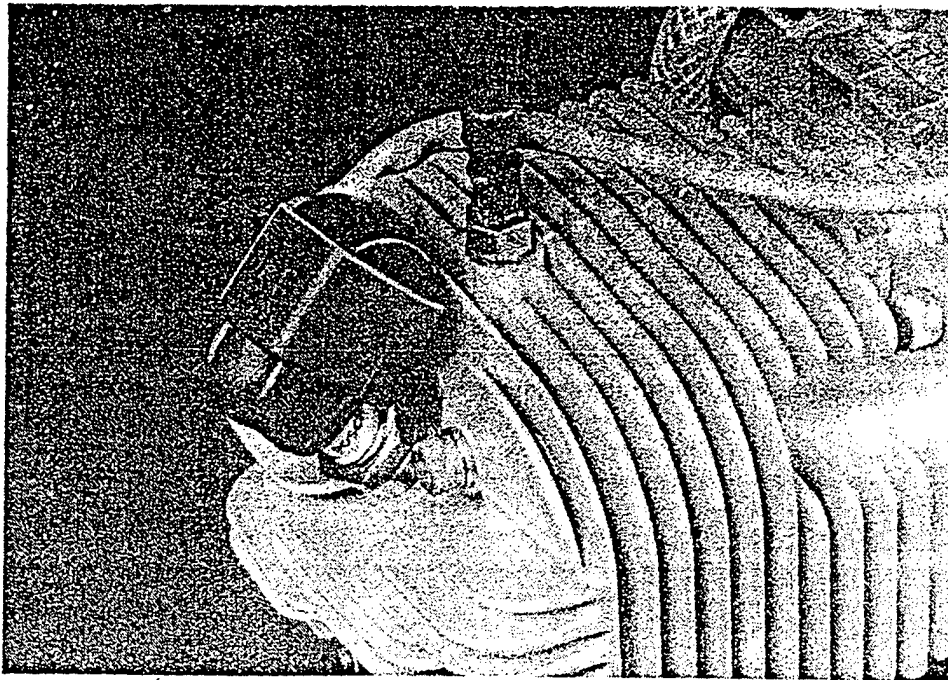
FIGURE 6-1

- 6.4.1 Check that spark plug leads are securely connected to spark plug terminals.
- 6.4.2 Turn on fuel supply.
- 6.4.3 Set decompressors by depressing caps situated on cylinder barrels (FIGURE 6-1).

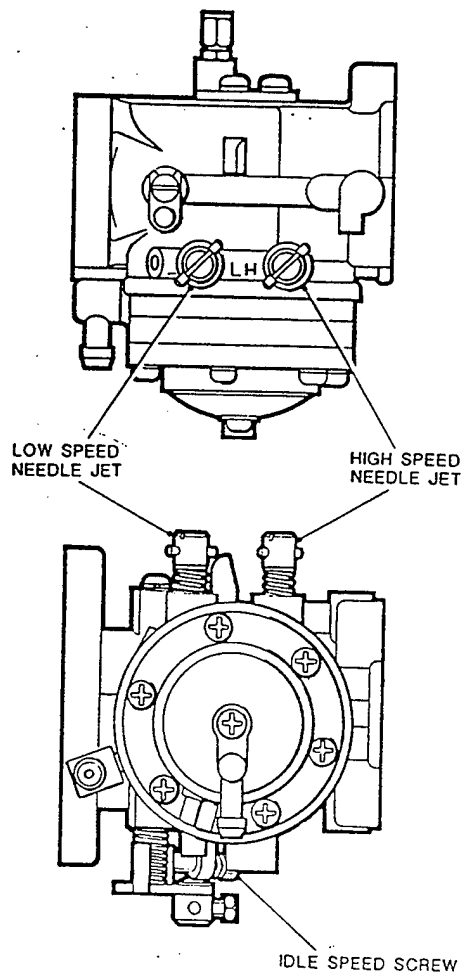
The engine should be fully warmed up before any adjustment is made to the carburettor.

The initial carburettor "Hi" and "Lo" needle jets and the idle-stop screw are adjusted at the factory, if further adjustment is required due to installation and/or geographical location, then:

- Screw idle-speed screw in or out to obtain required idle speed.
- The low-speed needle jet should be adjusted to obtain a smooth idle.

Adjustment of the high-speed needle jet must be done while monitoring the spark plug gasket temperatures and the engine speed. The high-speed adjustment is made with a hot engine, once the idle adjustments have been satisfactorily completed.
