FINAL REPORT  
APRIL 1996

REPORT NO. 95-01

PALLETIZED LOADING  
SYSTEM (PLS) FLATRACK  
SIDEBOARD KIT  
EVALUATION

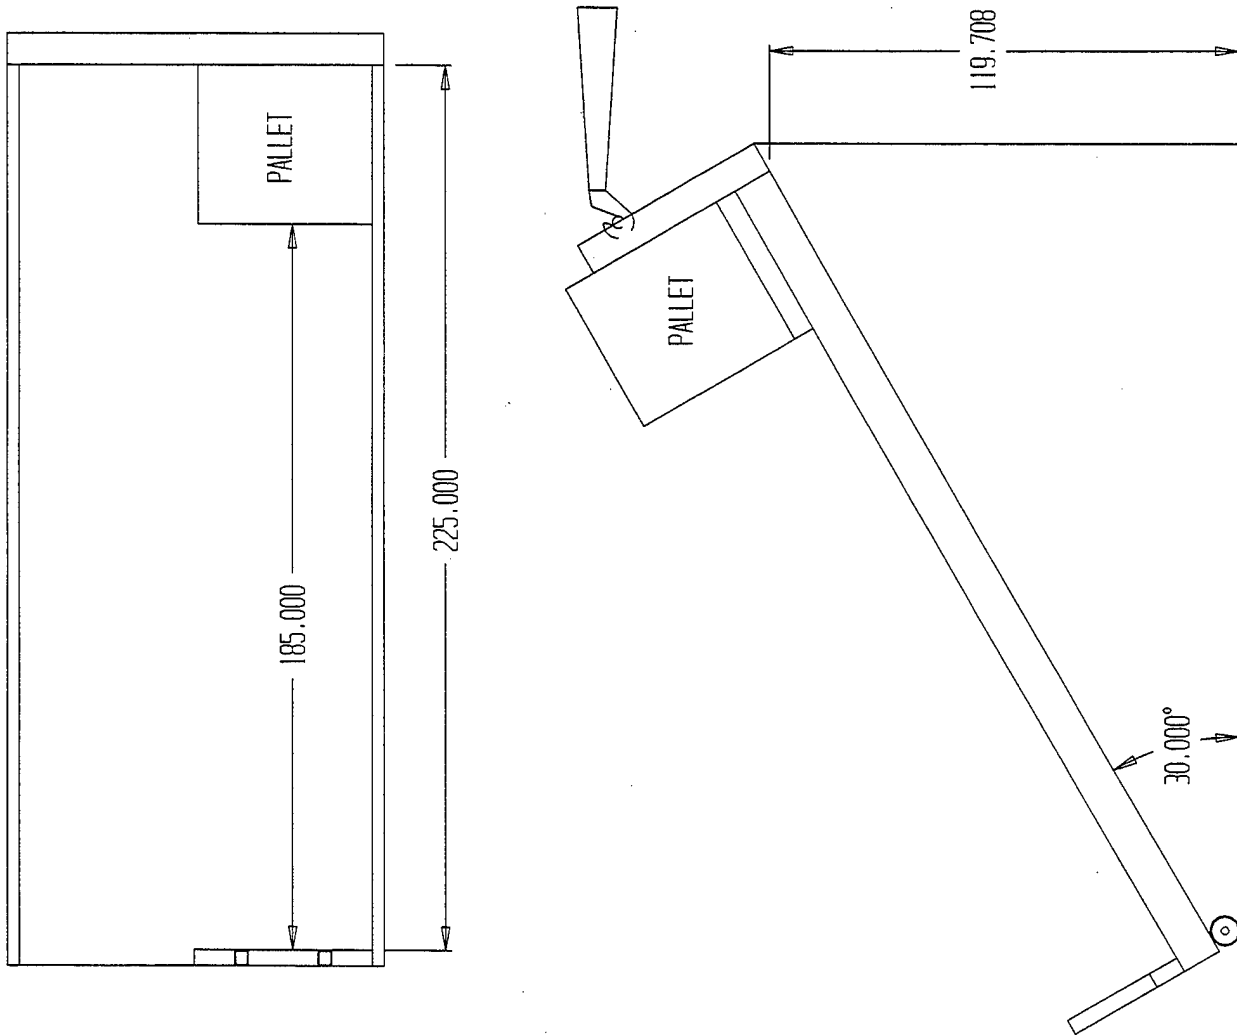
Figure 1

The M1077 flatrack was raised to 119 inches before the pallet overcame static friction (see Figure 1, page 4-2). The pallet slide path was 185 inches to the rear sideboard. The critical angle was 31 degrees.

1. Pallet - caused the upper two rows of PA116 containers to disengage from the locks on the lower rows.
2. Side Board Panel - minor deformation to the panel was incurred. The stakes could easily be removed from the sideboard.

3. Stakes - the upper part of the post had no permanent deformation. The base plug - which fits into the stake pocket - was permanently deformed to the plastic region. Due to the plasticity, finite element analysis (FEA) will be used to determine the load forces impacted into the plug. The model is a cantilevered beam.

4. M1077 stake pockets - permanent deformation and cracking was observed at the top of the two stake pockets which held the side board posts. Cracked steel was also found on the top of the pocket corners where they were formed into a "U" shape. This deformation was caused by the torsional load of the stake when the sliding pallet struck the sideboard.
