Technical Report EL-97-1  
January 1997

# **Low-Flow Aquatic Habitat Restoration Evaluation, the RCHARC Methodology, Goose Creek, Colorado**

by *C. Bradley Florentin, Steven R. Abt,  
Chester C. Watson, Kent L. Collins,  
Colorado State University*

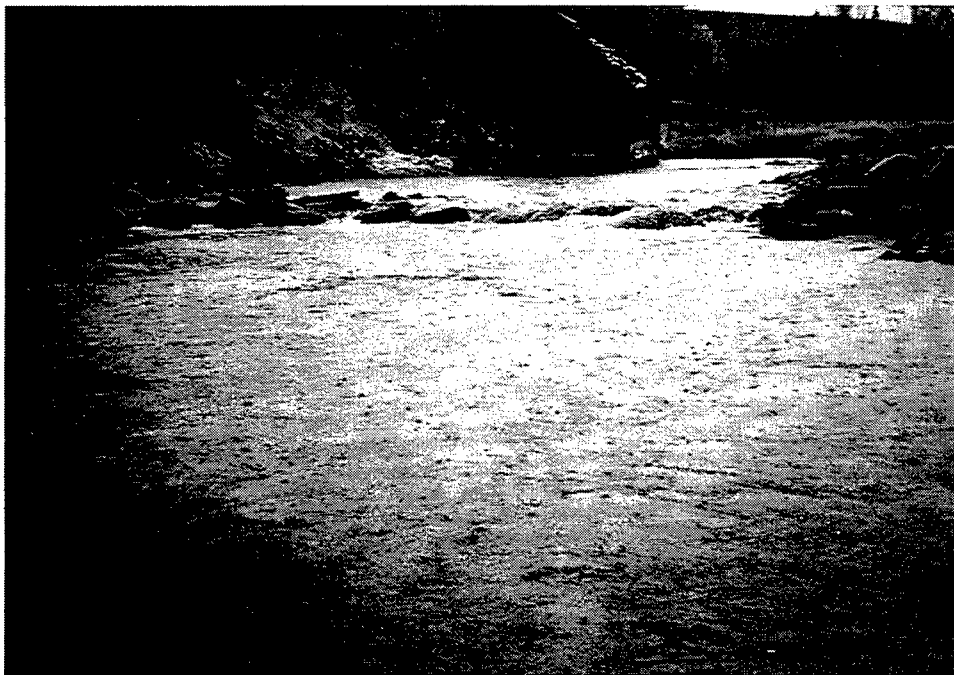
Figure 10. Photograph of degraded reach

The degraded reach is located adjacent to an abandoned mine. The tailings from the mine encroach into the stream and have contaminated the habitat. The stream banks have severely eroded, and bank vegetation has not survived in the adverse environment. The degraded stream reach is unstable with a tendency to braid (shallow depth and a large top width averaging about 11.05 m). The channel is inundated with algae and moss, and the bed is

composed of small cobbles and coarse gravel. A photograph of the degraded section is presented in Figure 10. Descriptions of individual cross sections in each of the three reaches are presented in Appendix A.
