**FORT DEVENS  
FINAL REMEDIAL  
INVESTIGATION  
FOR GROUP 2 & 7 SITES**

**FINAL  
REMEDIAL INVESTIGATION REPORT  
AREA OF CONTAMINATION (AOC) 41**

**ABB Environmental Services, Inc.  
Portland, ME  
Project No. 07053-15**

**February 1996**

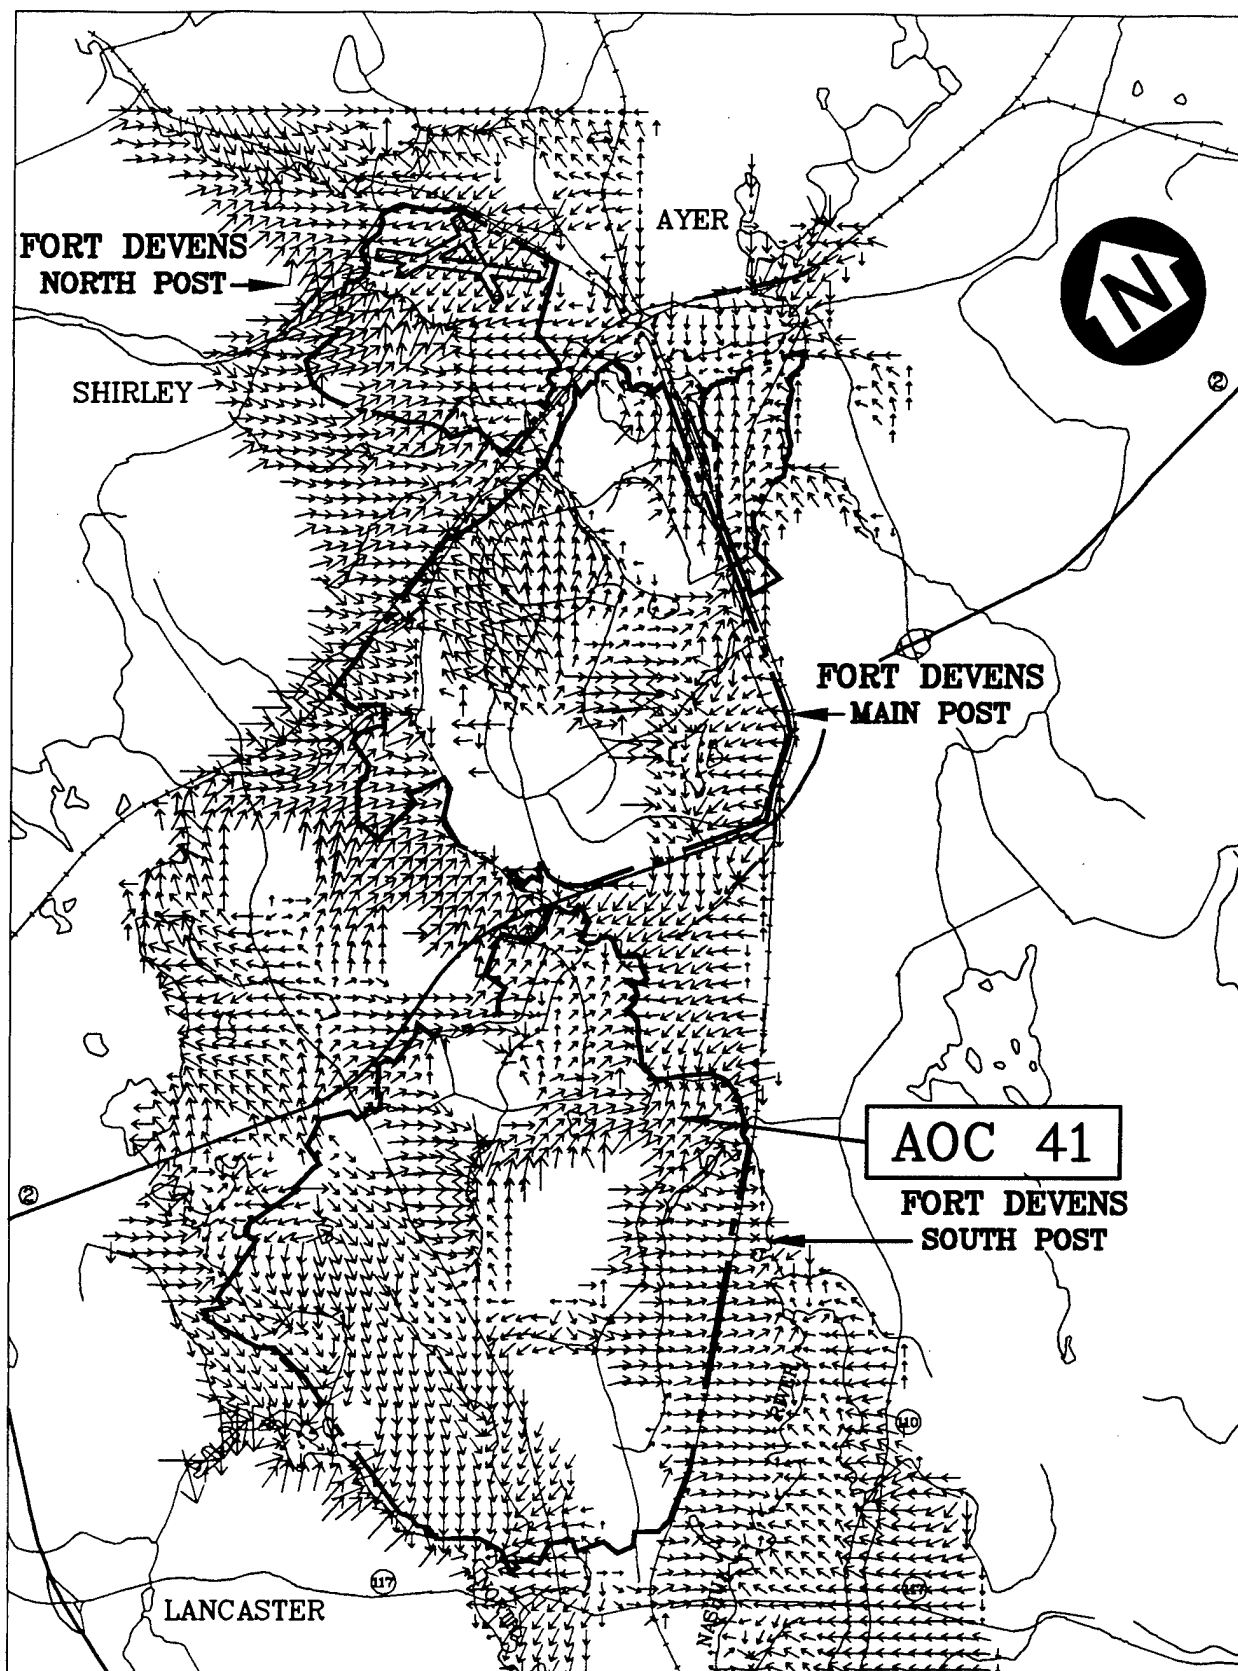
GROUNDWATER FLOW VECTORS

SOURCE:  
DRAFT FINAL GROUNDWATER FLOW MODEL AT FORT DEVENS, MA,  
ETA, INC. OCTOBER 30, 1992.

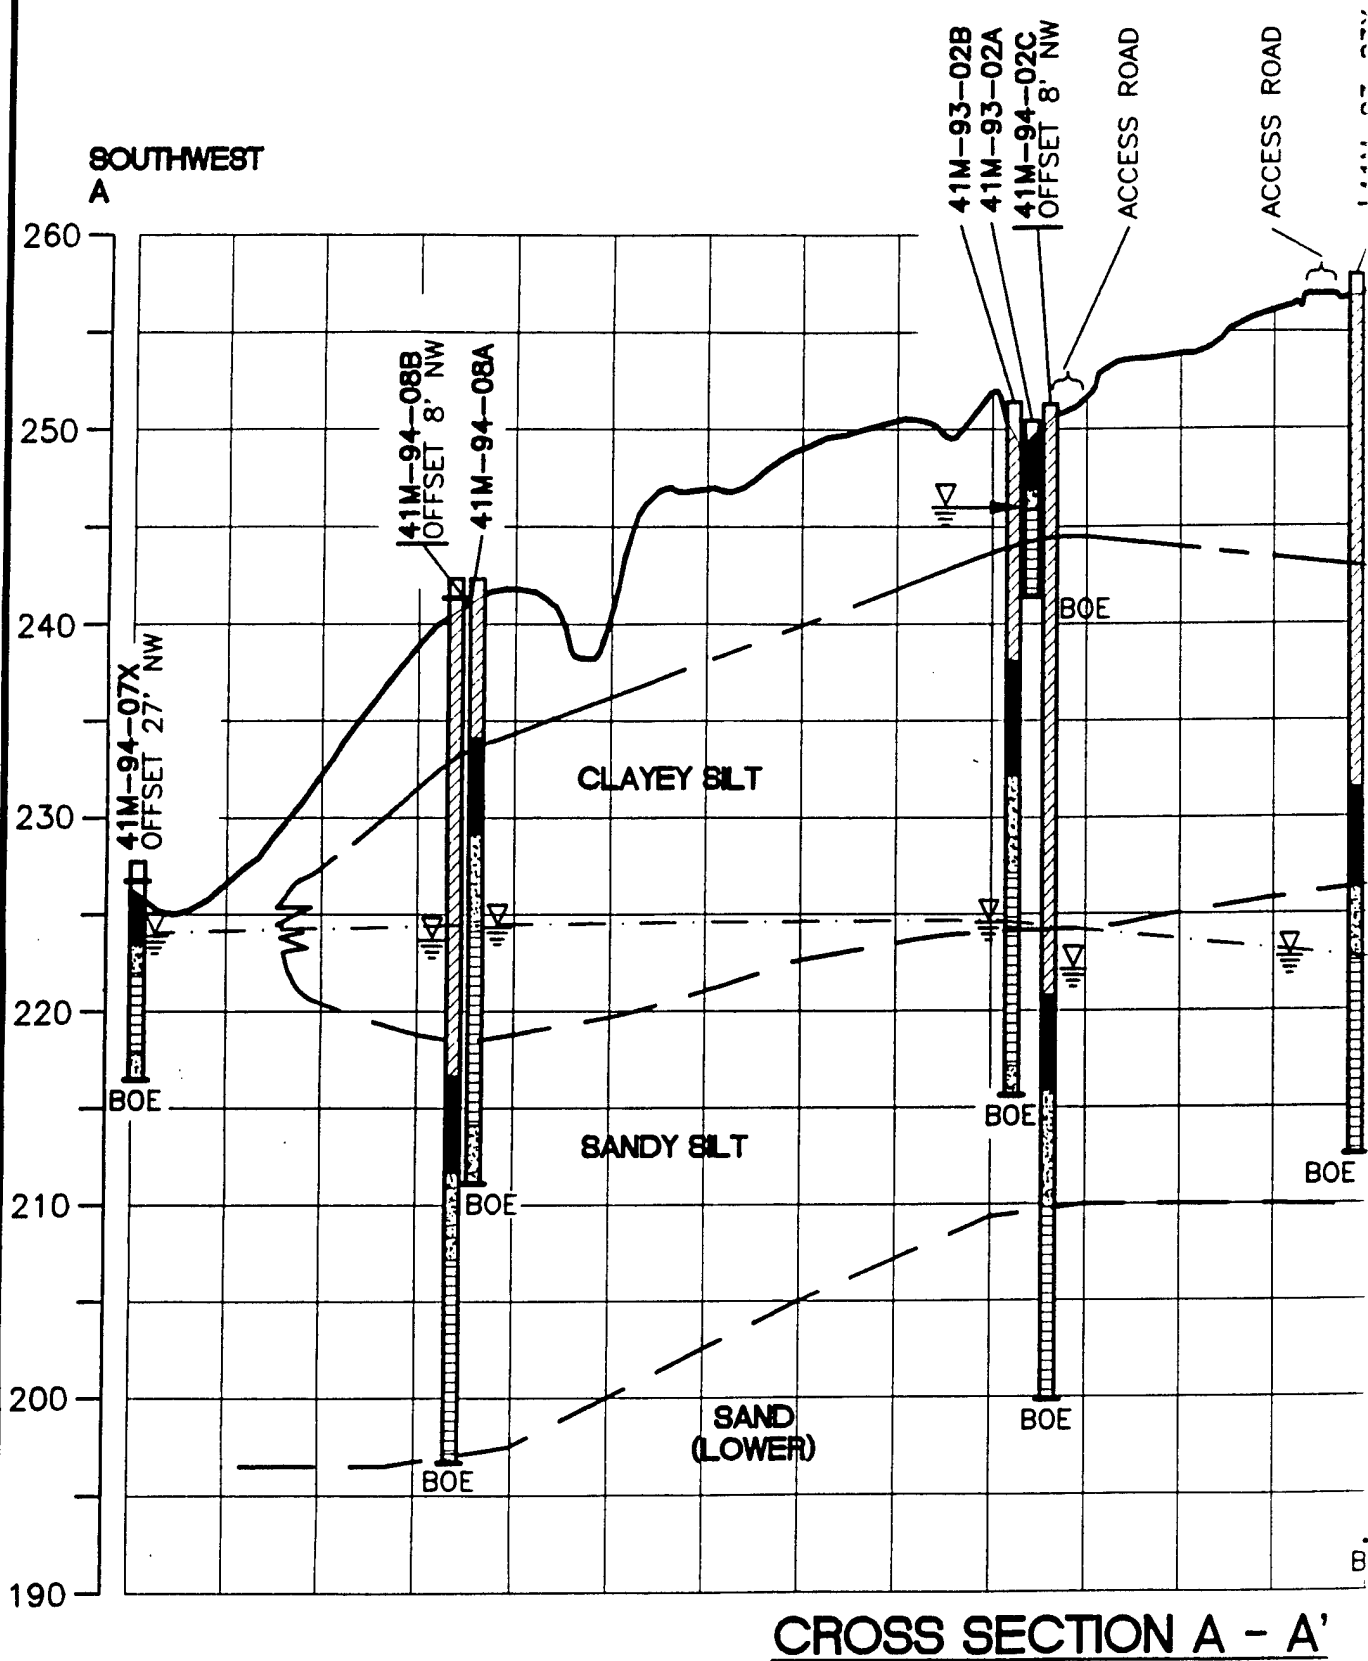
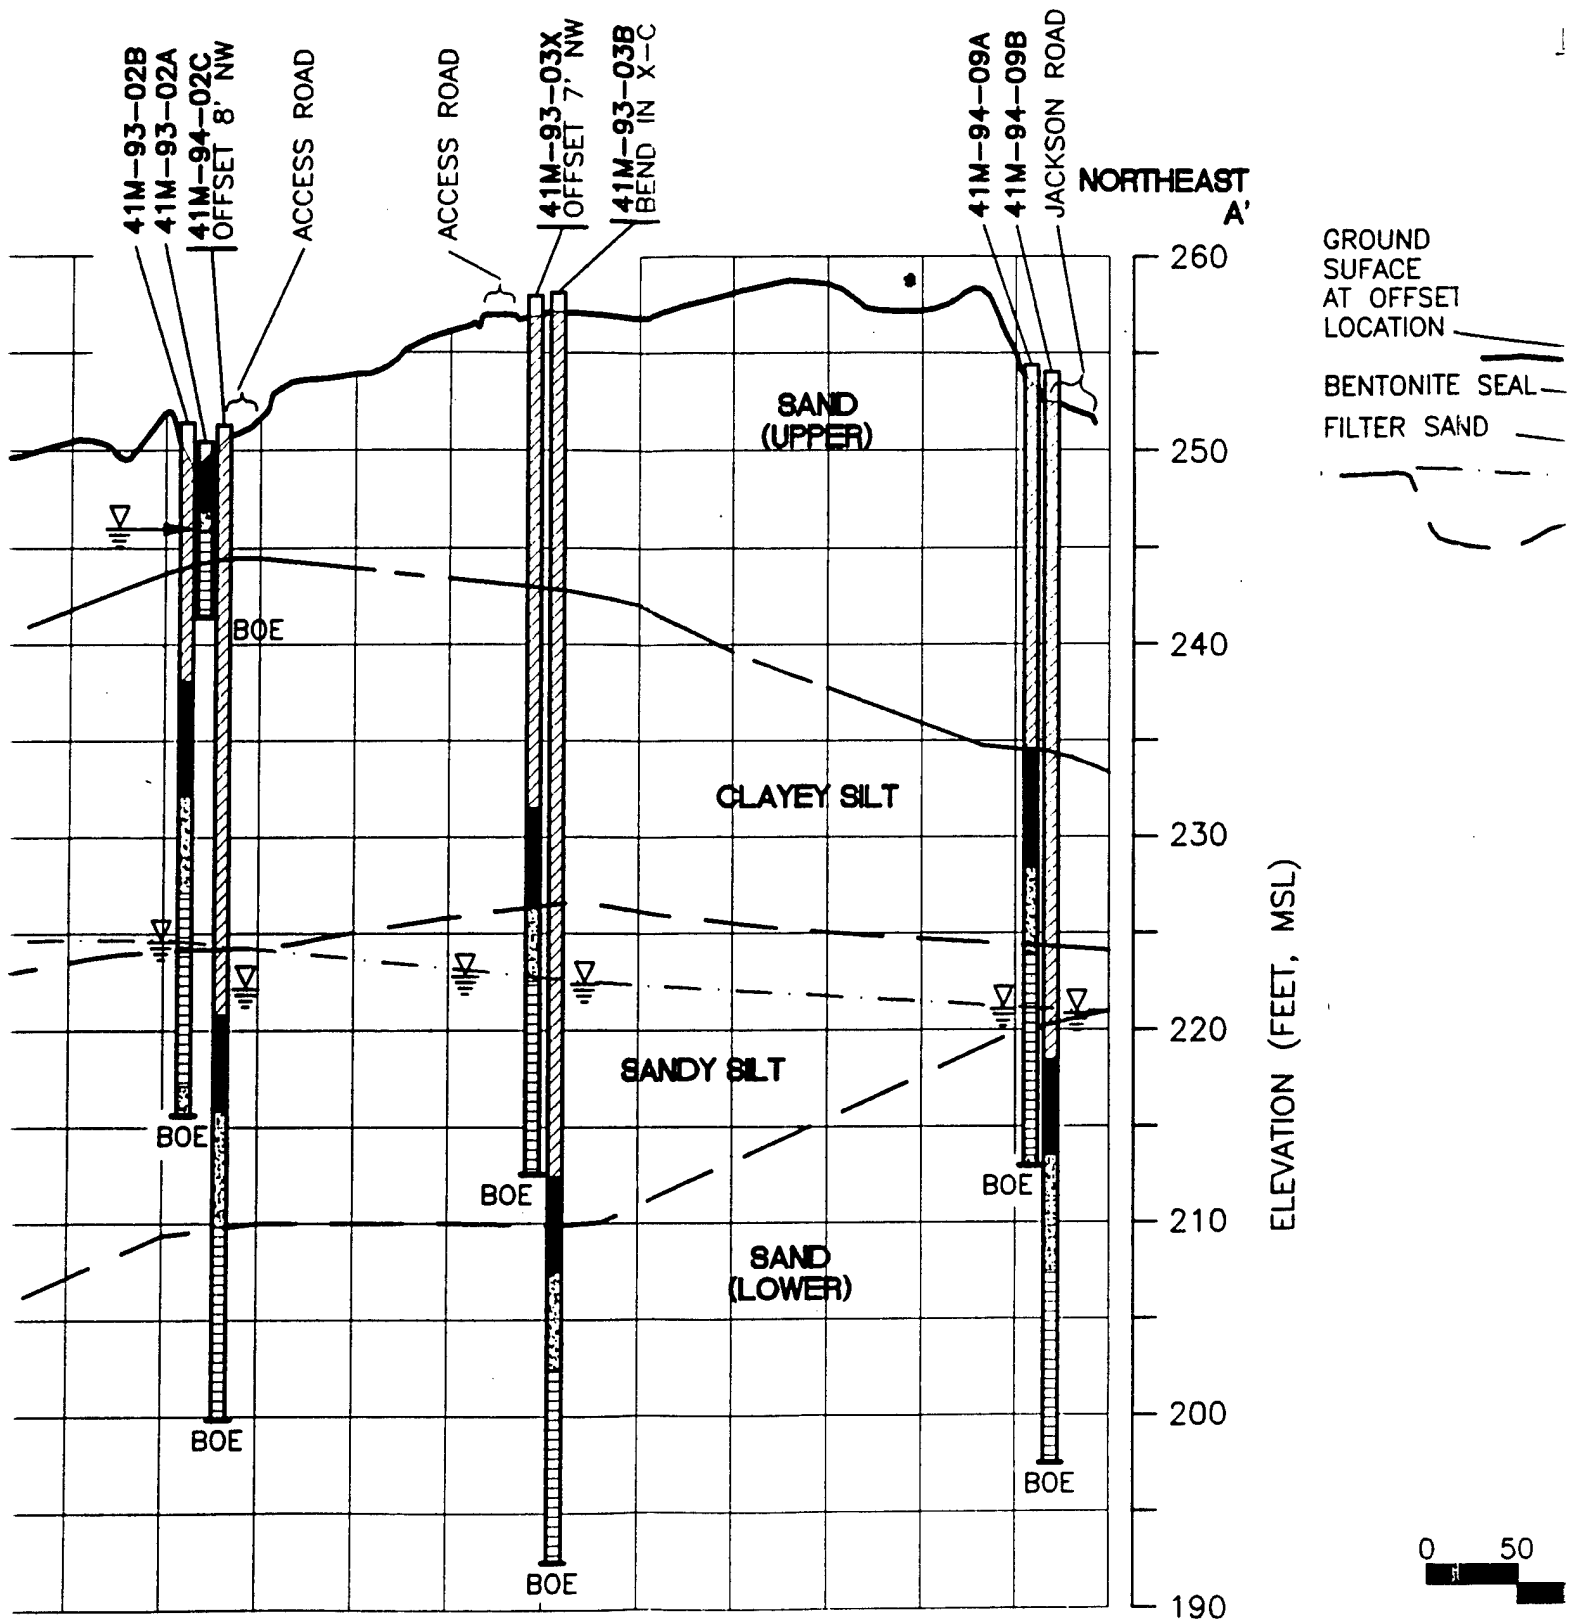
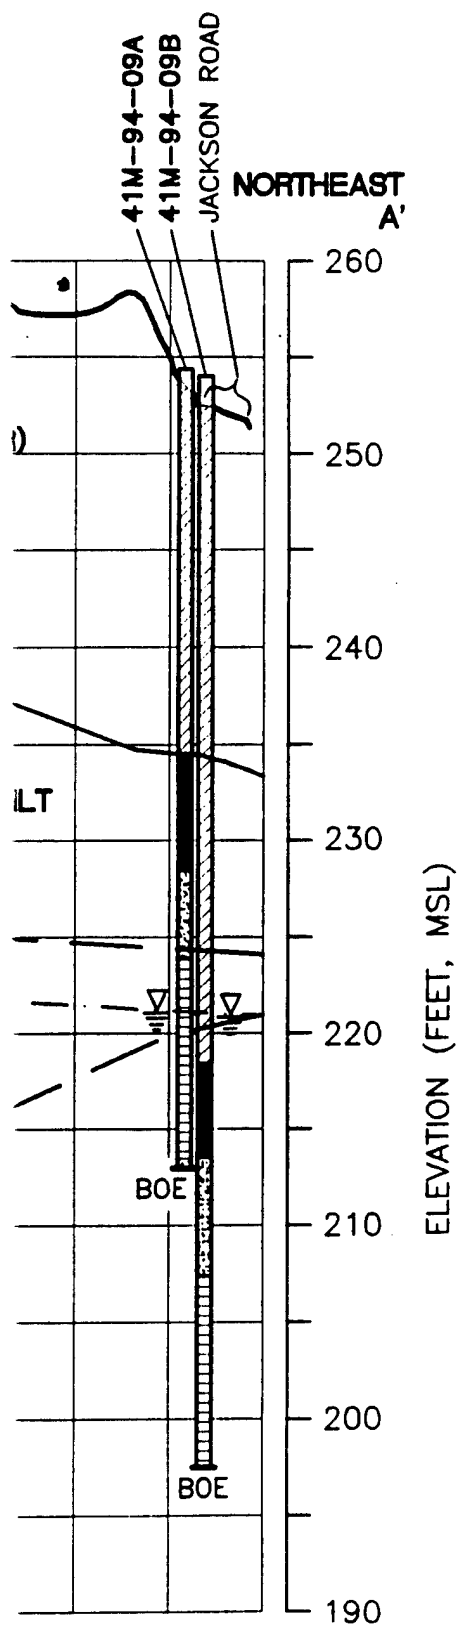
**FIGURE 6-2**  
**INTERPRETIVE GEOLOGIC CROSS-SECTION A-A'**  
**AOC 41-UNAUTHORIZED DUMPING AREA (SITE A)**  
**REMEDIAL INVESTIGATION REPORT**  
**FORT DEVENS, MA**

1. FOR ORIENTATION OF CROSS SECTION SEE FIGURE 6-1.
2. GEOLOGIC CONDITIONS BETWEEN WELLS ARE AN INTERPRETATION OF AVAILABLE DATA. ACTUAL CONDITIONS MAY VARY.

HORIZONTAL SCALE: 1"=100'  
 VERTICAL SCALE: 1"=10'  
 VERTICAL EXAGGERATION: 10:1

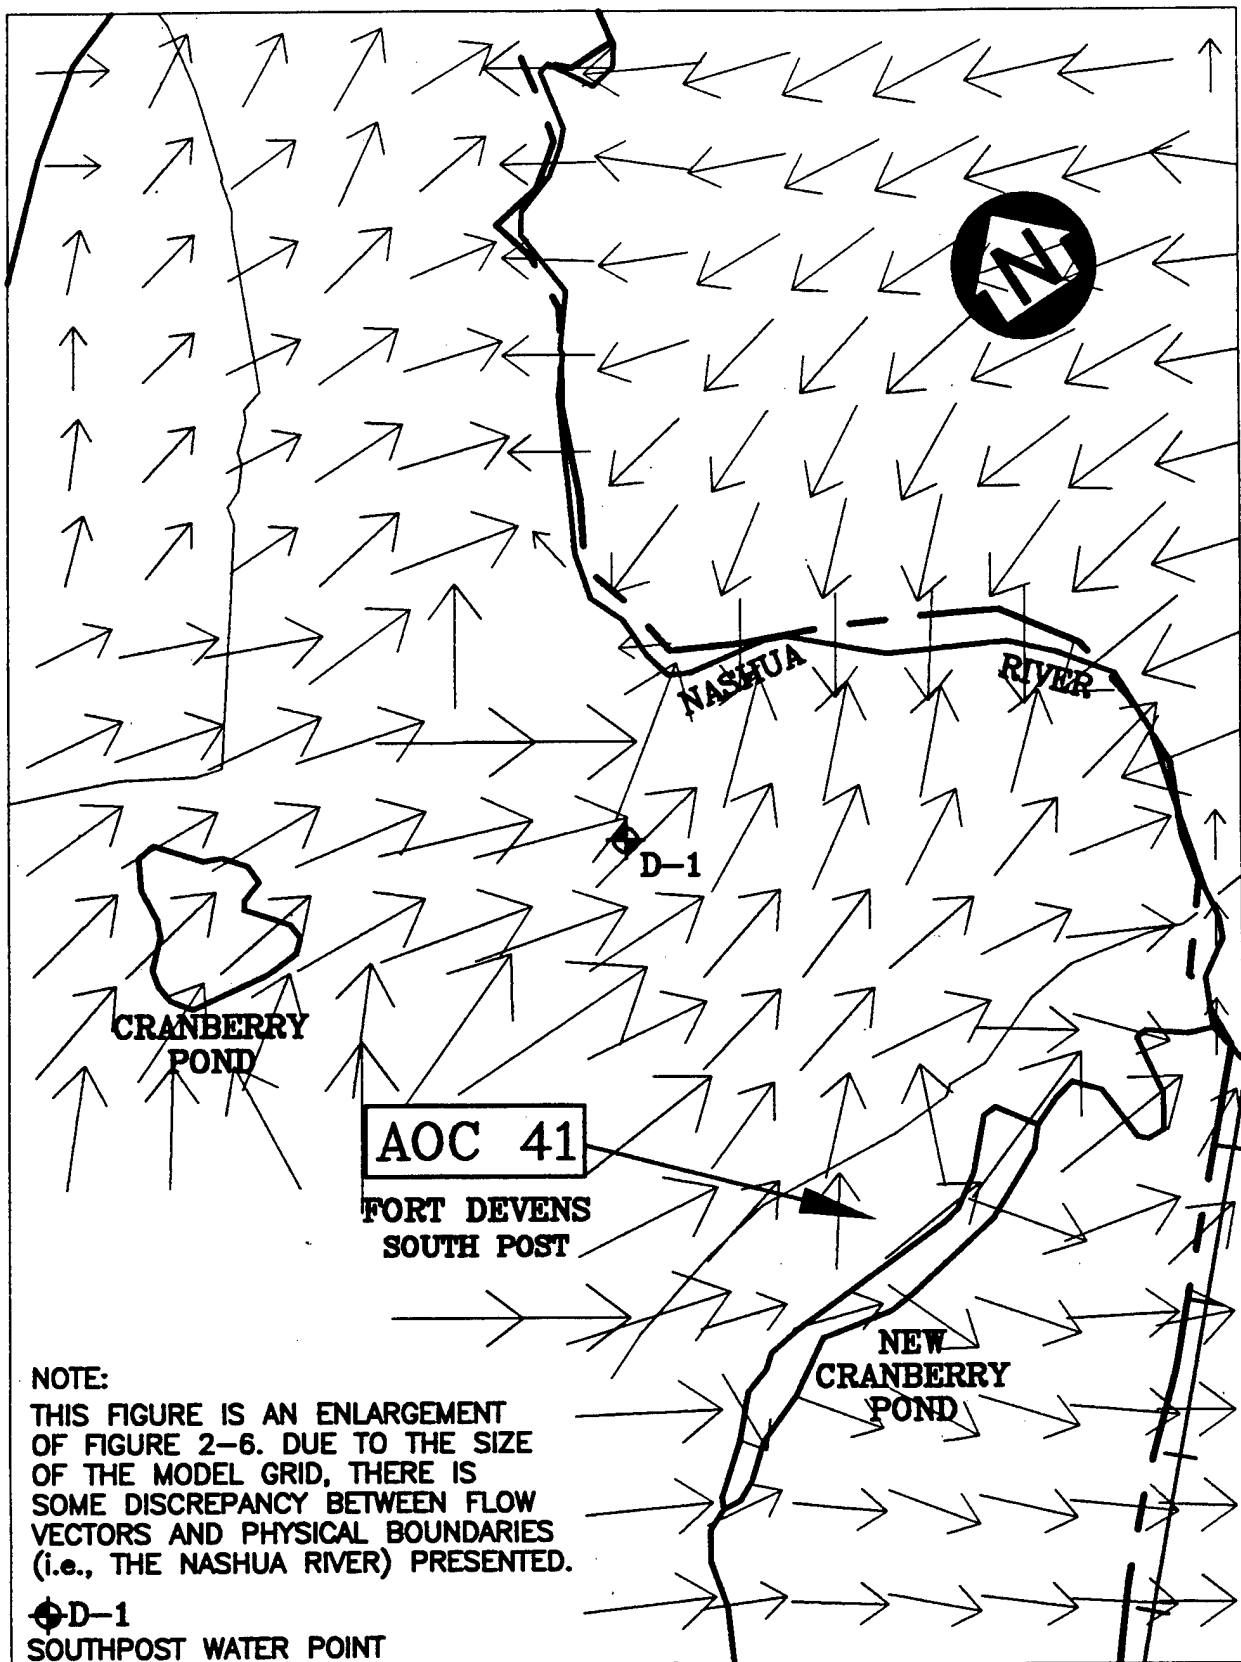
NOTE:  
THIS FIGURE IS AN ENLARGEMENT  
OF FIGURE 2-6. DUE TO THE SIZE  
OF THE MODEL GRID, THERE IS  
SOME DISCREPANCY BETWEEN FLOW  
VECTORS AND PHYSICAL BOUNDARIES  
(i.e., THE NASHUA RIVER) PRESENTED.

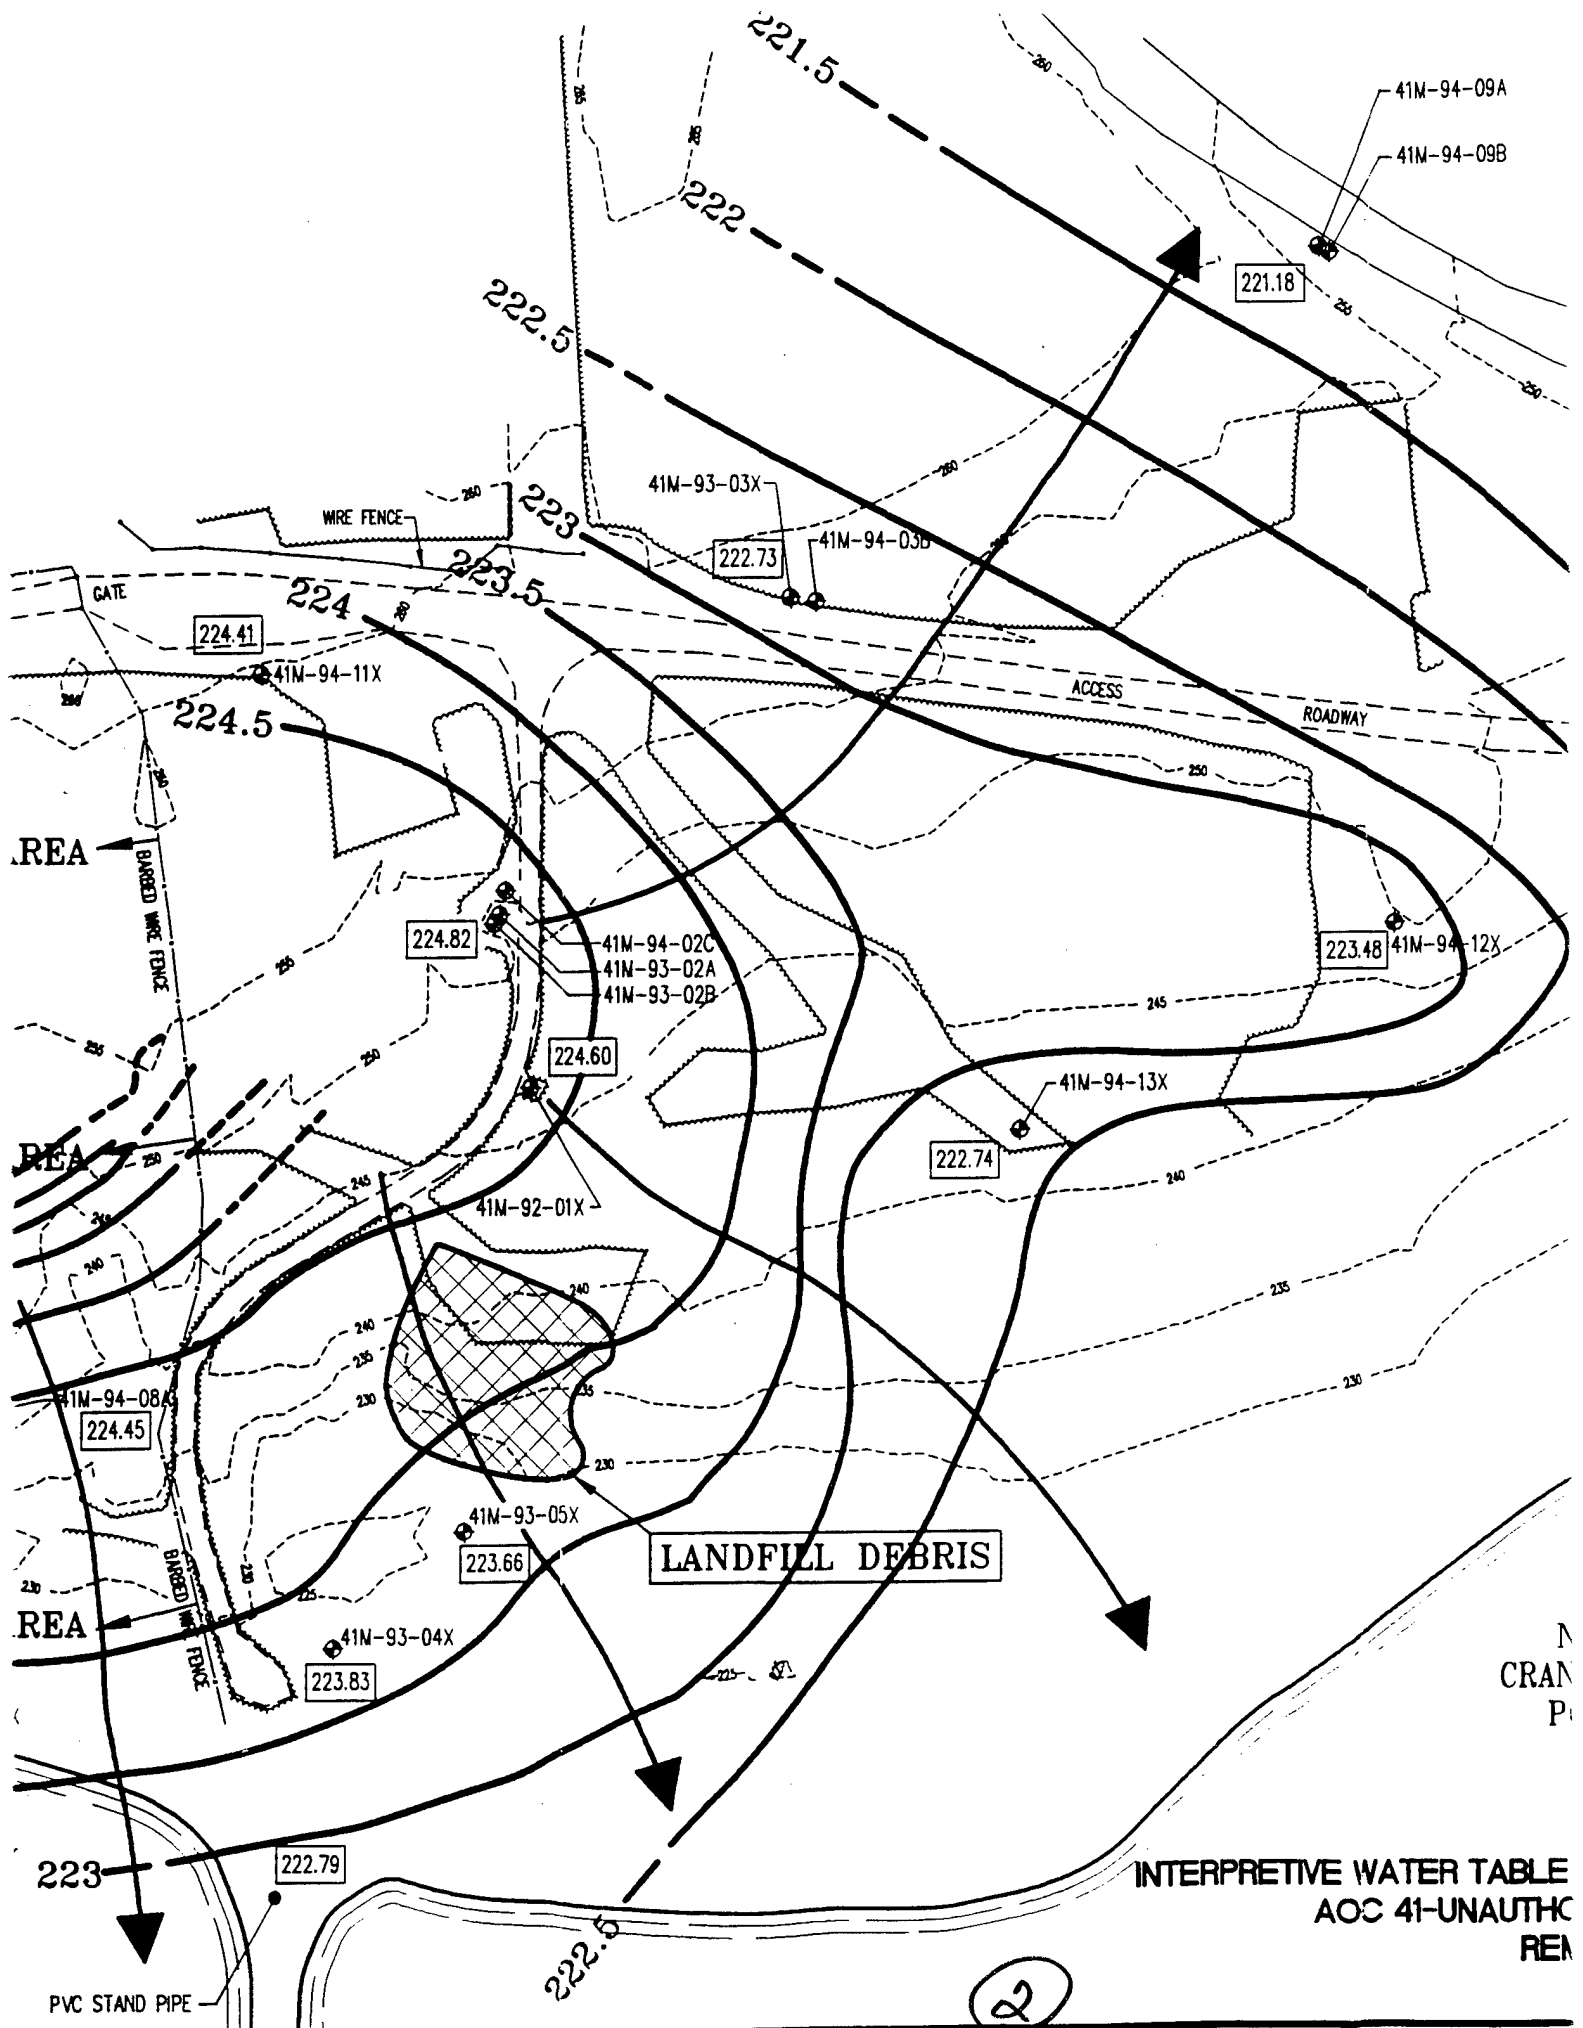
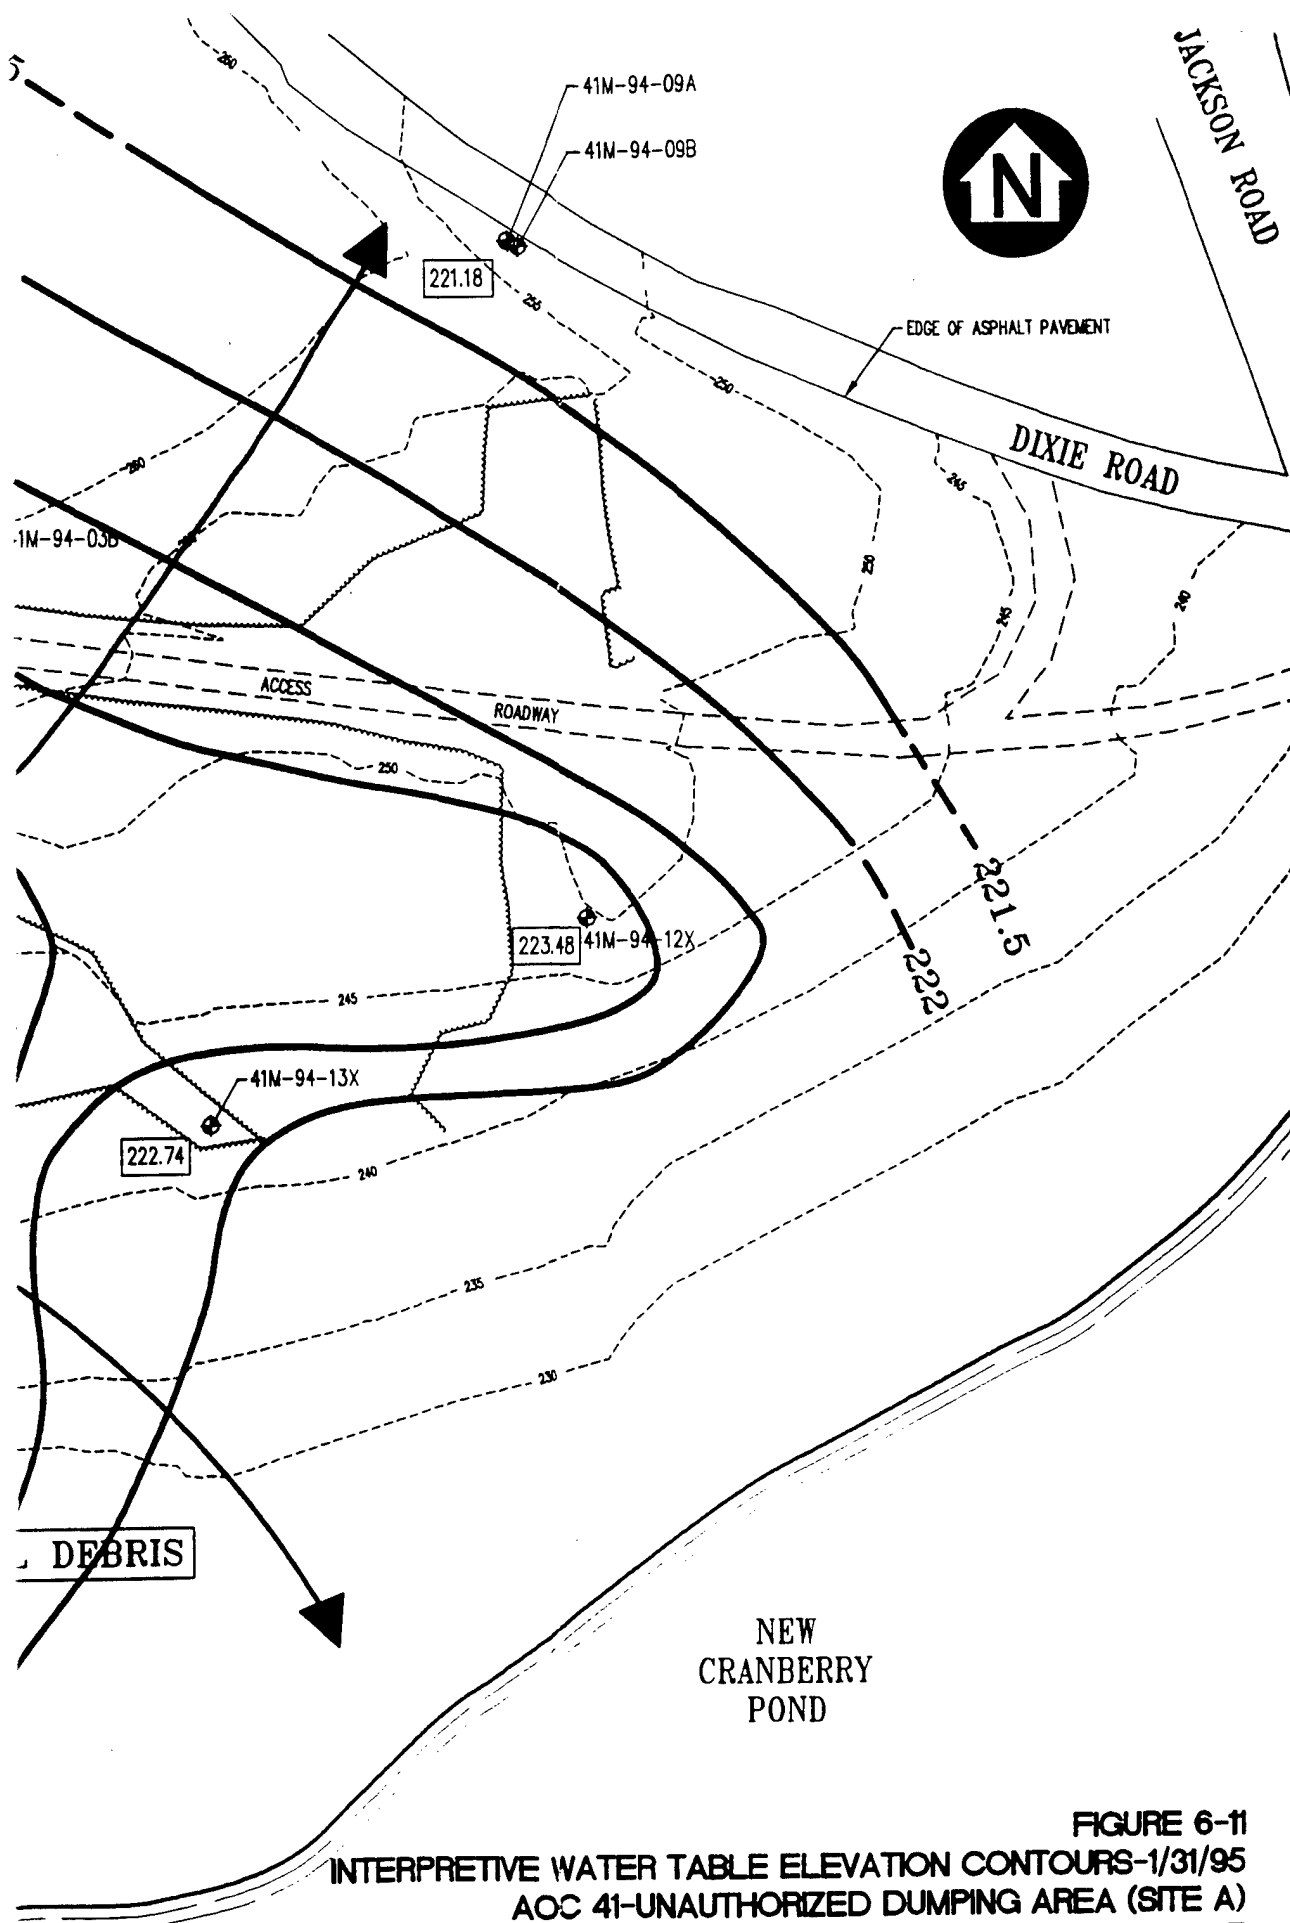
FIGURE 6-11  
 INTERPRETIVE WATER TABLE ELEVATION CONTOURS-1/31/95  
 AOC 41-UNAUTHORIZED DUMPING AREA (SITE A)  
 REMEDIAL INVESTIGATION REPORT  
 FORT DEVENS, MA

GROUNDWATER CONTOUR INTERVALS ARE  
0.5 FEET INCREMENTS.

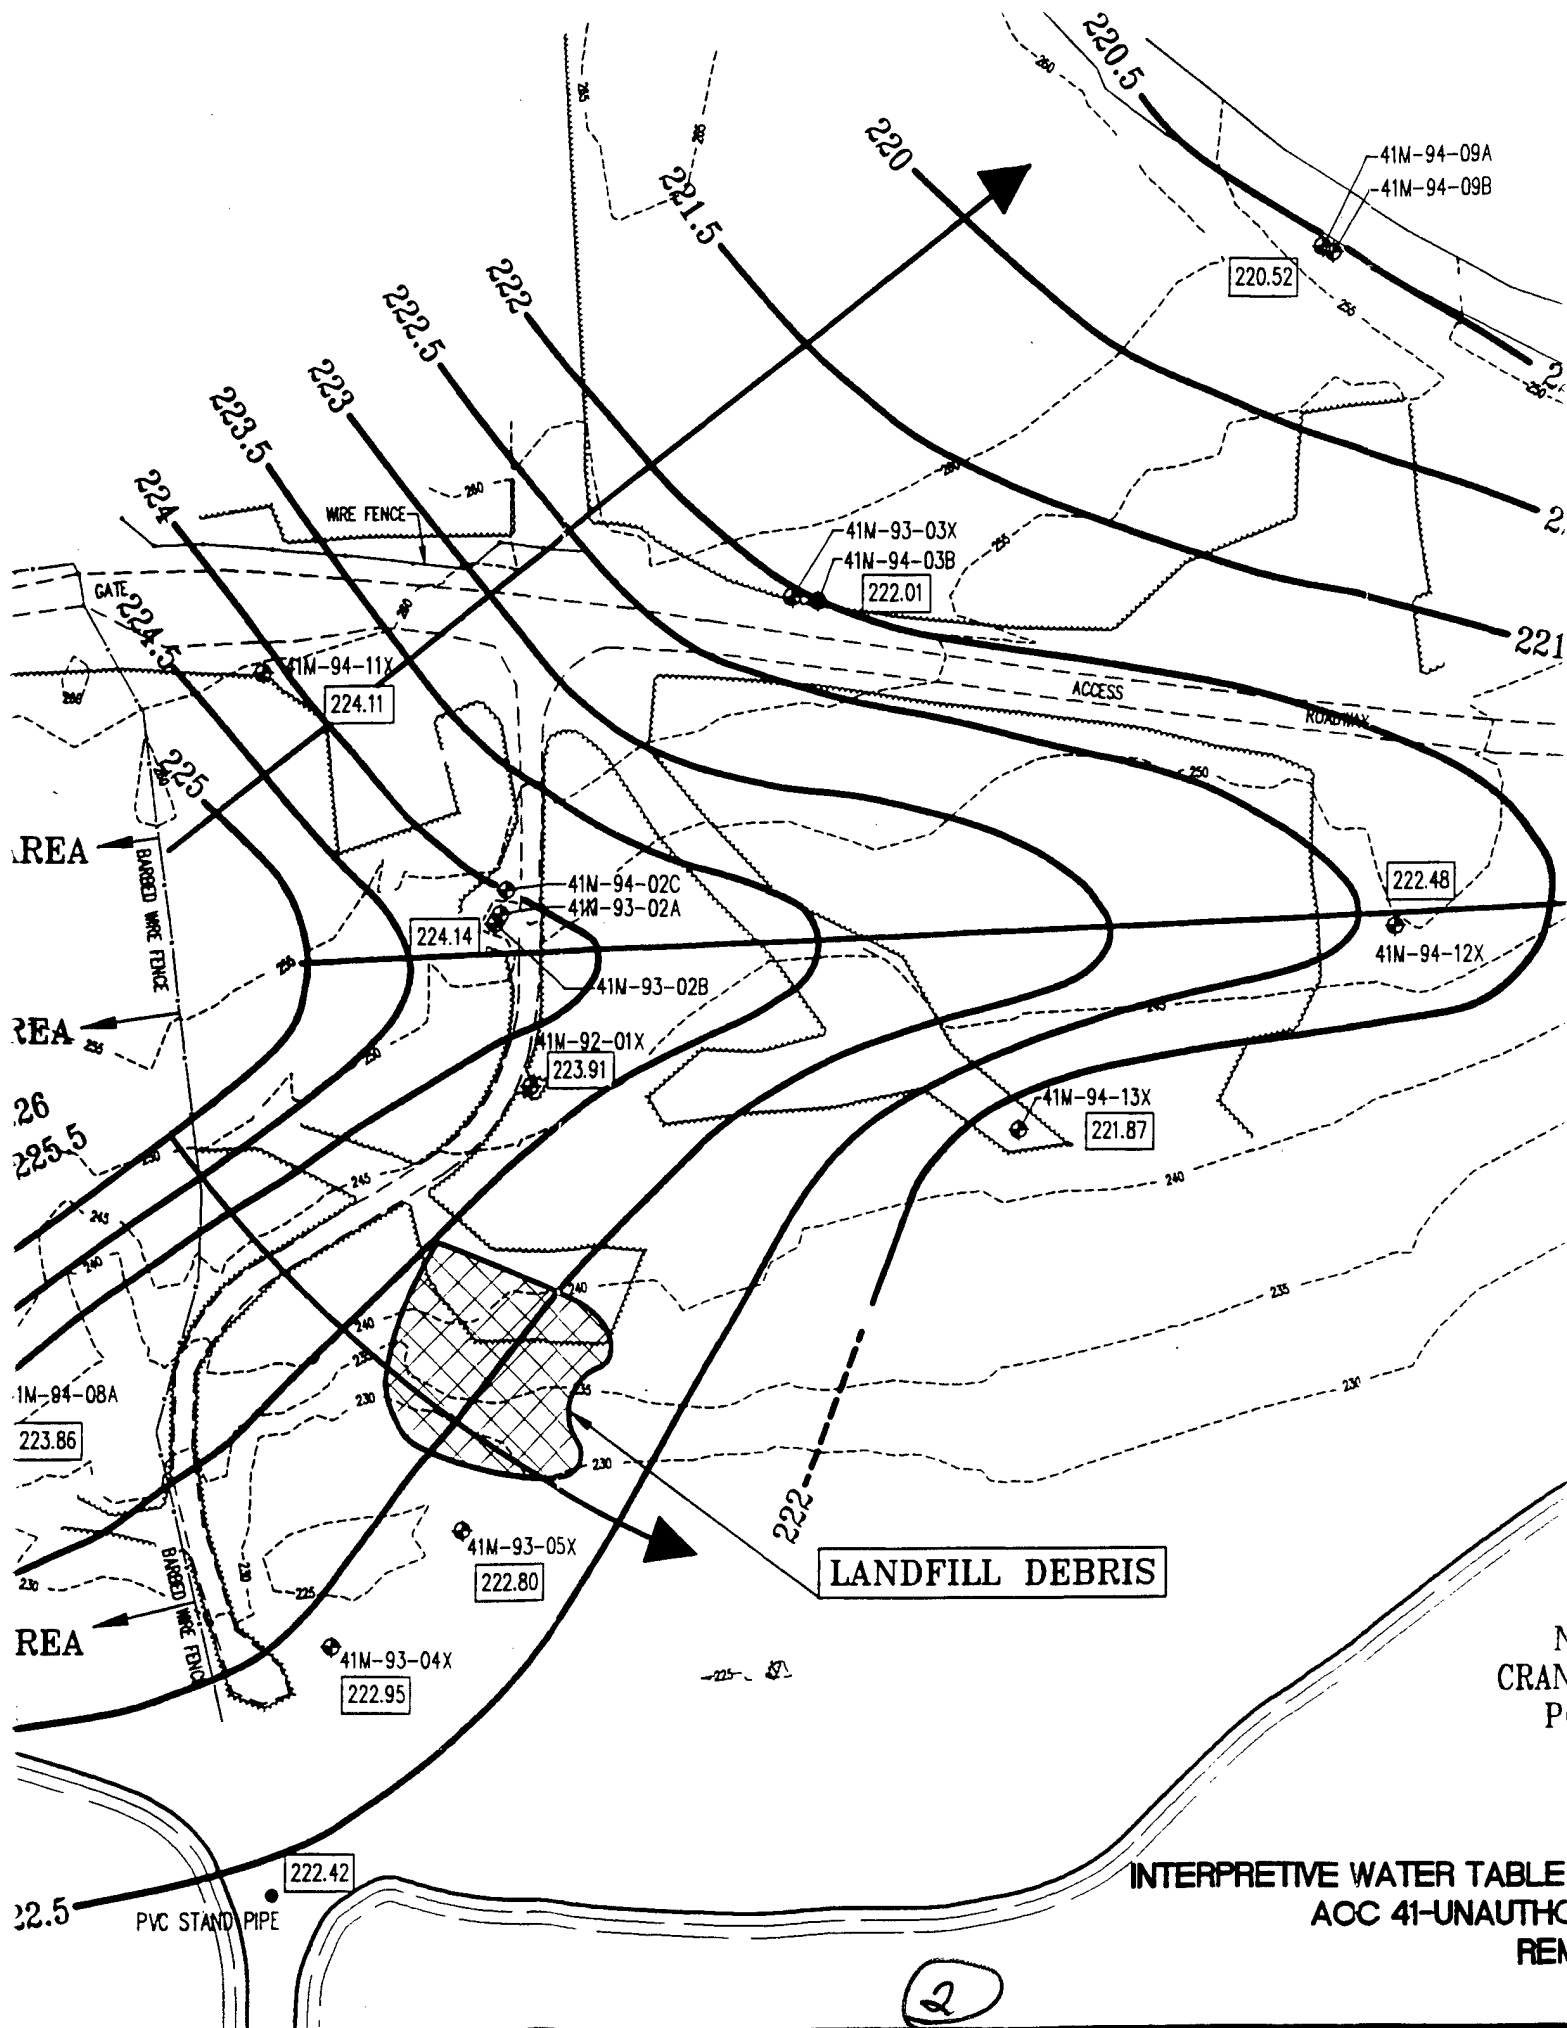
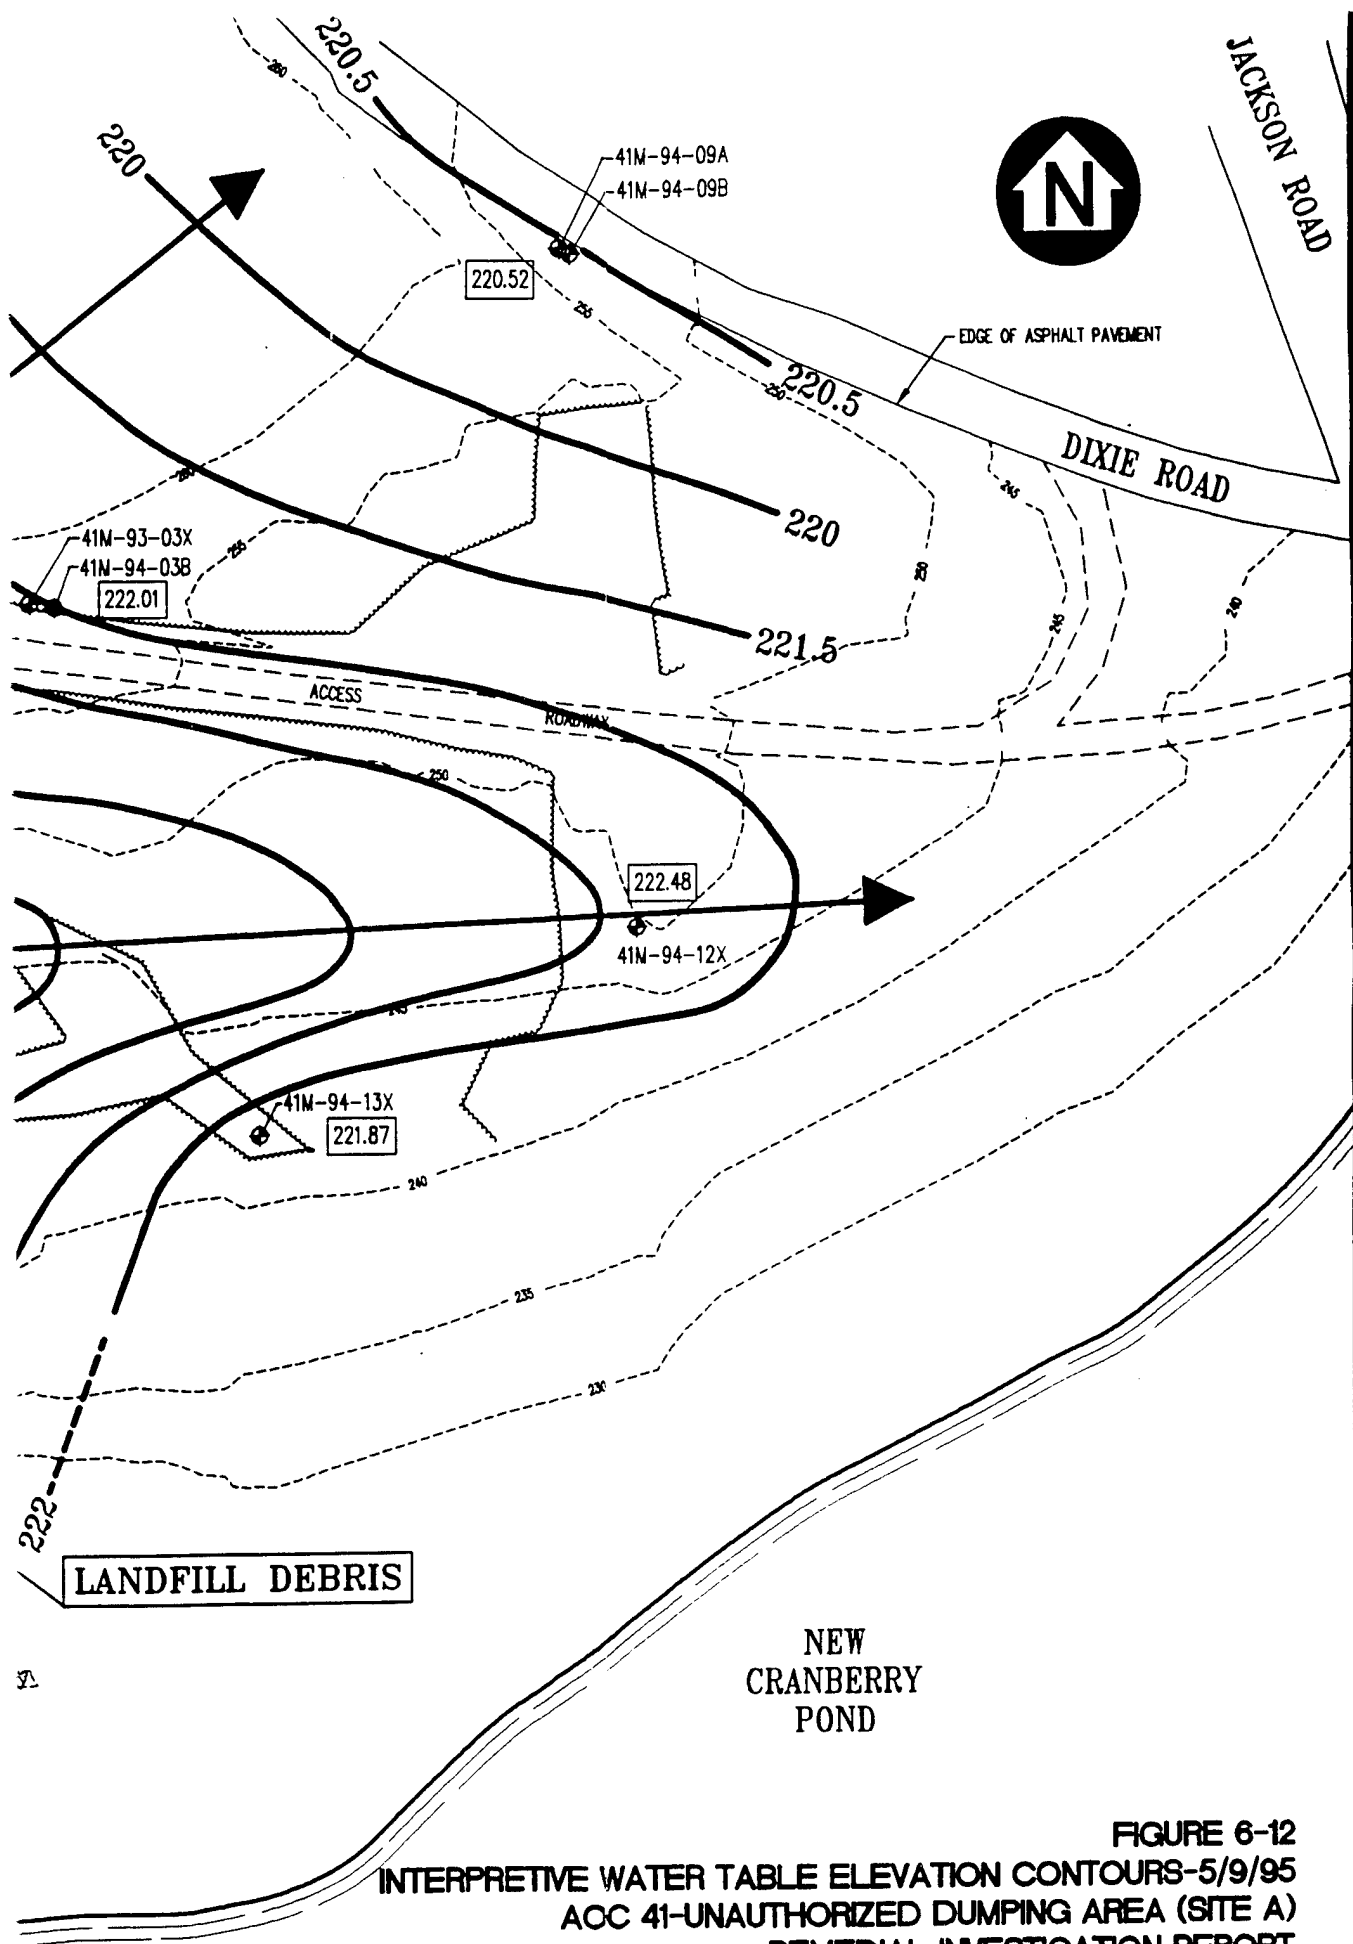
FIGURE 6-12  
 INTERPRETIVE WATER TABLE ELEVATION CONTOURS-5/9/95  
 ACC 41-UNAUTHORIZED DUMPING AREA (SITE A)  
 REMEDIAL INVESTIGATION REPORT  
 FORT DEVENS, MA

GROUNDWATER CONTOUR INTERVALS ARE 0.5 FEET INCREMENTS.
