**FORT DEVENS  
FINAL REMEDIAL  
INVESTIGATION  
FOR GROUP 2 & 7 SITES**

**FINAL  
REMEDIAL INVESTIGATION REPORT  
AREA OF CONTAMINATION (AOC) 41**

**ABB Environmental Services, Inc.  
Portland, ME  
Project No. 07053-15**

**February 1996**

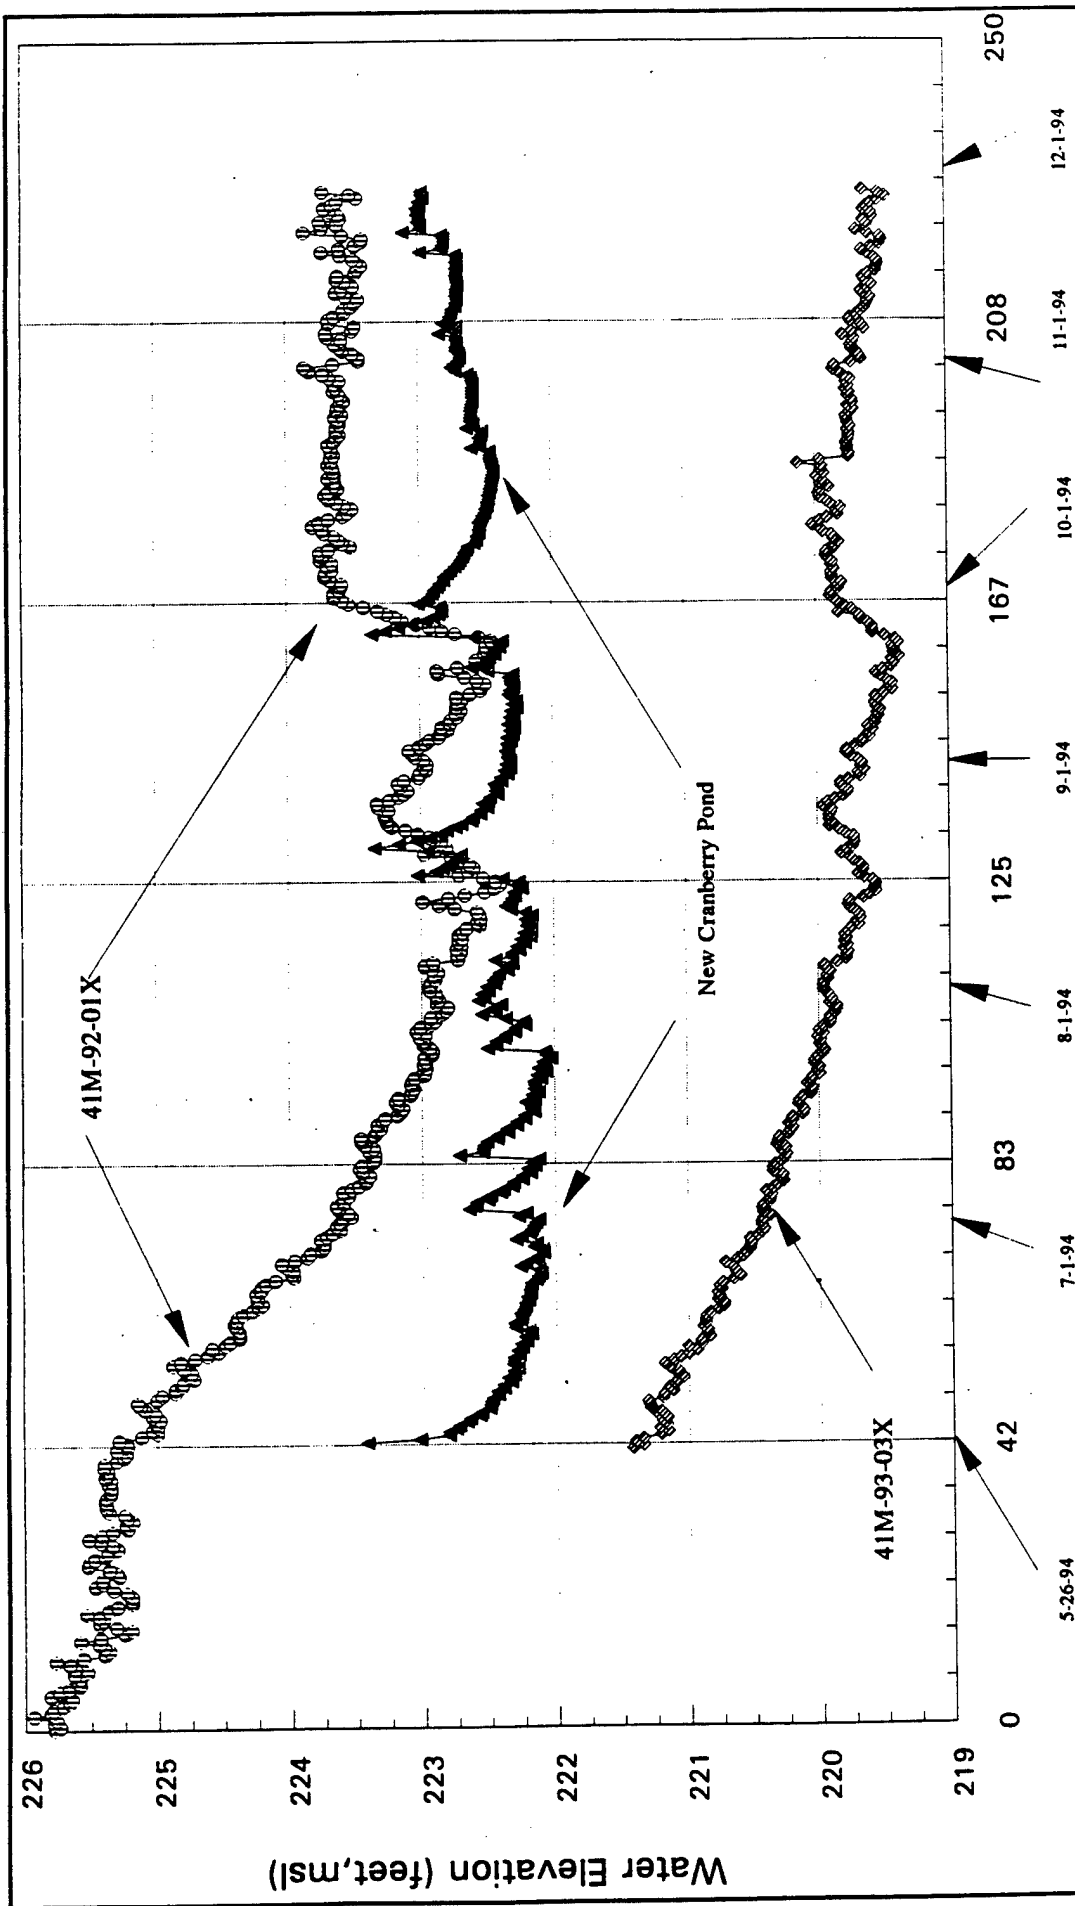
**FIGURE 6-14**  
**LONG-TERM WATER LEVEL MONITORING**  
**AOC 41-UNAUTHORIZED DUMPING AREA (SITE A)**  
**REMEDIAL INVESTIGATION REPORT**  
**FORT DEVENS, MA**

Time in Days Since 1500 hrs on 4-14-94

During the course of the previous investigations, it became apparent that the relationship between the water level within New Cranberry Pond had an impact on local groundwater flow. Also, the lag time between the pond variations and those observed in monitoring wells at the site were important. Therefore, a long-term water level monitoring program was initiated prior to the beginning of the RI field investigation. On April 14, 1994 a pressure transducer and In-Situ Hermit™ Well Sentinal data logger were installed in 41M-92-01X, and water level measurement recording began. On May 26, 1994 two additional pressure transducers and similar data loggers were installed at 41M-93-03X and at a PVC well screen standpipe on the north shore New Cranberry Pond (see Figure 5-4). The data loggers recorded data uninterrupted from each measurement point until December 1, 1994. The data recorded is presented in Appendix D-3.
