Technical Paper 1193

Influence of Fretting on Flexural Fatigue of 304 Stainless Steel and Mild Steel

Robert C. Bill and Douglas A. Rohn

APRIL 1978

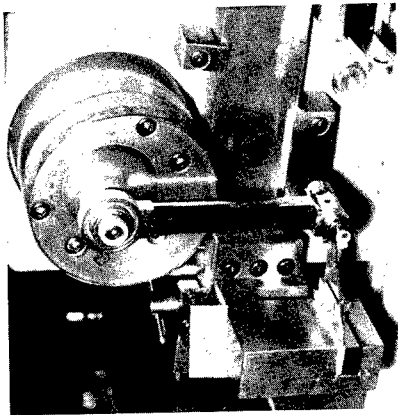
(a) Flexural fretting fatigue apparatus.

Figure 1. - Test apparatus and specimen.

The fretting-fatigue apparatus used in this investigation is shown in figure 1(a). The standard flexural-fatigue machine consists of a variable-speed motor, eccentric head, connecting rod, specimen grip, and vise clamp. Rotation of the head causes the connecting rod to flex the end of the specimen. The eccentric head can be set to provide zero- to 5.08-centimeter (2-in.), peak-to-peak deflection at the end of the connecting rod. Flexural stresses can be calculated from this deflection considering specimen geometry and material constants. A counter records head revolutions, and after specimen failure a shutdown switch is tripped by the connecting rod.

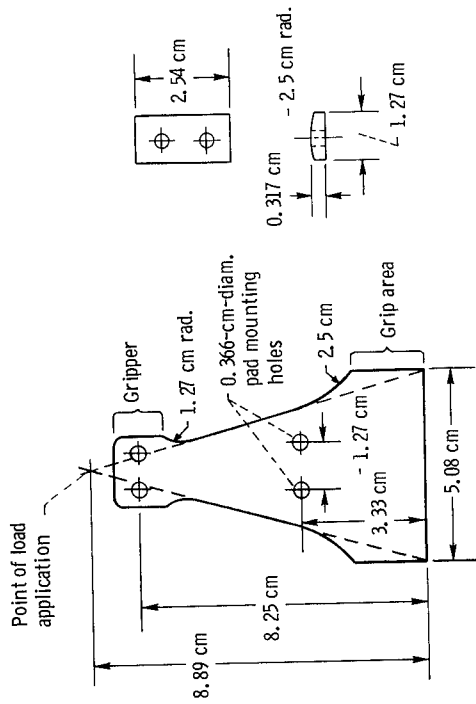
(b) Flexural specimen.

(c) Fretting pad.

The fatigue specimen is in the form of a constant-stress-cross-section, flexural sheet, 0.75-millimeter (0.030-in.) thick. As indicated in figure 1(b) the specimen geometry is basically triangular. The relation between width and height of this triangle is determined so that, when end loaded as a cantilever beam, the ratio of bending moment to cross-sectional moment of inertia is the same at all points along the specimen. Thus the bending stresses are equal over the beam's length. Outside the constant-stress area are the vise mounting and connecting rod clamping areas, with fillets to reduce stress concentrations.

As indicated in figure 1(b), two holes are provided in the constant-stress portion of all specimens to permit mounting of the fretting pads. The stress concentration factor associated with the mounting holes is calculated to be 1.59 (ref. 13). All fatigue-stress levels discussed reflect nominal flexural stresses in the fatigue specimen, and do not consider stress-concentration effects due to the presence of the holes.

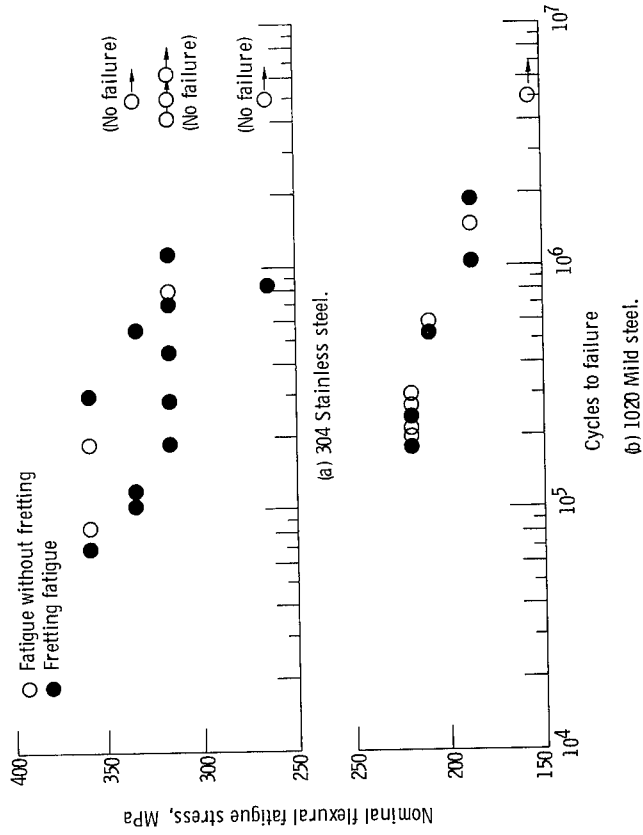
Figure 2. - Fretting fatigue life.

The fretted and unfretted fatigue lives of 304 stainless steel and 1020 steel at various flexural-stress levels are shown in figure 2. It is apparent that fretting effects the fatigue life of 304 stainless steel much more than 1020 steel. The greater resistance of 1020 steel to this type of fatigue may be a consequence of plastic flow in 1020 steel under the combined contact and flexural stresses. When plane-strain conditions prevail, the combined-stress condition may be expressed as

Fretting has a much more significant effect on the fatigue life of 304 stainless steel at the lower flexural-stress levels shown in figure 2. Fatigue-life reductions of as much as a factor of 10 are indicated at 265, 317, and 334 megapascals (38 500, 46 000, and 48 500 psi). No effect due to fretting is observed at 359 megapascals (52 000 psi). This might be expected because at the higher stress level, the unfretted fatigue life is so short that it is nearly the same as the number of cycles required to accumulate fretting damage.

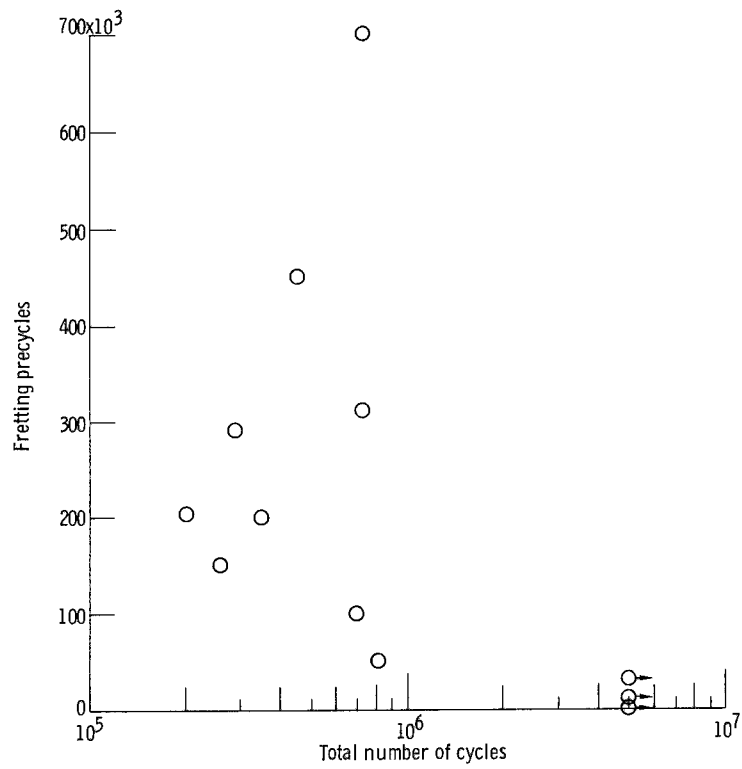
Figure 3. - Two part fretting fatigue of 304 stainless steel. Fatigue stress, ± 317 megapascals.

The results of the two-part fretting fatigue experiments on 304 stainless steel are summarized in figure 3. The salient point is the presence of a fretting-fatigue threshold as was reported by Hoepfner and Goss for Ti-6Al-4V in reference 10. It appears that fewer than 30 000 fretting cycles are insufficient to initiate the surface damage necessary to start a crack. After about fretting 50 000 cycles, the damage is done, so to

speak. Fatigue life is not systematically shortened by exposure to further fretting damage.

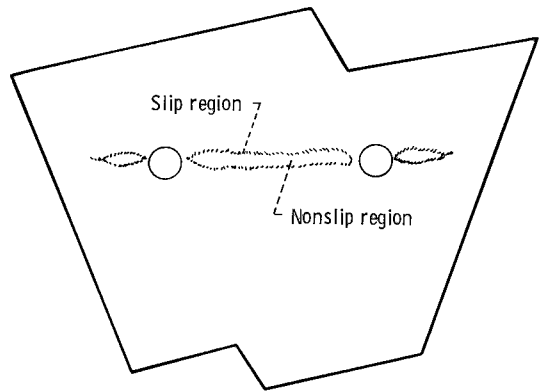
Figure 4. - Distribution of slip and nonslip regions in fretting pad contact area on fretting fatigue flexural specimen.

The fretting-pad contact pattern seen on the fatigue specimen surface after failure is shown schematically in figure 4. There are two distinct regions associated with the contact area, namely, regions of slip and regions of nonslip. Slip regions completely enclose the nonslip central regions, and are characterized by very fine fretting surface damage, as may be seen in figure 5. The nonslip central regions show virtually no evidence of surface distress.

The average width of the fretting pad contact area is about 750 to 1000 micrometers (0.030 to 0.040 in.), rather than the 250 micrometers (0.010 in.) predicted from Hertzian contact equations. There are two effects contributing to this discrepancy: First, the cylinder-on-flat contact is interrupted over the assumed 2.54-centimeter (1-in.) length by the relief around the bolt holes, with consequently reduced effective contact length, increased Hertzian stresses, and increased contact width. Second, since the flexural-fatigue specimen is only 750 micrometers (0.030 in.) thick, some overlap of the contact stresses due to the fretting pads clamped on either side of the specimen might occur. Again, increased contact width would be expected.

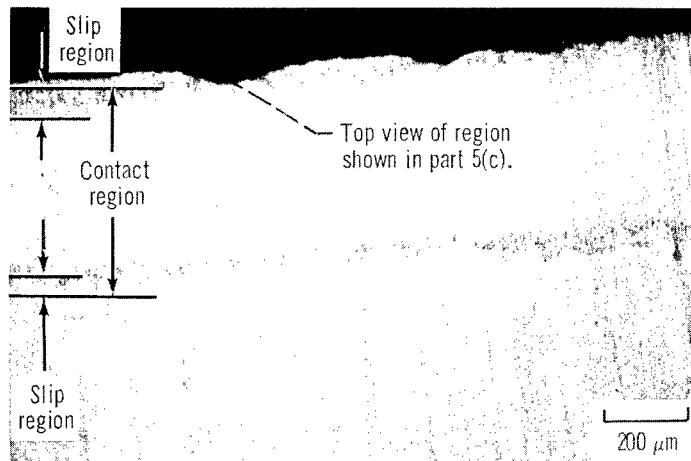
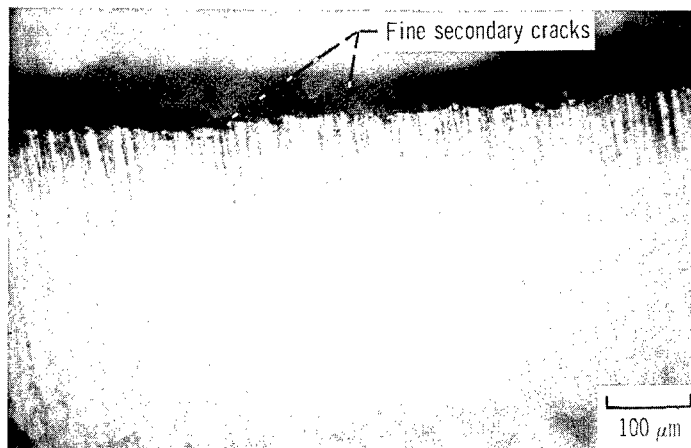
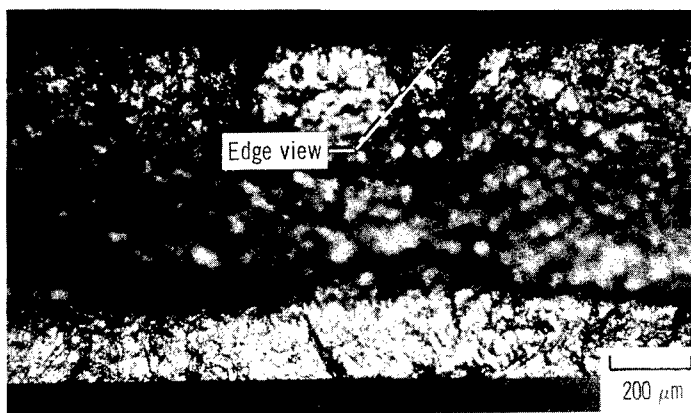
(a) Overview of contact region on fractured fretting fatigue specimen.

(b) Close-up of edge of fracture surface.

(c) Edge view showing fracture surface.

Figure 5. - Photomicrographs of fretted surface and fracture surface of 304 stainless-steel specimen after fretting fatigue failure under ± 317 -megapascal flexural-fatigue-stress experiment.

Examination of fretting-fatigue specimens indicates that both the primary fatigue crack (the one that led to final failure) and secondary cracks that did not propagate to failure began in the slip regions of the contact area. Figure 5 clearly shows the interaction of the fretting region with the final fatigue failure, as well as numerous fine cracks near the fracture edge that did not propagate to failure. The fracture surface (fig. 5(b)) correlates with the plan view (fig. 5(a)) and shows numerous crack-initiation sites.

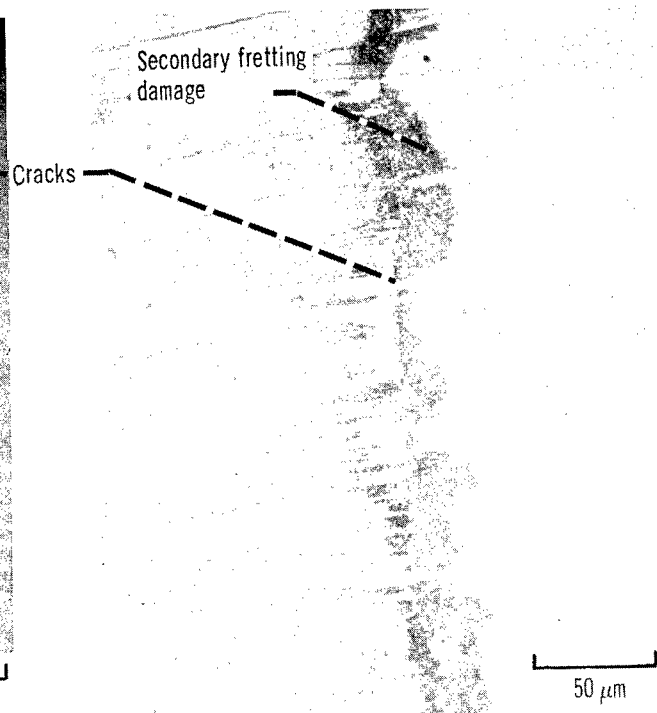
(a) Region near one of bolt holes.

(b) Region showing secondary surface fretting damage.

Figure 6. - Fretting fatigue cracks initiated in fretting region not adjacent to fracture surface. Flexural stress, ± 317 megapascals; 304 stainless steel.

Cracks were also observed in the fretted, slip region, not adjacent to the final fracture surface, as may be seen in figure 6. The especially heavy fretting surface damage in figure 6(b) on the side of the crack toward the vise grip is due to a "secondary" fretting effect. After the crack was able to propagate a considerable distance along the fatigue specimen, slip motion no longer varied smoothly over the original slip region. Rather, the crack acted as sort of a hinge forcing increased relative motion between the fretting pad and that part of the fatigue specimen toward the vise grip.

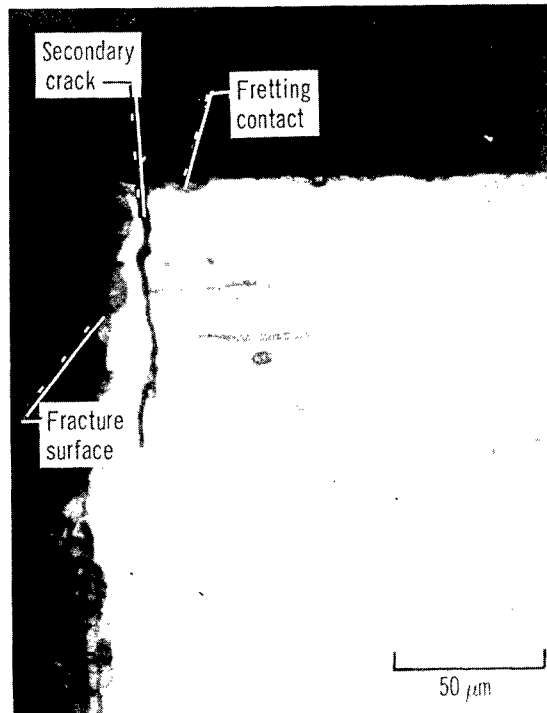
Figure 7. - Section through fracture surface. 304 stainless steel after fretting fatigue failure under ± 317 -megapascal flexural fatigue stress.

A section view of a fretting fatigue fracture surface is shown in figure 7. Evidence of surface pitting due to the fretting action may be seen. Of particular interest is the crack that was initiated in the fretting area but did not link up with the primary crack.

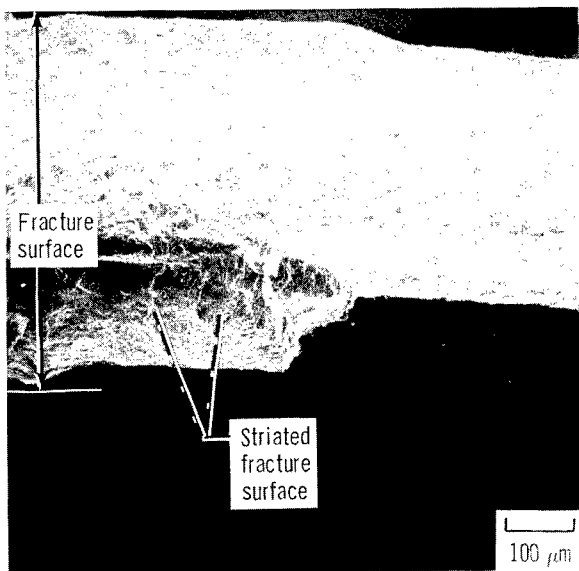
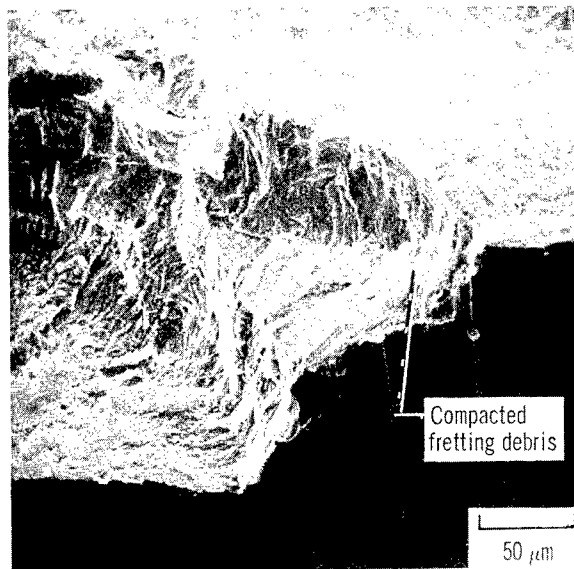
(a) Overview showing area of rapid crack propagation.

(b) Close-up showing adherent compacted fretting debris.

Figure 8. - Scanning electron micrographs of fretting fatigue fracture surface on 304 stainless steel. Flexural fatigue stress, ± 317 megapascals.

Fracture-surface features on the flexural-fatigue specimens are shown in figure 8. Two distinct regions are seen on the fracture surface. Near the contact surface where fretting takes place, there is evidence of rapid crack growth into the fatigue specimen, as indicated by the distinctly striated areas. With increasing depth into the fatigue specimen, a region is encountered in which cracks propagate parallel to the bending

axis as well as into the specimen. The "smeared" appearing areas on the fracture surface of figure 8(b) are caused by adherent, compacted fretting debris.

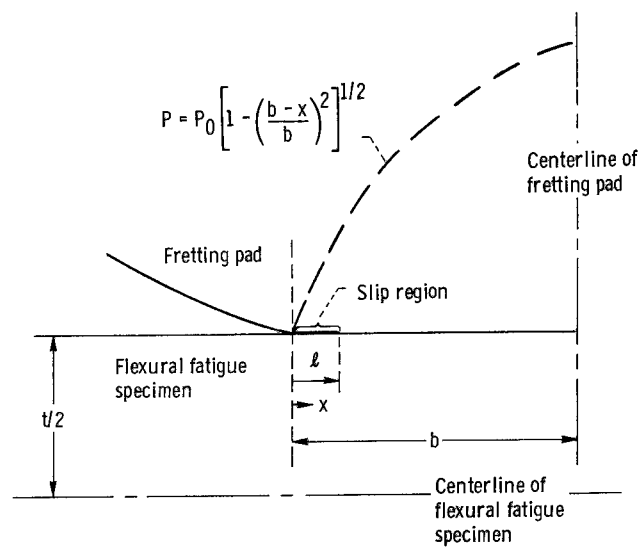
Figure 9. - Features of contact geometry of fretting pad and flexural fatigue specimen.

The portion of the contact region between the fretting pad and the flexural fatigue specimen actually undergoing slip, as shown in figure 9, is predicted based on analogy with some results developed for cracks (ref. 14). Shear displacement between the surfaces in the slip region follows from surface displacement distribution for an elliptical crack, according to the equation
