FINAL REPORT

EXECUTIVE SUMMARY

SPECIFIED FACILITY ENERGY STUDIES FOR
ENERGY ENGINEERING ANALYSIS PROGRAM (EEAP)
AT U.S. ARMY SUPPORT COMMAND,
HAWAII (USASCH) INSTALLATIONS

FT. SHAFTER
TRIPLER ARMY MEDICAL CENTER
SCHOFIELD BARRACKS

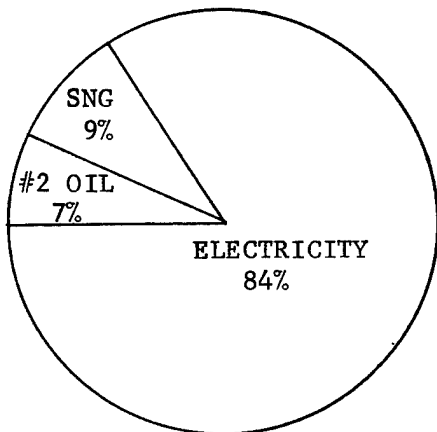
FT. SHAFTER:
TOTAL 90,852 MBTU/YR

Available data from USASCH files show that FY-1986 energy consumption at the various installations was as shown in Table 3 (illustrated in Figure 1). Energy consumption totals for each installation are also broken out into the various source energy types: electricity, oil, and gas. The grand total of energy consumption at all three installations was 630,164 MBTU, and total cost was \$11,309,544.

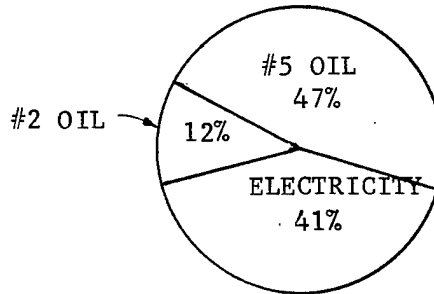
TOTAL 39,868 MBTU/YR

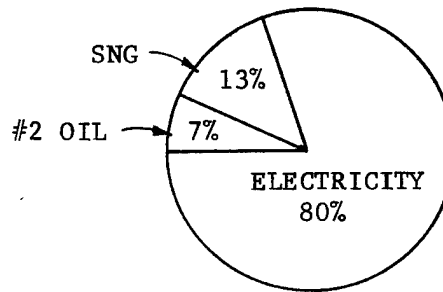
TOTAL 6,248 MBTU/YR

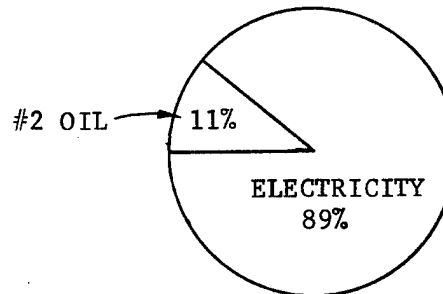
TOTAL 1,246 MBTU/YR

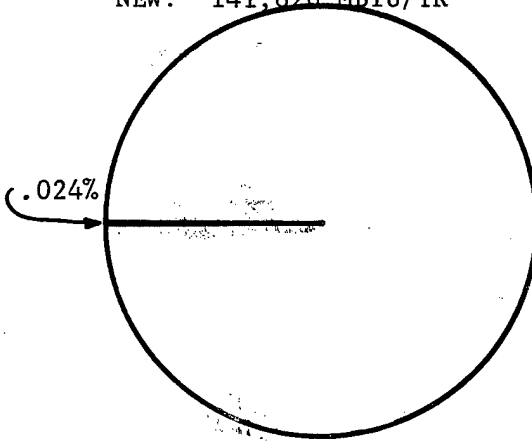
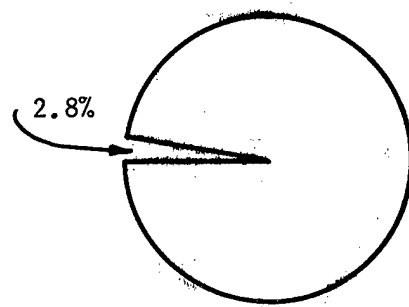
TRIPLER AMC:
 NOW: 141,861 MBTU/YR
 NEW: 141,826 MBTU/YR

NOW: 1,246 MBTU/YR
 NEW: 1,211 MBTU/YR
