TRI-SERVICE CONFERENCE ON CORROSION

Evaluation of Environmentally Acceptable Protection Schemes for High Strength Steel Fasteners

B. Placzankis, M. Levy, J. Beatty, S. Isserow, M. Kane
US Army Research Laboratory
Materials Directorate
Metal Research Branch
Corrosion Science Team
Watertown, MA 02172-0001

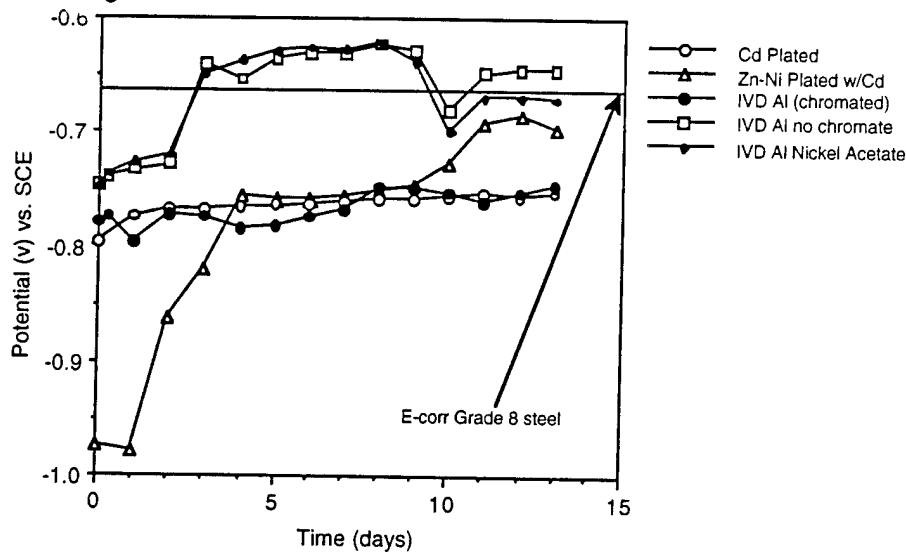
All possible Joint A coupling schemes were not tested due to the limited number of test blocks available. Potential measurements and observations were made during the course of immersion testing of the coated Joint A assemblies. Their potentials are plotted as a function of time in Figure 8.

**Figure 8 - Potential vs. Time
3.5% NaCl Immersion - Joint A**

Complementary photographs at 312 hours of immersion are shown in Figures XX-XXV: Appendix B. The potential of the Cadmium coated assembly remained relatively stable throughout the entire test, indicative of its excellent corrosion resistance. The Zn-Ni plated bolt with Cd washer and nut exhibited very little rust on the bolt and washer after 12 days of immersion. This coincided with the potential stabilizing to that of Cadmium after an initial rapid increase over the first two days to the Cadmium potential. A gradual rise in potential beginning between 9 and 10 days culminating with the appearance of rust indicated that the Cd coating on the nut and washer had broken down. The IVD Al specimens again displayed performance that was dependent upon coating thickness. In the case of the thick chromated IVD Al, E-corr measurements, while somewhat less stable, slowly increased from (-0.775) to (-0.750) similar to the values recorded for Cd. The two thin IVD coatings began negative with respect to steel at around (-0.75) and

rapidly climbed to the potential of steel within 96 hours. Aluminum sacrificial products were not visible as in the Zinc plated fasteners as they either dissolved or were carried away in the circulation of the bath. At the 96 hour mark all that was visible was red rust with a few small patches of IVD Al which disappeared and were replaced by rust after 120 hours. The coated Joint A assemblies may be ranked in the following order of decreasing merit: Cd, chromated IVD Al, Zn-Ni with Cd washer and nut; IVD Al (no treatment), IVD Al with nickel acetate.

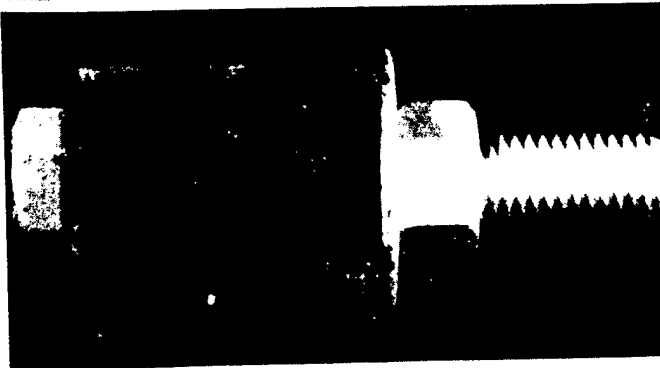
Figure V - Chromated
IVD Aluminum Joint A
Assembly

The Joint A assembly has been described in Figure 2. Note that both blocks of the assembly were fabricated of 4130 steel. For each assembly the bolt, washer and nut were coated with the same material. Table 2 summarizes observations made as a function of time exposure for a total of 312 hours. Figures IV-VI, Appendix A, contain supporting photographic evidence. Cadmium plate and IVD Al (chromated) again were the best performers (no corrosion products 312 hours) followed by Zn-Ni. The Zn-Ni plate (shown at 312 hours) showed no evidence of white corrosion products for 120 hours of exposure.

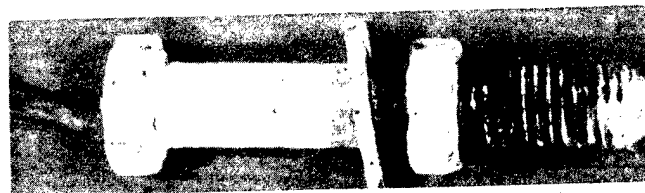
Figure XV - Zn-Ni Plated Control

Figure 7 contains plots of potential measurements made for the coated control assemblies during the course of their immersion in 3.5% NaCl solution. Though not rate sensitive, this technique will show "breakdown" or "loss of protection" when the corrosion potential changes from the base value of the coating towards that of uncoated steel. Photographs of the coated control assemblies after immersion for 312 hours complement the potential time data (Figures XIV-XIX).

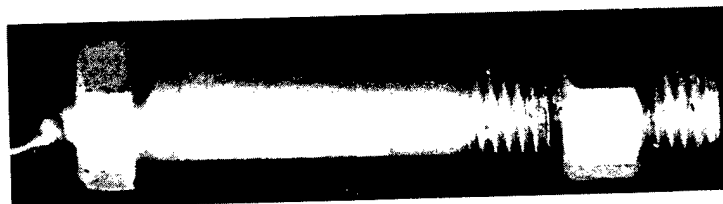
Figure XVII - Chromated IVD Al Control
with Cd Nut
