# TRI-SERVICE CONFERENCE ON CORROSION

**Cost-effective and Environmentally Safe Corrosion Prevention  
for 2nd Marine Air Wing Support Equipment  
Using Desiccant Wheel Dehumidification (DEW)**

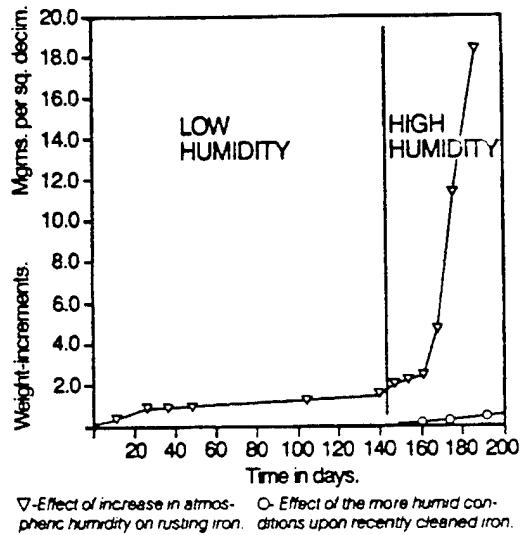
Figure 1. Corrosion rates depend on relative humidity (1)

As early as 1927, the English electrochemist W.H.J. Vernon observed the close relationship between the relative humidity in the environment and the rate of corrosion of ferrous metals (1). In more recent times, it has become clear that the number of water molecules adsorbed onto a surface held at room temperature is a function of the relative humidity of the air surrounding the surface(2). Figures 1 and 2 show the close correlation between the number of monolayers of water adsorbed on a surface and the rate of corrosion of ferrous metal as defined by Vernon in 1927.

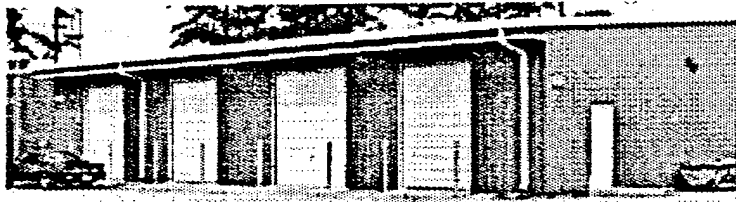
*Left: The exterior of building 4183*

*Below: The inside of the building showing the DEW unit and simple air ducting*

Building 4183 was originally built as an ordnance warehouse. In some respects, it was ideal for conversion to a controlled humidity facility, because it was insulated and has fairly tight, steel-panel walls. While there is no need for insulation in a humidity control situation, the insulation layer helps block air, which might otherwise infiltrate through joints in steel wall sections. The building measures approximately 70' x 100' with a 25' ceiling. The side-wall ventilation grills were cranked shut, and covered with polyethylene sheeting. The sheeting was taped to the building walls with ordnance tape. This cloth-reinforced tape is durable, and has an extremely aggressive tack. It is used for a wide variety of fast repairs and temporary fastening jobs. Apart from vent sealing, the only other air-tightening consisted of caulking obvious air leaks with standard construction-grade silicone sealant.

Initially, MALS-14 installed a DEW-300 desiccant wheel dehumidifier in the building. However, strip-chart humidity recorders located in the space showed that 300 cfm dehumidification capacity was not sufficient to keep the area between 30 and 40% rh.
