Technical Report CHL-97-27  
October 1997

# **Navigation Conditions at Lock and Dam 22, Mississippi River**

## **Hydraulic Model Investigation**

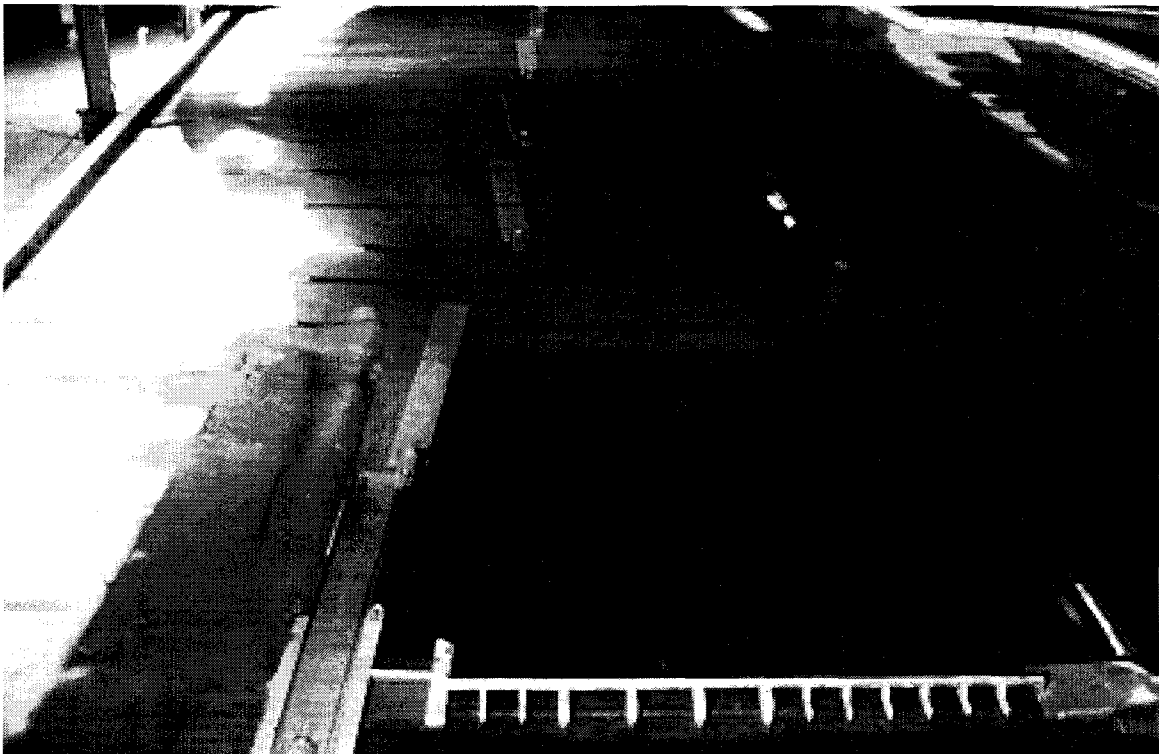
Photo 8. Existing conditions. looking upstream. discharge 162,000 cfs, path of upbound tow leaving 600-ft lock

**Navigation conditions.** Due to the alignment of the right bank upstream of the lock relative to the upper guide wall and the set of the currents moving across the upper approach of the lock, navigation conditions for downbound tows were extremely difficult even with the lower riverflows and could be hazardous under some conditions. Field data show that a helper towboat is used by downbound towboats to push their tows into the guide wall with most flow conditions. Downbound tows approach the upper guide wall by flanking the stern of the towboat in close to the rock dike running along the right bank, bringing the tow to a complete stop with the head of the tow swinging riverward (Photo 1), and allowing the helper towboat to push the head of the tow into the guide wall (Photos 2 and 3). The helper towboat holds the tow close to the guide wall as the tow moves into the lock chamber. Experiments made with the model tow show the same maneuvers were required for a downbound tow approaching the 600-ft lock (Photo 7). Upbound tows leaving the lock tend to be moved riverward as they leave the lock approach, and tows take a set toward the right descending bank to overcome the currents (Photo 4). However, no major difficulties were indicated for tows with sufficient power and steerage to overcome the currents. Experiments made with the model tow show the same maneuver was required for an upbound tow leaving the 600-ft lock (Photo 8).

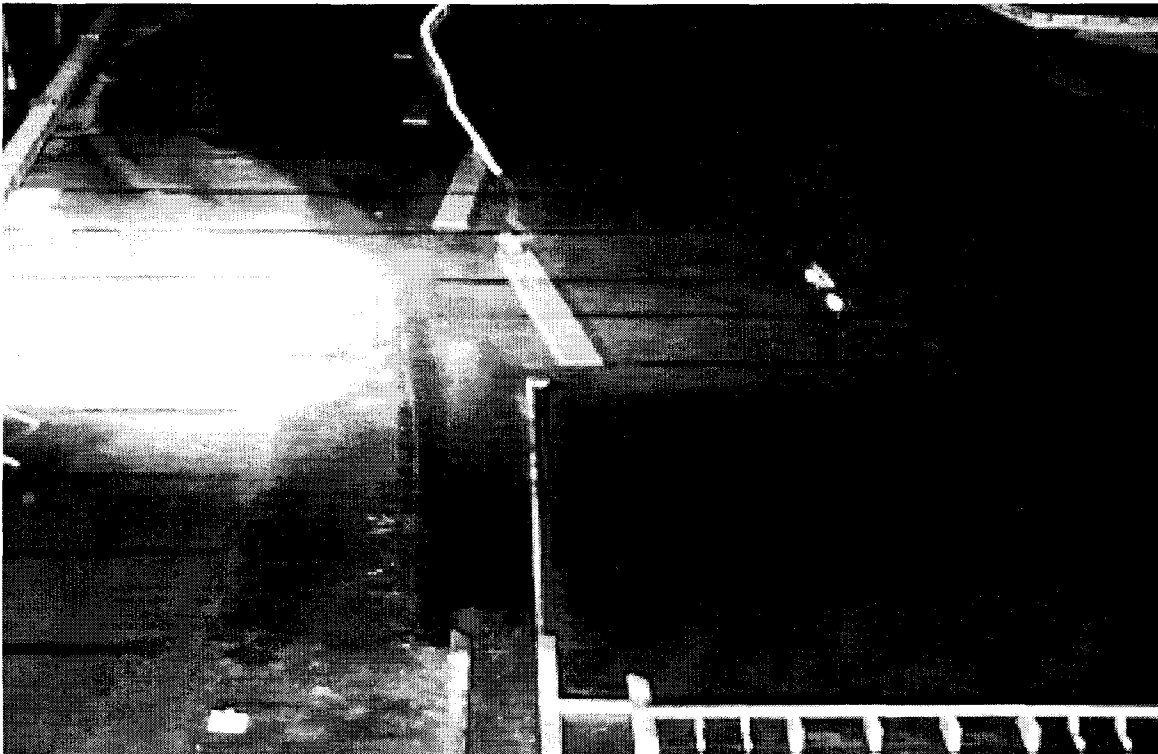
Photo 12. Lock Location 2. Plan A, looking upstream, discharge 162,000 cfs, showing path of downbound tow approaching 1,200-ft lock

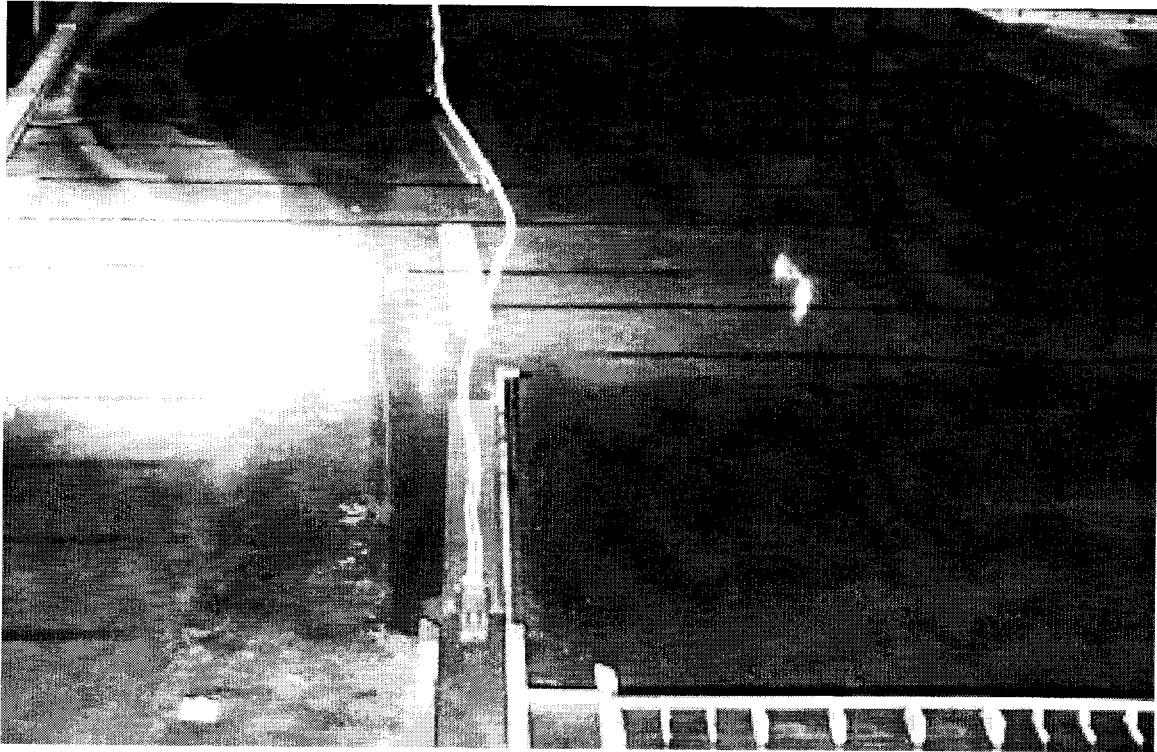
Photo 13. Lock Location 2. Plan A. looking upstream, discharge 162,000 cfs, showing path of upbound tow leaving 1,200-ft lock

Upbound tows could leave the upper lock approach without any major difficulties. However, as the tow moved upstream of the right bank realignment, it was required to take a landward set to counteract the currents moving across the navigation channel (Photo 13).

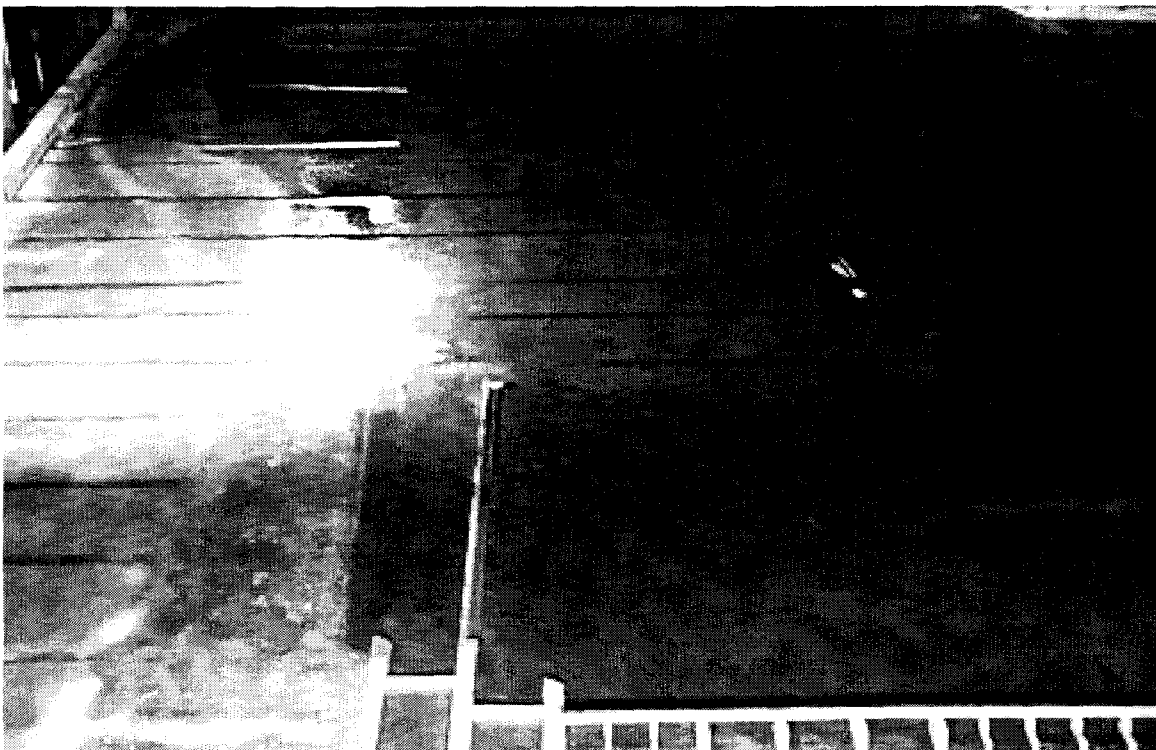
Photo 16. Lock Location 2. Plan B, looking upstream, showing upper approach of 1,200-ft lock

Lock Location 2, Plan B, was the same as Plan A except that a system of five spur dikes was constructed along the right descending bank upstream of the dam to train currents along the right bank (Figure 7 and Photo 16). The river ends of the dikes were aligned with the 20-ft berm running along the top bank of the upper lock approach. This provided approximately 8,000 ft of straight navigation channel approaching the lock. The spacing between the dikes at the river end was about 1,000 ft. The first dike was located 3,251 ft upstream of the axis of the dam and had a 250-ft-long trail dike extending downstream from its river end running parallel with the navigation channel (L-head dike). The dikes were added to align the flow parallel with the upper guard wall and away from the right bank. The NAD 83 State Plane Coordinates for the dike are listed in the following tabulation:

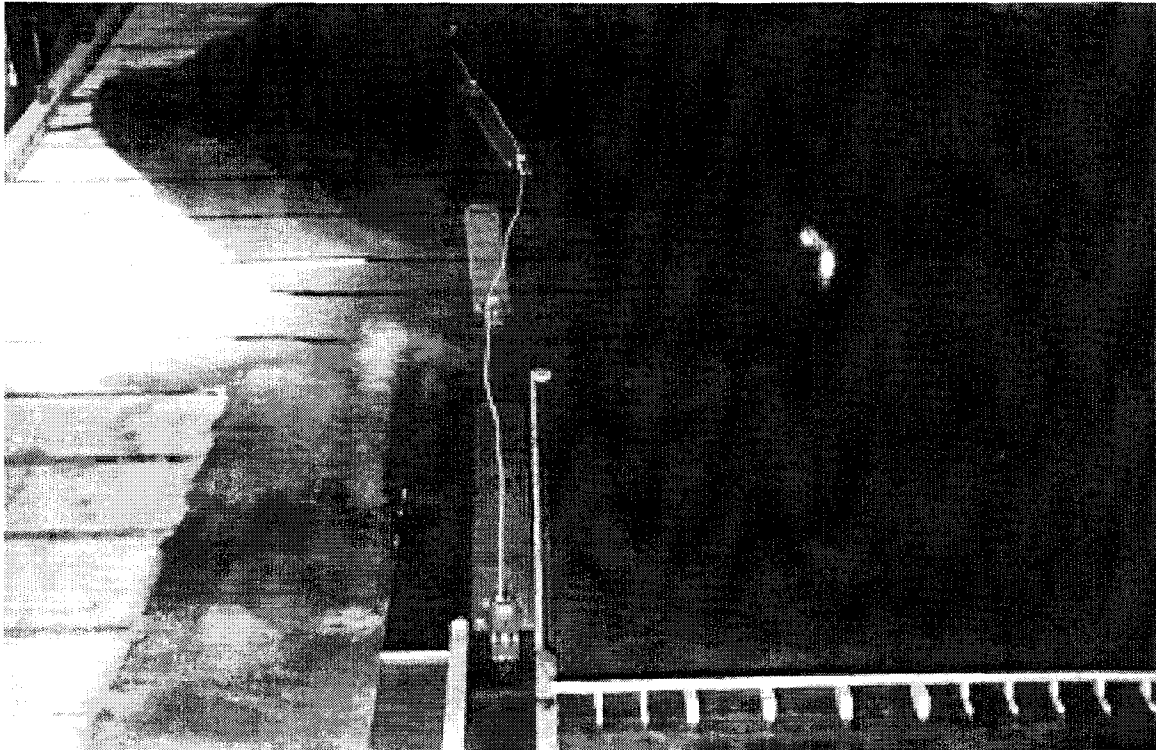
Photo 23. Lock Location 3, Plan A, looking upstream, discharge 162,000 cfs, showing path of upbound tow leaving 1,200-ft lock

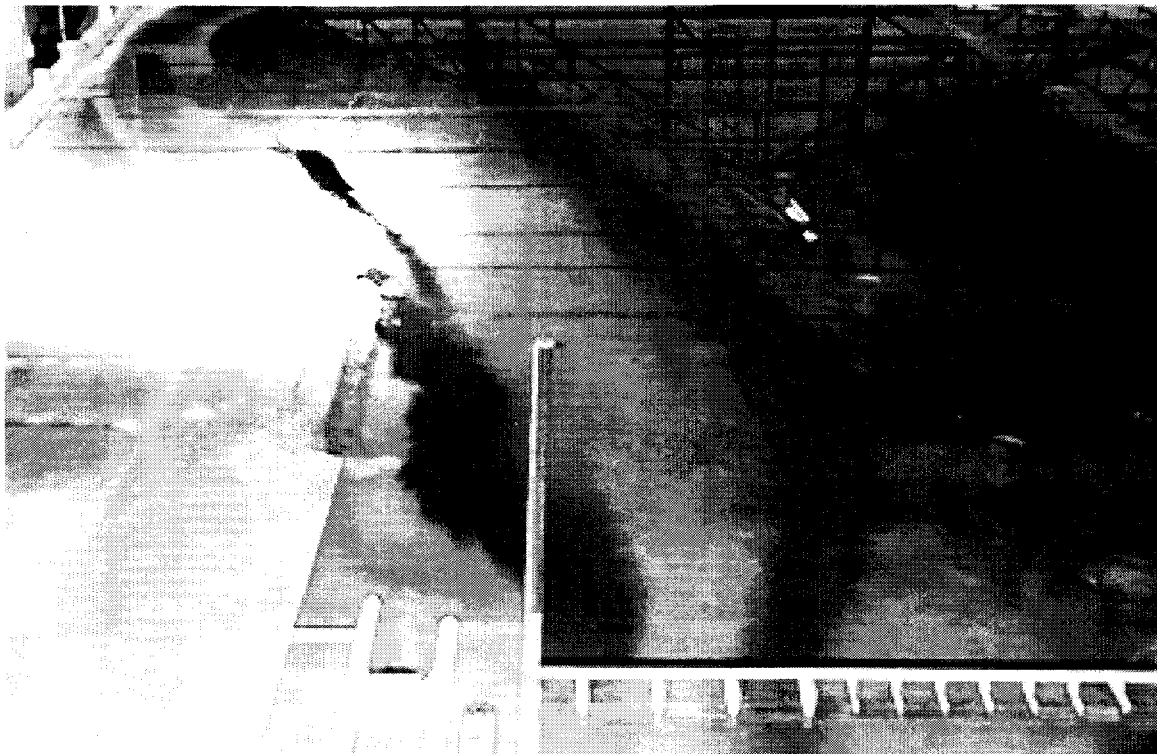
Photo 28. Lock Location 4, Plan A, looking upstream, discharge 162,000 cfs, dye showing current pattern approaching locks
