Technical Report CHL-97-28  
September 1997

# **Navigation Conditions at Lock and Dam 25, Mississippi River**

## **Hydraulic Model Investigation**

by Ronald T. Wooley

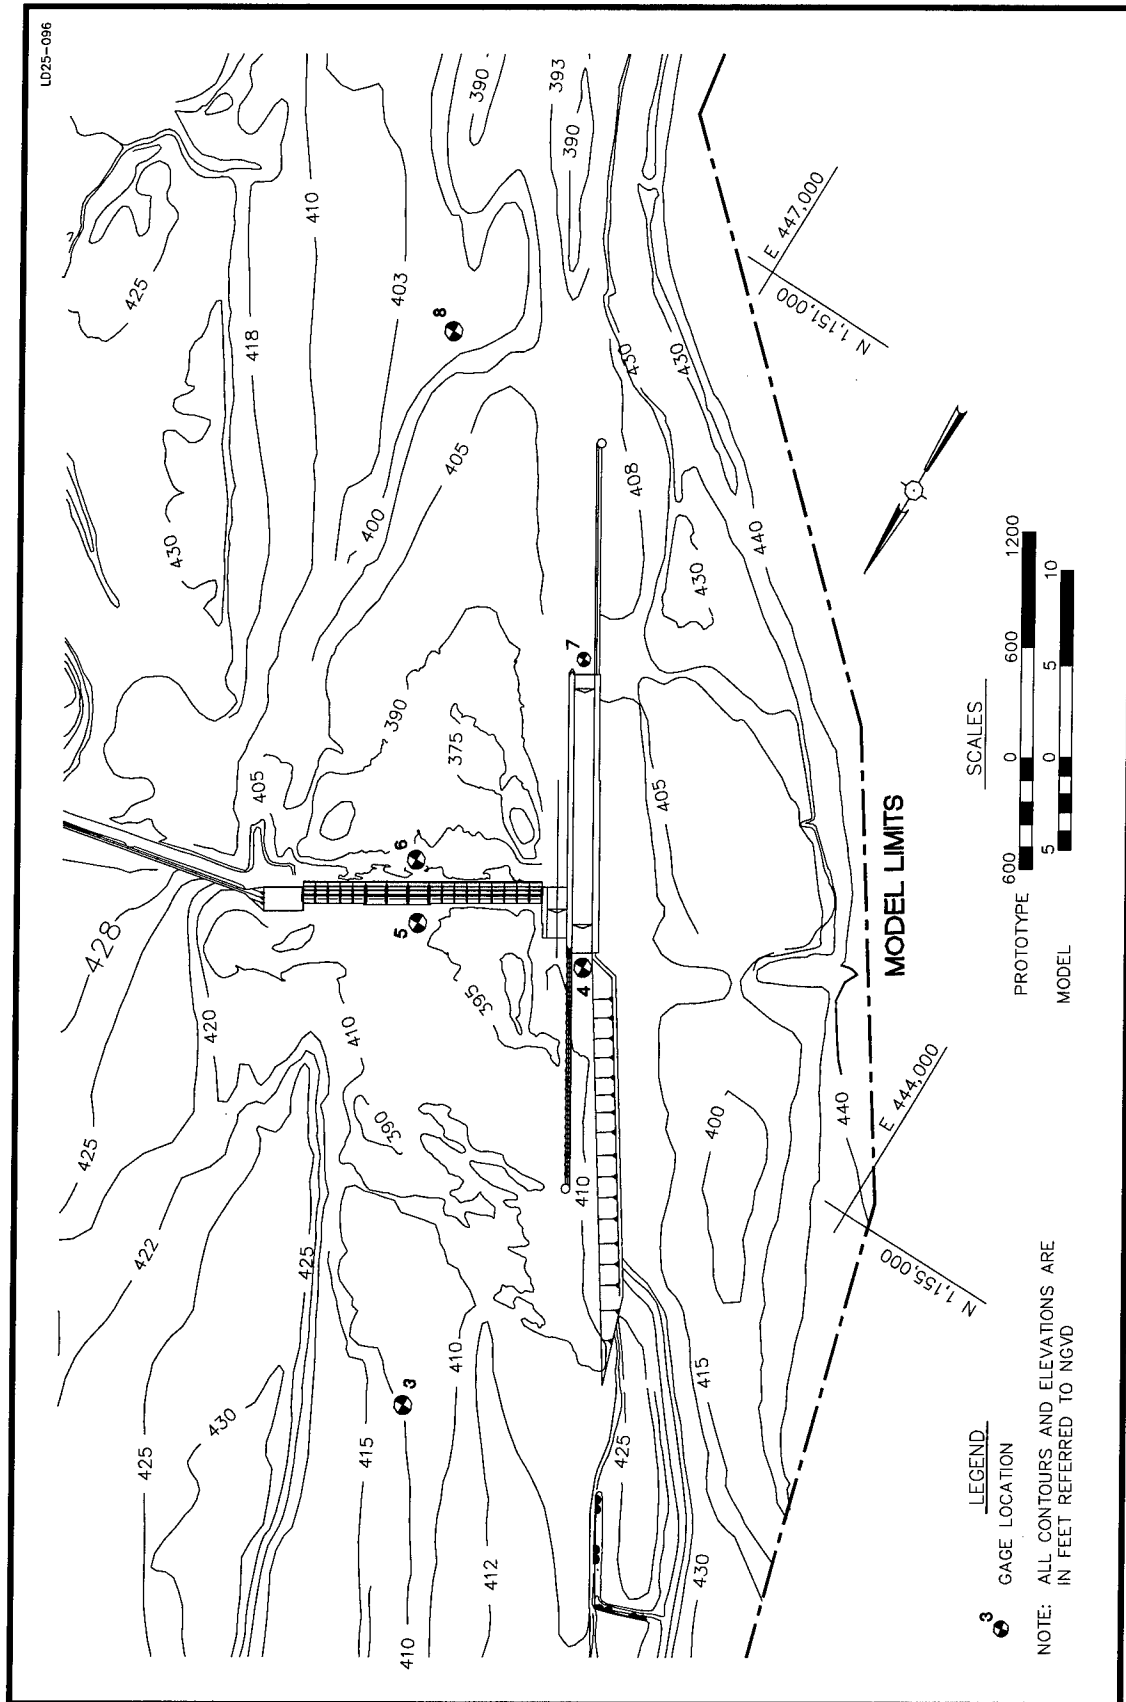
Figure 6. Lock Location 2, Plan A

- a. A 110-ft-wide by 1,200-ft-long lock chamber replacing the existing lock chamber.
- b. A 1,200-ft-long ported upper guard wall with twenty-four 30-ft-diam cells spaced 50 ft on centers and a 50-ft-diam guard cell at the upstream end of the wall. This provides twenty-three 20-ft-wide port openings and one 40-ft-wide port opening with the top of ports at el 418.7 (15 ft

- c. A 1,200-ft-long solid lower guide wall extending downstream from the landside lock wall.
- d. Modification of the upper lock approach by removing the existing upper guide wall and the stone dike along the right bank by excavating and reshaping the bank line to provide a 150-ft-wide entrance at the upstream end of the guard wall. The right bank was excavated to a 1V on 3H slope from a baseline at el 410 that extended from the landside wall of the lock chamber upstream to the right bank L-head dike. The 1V on 3H slope was extended up to el 444 with a 20-ft-wide berm to replace the existing levee along the right bank and to control the pool up to el 444. The entrance channel along the length of the upper guard wall was graded to el 410.
- e. Removal of the existing ported guard wall on the auxiliary lock.

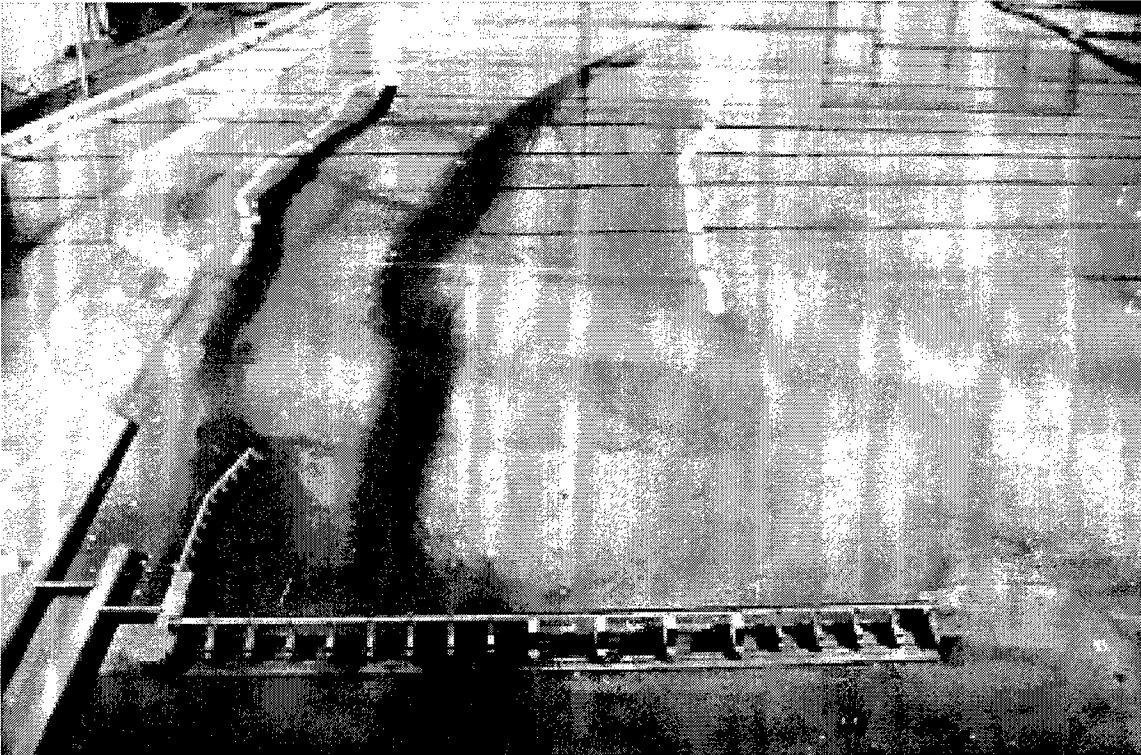
Photo 6. Existing conditions, looking upstream, discharge 166,000 cfs. Dye showing current pattern approaching existing lock

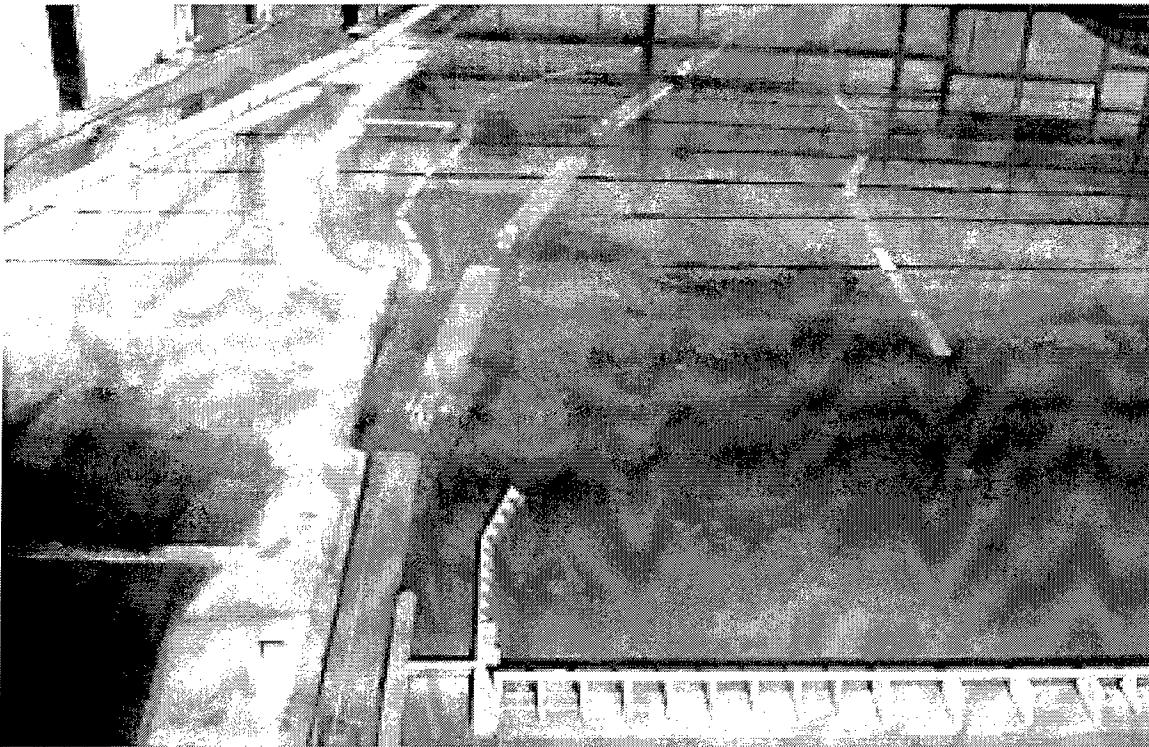
Photo 8. Existing conditions, looking upstream, discharge 166,000 cfs, path of upbound tow leaving existing lock

**Navigation conditions.** Due to the alignment of the navigation channel upstream of the lock and the set of the currents moving across the upper lock approach toward the spillway, navigation conditions for downbound tows were extremely difficult even with the lower riverflows and could be hazardous under some conditions. Field data show that a helper towboat is used by downbound towboats to push their tows into the guide wall with most flow conditions. Downbound tows approach the upper guide wall by flanking the stern of the towboat in close to the rock dike running along the right bank, bringing the tow to a complete stop with the head of the tow swinging riverward (Photos 1 and 2), and allowing the helper towboat to push the head of the tow into the guide wall. The helper towboat holds the tow close to the guide wall as the tow moves into the lock chamber. Experiments made with the model tow show the same maneuvers were required for a downbound tow approaching the 600-ft lock (Photo 7). Upbound tows leaving the lock tended to be moved riverward as they left the lock approach, but no serious difficulties were indicated for tows with sufficient power and steerage to overcome the currents (Photo 8).

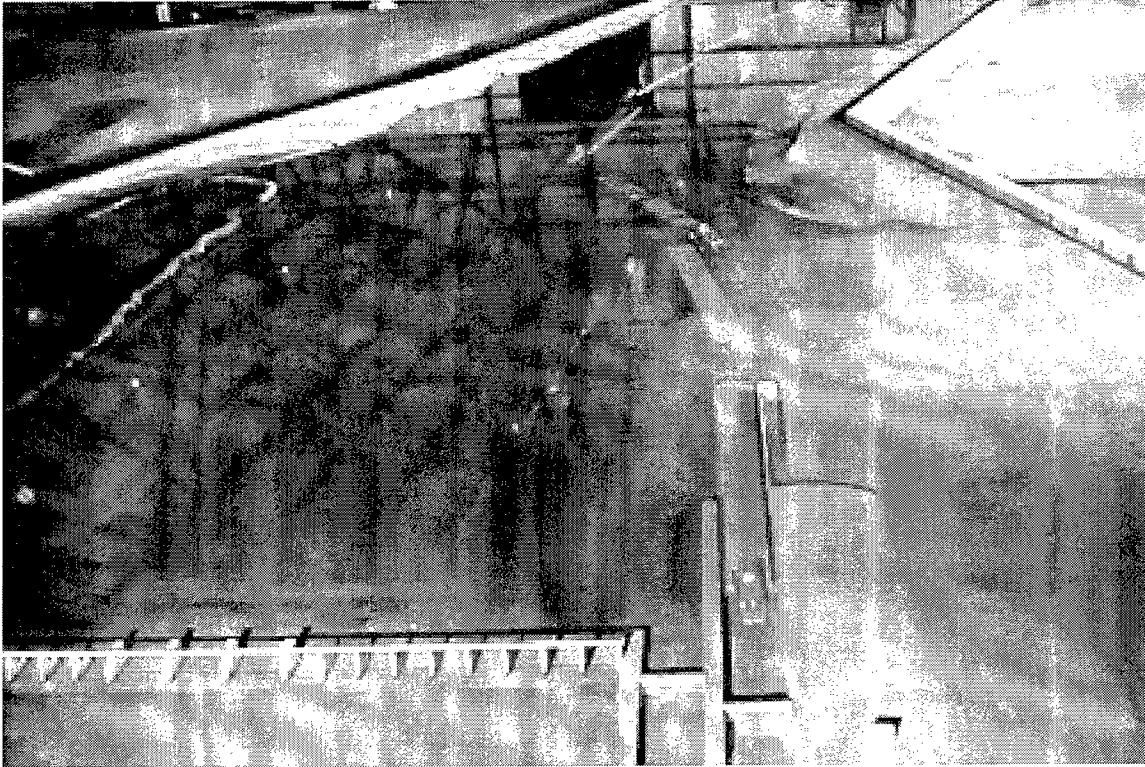
Photo 9. Existing conditions, looking downstream, discharge 166,000 cfs, path of downbound tow leaving existing lock

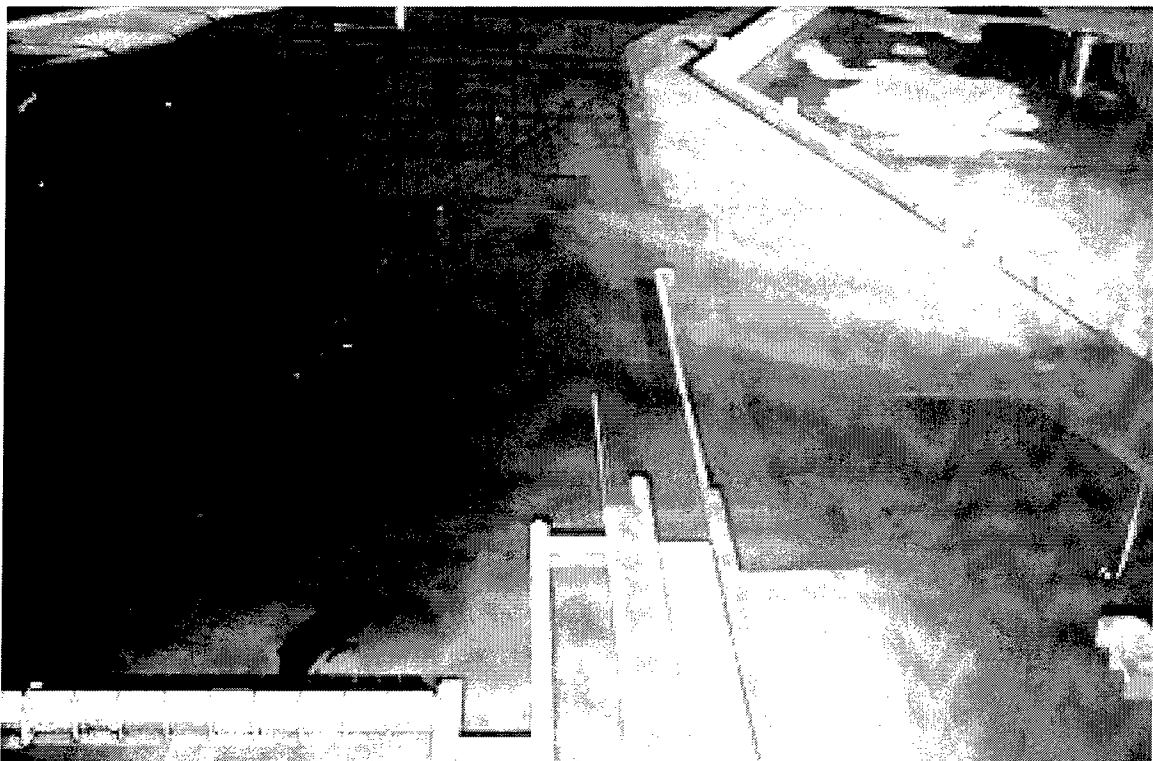
Photo 12. Lock Location 1, Plan A, looking downstream, showing lower lock approach

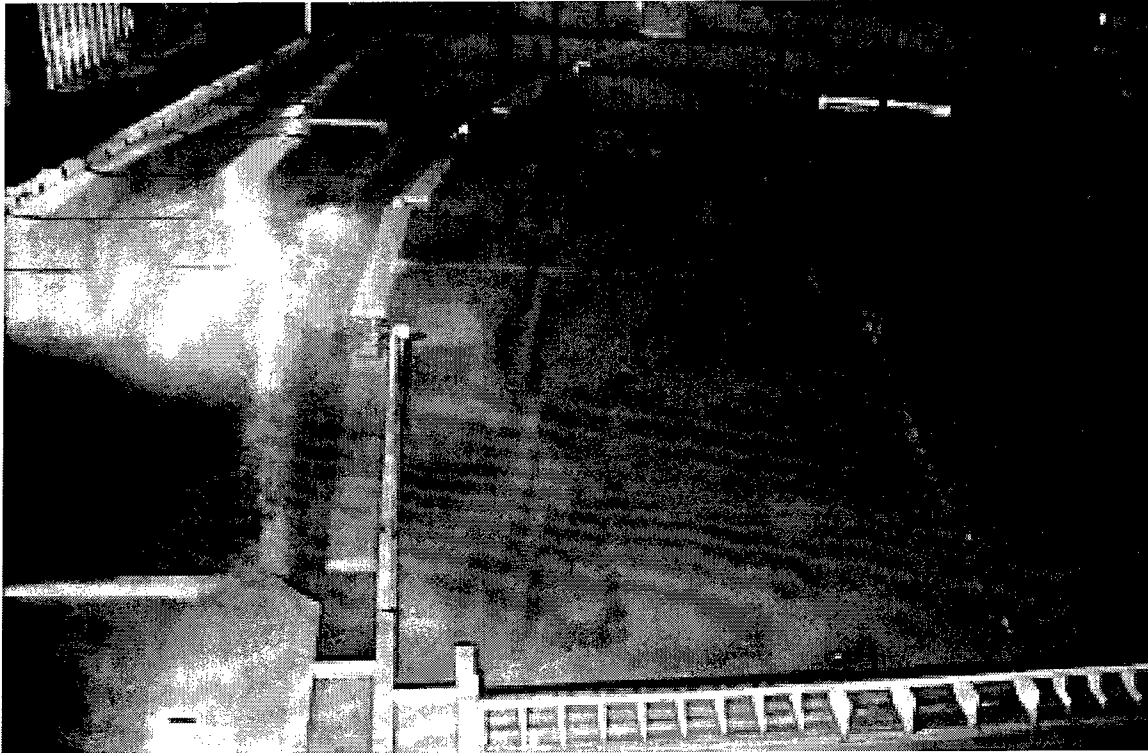
Photo 19. Lock Location 2, Plan A, looking upstream, discharge 138,000 cfs, path of down-bound tow approaching 1,200-ft lock

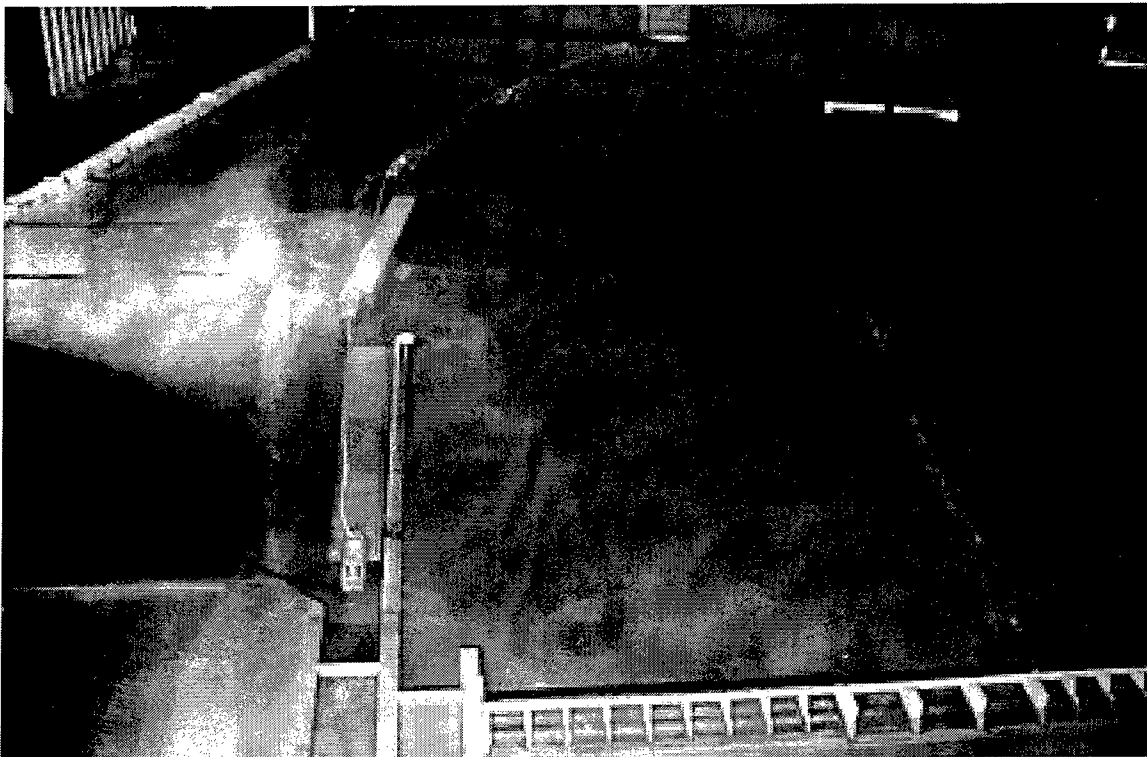
Photo 20. Lock Location 2, Plan A, looking upstream, discharge 327,000 cfs, path of upbound tow leaving 1,200-ft lock

crossing upstream of the lock, start reducing speed about one tow length upstream of the upper end of the guard wall, enter the lock approach at a slow speed, and align with the guard wall. As the tow entered the lock approach, the flow through the ports in the guard wall assisted the tow in aligning with and approaching the wall by moving the tow toward the wall. There was no indication of excessive flow through the ports. It should be noted that the short length of channel upstream of the lock provided marginally acceptable navigation conditions for downbound tows because the margin for pilot error or misaligned tows was small. A downbound tow was still turning to enter the upper approach less than one tow length upstream of the guard wall (Photo 19), and any error in alignment or judgment could have resulted in the tow either striking the end of the guard wall or being rotated around the upstream end of the guard wall. An upbound tow leaving the lock could move away from the guard wall, start turning riverward as the towboat cleared the upstream end of the guard wall, and navigate upstream through the reach without any major difficulties (Photo 20).

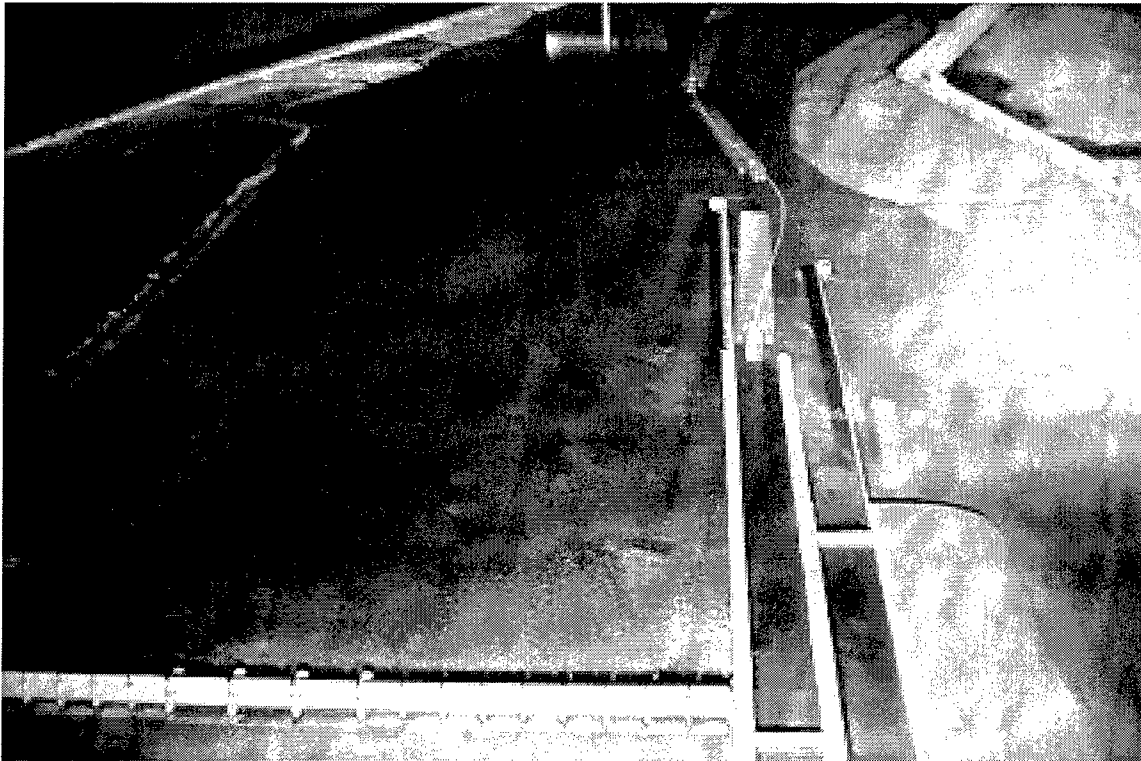
Photo 25. Lock Location 3, Plan A, looking downstream, discharge 65,000 cfs, path of downbound tow leaving 1,200-ft lock
