NRL/FR/6180--97-9861

# Virtual Environment Firefighting/Ship Familiarization Feasibility Tests

| REPORT DOCUMENTATION PAGE | | | Form Approved<br>OMB No. 0704-0188 | |
|---|---|---|---|--|
| 13. ABSTRACT (Maximum 200 words)<br><br>Virtual Environments Firefighting/Ship Familiarization Feasibility Tests were conducted on the ex-USS <i>Shadwell</i> . The results of these tests indicate that there are measurable gains using virtual environment (VR) training with respect to water usage and time to achieve complete extinguishment. The data also indicates gains for the time to travel from Repair 2 to the fire compartment and begin the initial attack. The time to transit from the 01 level to the fire area under reduced visibility was reduced by one-half for subjects trained with VR. | | | | |

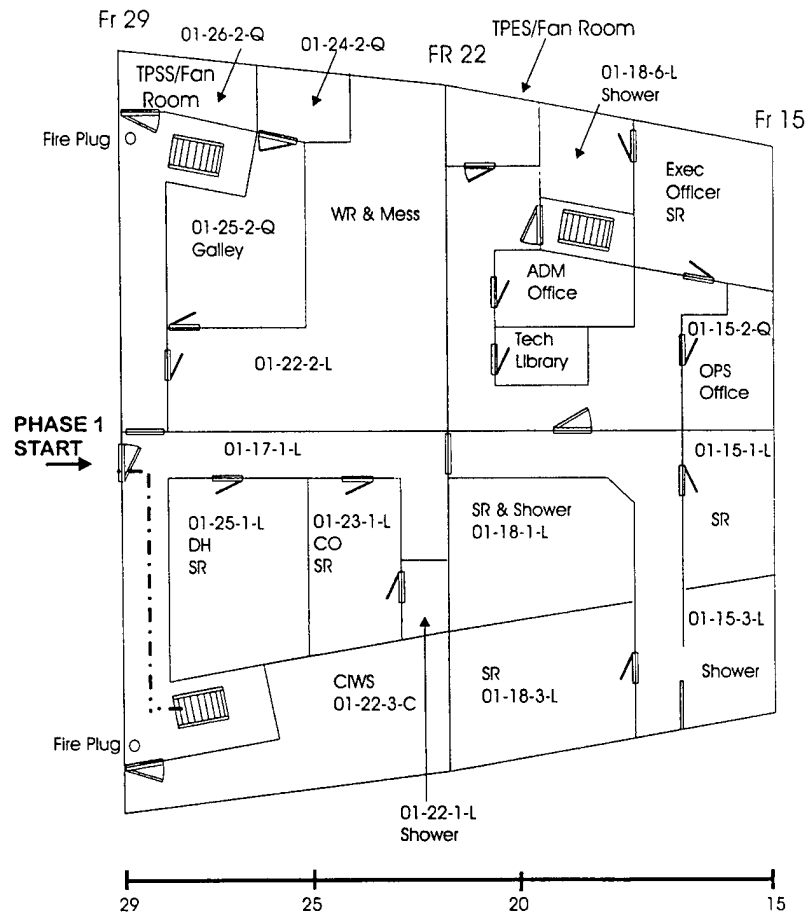
Fig. 1 — Plan view diagram of superstructure (01) deck

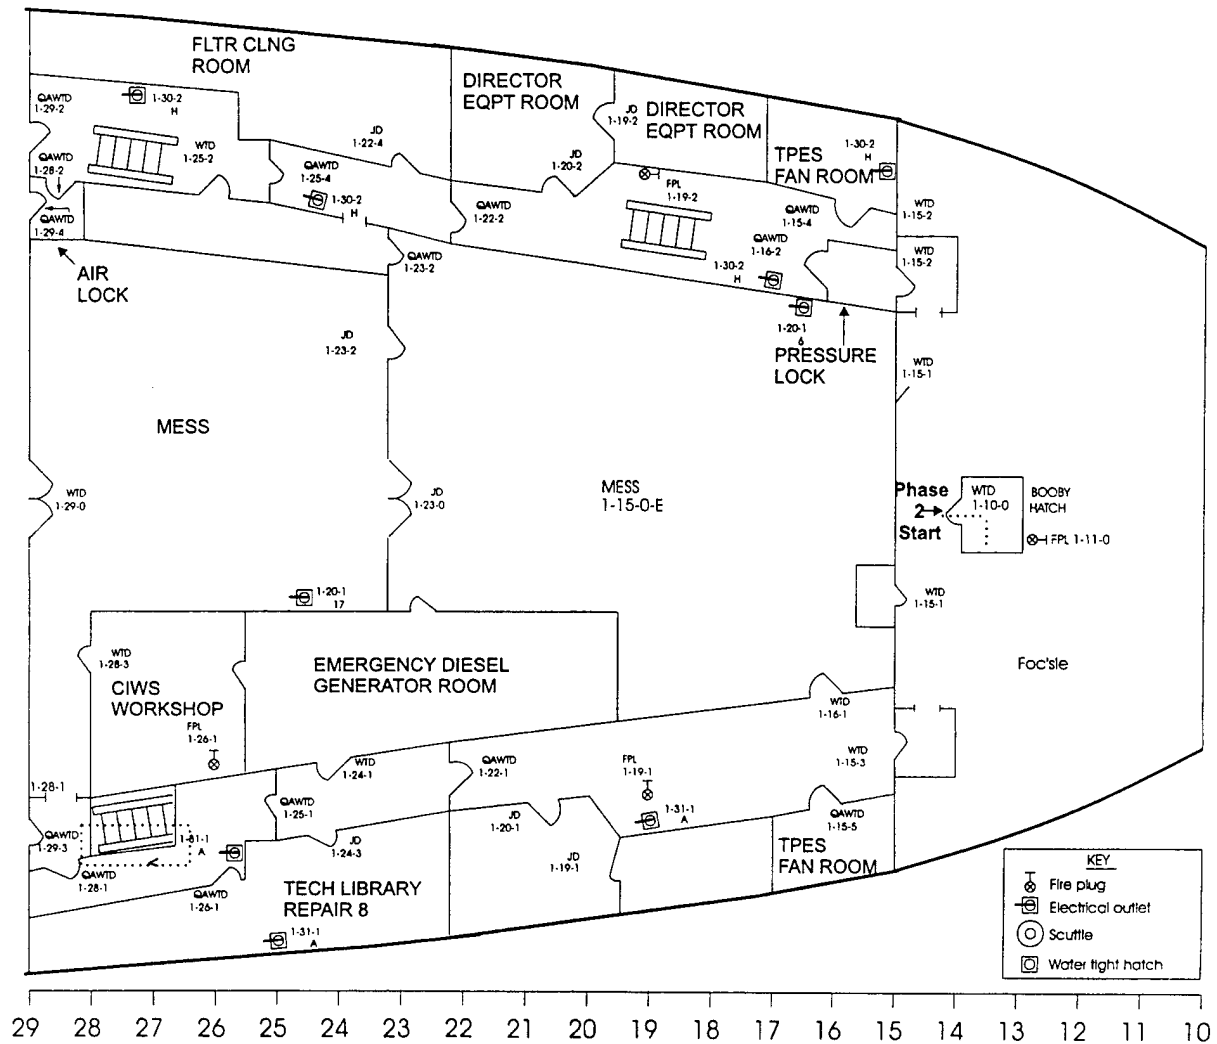
Fig. 2 — Plan view diagram of Main Deck

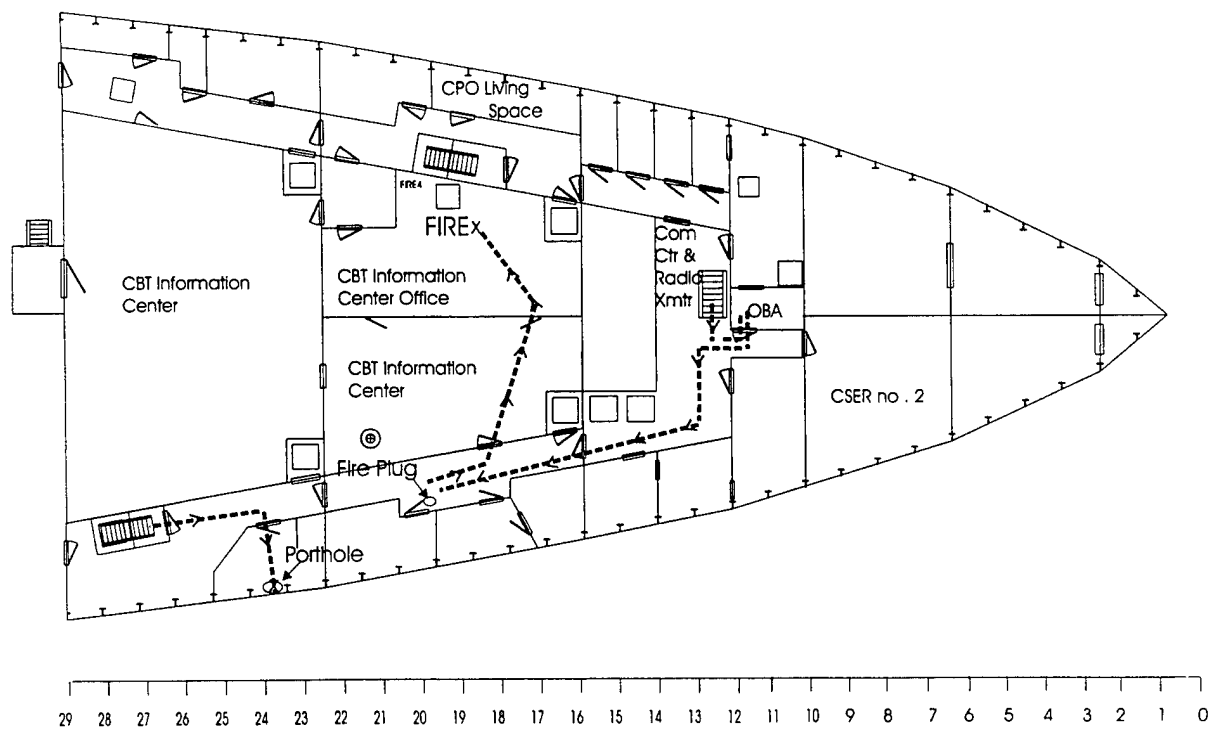
Fig. 3 — Plan view diagram of Second Deck

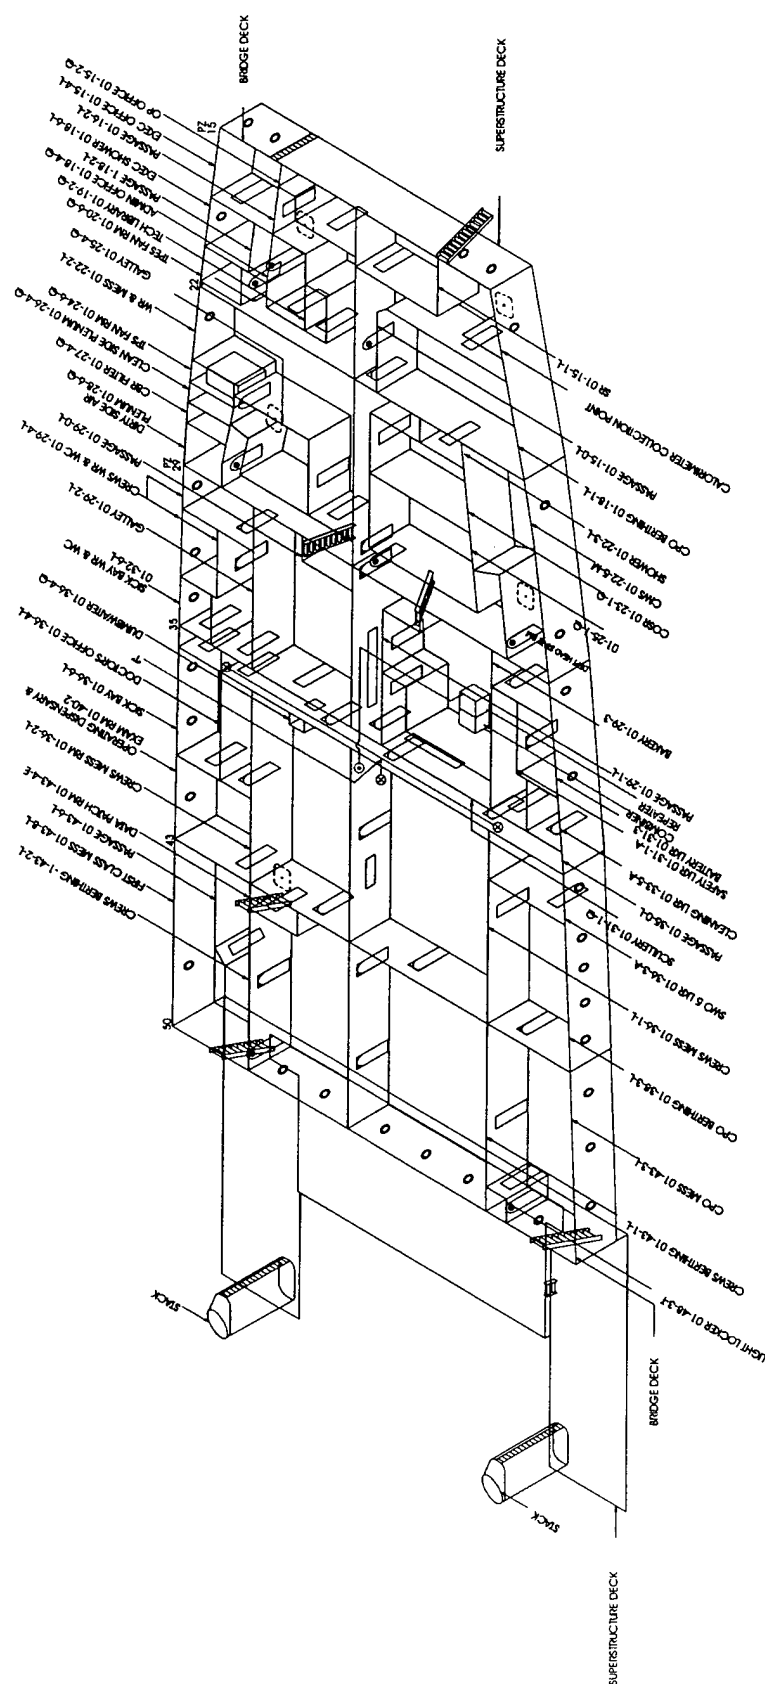
Fig. 4 — Portion of DC plates showing superstructure (01) deck

Prior to an individual's turn to take the test, they were given 5 min for mission rehearsal where they could study the DC plates and a written mission statement. DC plates are a collection of isometric views of a ship, which taken together, detail the ship's systems. The DC plates used for this test show only the structural layout of the ship. Figures 4, 5, and 6 are copies of portions of the DC plates that show the test area. Figure 7 shows the mission statement used for Phase I.

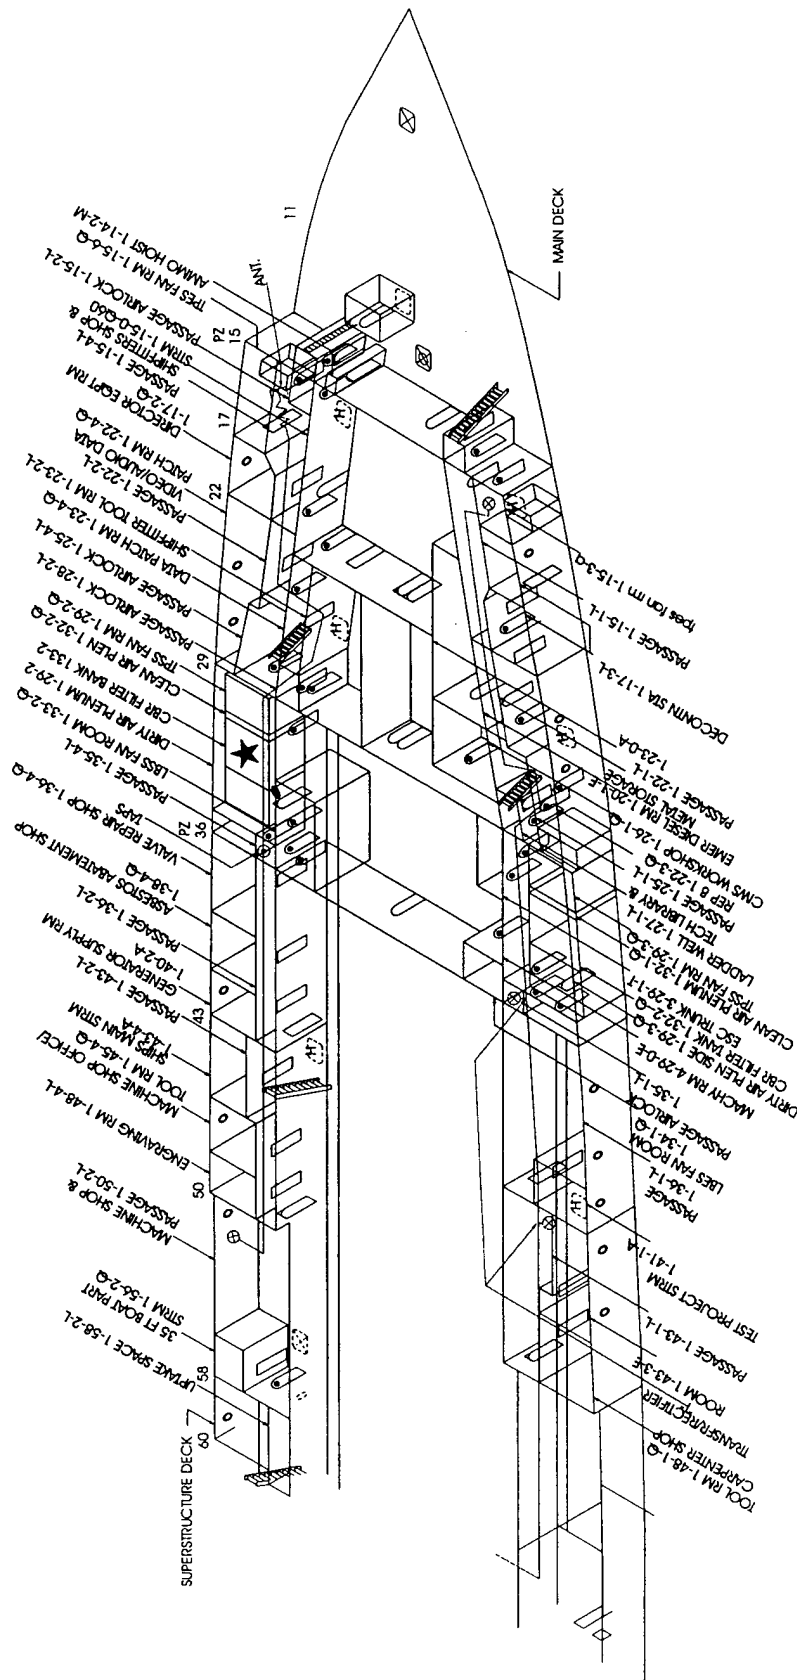
Fig. 5 — Portion of DC plates showing Main Deck

The fire tests were conducted in the forward area of the ex-USS *Shadwell*, on the First (Main) and Second Decks between FR 9 and FR 22 (Figs. 5 and 6). The actual test area was on the Second Deck between FR 15 and FR 22 (Fig. 6). This area had been modified from its original configuration for the 1994 Attack Team Workshop [5] by the addition of the fore-to-aft centerline bulkhead. The compartment to port of the centerline bulkhead is designated as the Storage Area (2-15-2-A), and the compartment to starboard is designated as the General Store Keeping (GSK) Office (2-15-1-Q). The centerline bulkhead has two joiner doors, one forward at FR 16 and another aft at FR 20, to provide access between these two compartments.

The layouts of the First (Main) and Second Deck test areas are shown in Figs. 5 and 6. Dimensional details of these areas are presented in Appendix A of Ref. 5. The staging area for the attack team was in the athwartship passageway adjacent to Repair 2 (2-9-1-Q). The team leader dressed out on the fo'c'sle prior to joining the rest of the attack team at Repair 2. Accesses used by the attack team to reach the fire compartment included QAWTD 2-15-1, QAWTD 2-17-1, and JD 2-17-0. The dimensions of the quick-acting watertight doors were 170 × 66 cm (66 × 26 in.), and the joiner doors in the centerline bulkhead were 210 × 61 cm (84 × 24 in). Emergency exit routes available to the attack team were FD 2-22-1 to the CIC aft safety area or QAWTD 2-17-1 and QAWTD 2-15-1 back to Repair 2 and then up to the fo'c'sle via the booby hatch at FR 11.

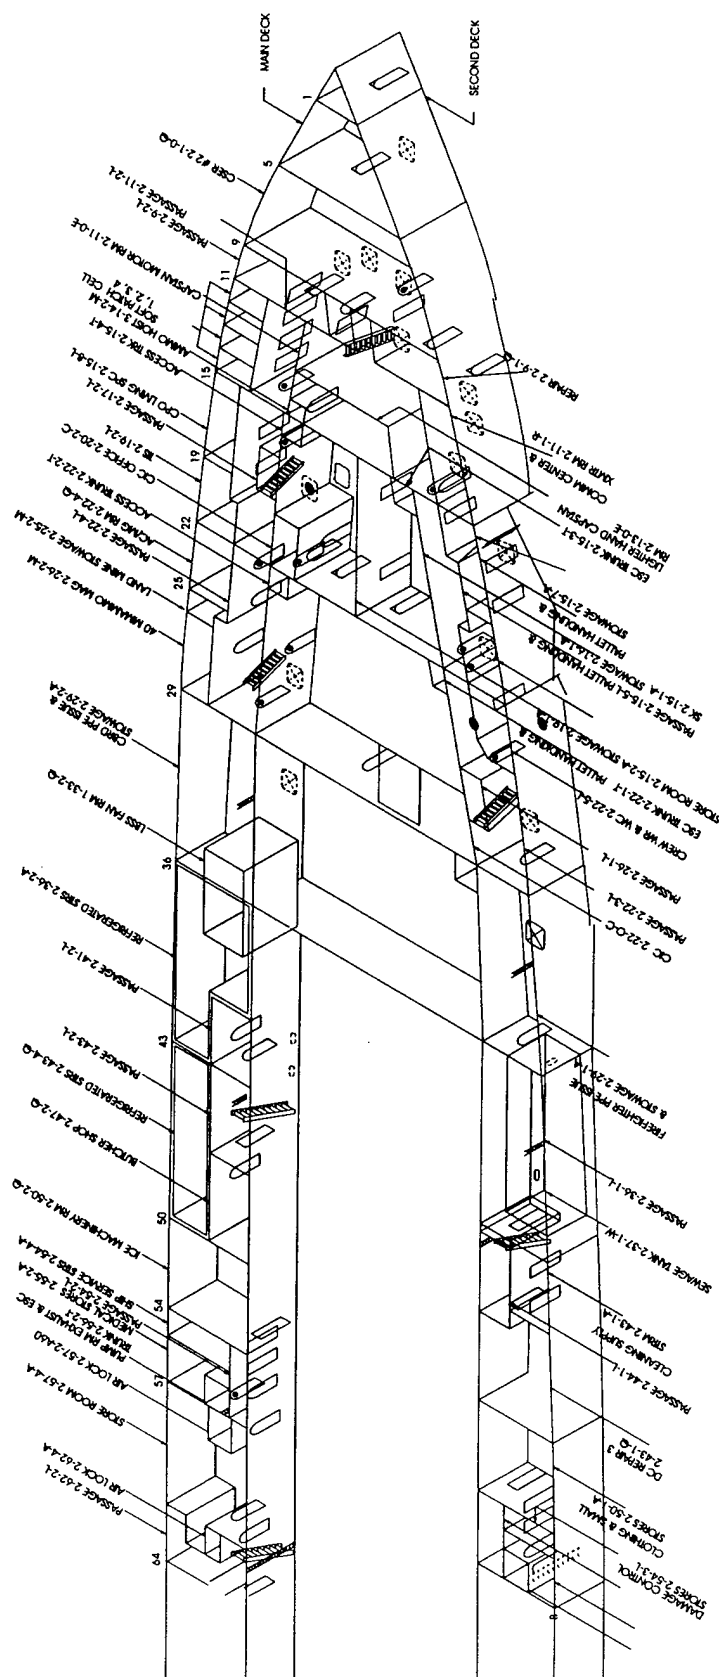
Fig. 6 — Portion of DC plates showing Second Deck

The fire area was in the aft portion of the storage area compartment (Fig. 6). Access to the fire area was via the starboard passageway through water-tight door QAWTD 2-17-1 into GSK, and then through the forward joiner door into the fire space. Repair 2 (2-9-1-Q) was used as the staging area for the attack team. The fo'c'sle area forward of the Ship Fitter's Shop (1-15-0-E) on the Main Deck, and Combat Information Center (CIC) aft (2-22-0-C) on the Second Deck served as emergency escape and muster areas.

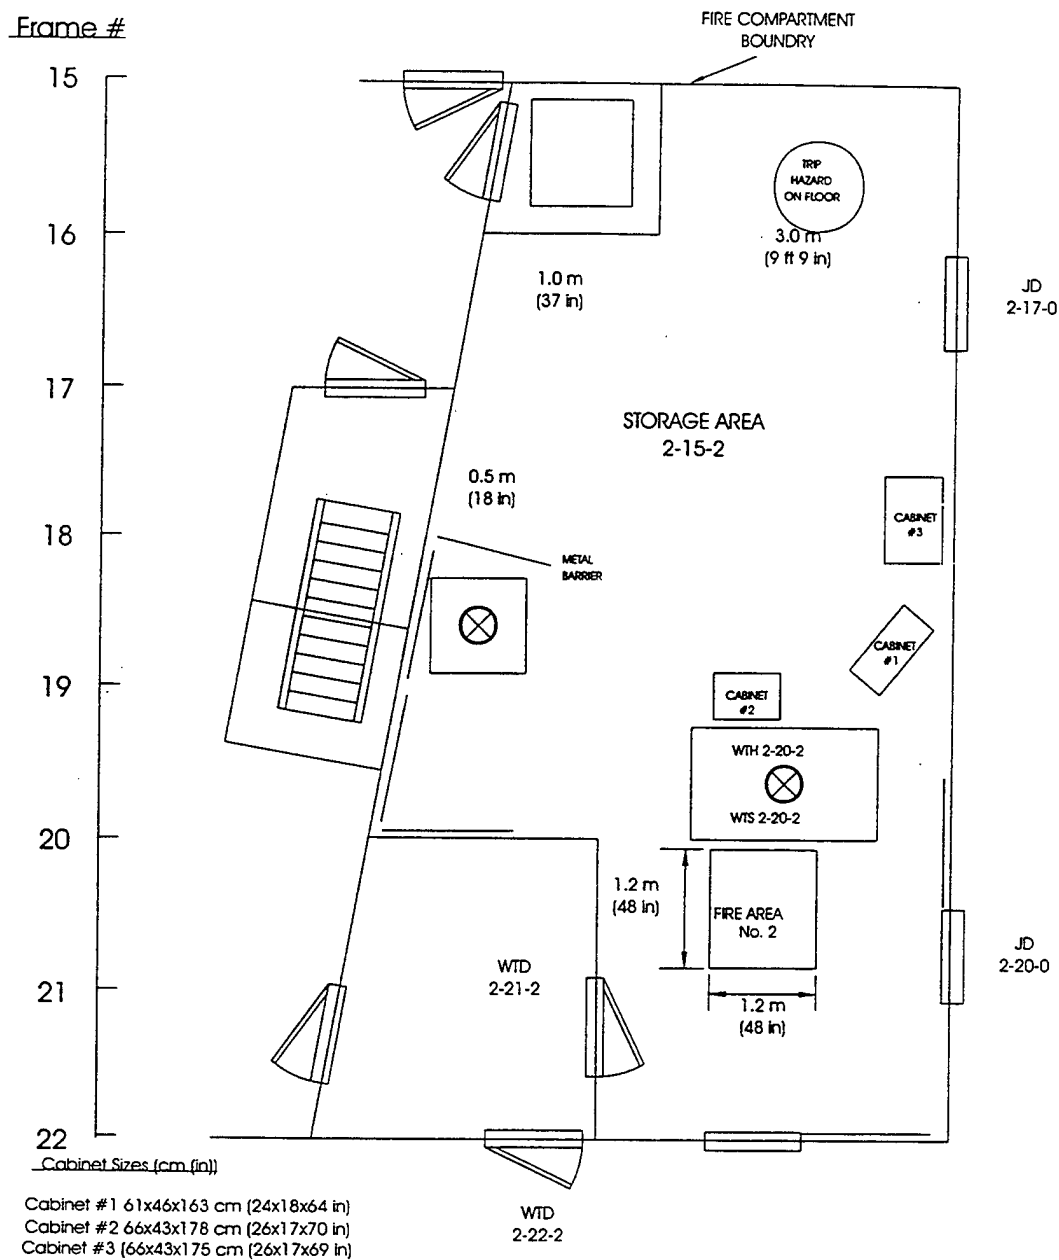
Fig. 8 — Second deck fire source and obstruction layout plan view, FR 15-22

Simulation of a typical storage area fire having a single fire source was provided by burning a wood crib. To further simulate a storage area fire and to make the attack more challenging, metal panels and lockers were located around the compartment such that they obstructed direct access to the fire source. The exact locations of the fire source and obstructions are shown in Fig. 8. The wood crib was made from red oak sticks cut to a nominal size of 5 × 5 × 120 cm (2 × 2 × 48 in.) and was assembled in place on a metal grate support stand that was 58-cm (23-in.) high (Fig. 9). The square wood crib had a total of 10 layers of sticks. Each layer had 10 sticks, with successive layers being placed perpendicular to each other. A 91-cm (36-in.) square metal pan located under the support stand was used to hold the initiating fuel. The initiating fuel was 19 L (5 gal) of commercial grade n-heptane. The metal panels used as obstructions were all 1.2-m (4-ft) high (Fig. 10).

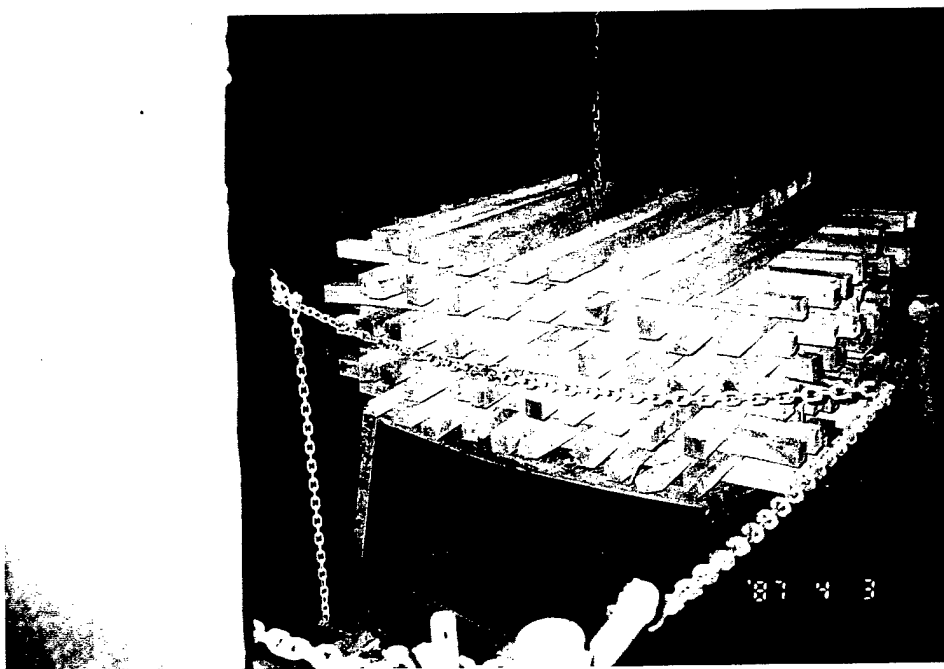
Fig. 9 — Wood crib assembled on support stand with initiating fuel plan below (shown without obstructions)

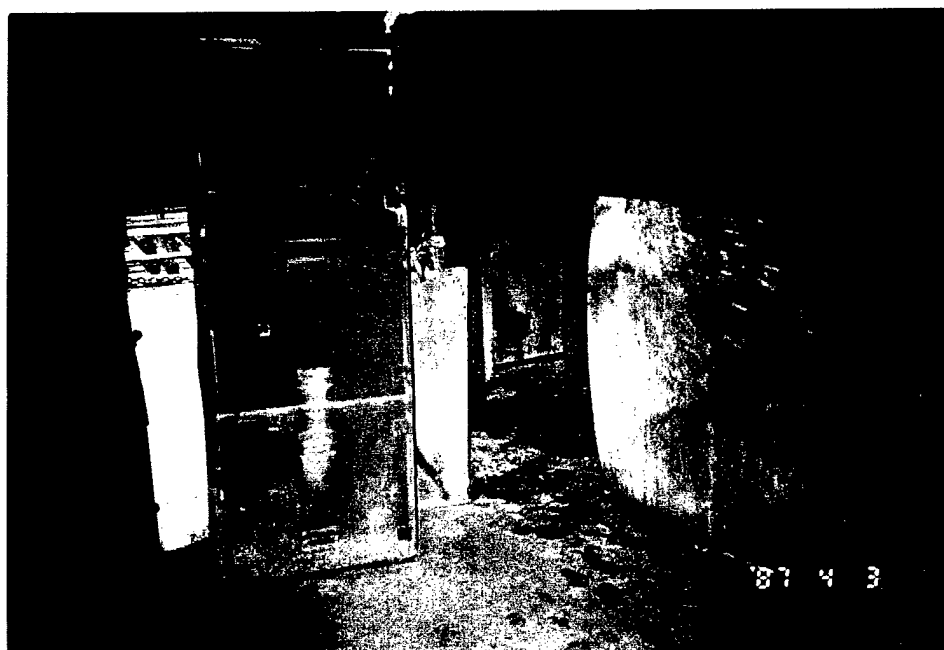
Fig. 10 — Obstructions located in front of and adjacent to fire source

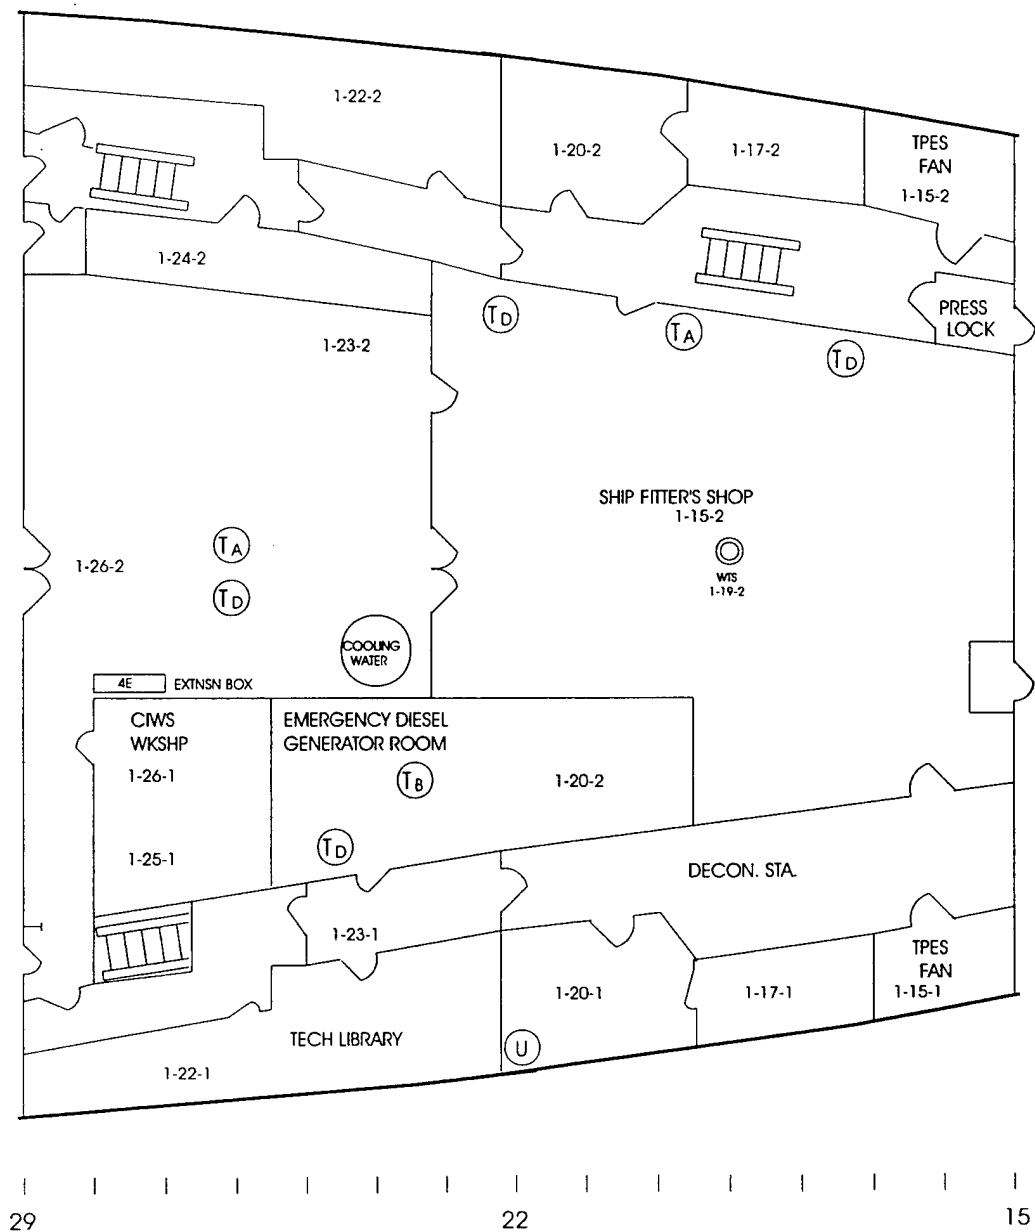
Fig. 11 — First (Main) Deck instrumentation layout plan view, FR 15-29

The locations of all instrumentation installed for these tests are shown in Figs. 11 and 12. The symbol legend for the instruments shown in these figures is provided in Table 1 along with notes on instrumentation that was out of service for specific tests. Key instruments located in the Second Deck test area are shown on Fig. 12 and are described below.

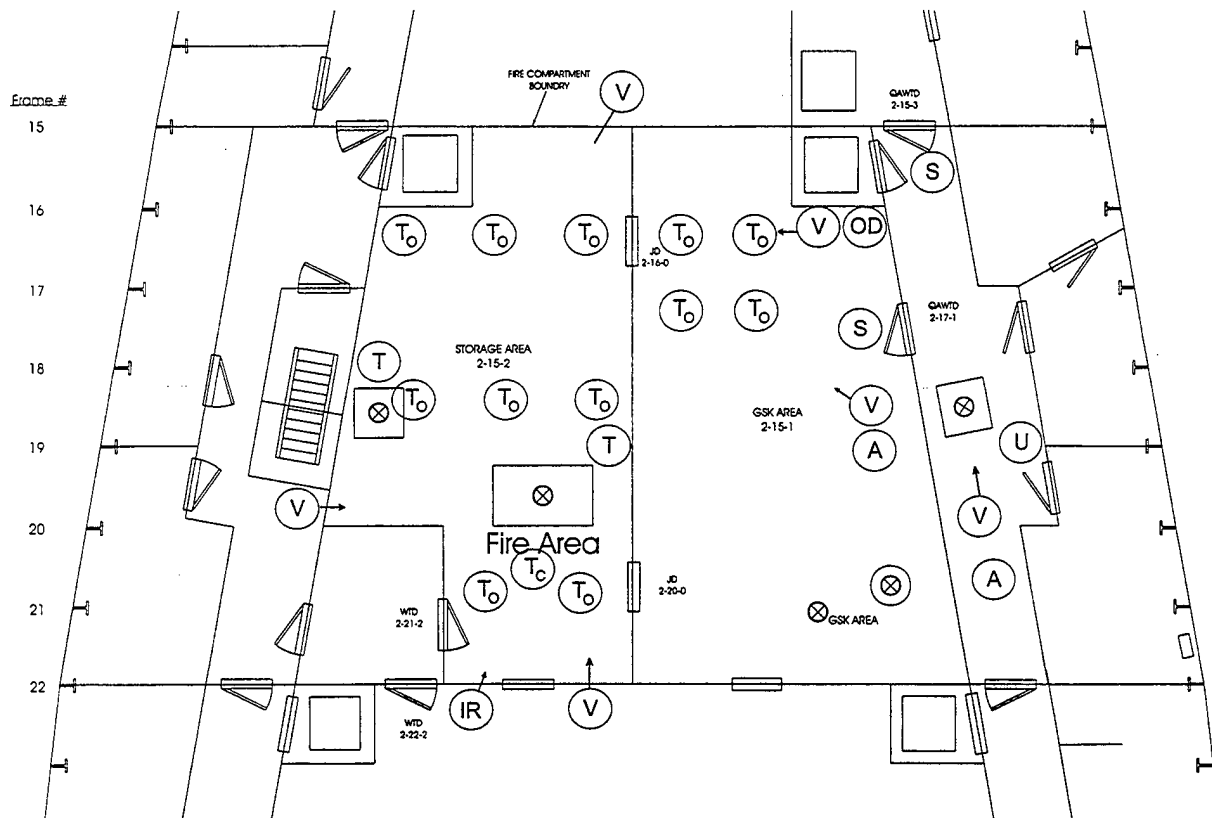
Fig. 12 — Second Deck test area instrumentation layout plan view, FR 15-23

Type K inconel-sheathed thermocouples, 3.2-mm (0.13-in.) outside diameter and 1.6-mm (0.06-in.) outside diameter were used to measure air, overhead, and crib flame temperatures. Two vertical thermocouple strings mounted on stands located at FR 18 on the port side of the fire compartment (2-15-2) and at FR 19 on the starboard side of the fire compartment (2-15-2) measured air temperatures. The thermocouples were mounted on the stands at 46 cm, 91 cm, 140 cm, 180 cm, 230 cm, and 274 cm (18 in., 36 in., 54 in., 72 in., 90 in., and 108 in.) above the deck. Overhead thermocouples mounted 15 cm (6 in.) below the overhead were located in the bays formed by the overhead structural framing immediately aft of FR 16, FR 18, and FR 20 in the storage area.

Thermocouples mounted in a similar manner were located in the bays immediately aft of FR 16 and FR 17 in the GSK compartment. These thermocouples measured the overhead temperatures. The forward two bays in the storage area had three thermocouples each, positioned 71 cm, 220 cm, and 361 cm (28 in., 85 in., and 172 in.) out from the center-line bulkhead. The aftmost bay in the storage area, and both bays in the GSK area had only two thermocouples each, positioned 71 cm and 220 cm (28 in. and 85 in.) out from the center-line bulkhead. Three thermocouples were extended down from the overhead at the fire source location to measure crib flame temperatures. These thermocouples were centrally located at the bottom, middle, and 31 cm (12 in.) above the top of the crib.

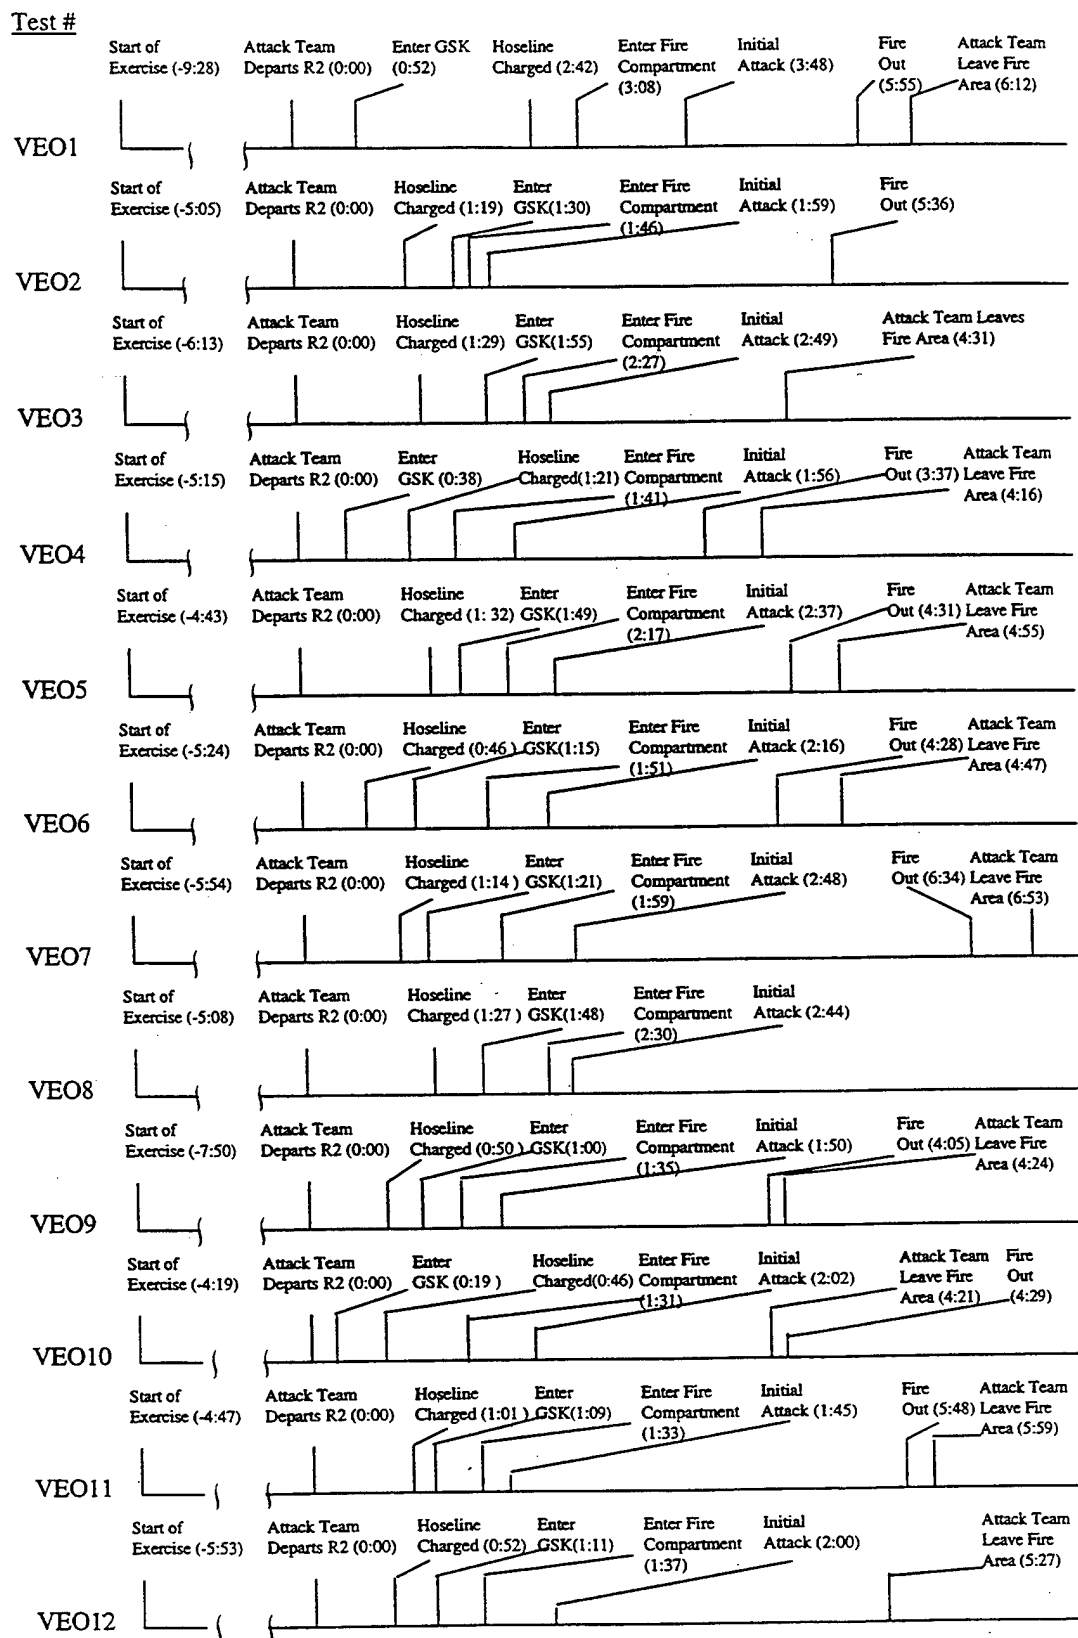
Fig. 13 — Event timelines for tests VEO1-VEO12

Items (a) through (f) allow a comparison of the traditional vs VE training methods because completion of these tasks is a function of familiarity with the space. Items (g) and (h) are dependent more on knowledge of firefighting tactics and procedures and, therefore, are not expected to be good indicators of the type of training received. As with the graphs, time zero for this evaluation began when the attack team departed from Repair 2. A graphical representation of these data is provided in Fig. 13.

Firefighter-response-time data presented in Fig. 13 indicate how well the attack team, under the direction of the test participant (team leader) was able to navigate the test space under realistic fire conditions. Selecting meaningful timing measures was difficult because different attack teams performed the required tasks in different sequences. For example, some teams charged the hose line in the starboard passageway rather than the GSK. In this case, it is not practical to evaluate the elapsed time required to man the hose line and enter GSK. In addition, data on times for the fire to be declared out and the attack team departed the fire compartment were not recorded for all tests and could not be evaluated.

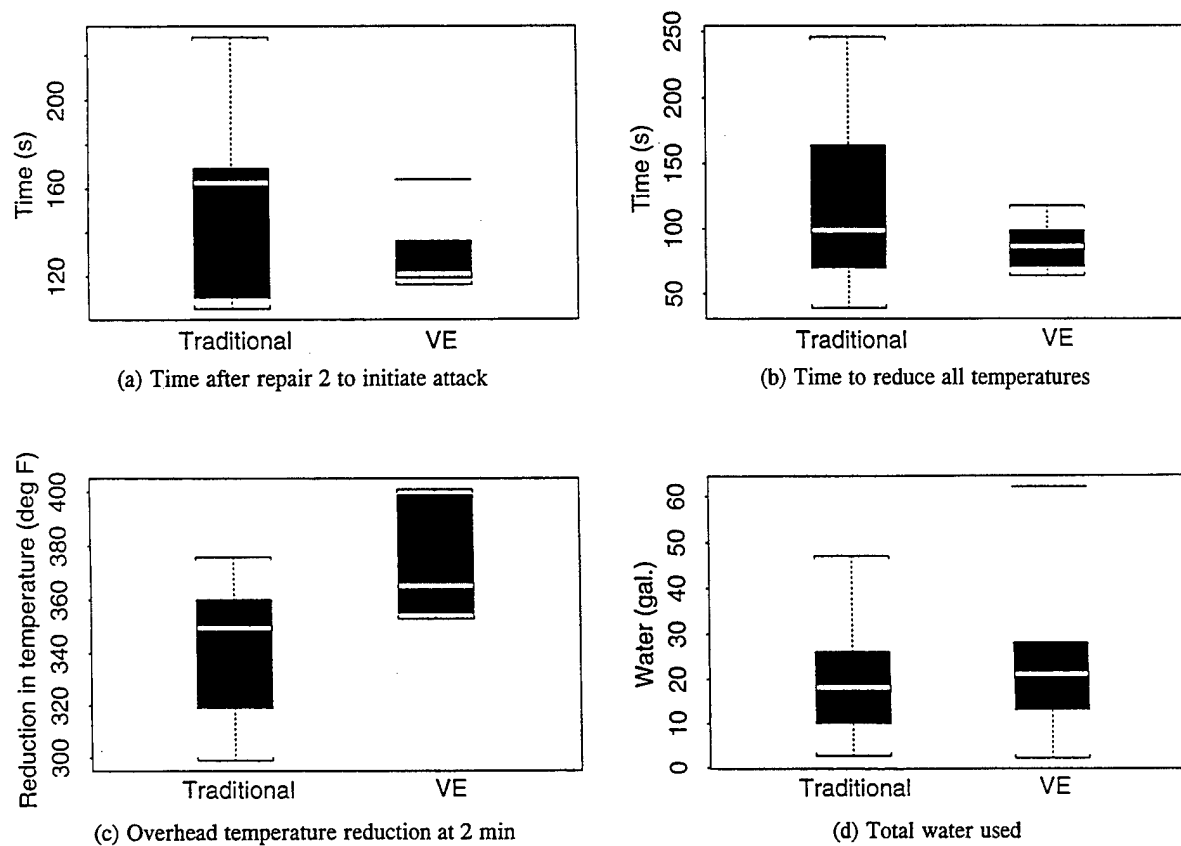
Fig. 14 — Box plots of key measures

Figure 14 shows a pair of box plots, one for each group, for each of the four key measures in Table 3. We have presented box plots (also called a box and whisker plots) because a box plot gives a picture of the variance (or spread) of the distribution for the data. The horizontal line in the interior of the box is located at the median of the data. The height of the box is equal to the interquartile distance (IQD), which is the difference between the third quartile of the data and the first quartile. The height of the box shows the variance if there are no outliers; two boxes of the same height indicate equal variance. If there are outliers, the size of the box is still a reasonable approximation of the variance. The whiskers (the dotted lines extending from the top and bottom of the box) extend to the extreme values of the data. Unusually deviant data (defined as data that are 1.5 times the IQD) are shown as lines above or below. The variances are markedly different for the top two data sets and similar for the bottom two in Fig. 14.

For the data for elapse time from departing Repair 2 to beginning the initial attack (Fig. 14(a)), the variance for the traditional group is more than six times greater than the VE group's. This difference suggests that the VE training group was more consistent in their approach during this phase. A formal test of the difference of variances is significant at  $p < 0.06$ , which is suggestive given the outlier in the VE group data. The VE group averages 26.7 s faster performance. More striking is the difference in performance between groups in the time to achieve extinguishment of the wood crib (i.e., the time required to reduce all wood crib temperatures below 150° C (302° F) (Fig. 14(b)). The variance is 16 times greater for the traditional group than the VE group. A formal hypothesis test of the difference of variances is highly significant at  $p < 0.009$ . (Note that the time for traditional group subject VE03 was thrown out because the fire was allowed to reflash to evaluate a thermal imager.) The traditional group is, on average, 36.1 s lower. The data suggest that rehearsing in VE helped the group perform the firefighting task in a more focused and consistent way.

The performance of both groups is similar for the bottom two measures in Fig. 14, which rely more on firefighter training. VE did help slightly to produce more consistent behavior, which can be seen in a variance that is somewhat less for the VE group in both cases. The variance for the traditional group for total reduction in average overhead temperature at 2 min after the initial attack is less than twice that of the VE group's (Fig. 14(c)). The VE group averages 26.2 s slower. These data are fairly reliable even with the reflashes. (Again, data for subject VE03 of the tradition training group were thrown out.) The graphical data for average overhead temperature show that the reflashes that did occur (as indicated by the wood crib temperature data) were not large enough to be measured at the overhead and did not pose a serious thermal threat. A formal test of difference in variances is not significant. The cumulative total water flow data are also similar (Fig. 14(d)). The difference in variance is only 124.7 (with the traditional group's larger) and is not significant. The average difference in amount is only 3.79 gal more for the VE group.

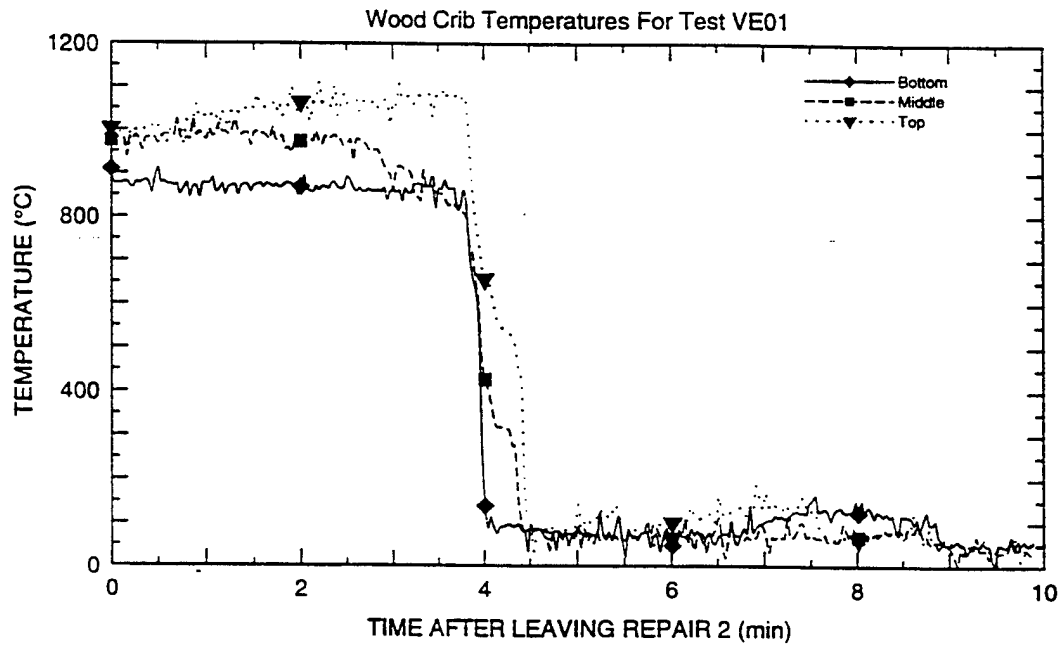
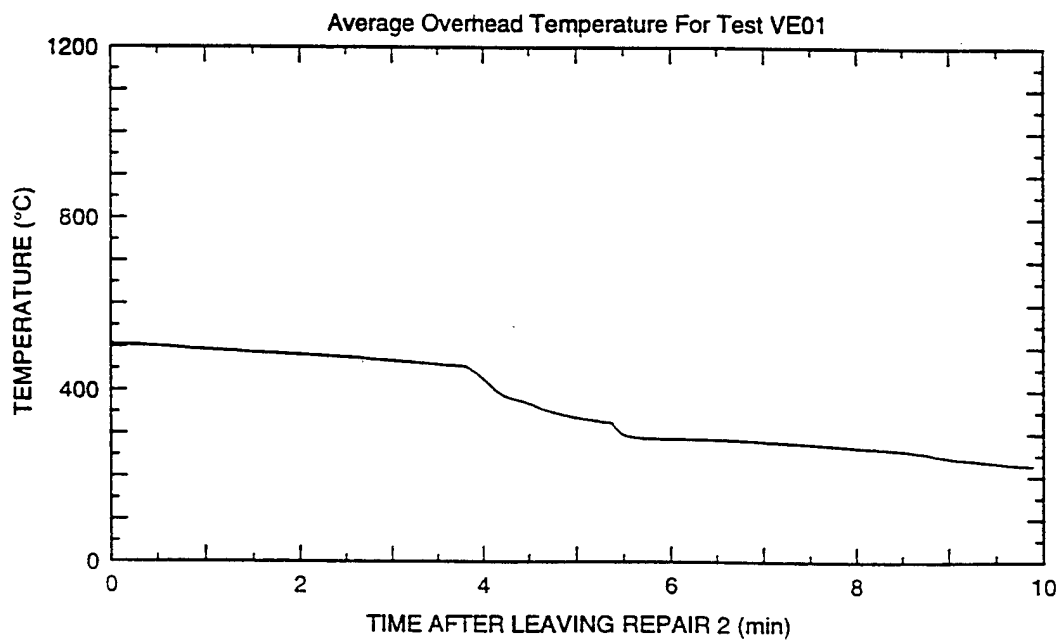
Fig. A1 — Wood crib and average overhead temperatures for test VE01

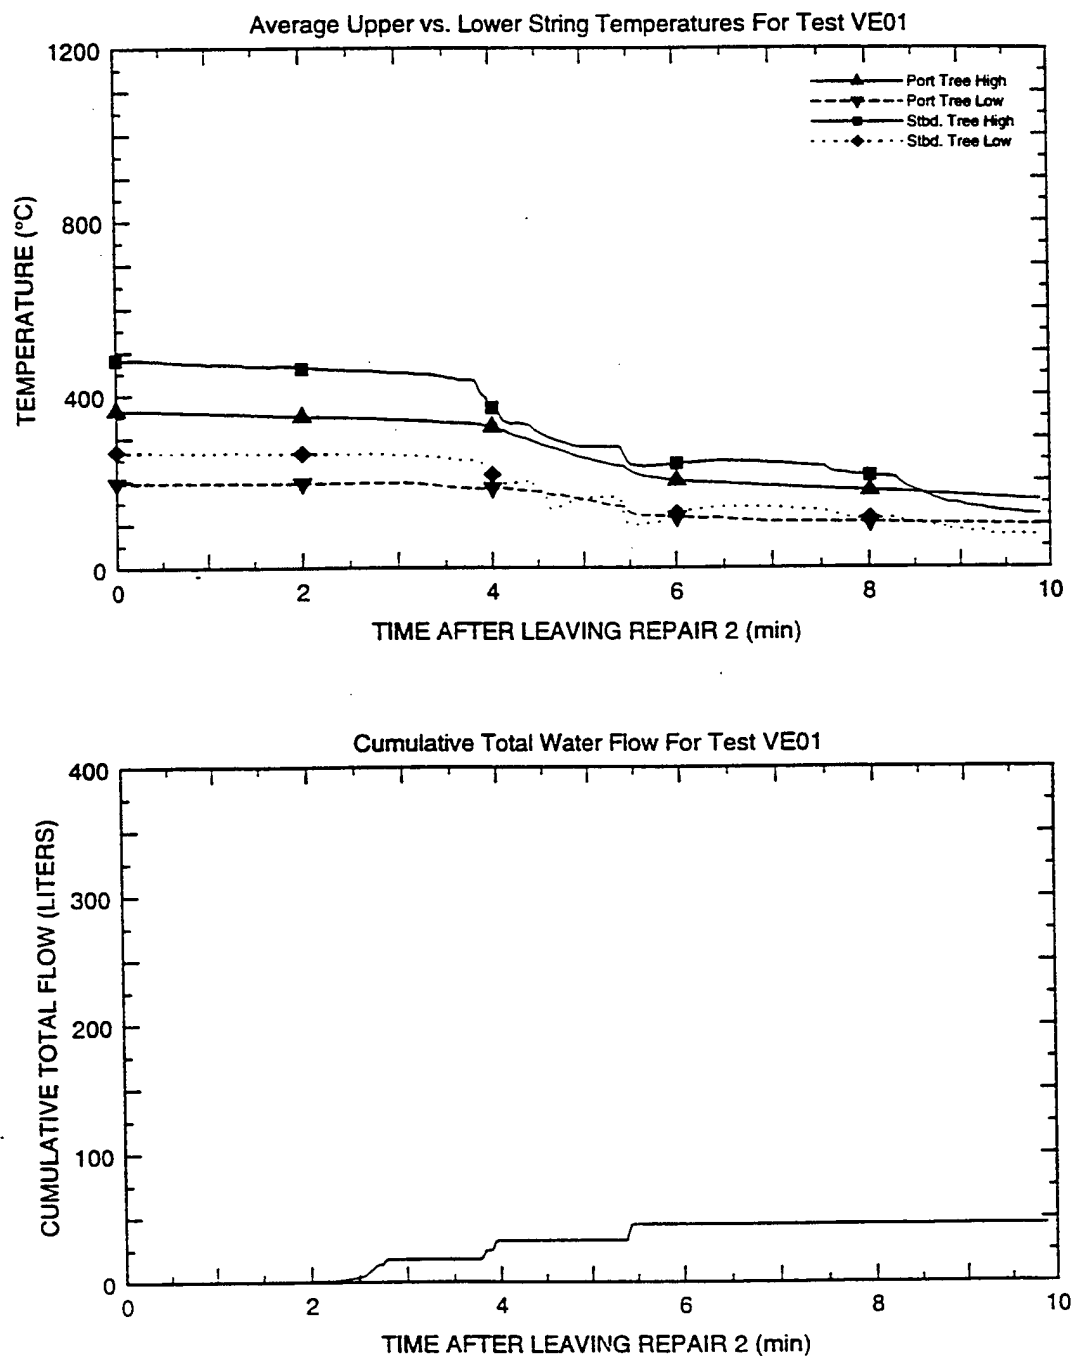
Fig. A2 —Average string temperatures and cumulative total water flow for test VE01

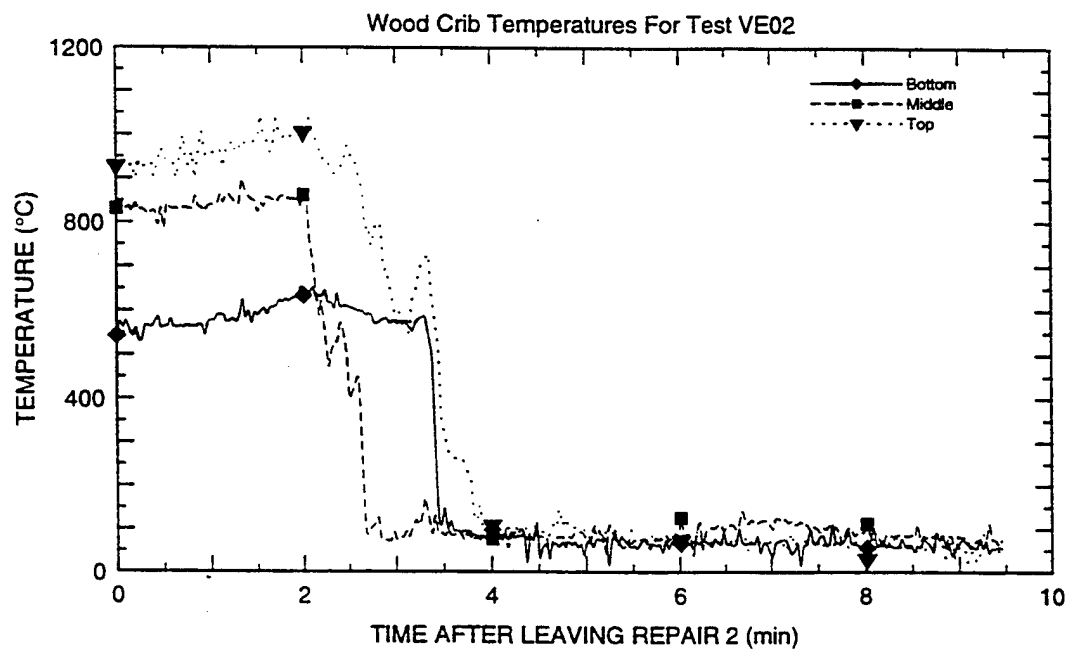
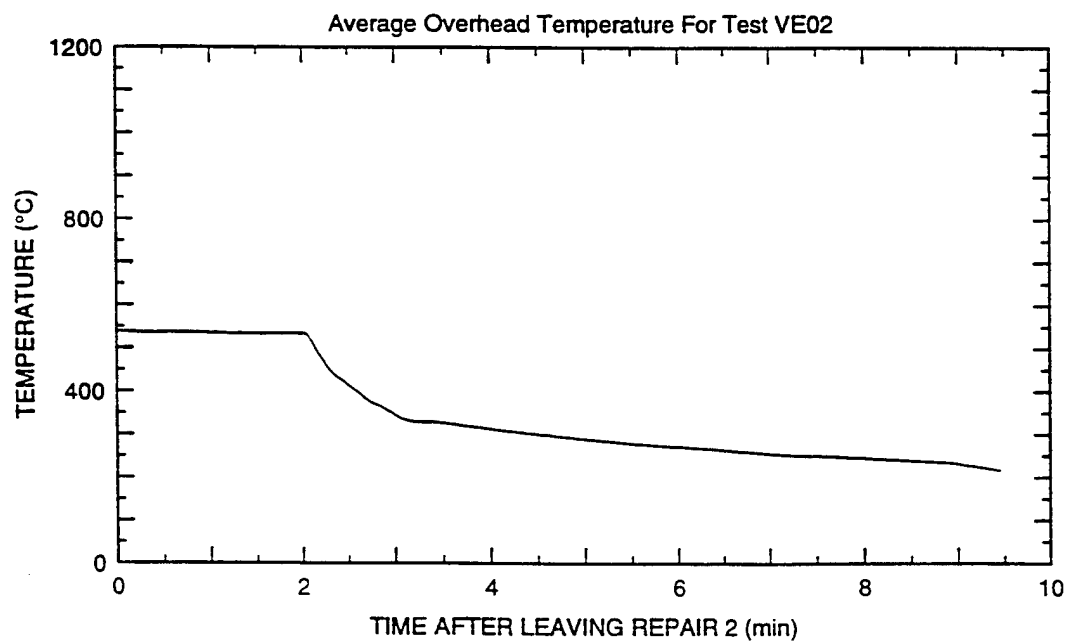
Fig. A3 — Wood crib and average overhead temperatures for test VE02
