NRL/FR/6180--97-9861

# Virtual Environment Firefighting/Ship Familiarization Feasibility Tests

| REPORT DOCUMENTATION PAGE | | | Form Approved<br>OMB No. 0704-0188 | |
|---|---|---|---|--|
| 13. ABSTRACT (Maximum 200 words)<br><br>Virtual Environments Firefighting/Ship Familiarization Feasibility Tests were conducted on the ex-USS <i>Shadwell</i> . The results of these tests indicate that there are measurable gains using virtual environment (VR) training with respect to water usage and time to achieve complete extinguishment. The data also indicates gains for the time to travel from Repair 2 to the fire compartment and begin the initial attack. The time to transit from the 01 level to the fire area under reduced visibility was reduced by one-half for subjects trained with VR. | | | | |

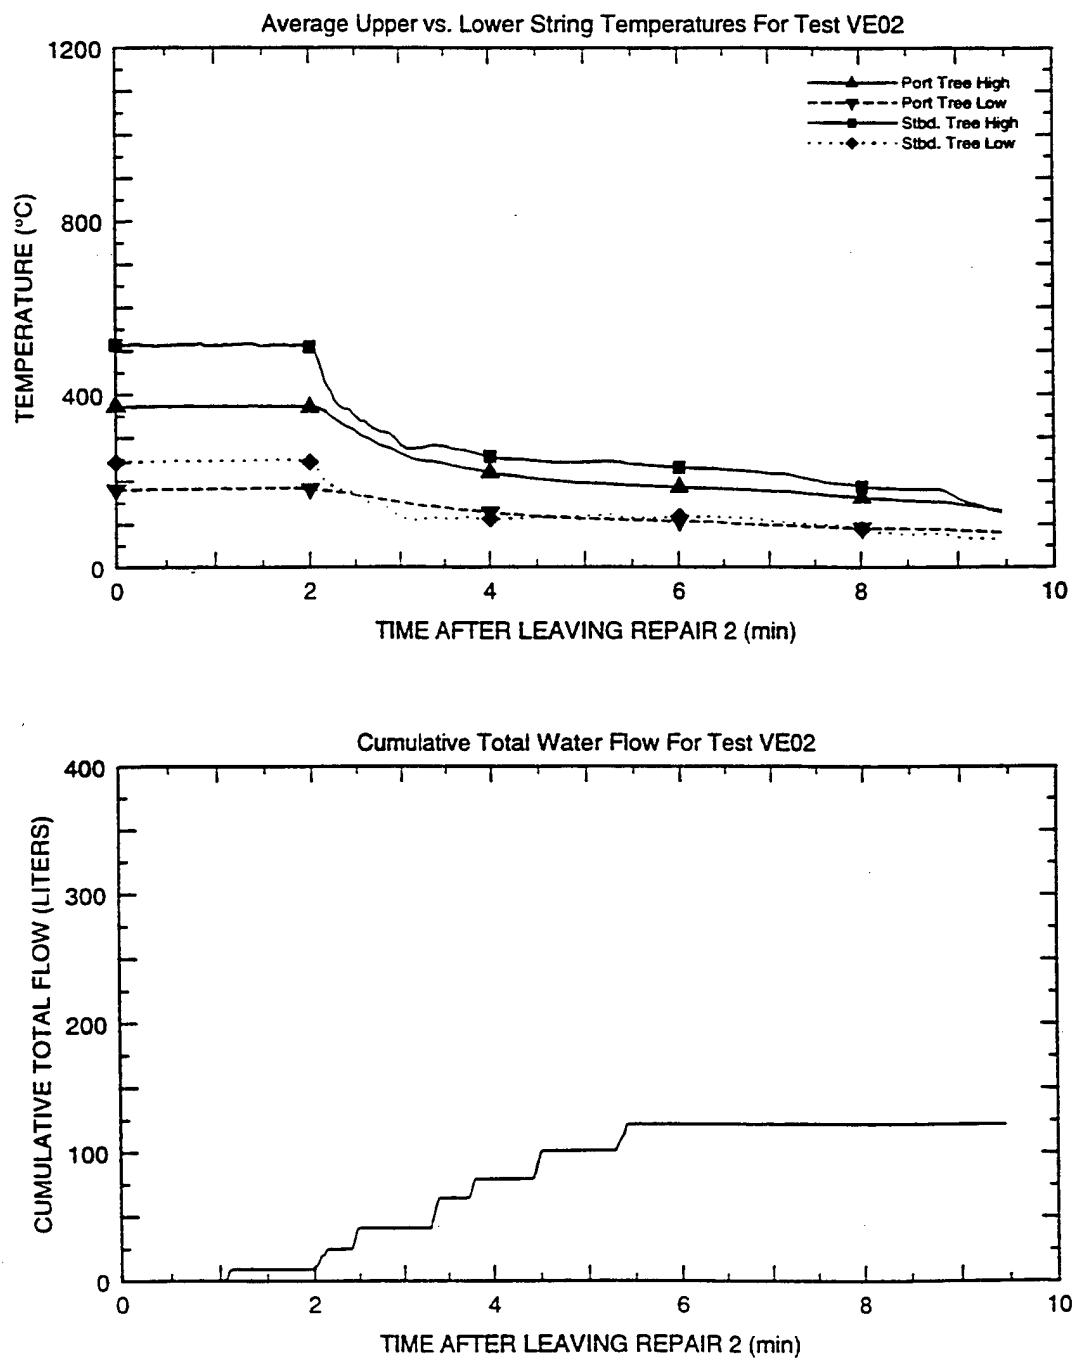
Fig. A4 — Average string temperatures and cumulative total water flow for test VE02

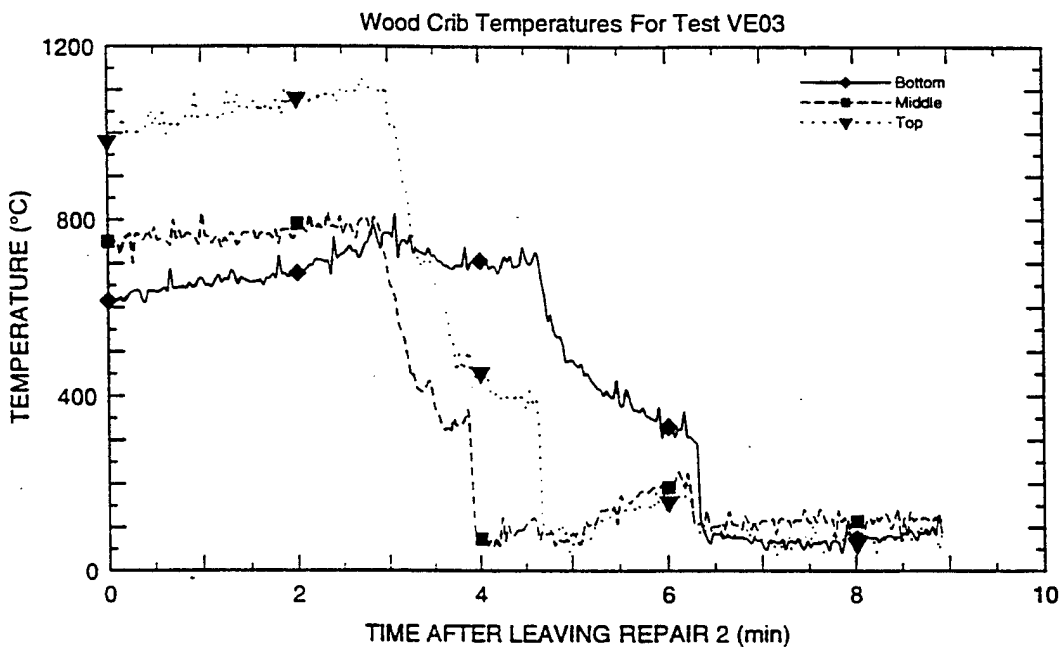
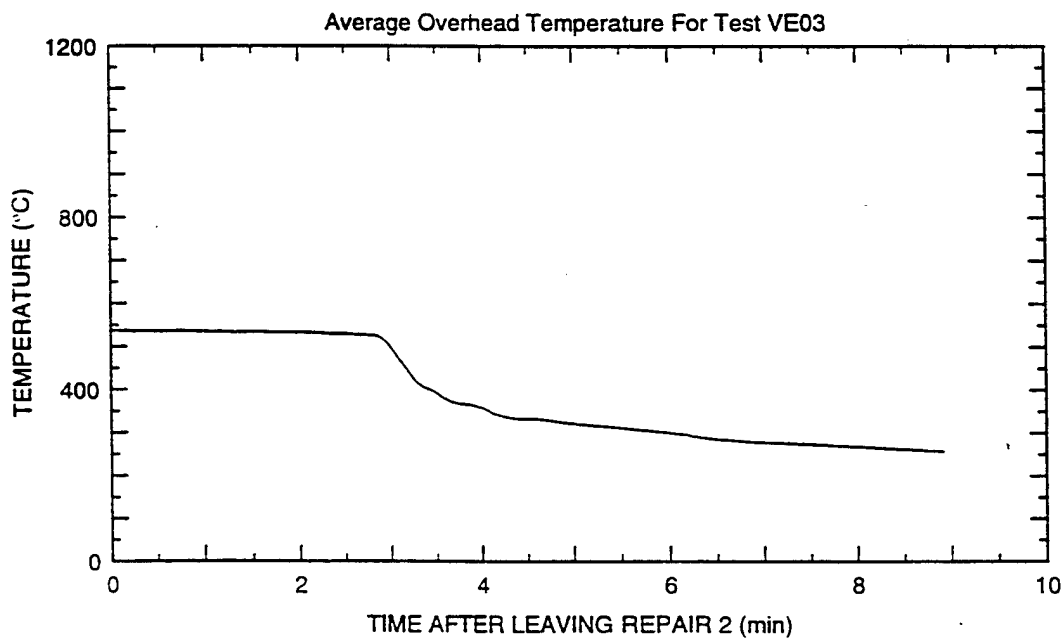
Fig. A5 — Wood crib and average overhead temperatures for test VE03

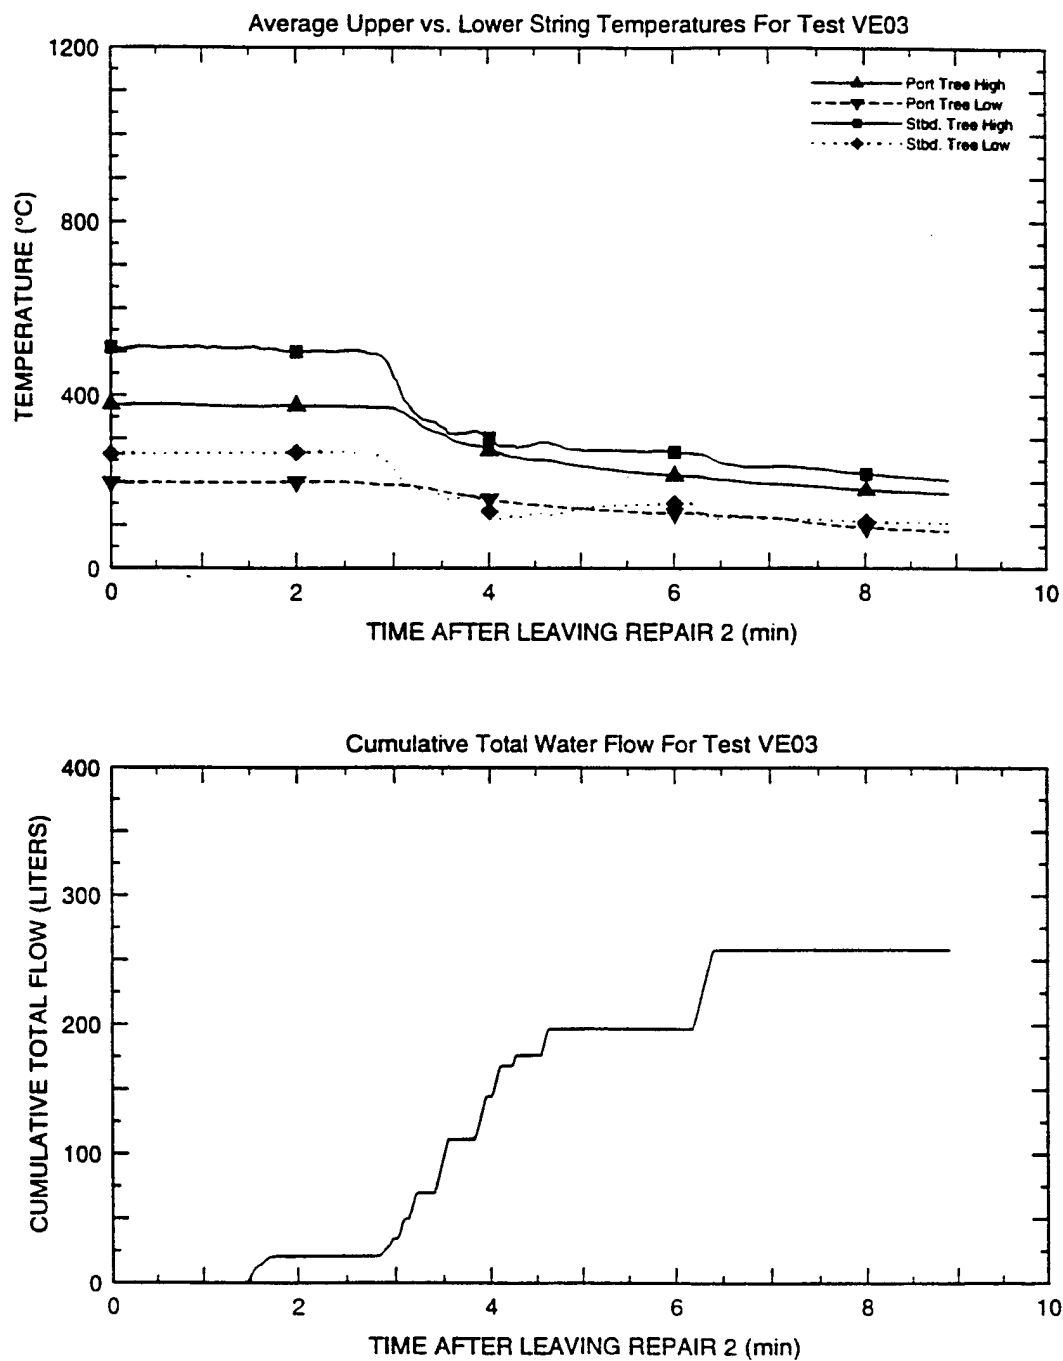
Fig. A6 —Average string temperatures and cumulative total water flow for test VE03

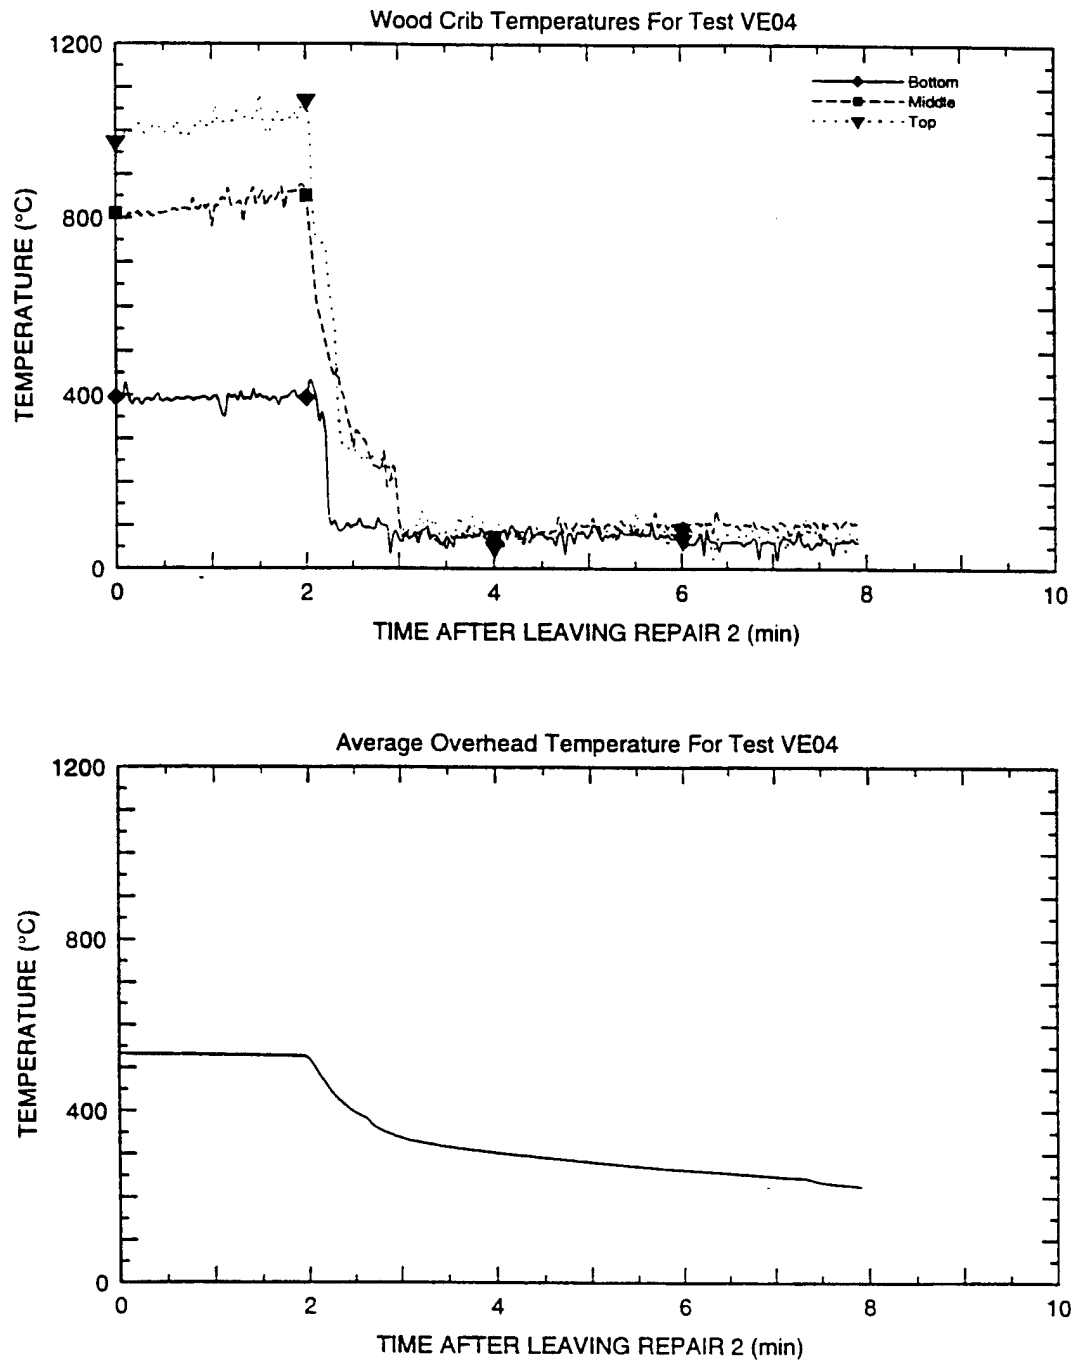
Fig. A7 — Wood crib and average overhead temperatures for test VE04

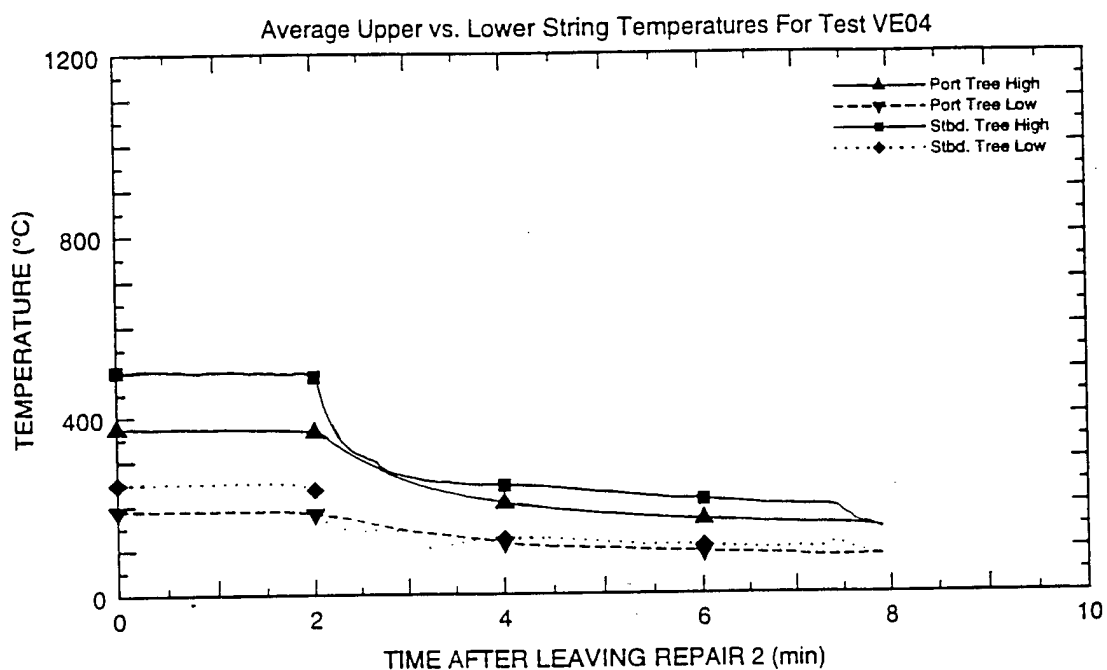
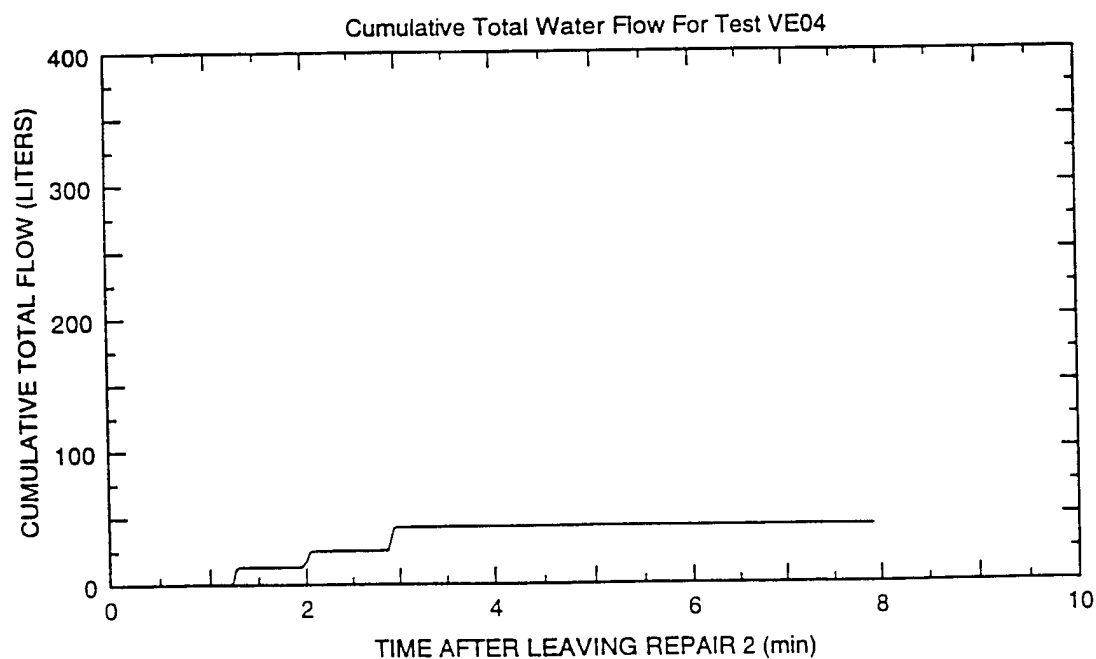
Fig. A8 — Average string temperatures and cumulative total water flow for test VE04

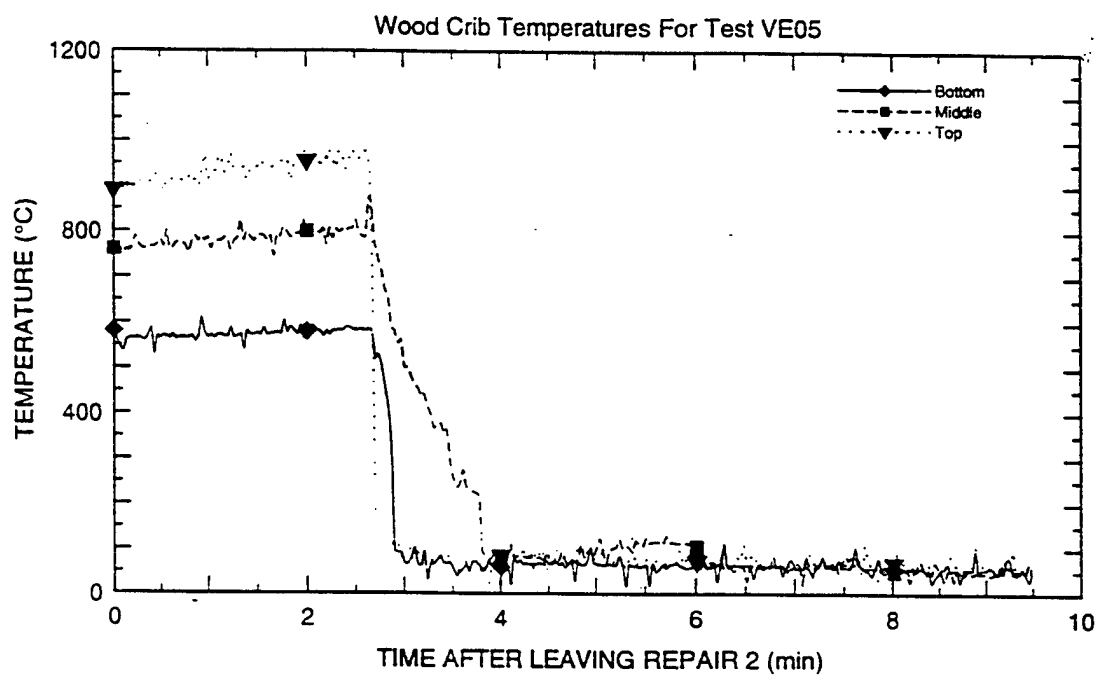
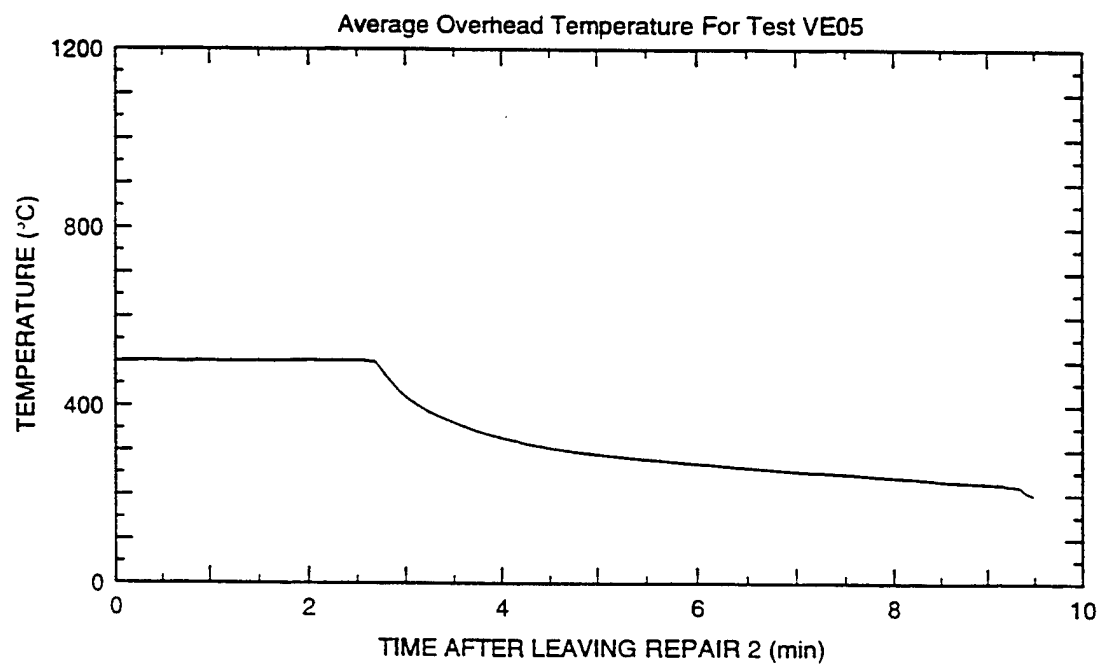
Fig. A9 — Wood crib and average overhead temperatures for test VE05

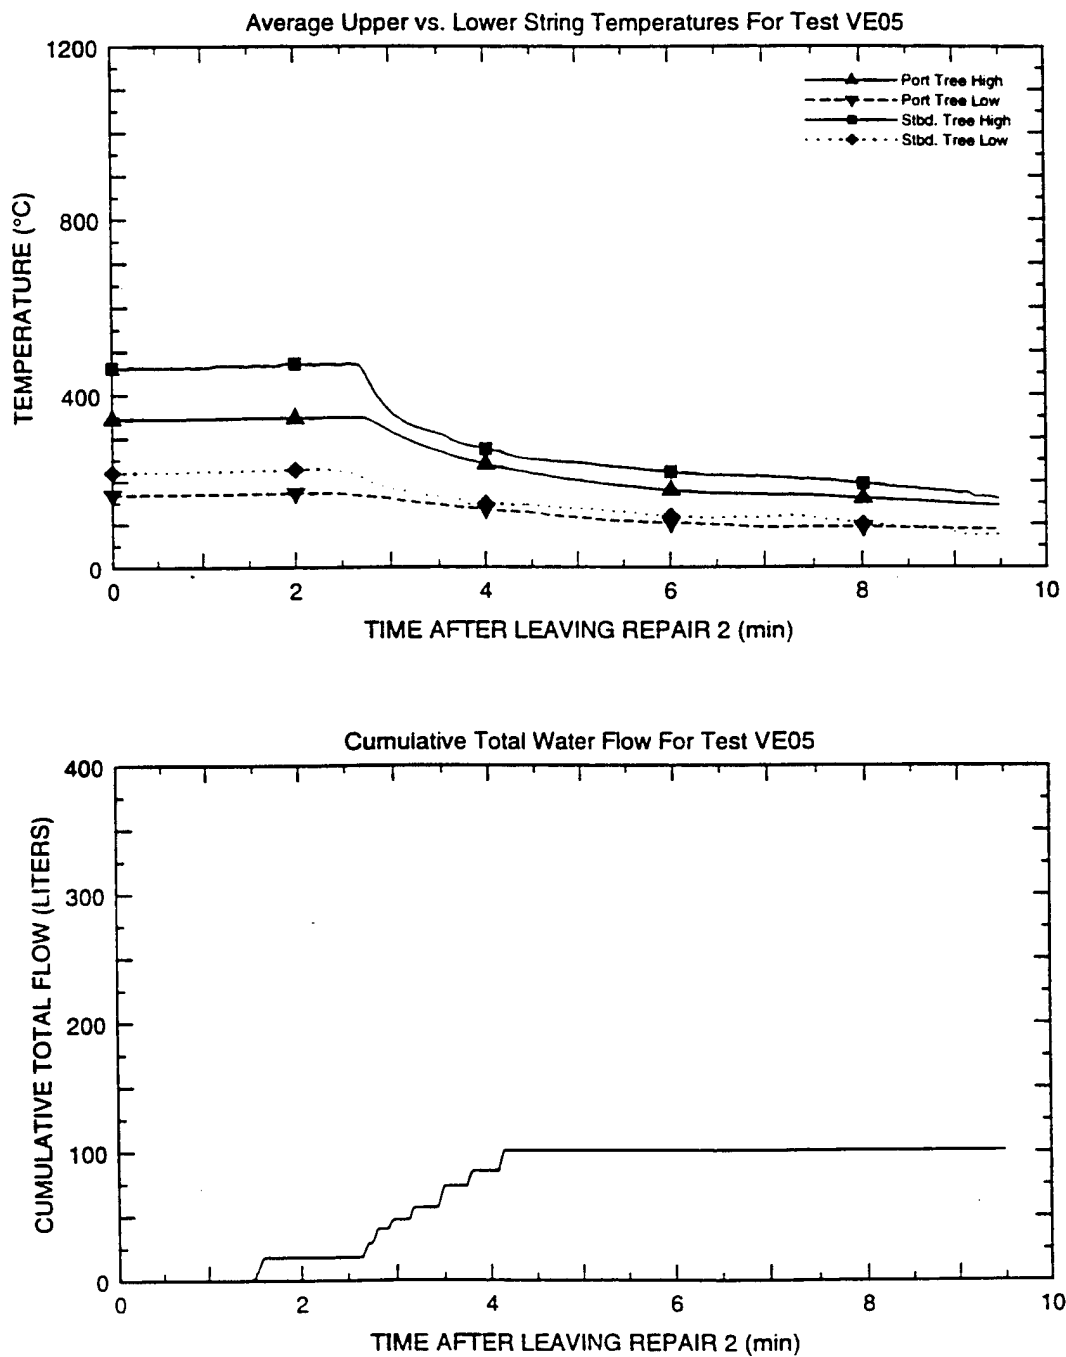
Fig. A10 — Average string temperatures and cumulative total water flow for test VE05

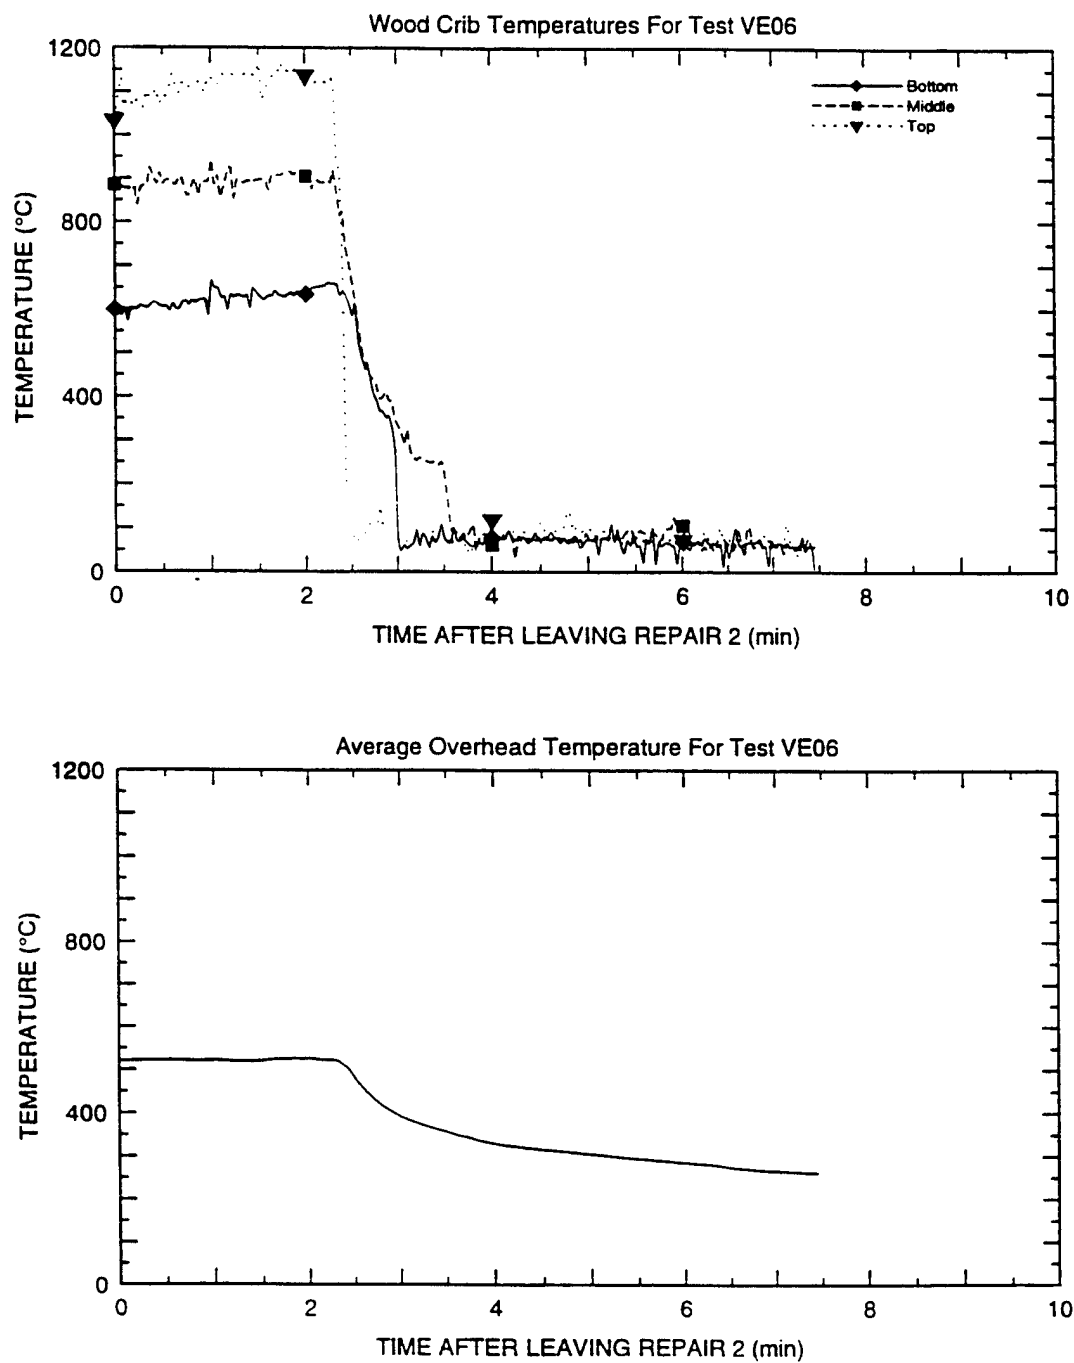
Fig. A11 — Wood crib and average overhead temperatures for test VE06

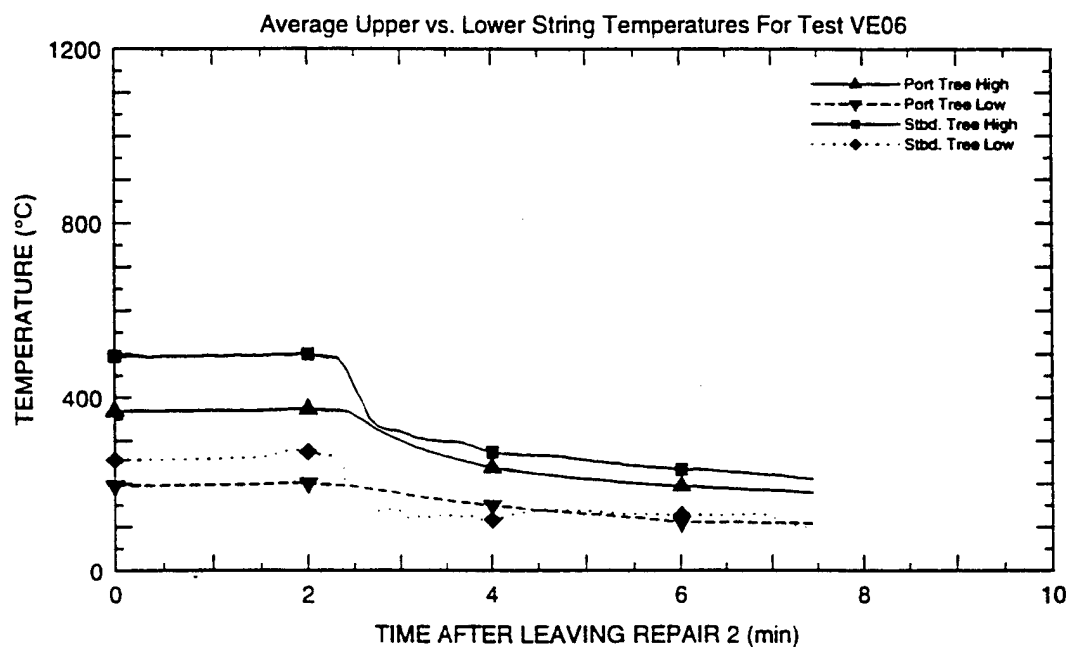
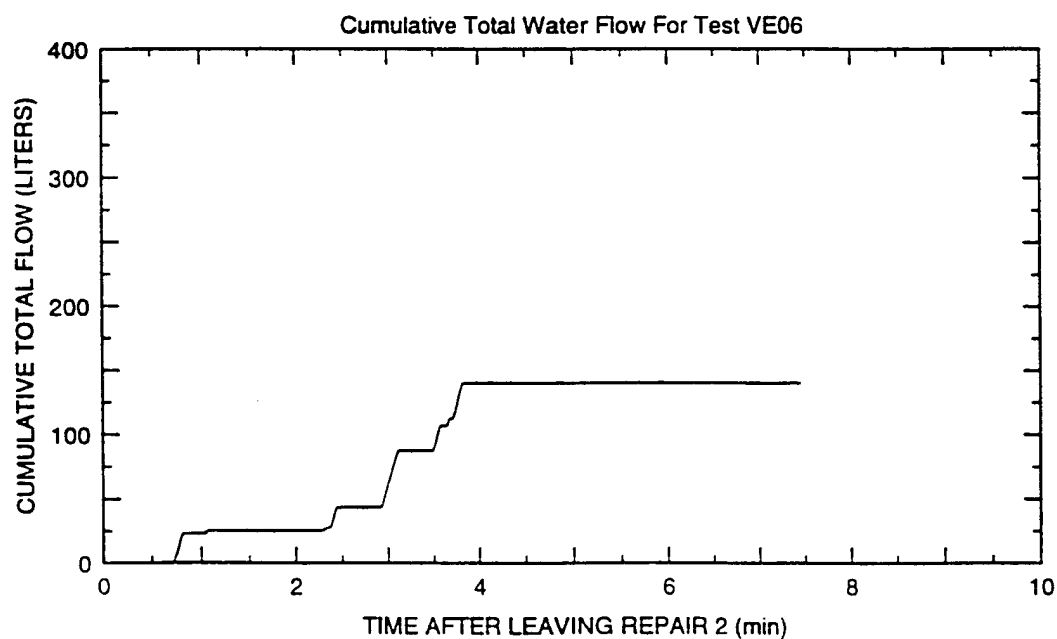
Fig. A12 — Average string temperatures and cumulative total water flow for test VE06

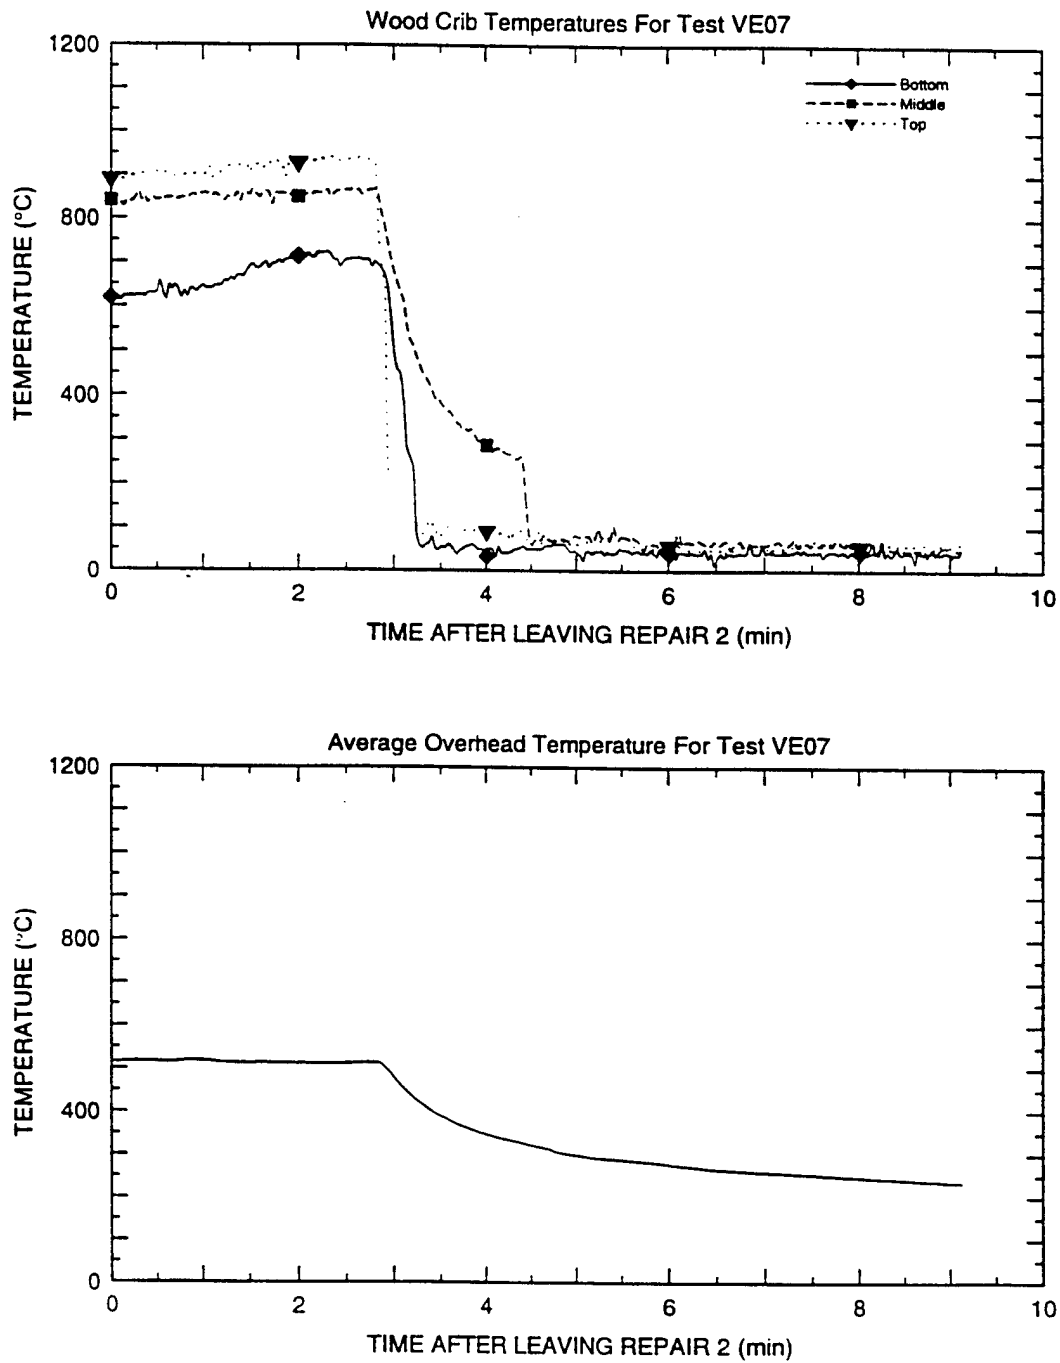
Fig. A13 — Wood crib and average overhead temperatures for test VE07

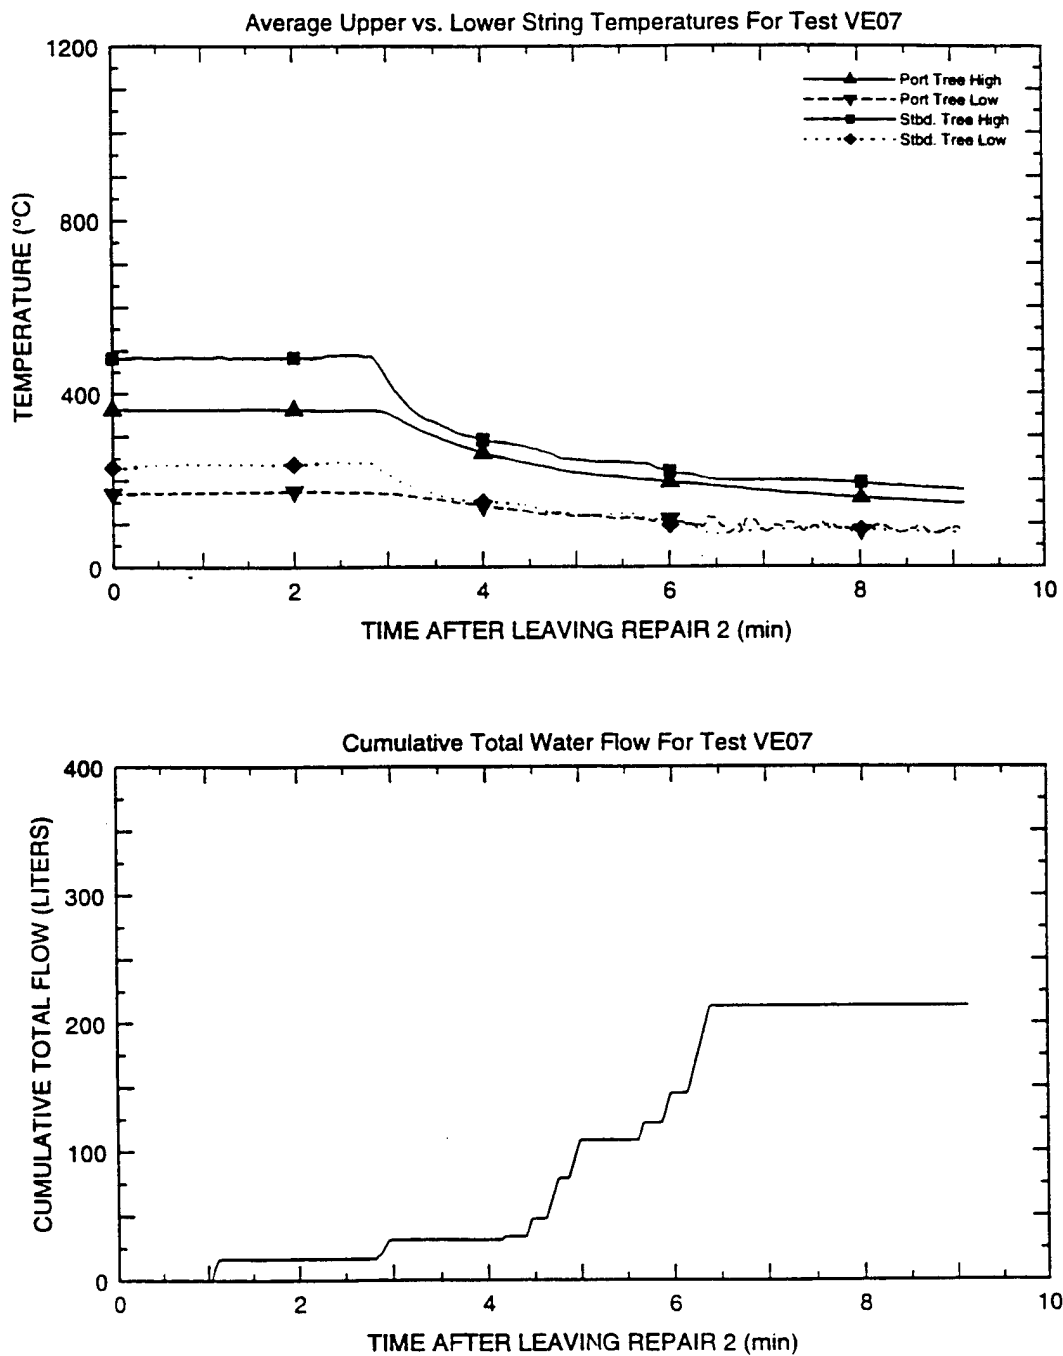
Fig. A14 — Average string temperatures and cumulative total water flow for test VE07

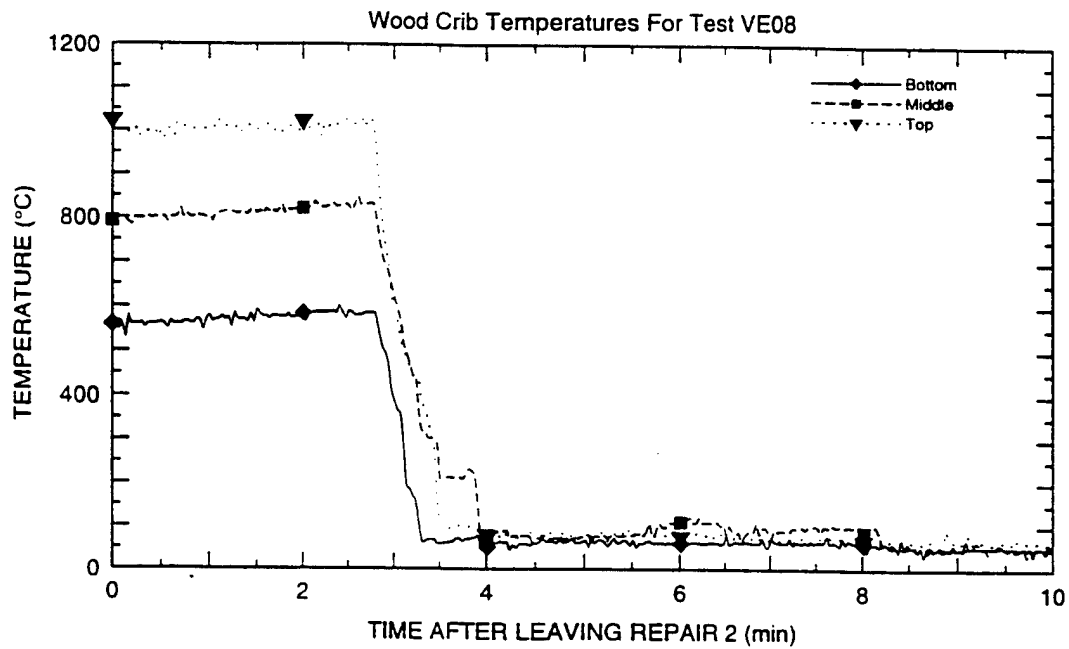
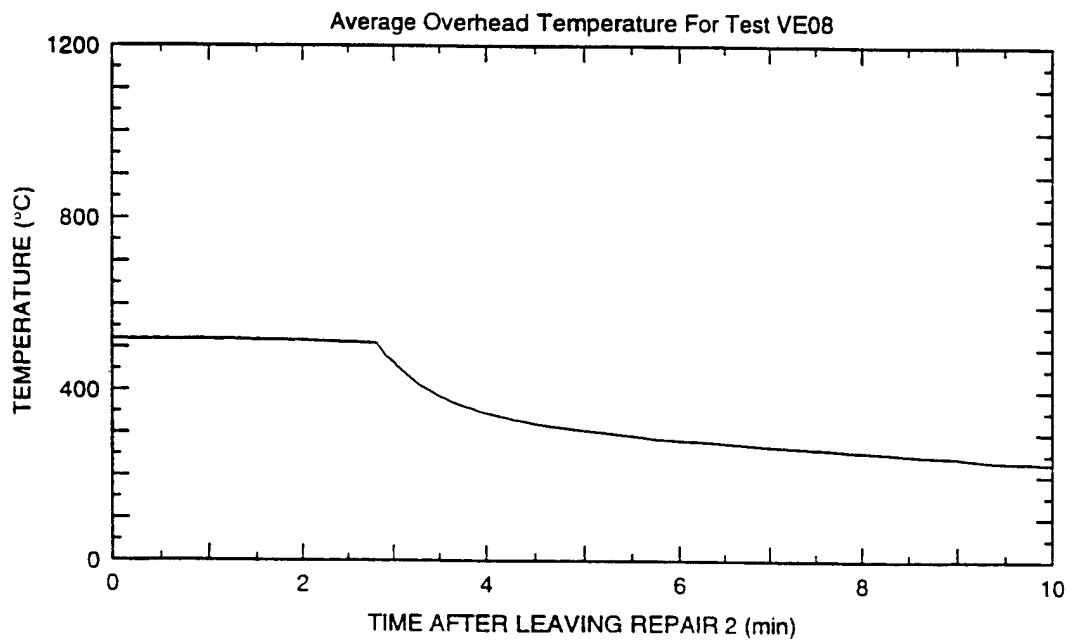
Fig. A15 — Wood crib and average overhead temperatures for test VE08

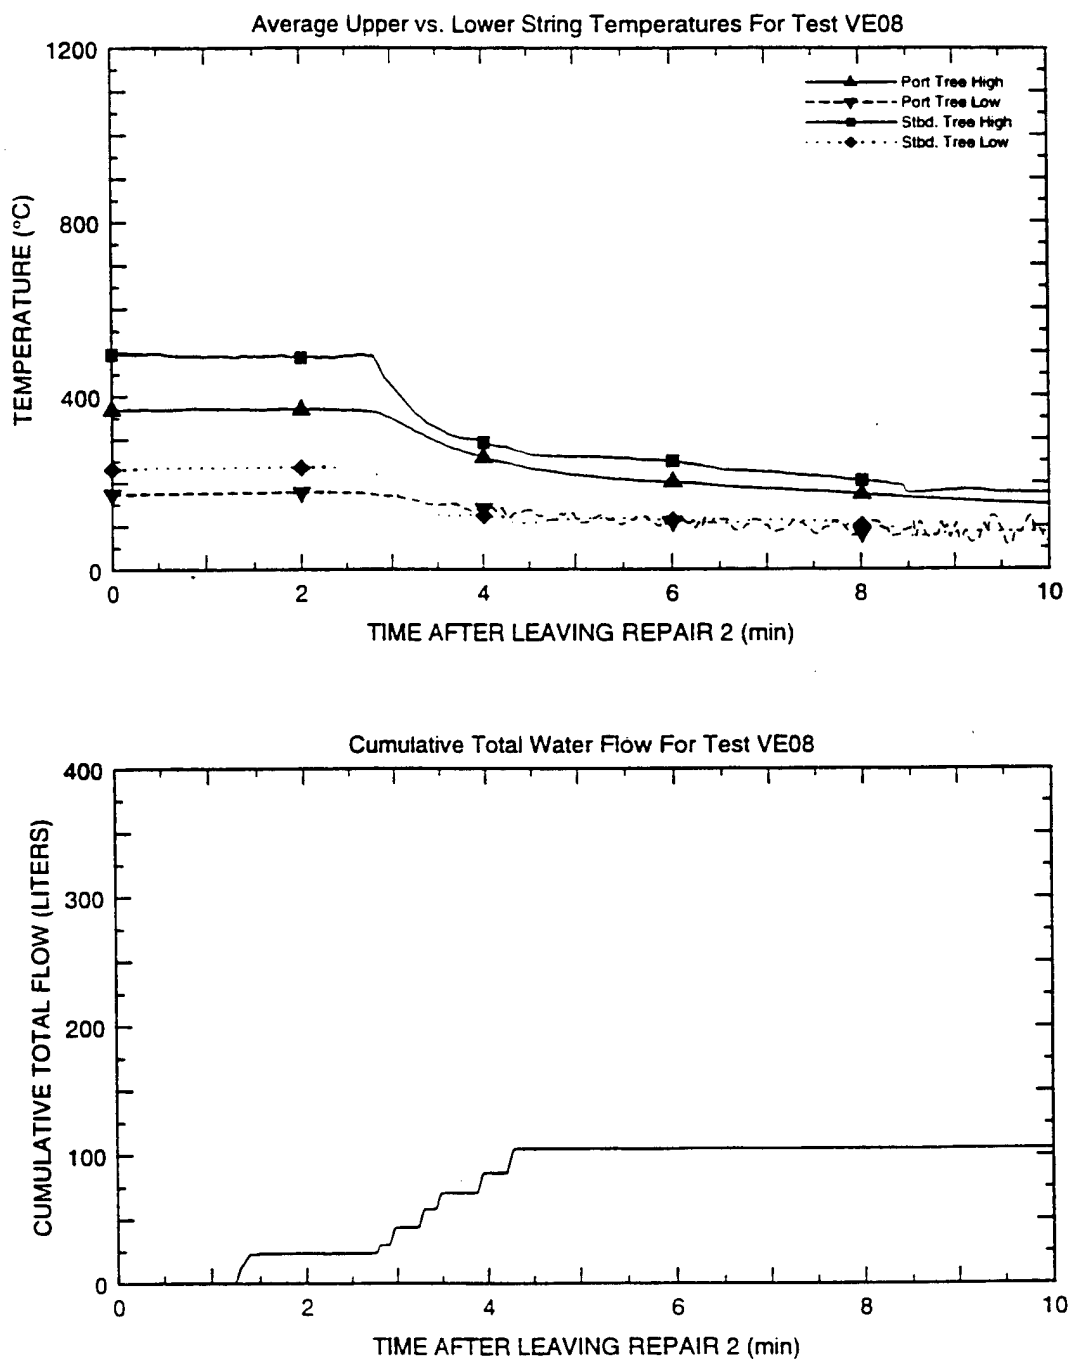
Fig. A16 — Average string temperatures and cumulative total water flow for test VE08

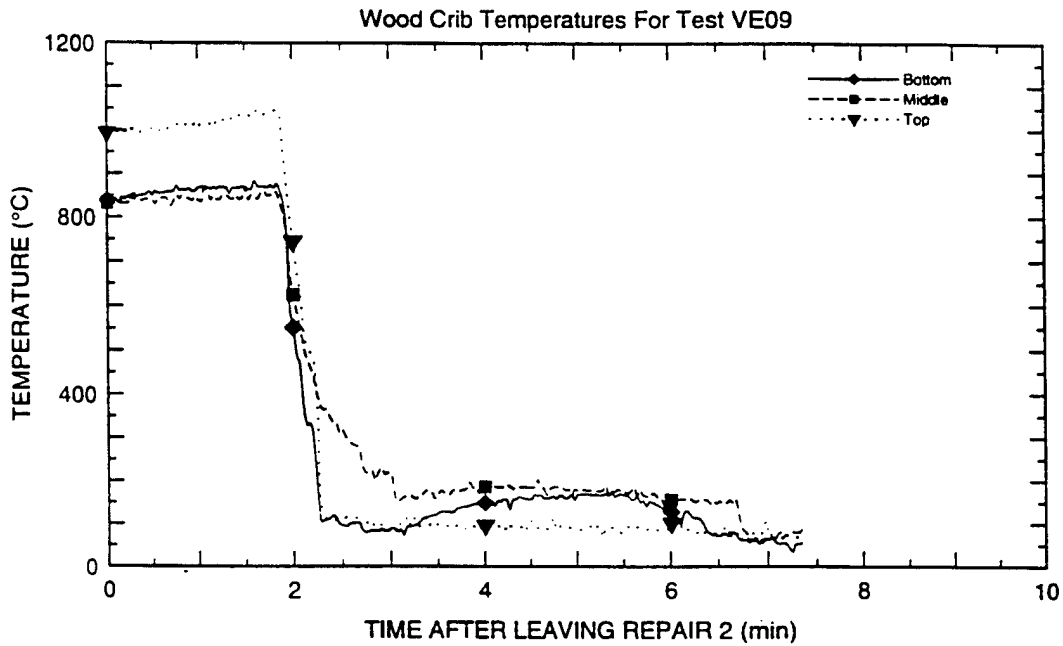
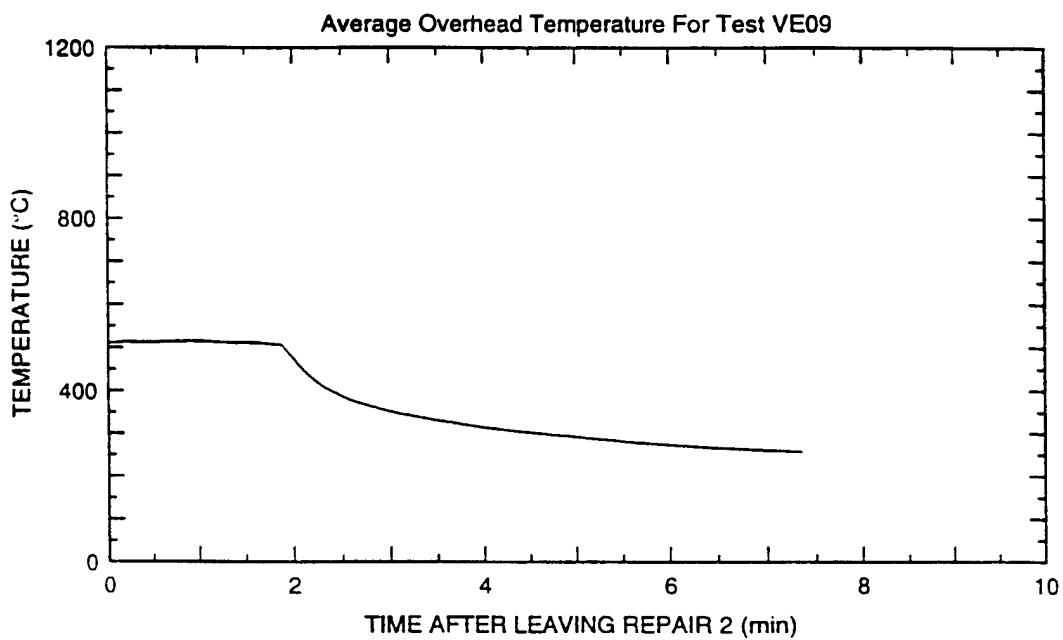
Fig. A17 — Wood crib and average overhead temperatures for test VE09

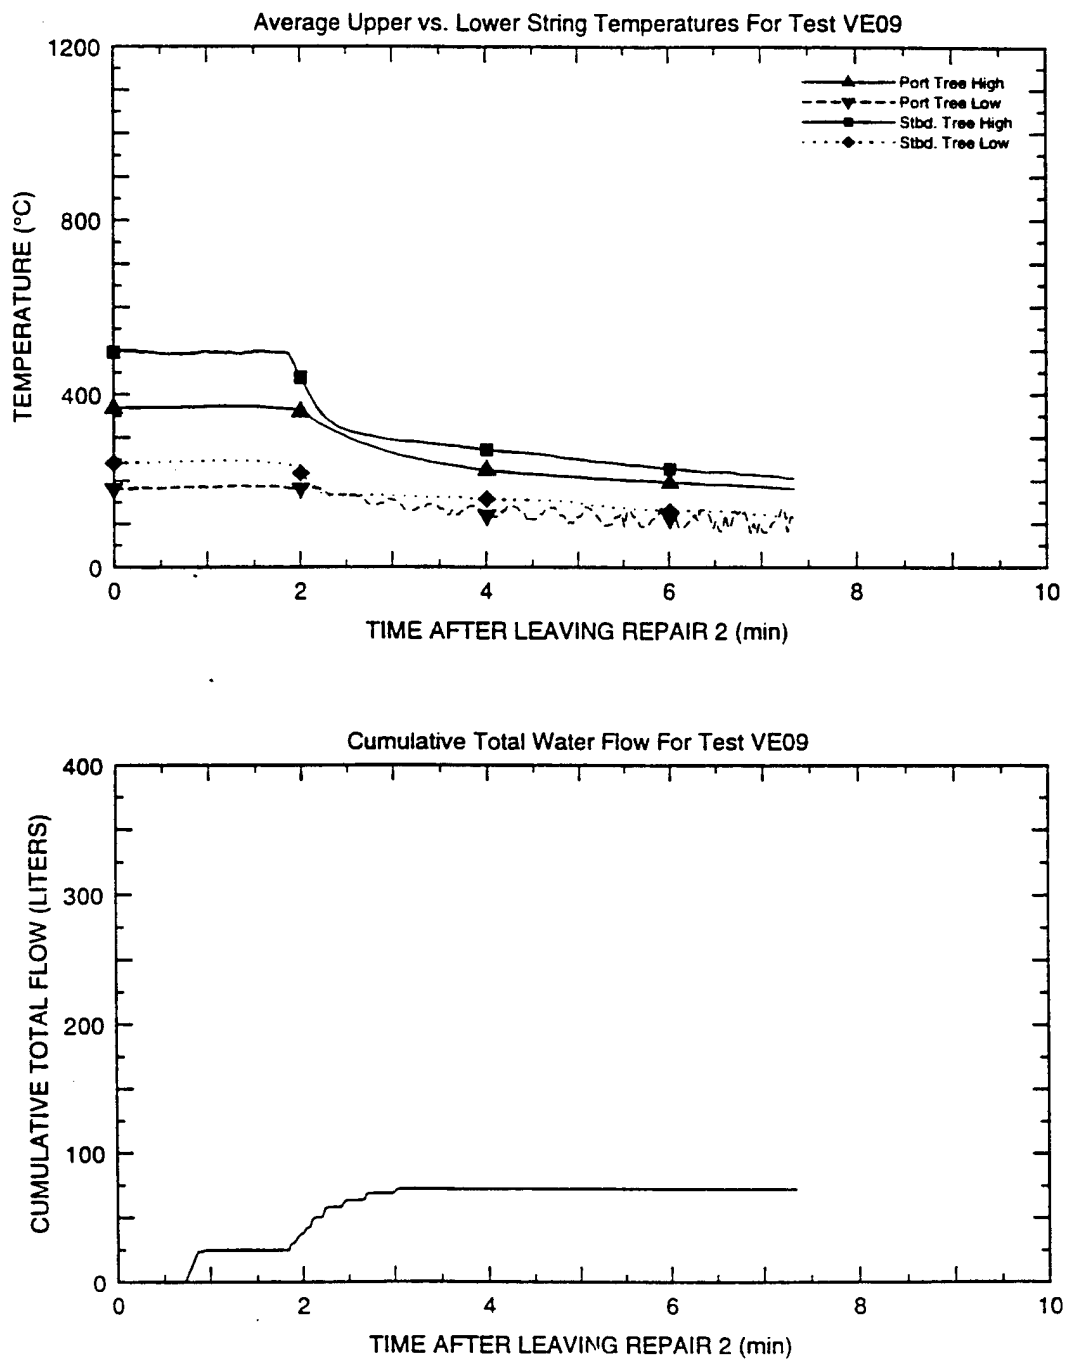
Fig. A18 — Average string temperatures and cumulative total water flow for test VE09

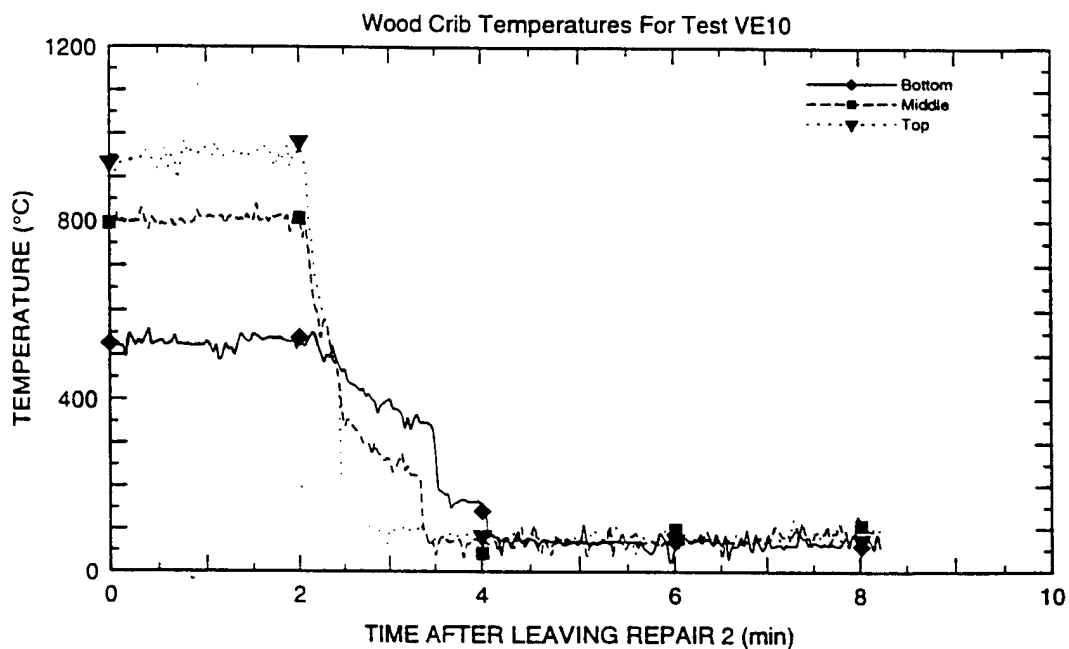
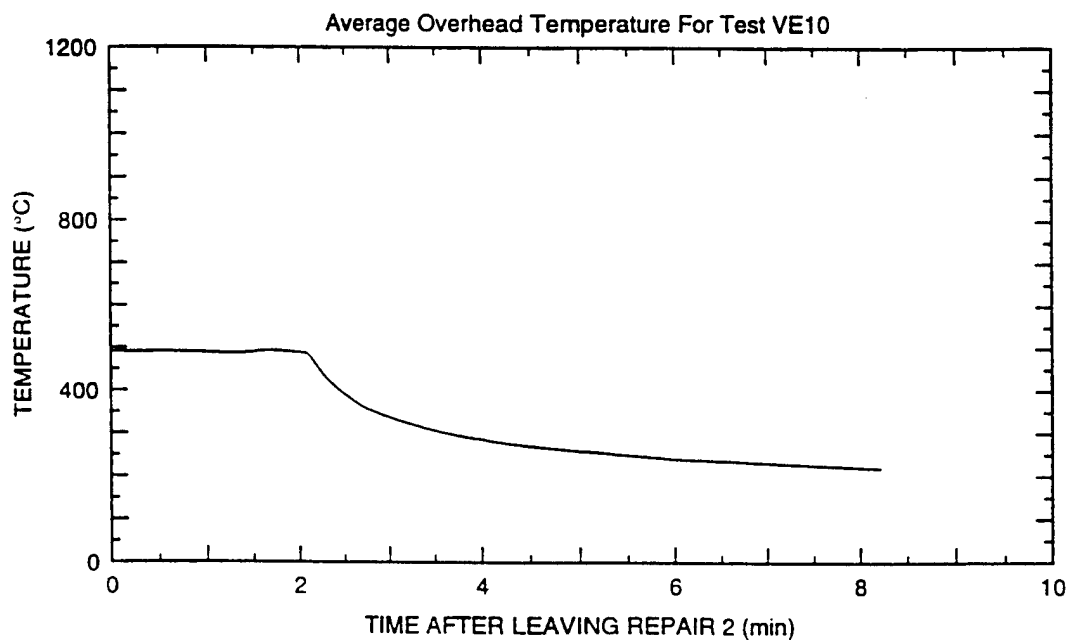
Fig. A19 — Wood crib and average overhead temperatures for test VE010
