NRL/FR/6180--97-9861

# Virtual Environment Firefighting/Ship Familiarization Feasibility Tests

| REPORT DOCUMENTATION PAGE | | | Form Approved<br>OMB No. 0704-0188 | |
|---|---|---|---|--|
| 13. ABSTRACT (Maximum 200 words)<br><br>Virtual Environments Firefighting/Ship Familiarization Feasibility Tests were conducted on the ex-USS <i>Shadwell</i> . The results of these tests indicate that there are measurable gains using virtual environment (VR) training with respect to water usage and time to achieve complete extinguishment. The data also indicates gains for the time to travel from Repair 2 to the fire compartment and begin the initial attack. The time to transit from the 01 level to the fire area under reduced visibility was reduced by one-half for subjects trained with VR. | | | | |

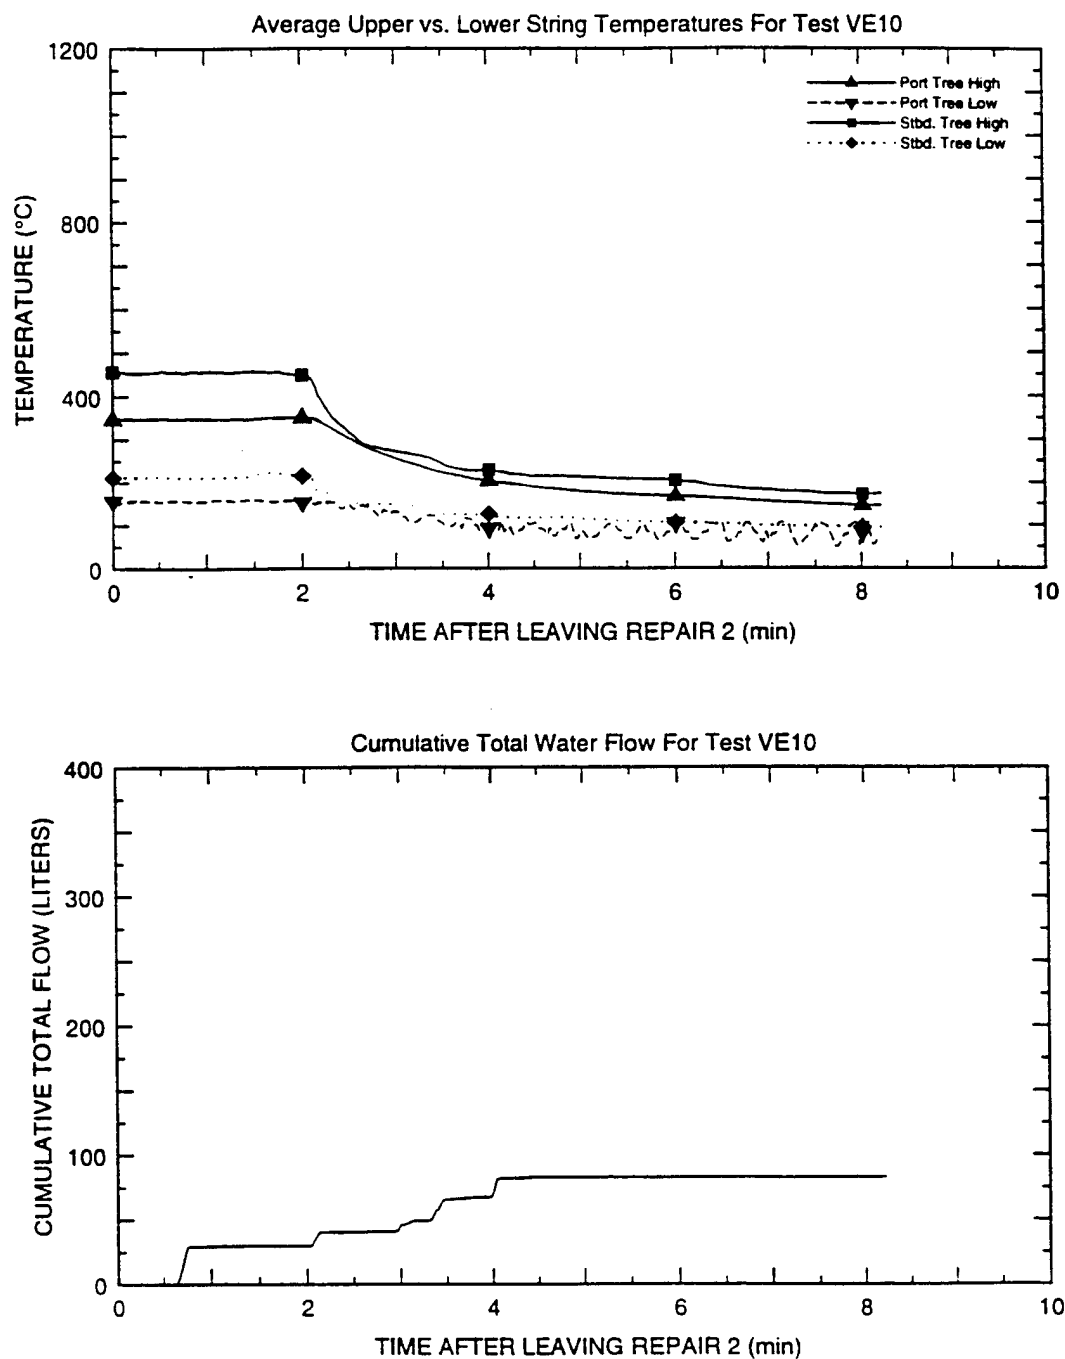
Fig. A20 — Average string temperatures and cumulative total water flow for test VE010

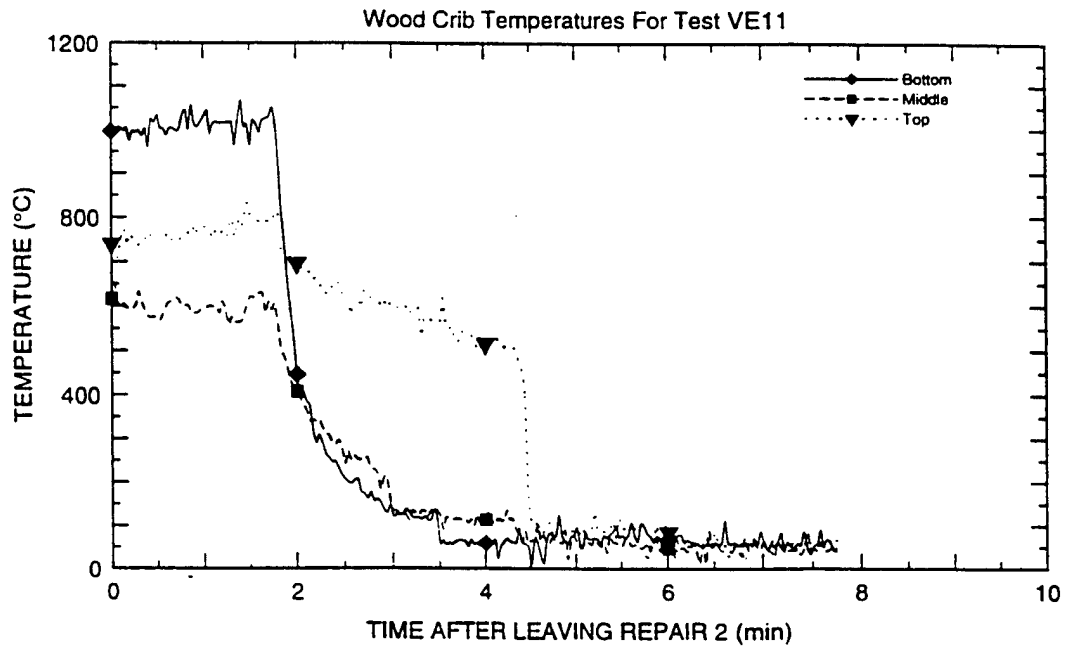
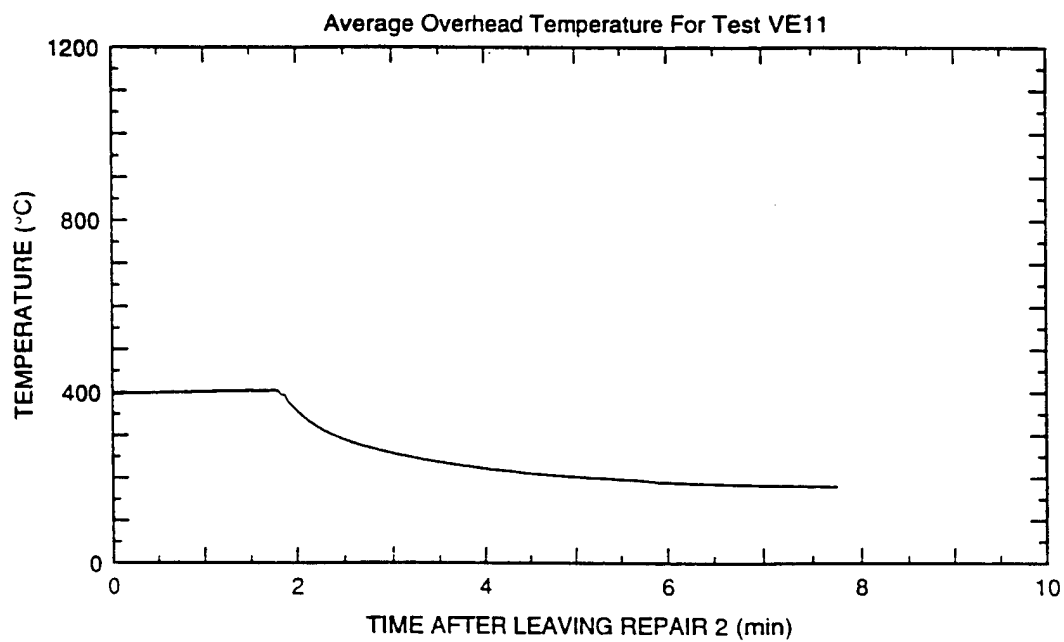
Fig. A21 — Wood crib and average overhead temperatures for test VE011

The data for test VE11 show that temperatures were generally about 100°-200° C (180°-360° F) lower than for the other tests. For this test, 80% of the wood used to construct the crib was previously burned wet wood. Reduced temperatures should be expected in this situation because a greater portion of the energy produced by the combustion process is being used to convert the moisture in the wood into a vapor. Also, because the wood was previously burned, the surface area available for combustion was reduced, which, in turn, results in a lower heat release rate.

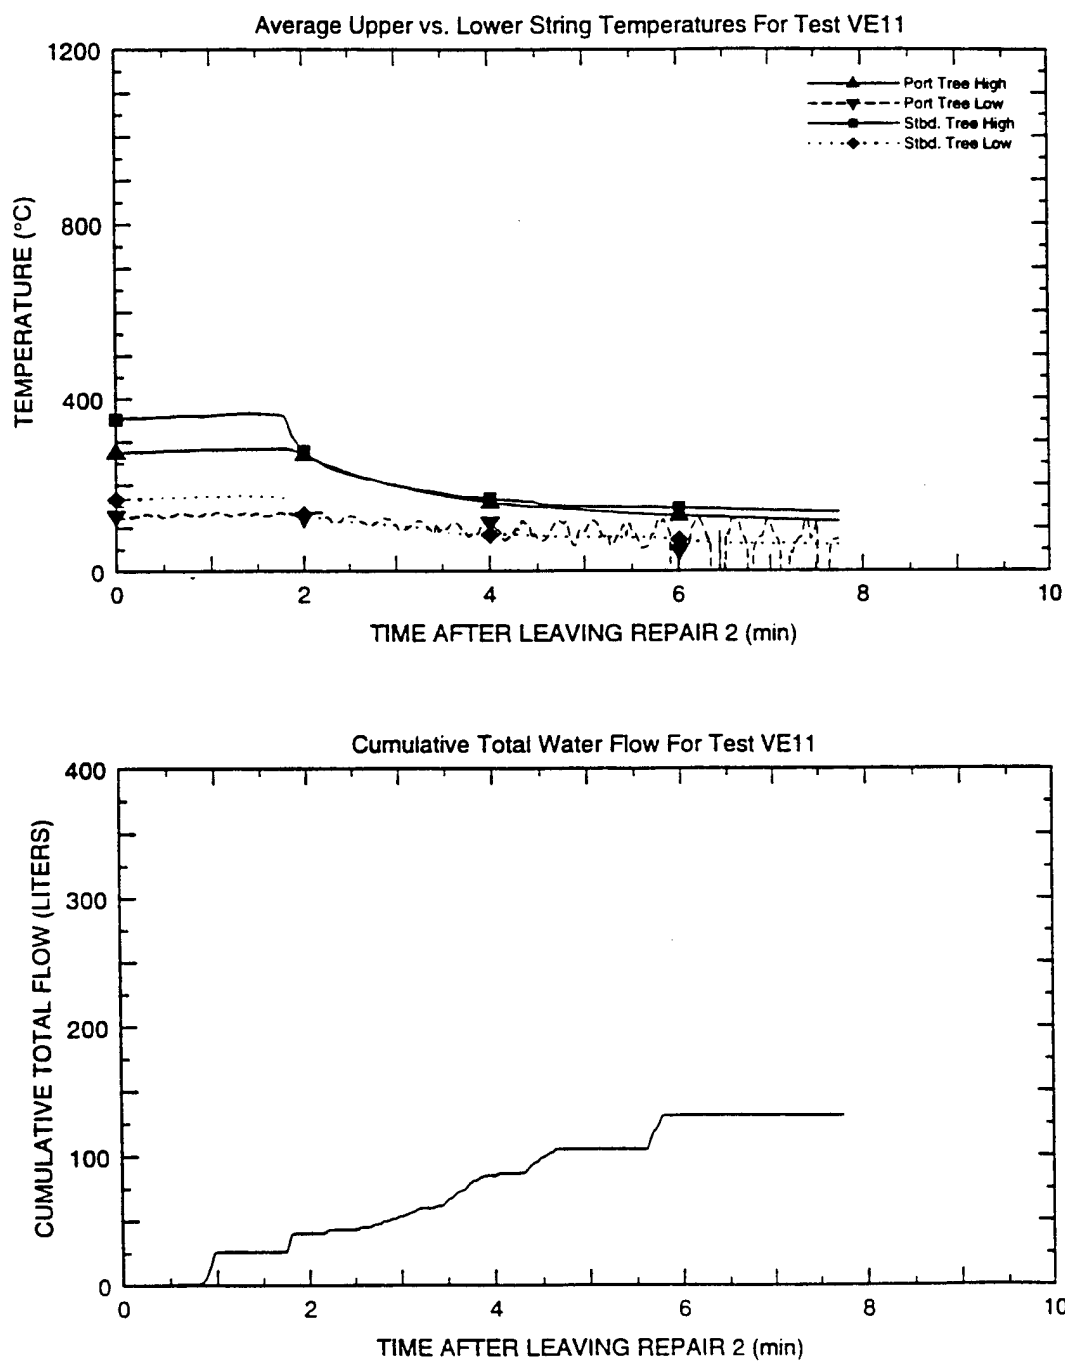
Fig. A22 — Average string temperatures and cumulative total water flow for test VE011

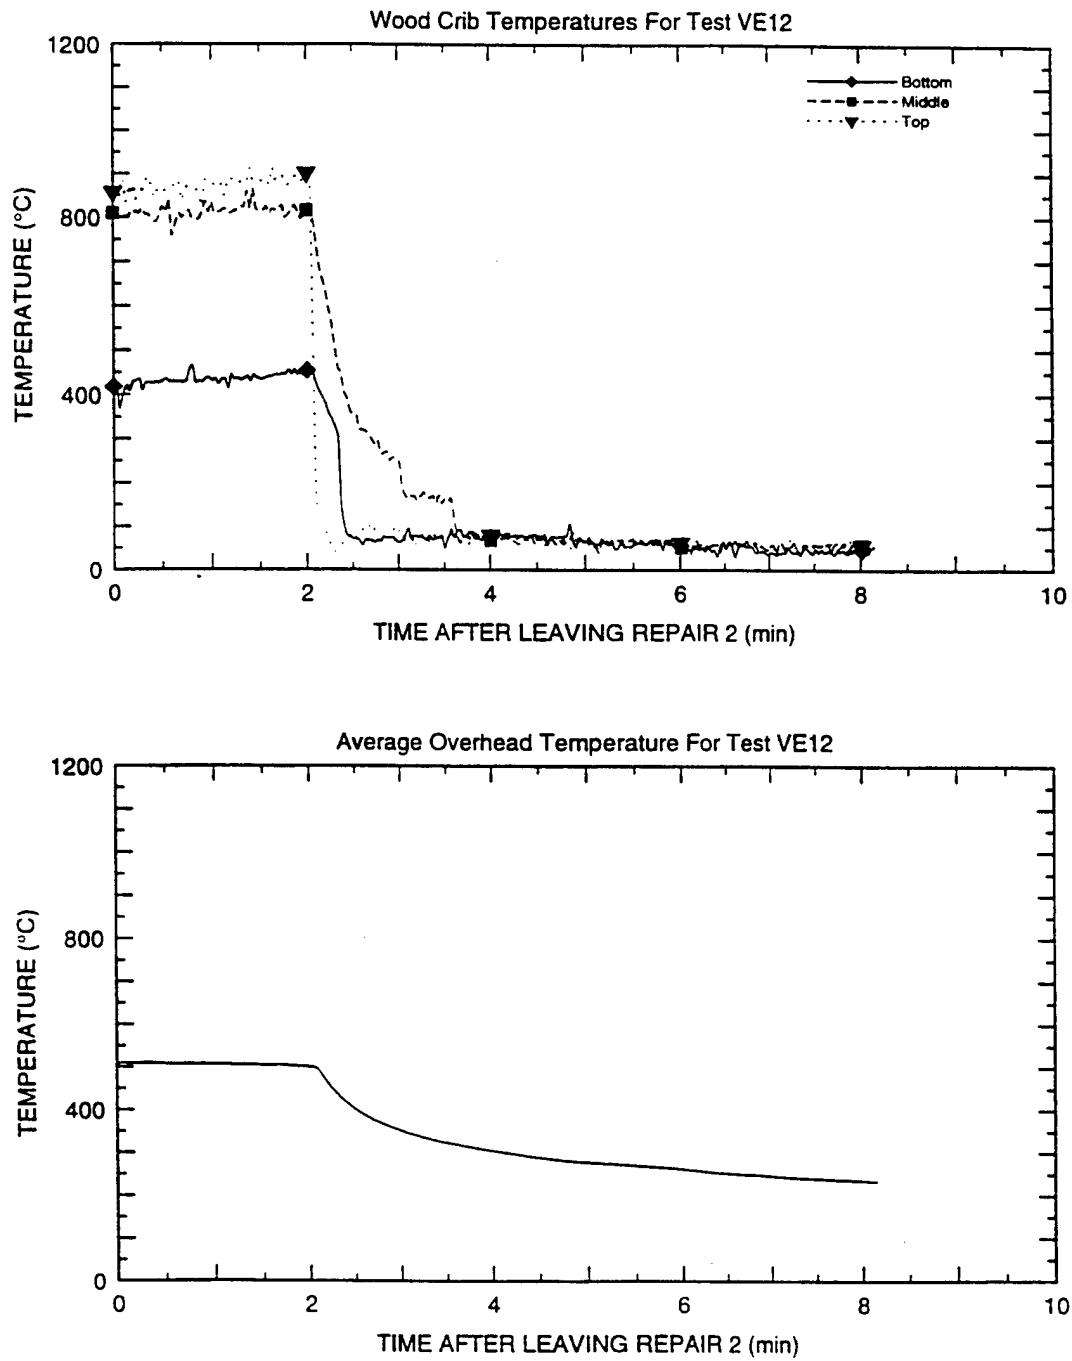
Fig. A23 — Wood crib and average overhead temperatures for test VE012

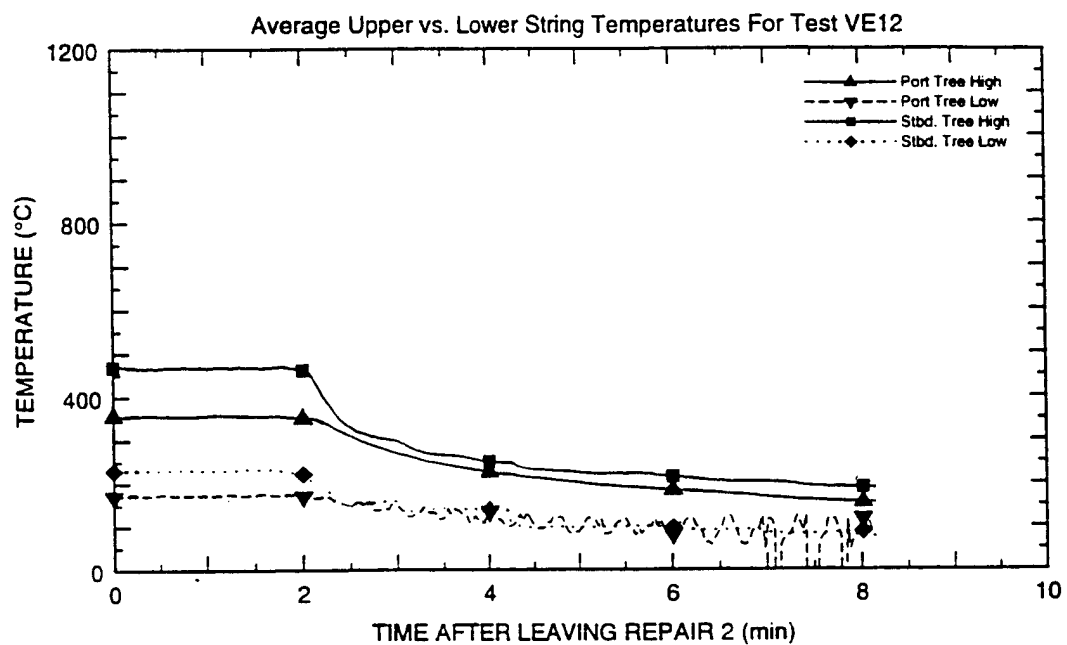
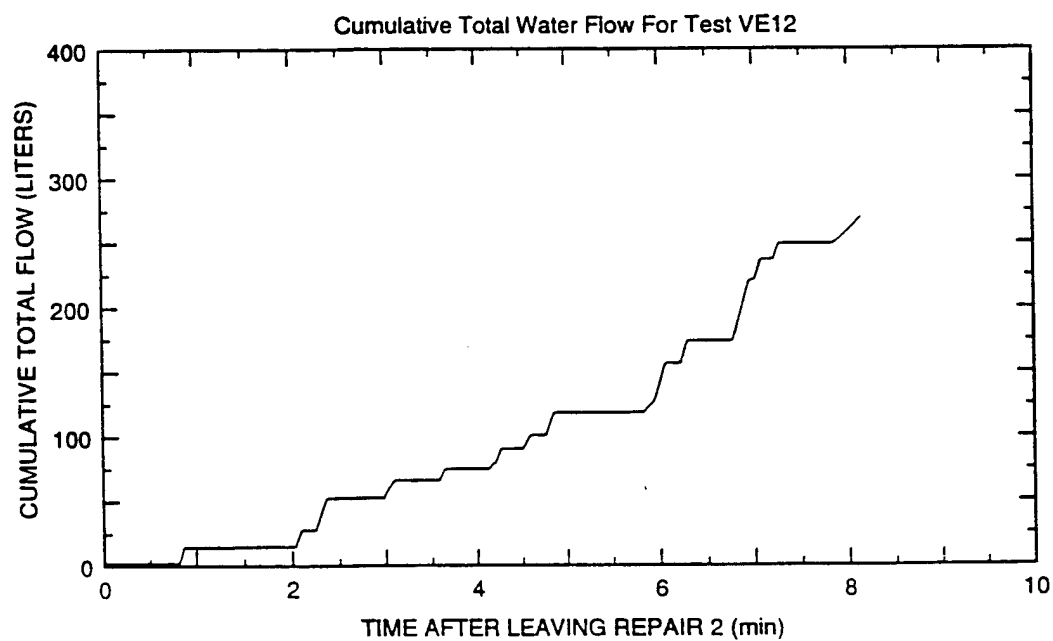
Fig. A24 — Average string temperatures and cumulative total water flow for test VE012
