STUDIES OF FRACTURE PROCESSES IN CEMENT- BASED MATERIALS UNDER COMPRESSION WITH MICROTOMOGRAPHY AND COMPUTER VISION

Final Technical Report
AFOSR Grant Number F49620-96-0377
15 July 1996 - 14 July 1997

Surendra P. Shah
Center for Advanced Cement-Based Materials
Department of Civil Engineering
Northwestern University

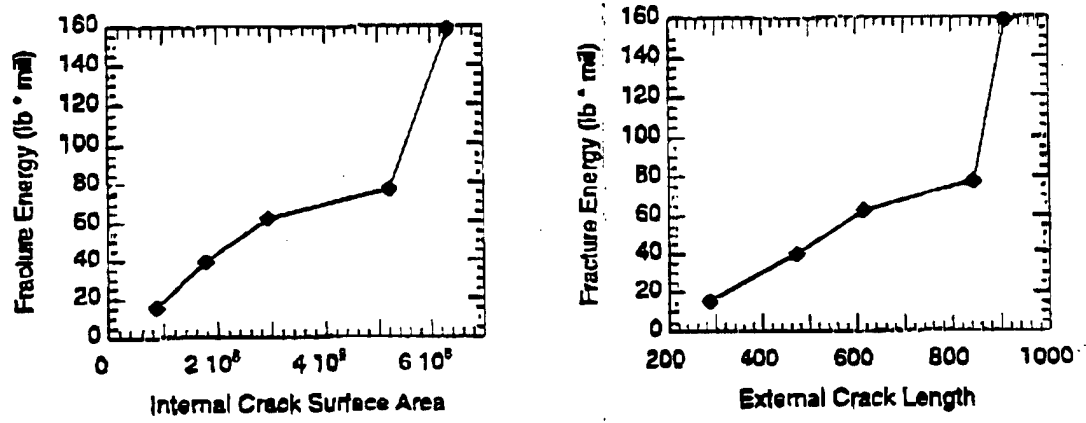
Figure 3. Internal crack surface area and external crack length versus fracture energy

A comparison of work of load versus internal crack area and work of load versus external crack length was made for a mortar specimen. Plots of both are shown in Figure 3. As

can be seen in these figures, both damage measures (internal crack area and surface crack length) give similar curves. Although this result must be confirmed with additional experimentation, a preliminary conclusion is that surface measurements may be used to infer the level of internal damage.

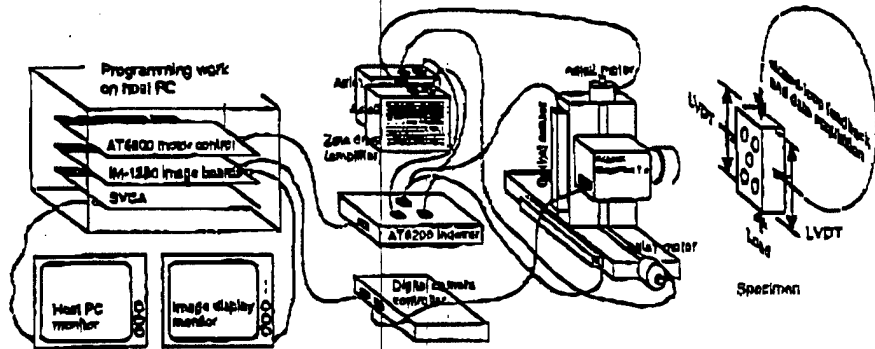
Figure 4. Hardware diagram for subregion scanning computer vision

This modified experimental system consists of three parts: a digitally controlled closed-loop servo-hydraulic loading system, a digital camera and analysis hardware, and a traveling mechanism. The diagram in Figure 5 is a schematic of the experimental setup. In practice, the specimen area was divided into 56 (8x7) subregions only one of which was covered by the digital camera's field of view at one time (Figure 5). To capture all 56 images, the camera system moved over the whole specimen area using the two (x- and y-axis) motorized stages.

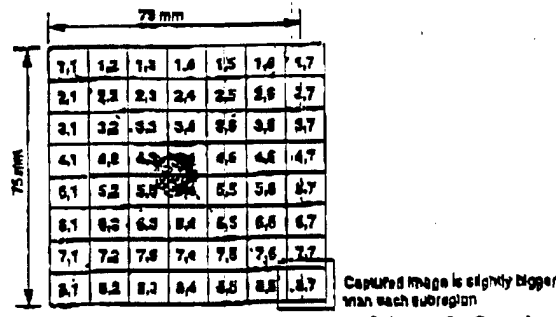
Figure 5. The specimen is divided into 8x7 subregion
