INVESTIGATION OF FALL PROTECTION FOR  
RESIDENTIAL ROOF CONSTRUCTION AND REPAIR IN HAWAII

A THESIS SUBMITTED TO THE GRADUATE DIVISION OF THE UNIVERSITY  
OF HAWAII IN PARTIAL FULFILLMENT OF THE  
REQUIREMENTS FOR THE DEGREE OF

CIVIL ENGINEERING

AUGUST 1997

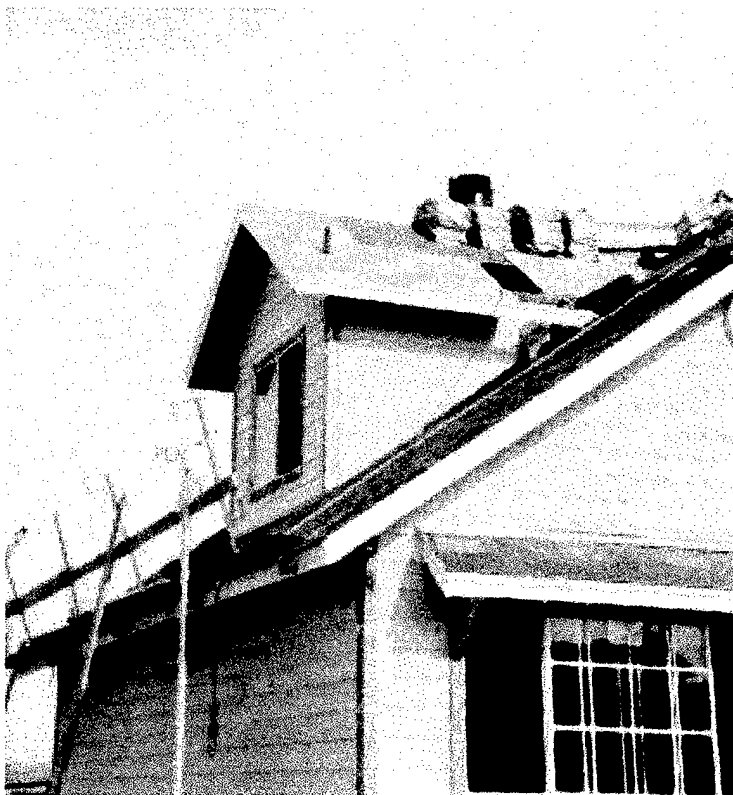
**Figure B.5: New construction, Ewa Beach; PR20 Eave Catchguard system and Trus-T PFAS variant, end view**

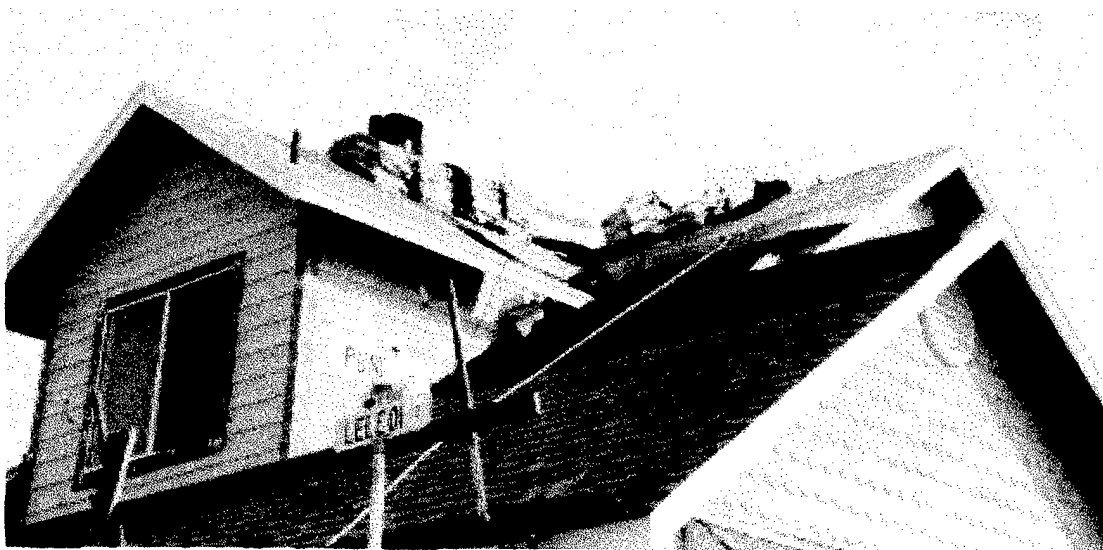
**Figure B.6: New construction, Ewa Beach; PR20 Eave Catchguard system and Trus-T PFAS variant, corner view**

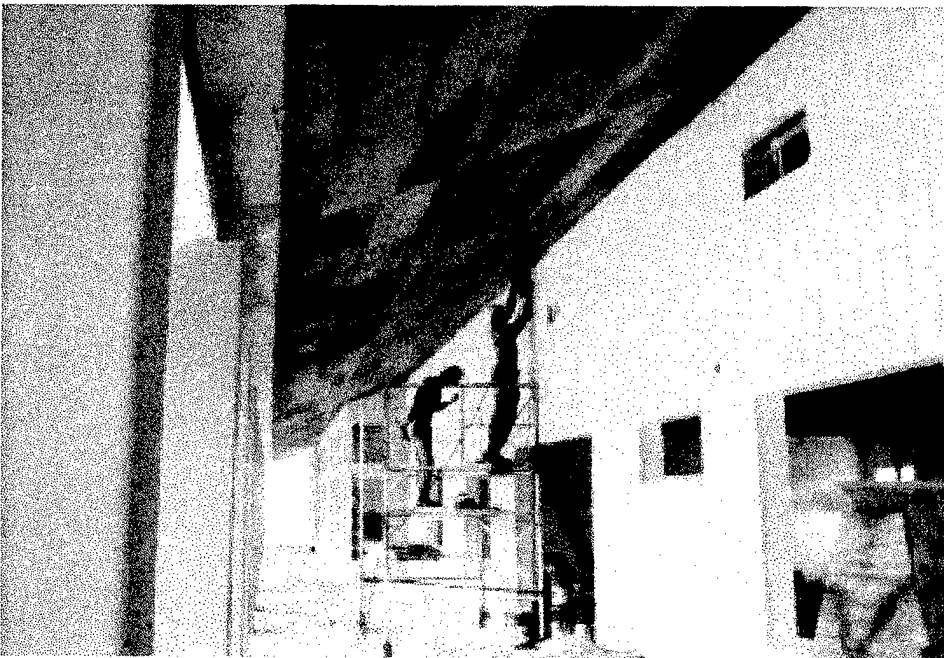
**Figure B.16: New construction, Child Development Center, Marine Corps Base Hawaii, Kaneohe; use of scaffolds for finish work**
