**FINAL  
REMEDIAL ACTION SUMMARY REPORT**

**117<sup>TH</sup> AIR REFUELING WING  
ALABAMA AIR NATIONAL GUARD  
BIRMINGHAM INTERNATIONAL AIRPORT  
BIRMINGHAM, ALABAMA**

**MARCH 1998**

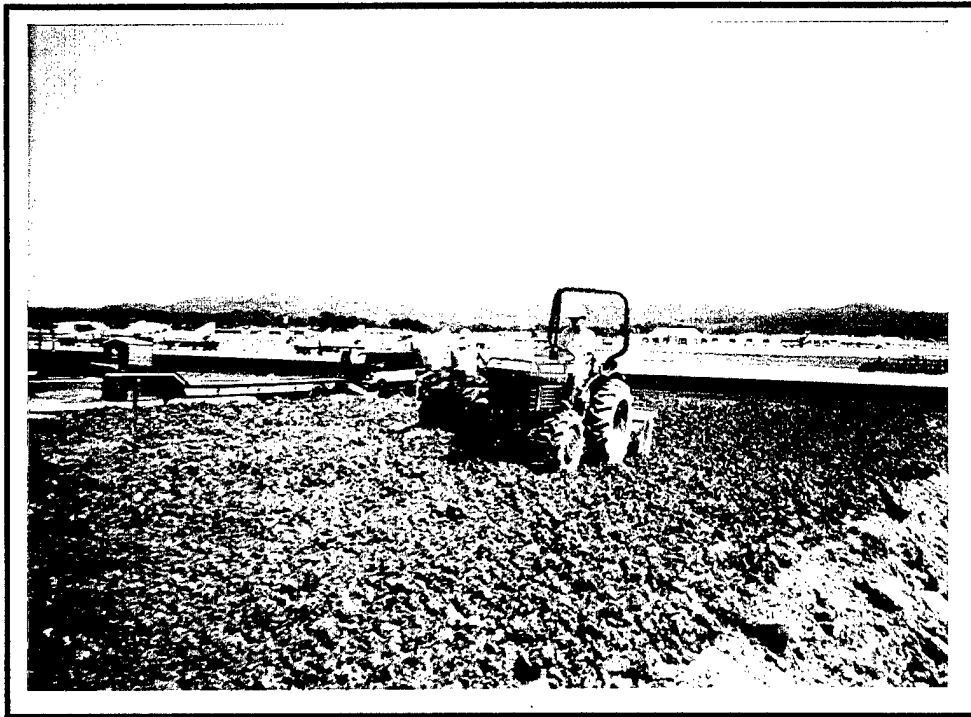
**Photo No. 9: Tilling of soil in a bio-cell.**

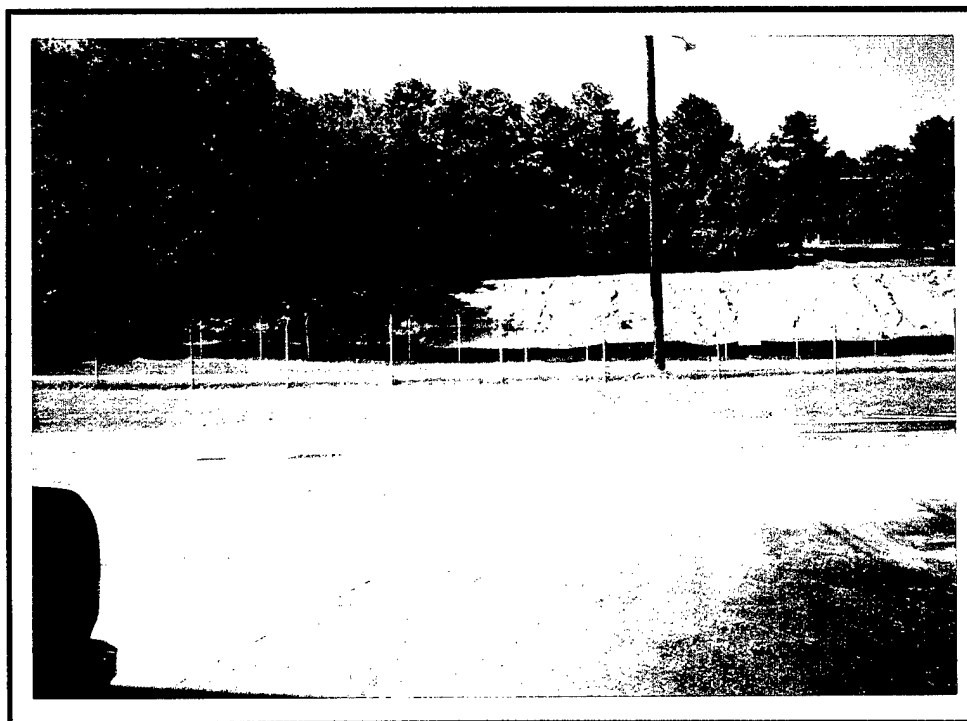
**Photo No. 12: Soil stockpile in the vicinity of Building 301.**
