Contract Report CHL-97-4  
December 1997

# Debris Control at Hydraulic Structures in Selected Areas of the United States and Europe

by *N. Wallerstein, C. R. Thorne, University of Nottingham*  
*S. R. Abt, Colorado State University*

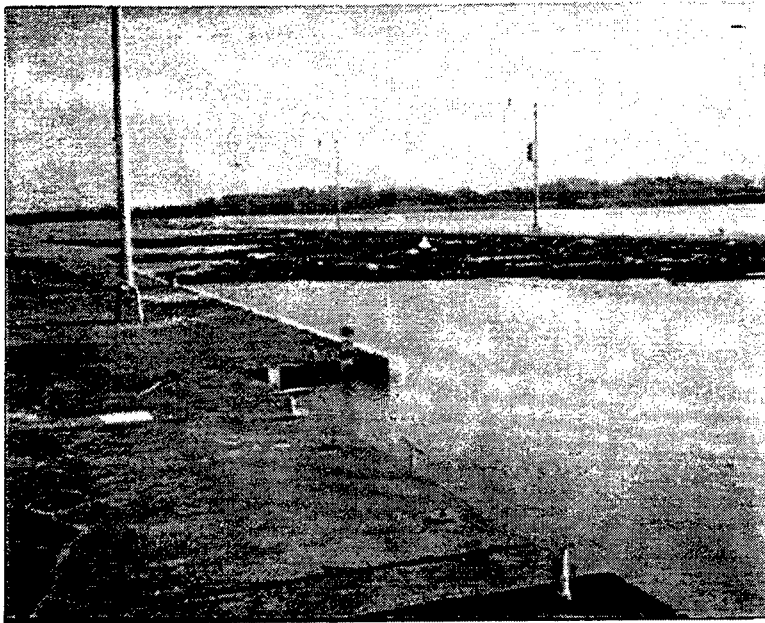
Black River, March 1995

Appendix D illustrates a typical debris jam in the Jonesville Lock ( March 21, 1995). Drift has been observed to nearly fill the 183 meter lock.

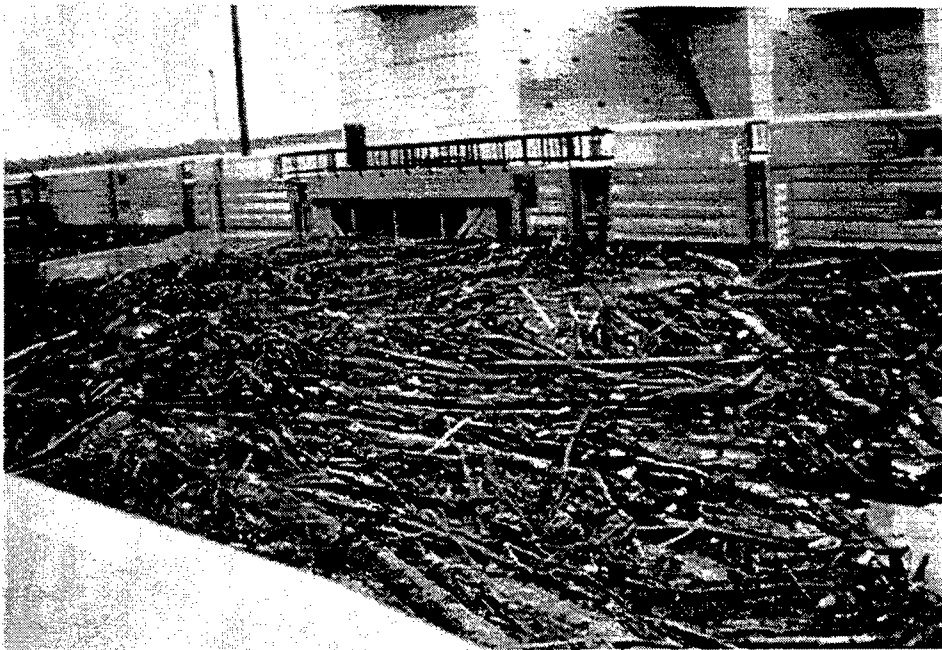
Typical log jam, Lock and Dam Operation

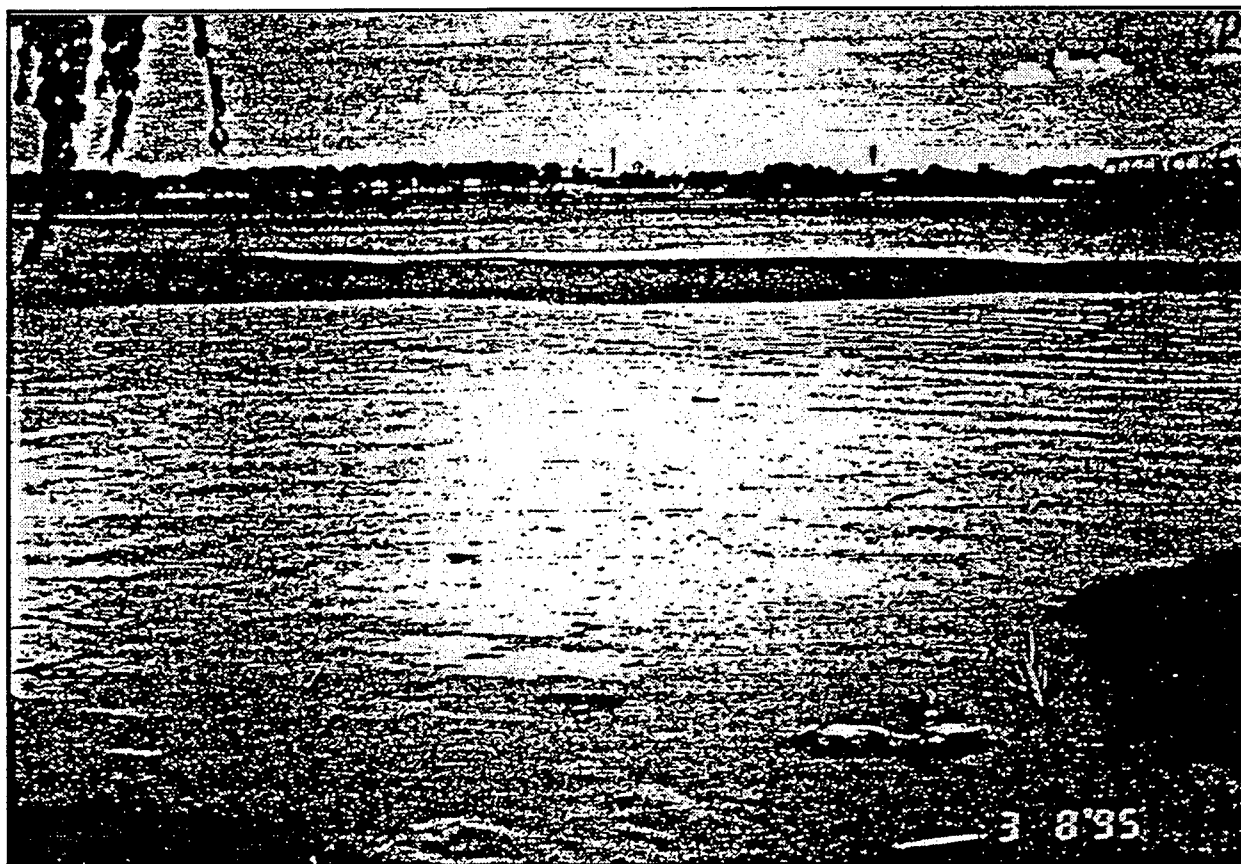
**FIGURE A - MUD FLATS UPSTREAM OF MCALPINE L&D  
(looking toward Indiana shore)**

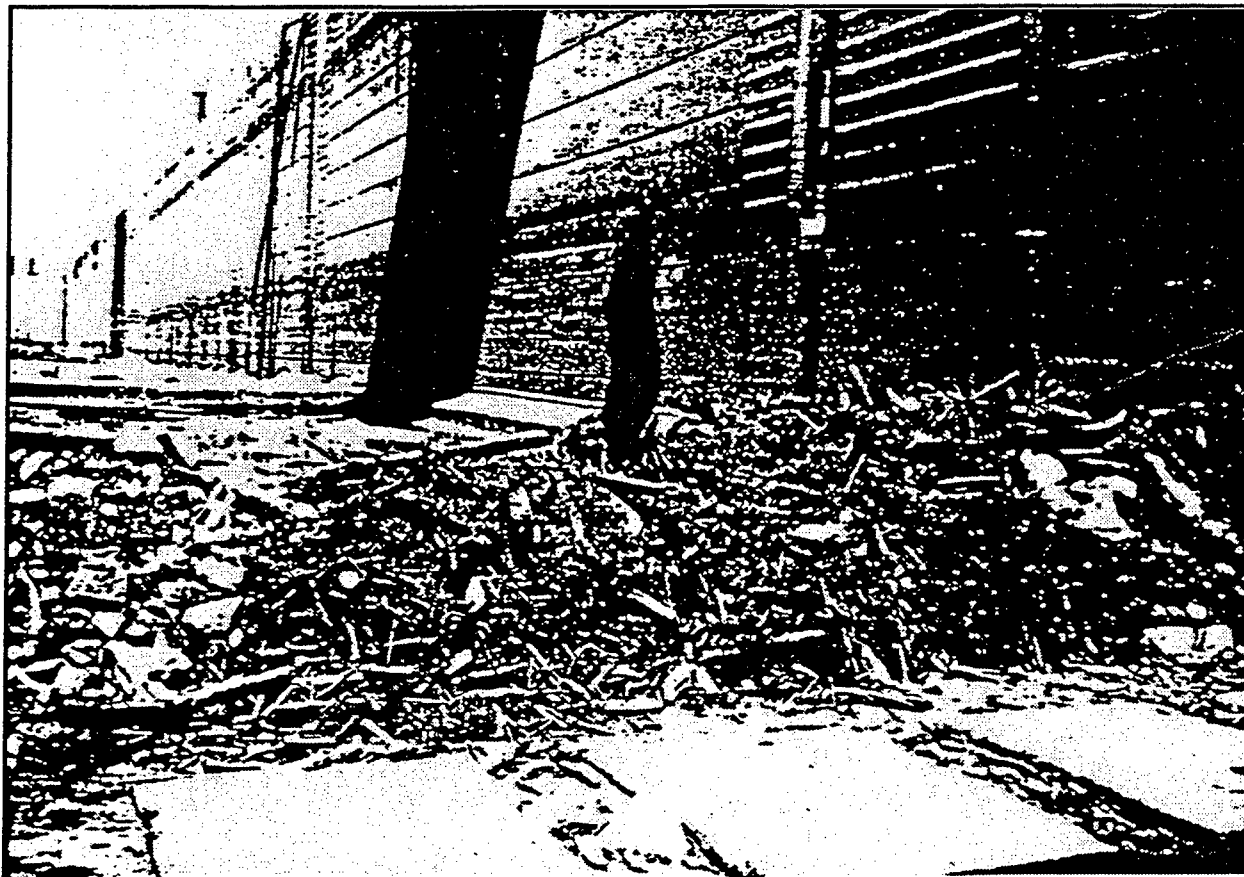
**FIGURE D - DEBRIS ACCUMULATION - MARKLAND 600-FT LOCK CHAMBER**  
(view from down in the lock chamber)

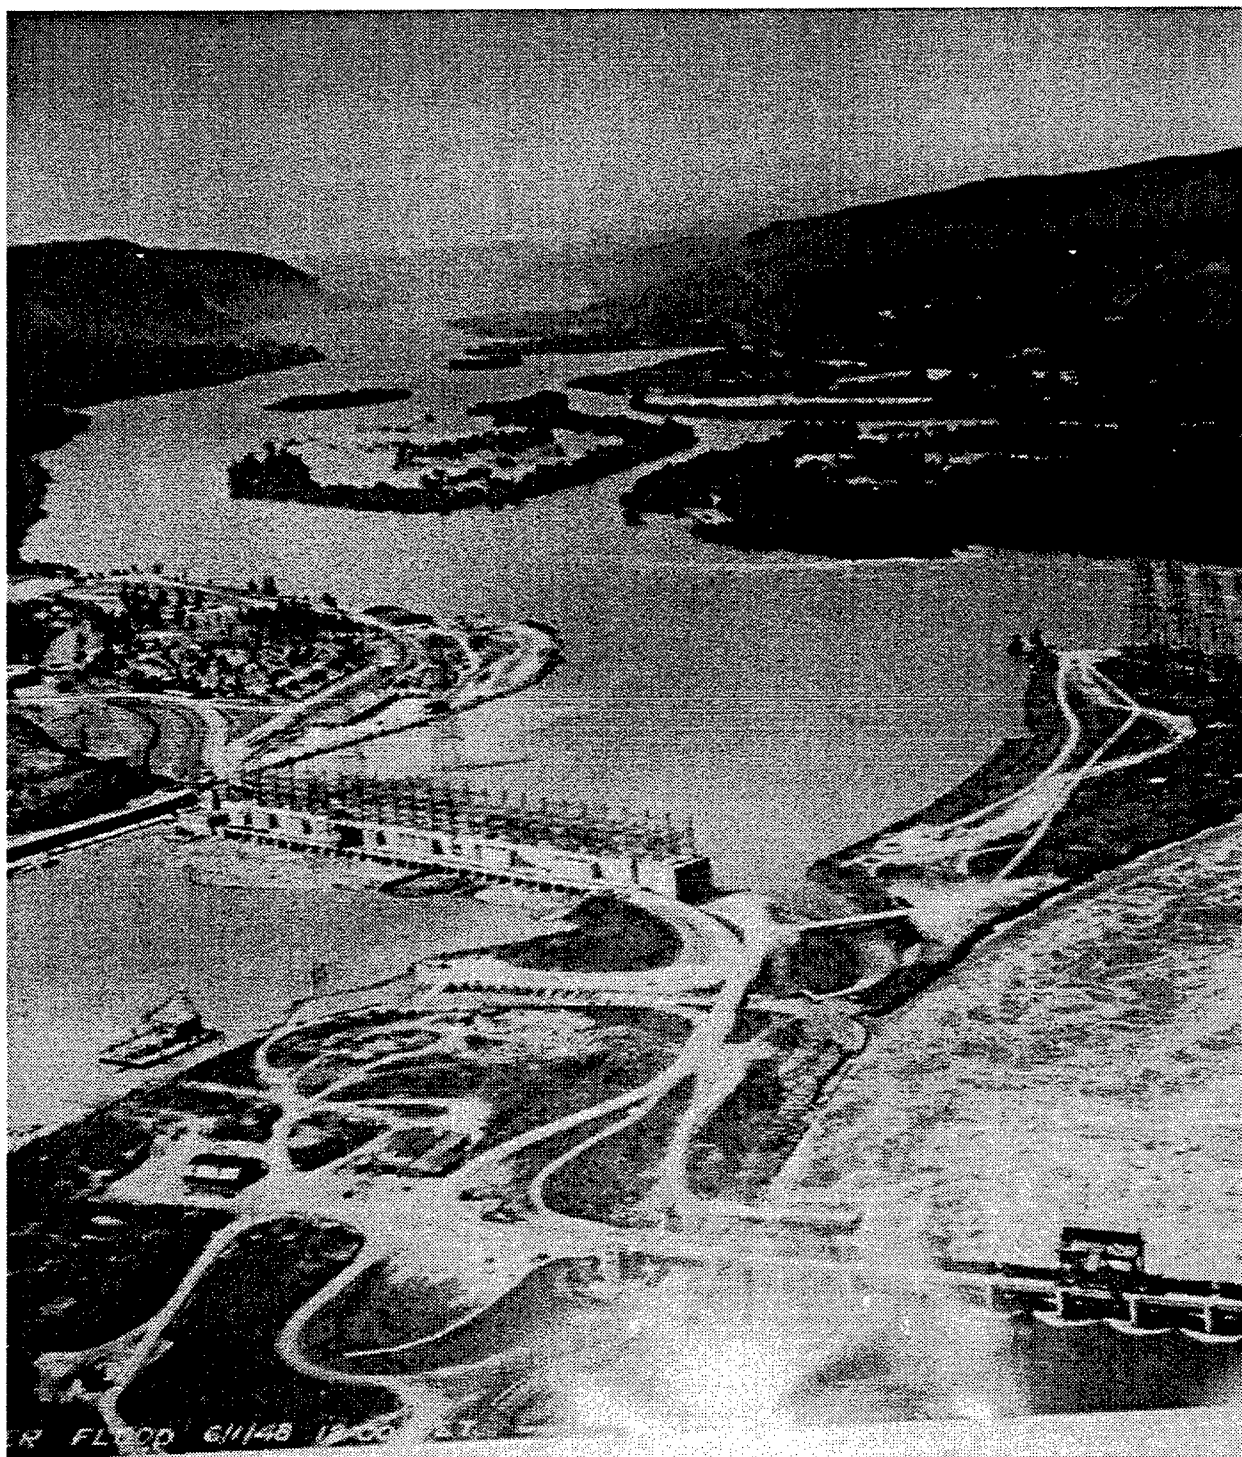
**Bonneville Powerhouse No. 1 with debris jam in 1948**
