MONOGRAPH

# Construction, Maintenance, and Operation of a Glacial Runway, McMurdo Station, Antarctica

George L. Blaisdell, Renee M. Lang, Gerald Crist,  
Keith Kurtti, R. Jeffrey Harbin, and Daniel Flora

March 1998

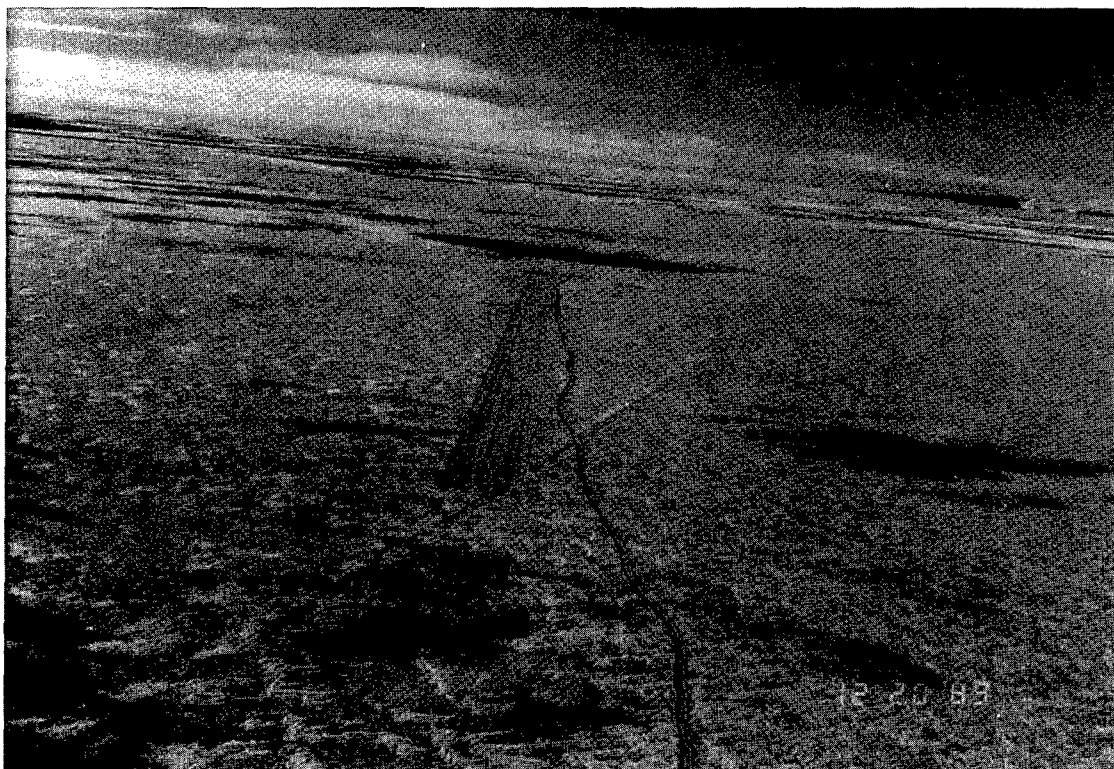
*a. Photo taken in late January 1965 looking south (U.S. Navy for U.S. Geological Survey).*

*Figure 12. Airphotos of transition between zones of accumulation and ablation.*

*b. Photo taken in late January 1970 looking south (U.S. Navy for U.S. Geological Survey). Note airstrips of Outer Williams Field located just outside the zone of accumulation.*

c. Looking north taken in December 1989 showing the initial Pegasus runway and areas of patchy snow to the west. The final Pegasus runway position is located just inside the accumulation zone about 150 m to the east of the airstrip seen here and about 2 km to the east of the former Outer Williams Field.

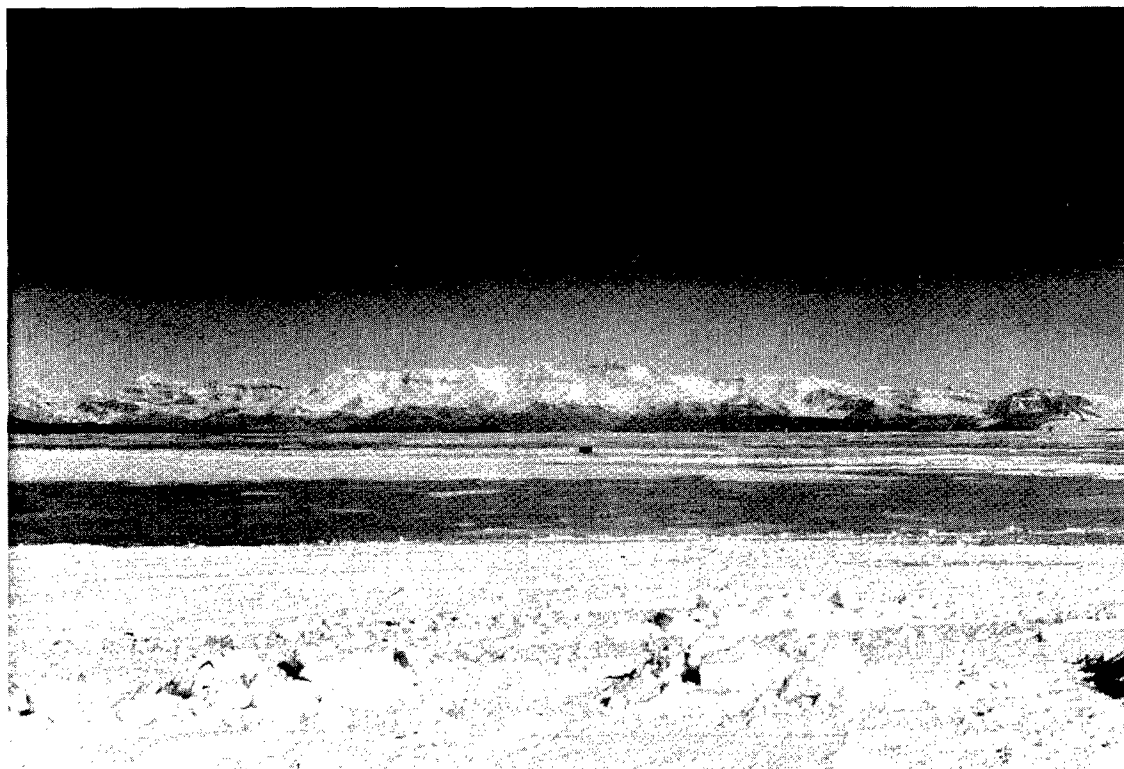
Figure 14. View to west of bare ice starting 250 m (800 ft) west of edge of Pegasus runway (December 1989).

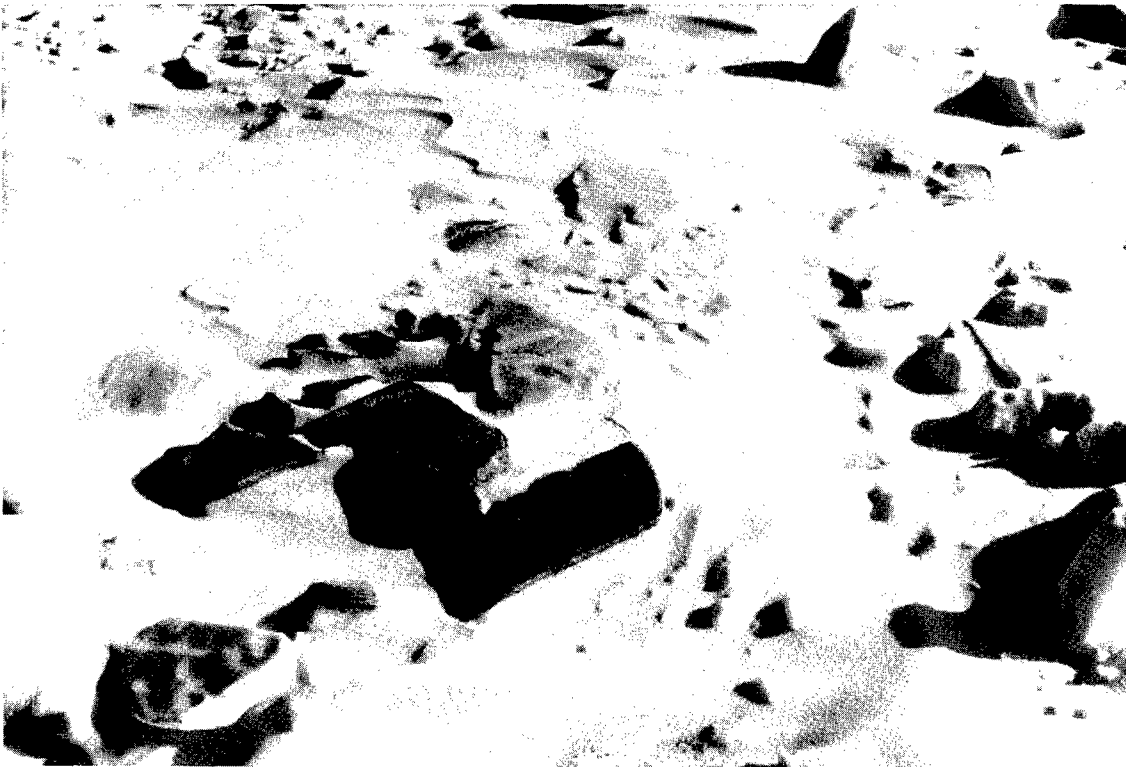
*Figure 16. Layers of wind-blown contamination in snow.*

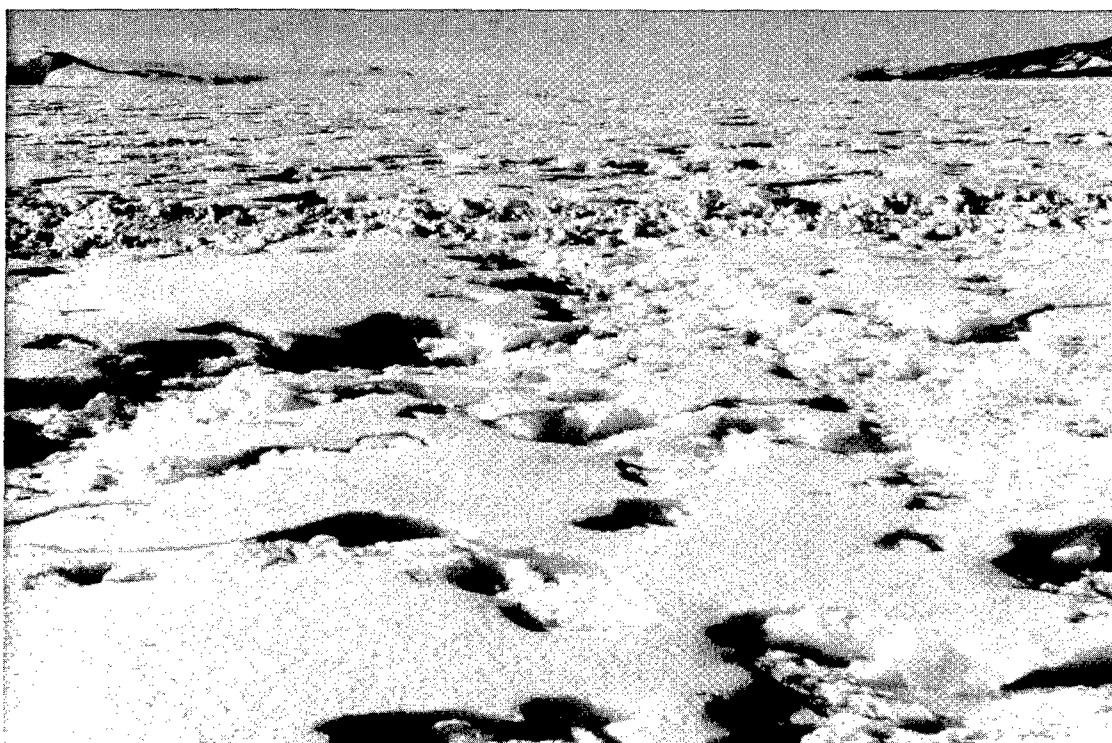
*Figure 17. Rotted snow surface resulting from differential ablation brought on by localized concentrations of mineral particles deposited by wind.*

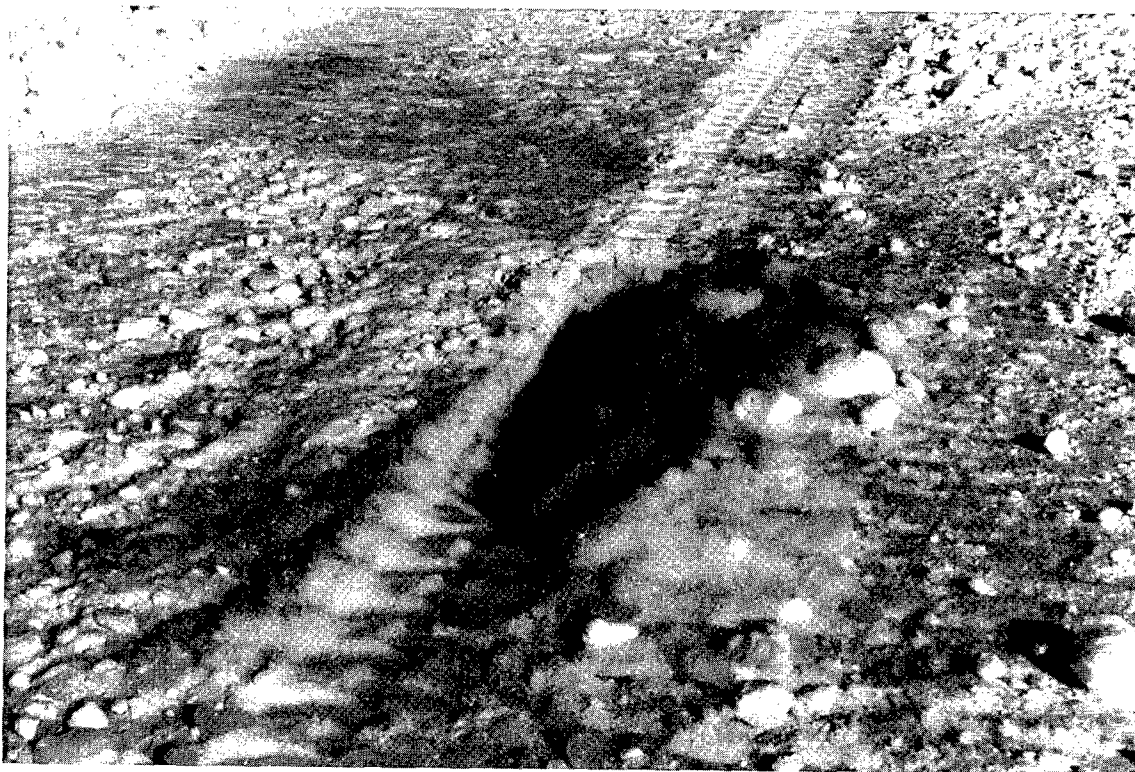
*Figure 23. Grader tracks showing breakthrough of thin ice cover over subsurface melt pool.*

Ice temperature profiles are the most important ice information because the mechanical behavior of ice subjected to loading is strongly influenced by its temperature. Vital information is the maximum temperature, particularly during the time period the runways would operate, and its location within the ice column. Subsurface melting may not always be obvious, but it could easily be disastrous for wheeled traffic (Fig. 23). If tem-

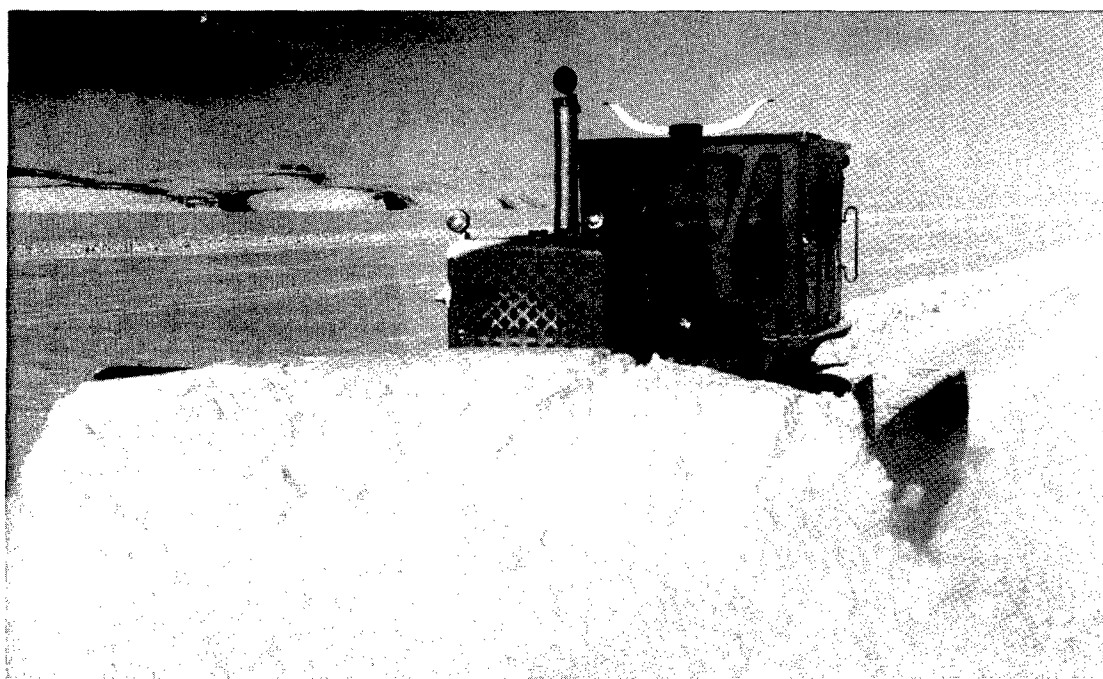
*Figure 28. Initial snow stripping on the Pegasus runway using a bulldozer with U-blade.*

We also used an elderly Caterpillar LGP D8 equipped with a Balderson coal U-blade to strip the snow from the glacial ice surface (Fig. 28). At first the bulldozer operator worked by "feel," attempting to hold the blade just at the snow/ice interface. Owing to the undulating ice surface and the need to provide some downforce on the blade to keep it from riding up in the snowpack, this often resulted in the blade gouging into the

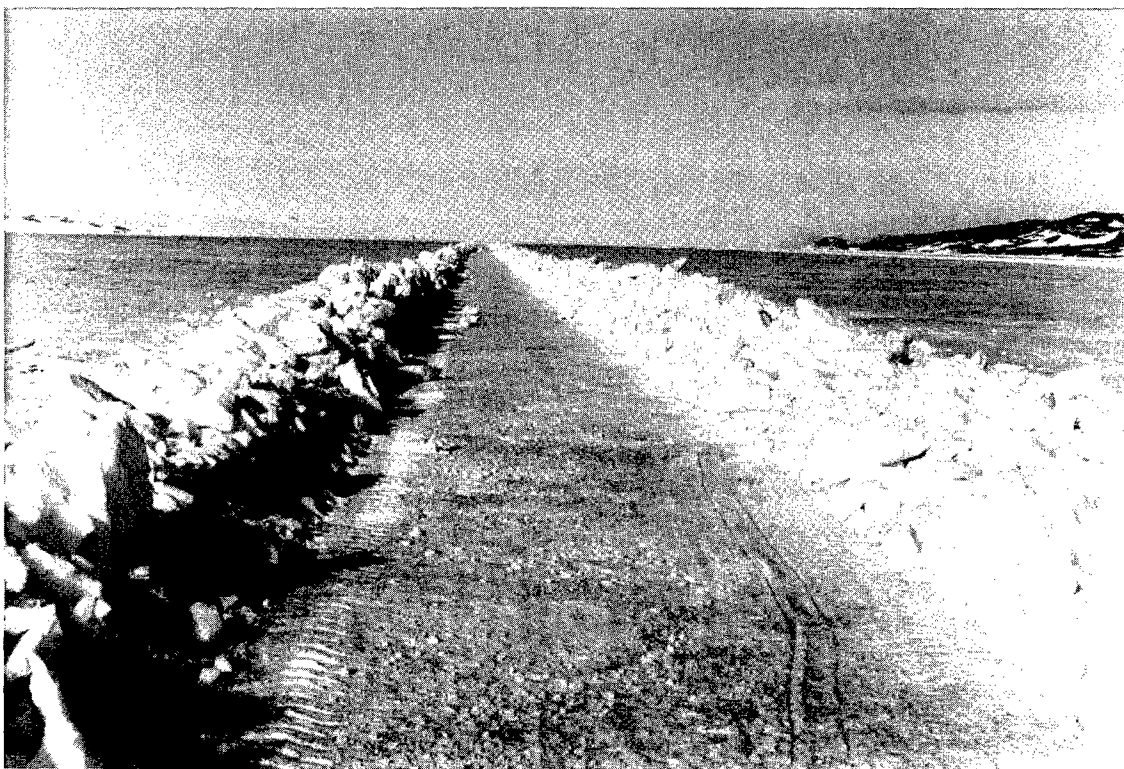
*Figure 32. Ice surface following initial snow stripping.*

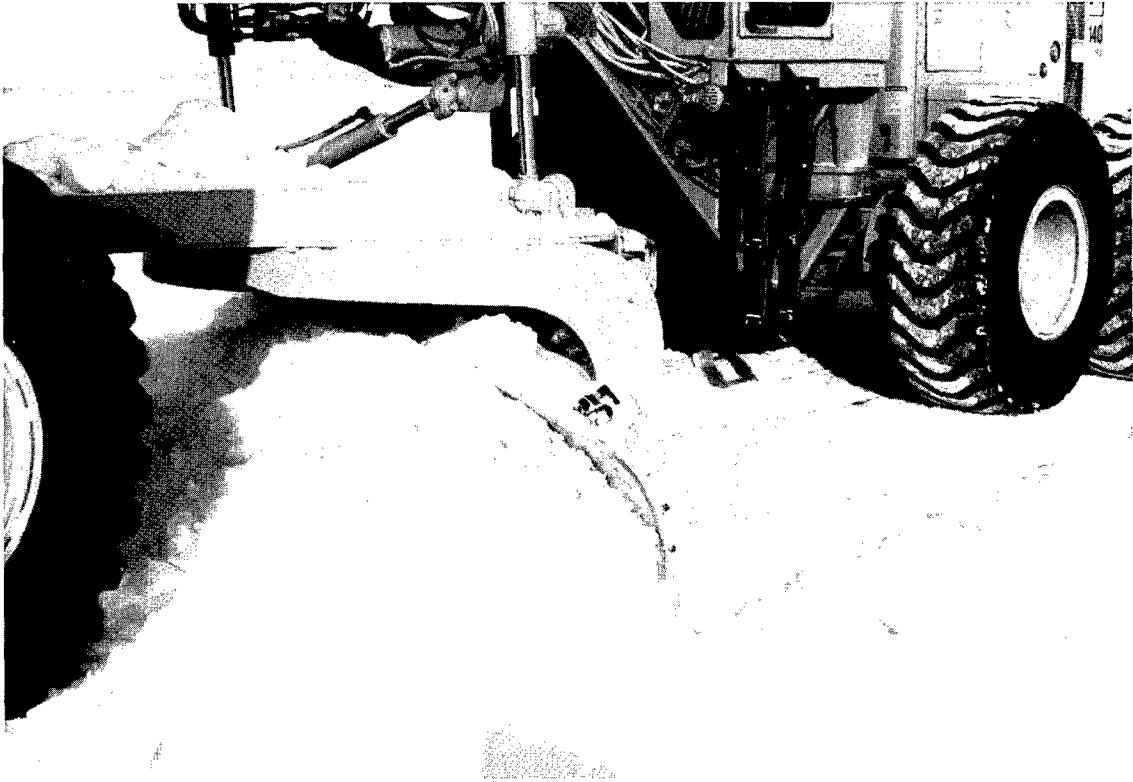
*Figure 34. Aggressive grader blade removing up to 20 cm (8 in.) of glacial ice in one pass.*

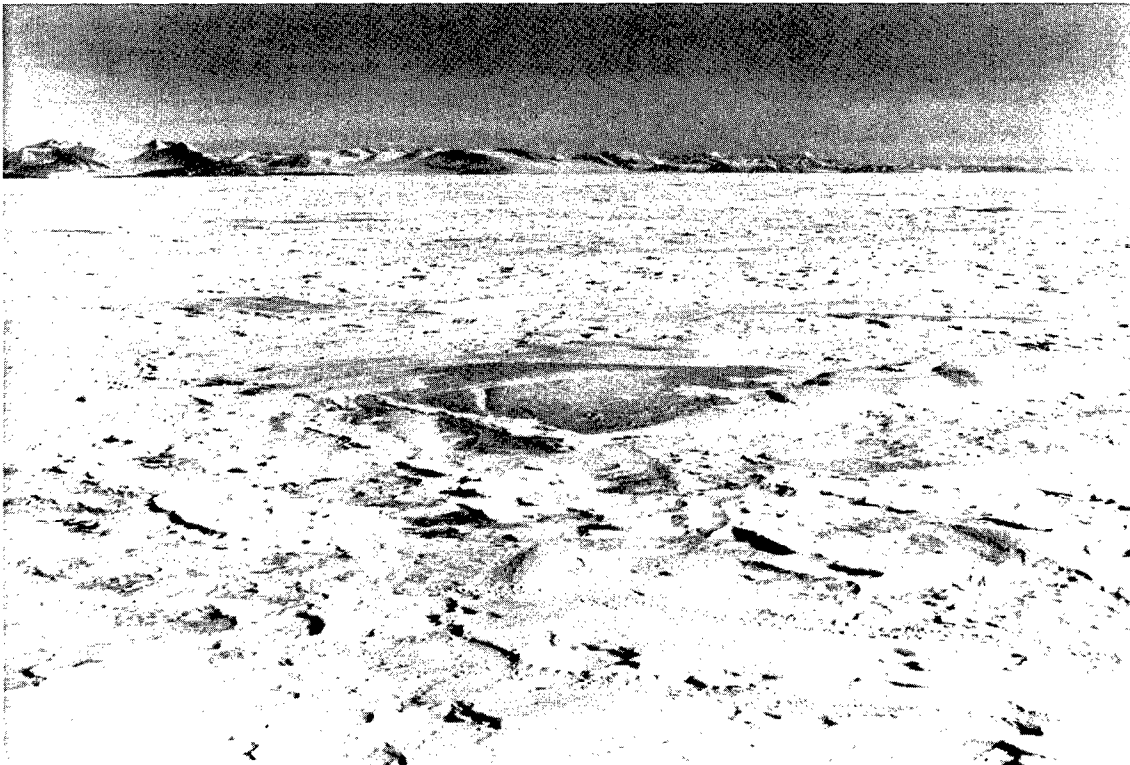
*Figure 35. Small ice blister formed from freezeup of melt pool showing radial cracks.*

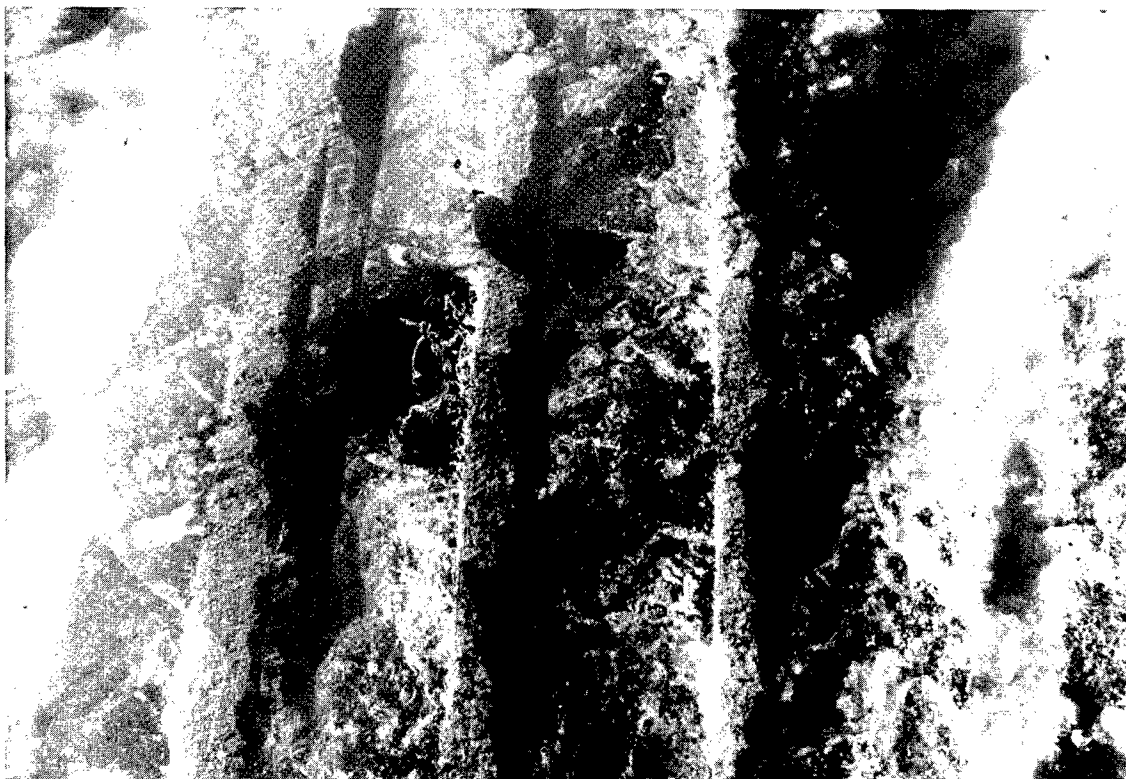
*Figure 38. Mineral matter trapped in the ice.*

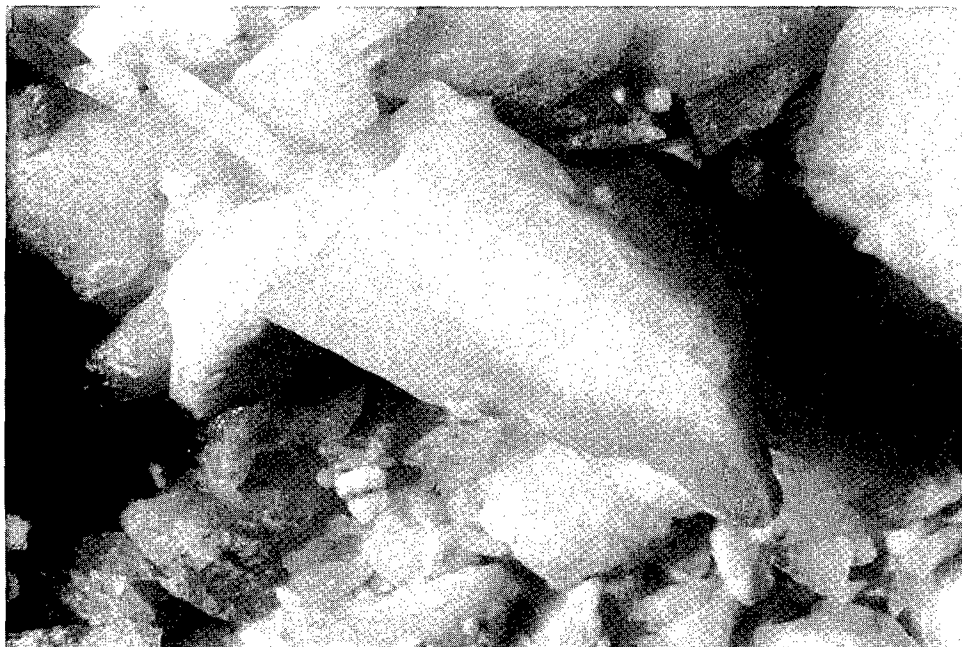
Figure 41. Poorly consolidated ice including snow pockets.

Following initial grading and debris removal, the runway should be carefully inspected and sampled to determine ice integrity, including the presence of cracks, variations in ice appearance or surface strength, potholes or other melt features, and to affirm the topography revealed from the initial survey data. Cores should be taken, especially in low spots, to determine how much ice might need to be graded to remove all porous or weak ice. This weak ice, which we called trash ice, is typically found in the shallow basins on the runway surface and often has large bubbles, incorporated lenses of snow, high concentrations of mineral particles, and occasionally is held together only with thin segments of ice plates (Fig. 41). The trash ice we discovered

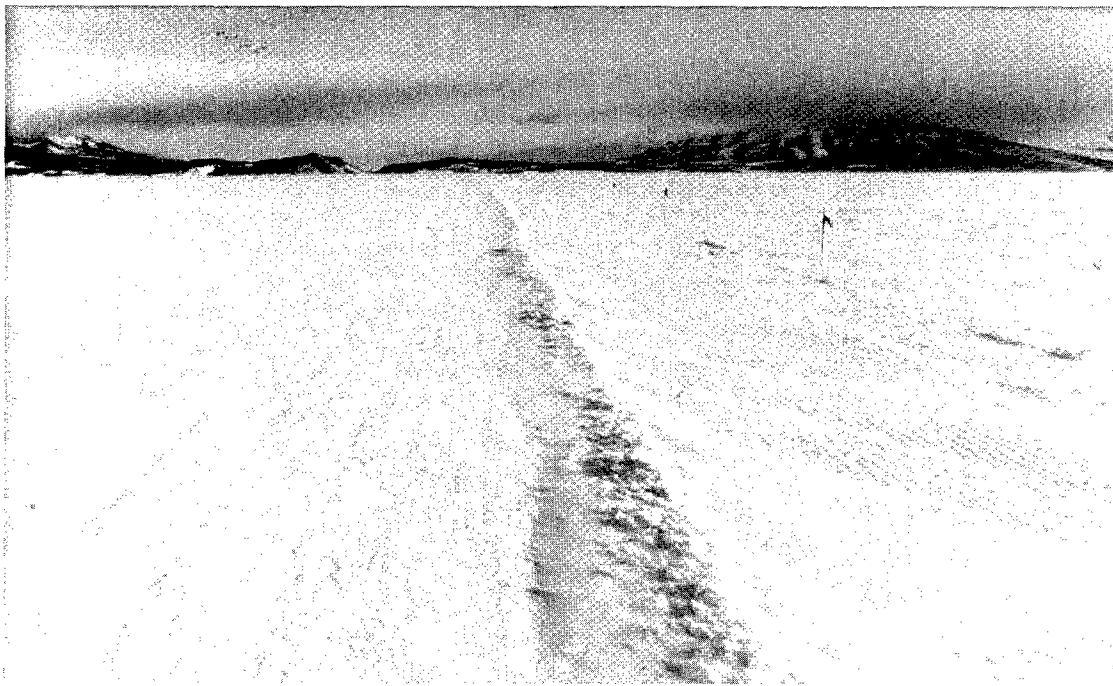
*Figure 48. Small windrows trapping blowing snow.*

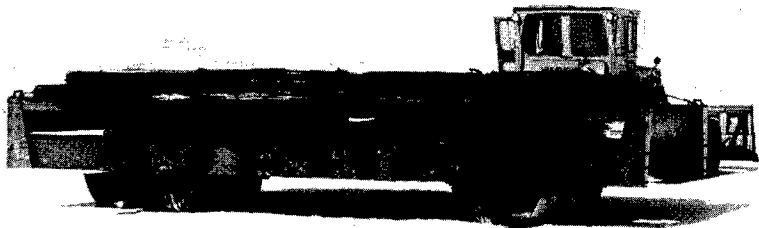
Figure 49. Cart for proof rolling the Pegasus runway shown configured for C-130 landing gear; ballast is steel plate.

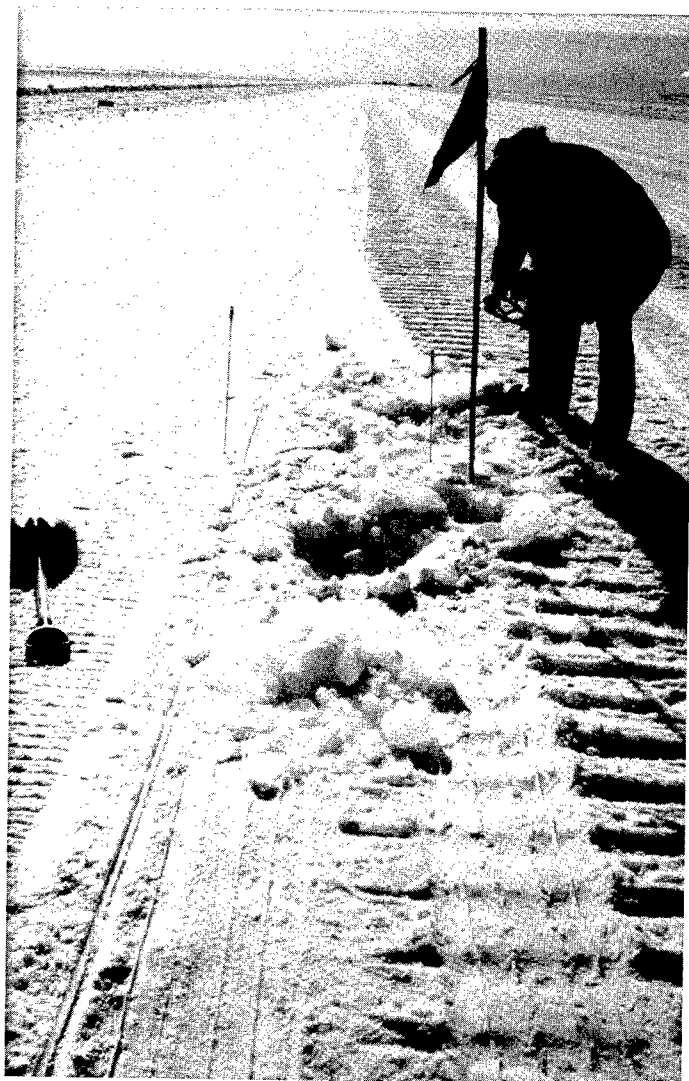
Figure 51. Site of failed runway ice caused by proof cart.

Approximately 30 weak spots were found by the proof roller. In these locations, the ice failed by crumbling, leaving a slight depression in the surface. Excavation of failed points revealed that they had an average size of 30 ft<sup>2</sup> (2.8 m<sup>2</sup>) and were 6-18 in. (15-46 cm) deep. In nearly every case, failure points were associated with a thin (0.25- to 0.5-in., 0.6- to 1.2-cm) gap. This gap was most likely caused during refreezing of melt pools that were known to have been present at this site during the 1991-92 summer season.

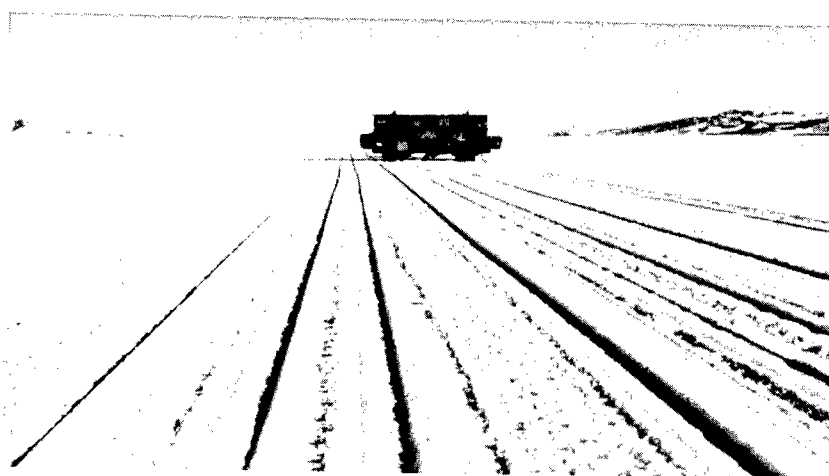
Figure 52. Closely spaced proof cart tire tracks during full-scale load certification of runway.

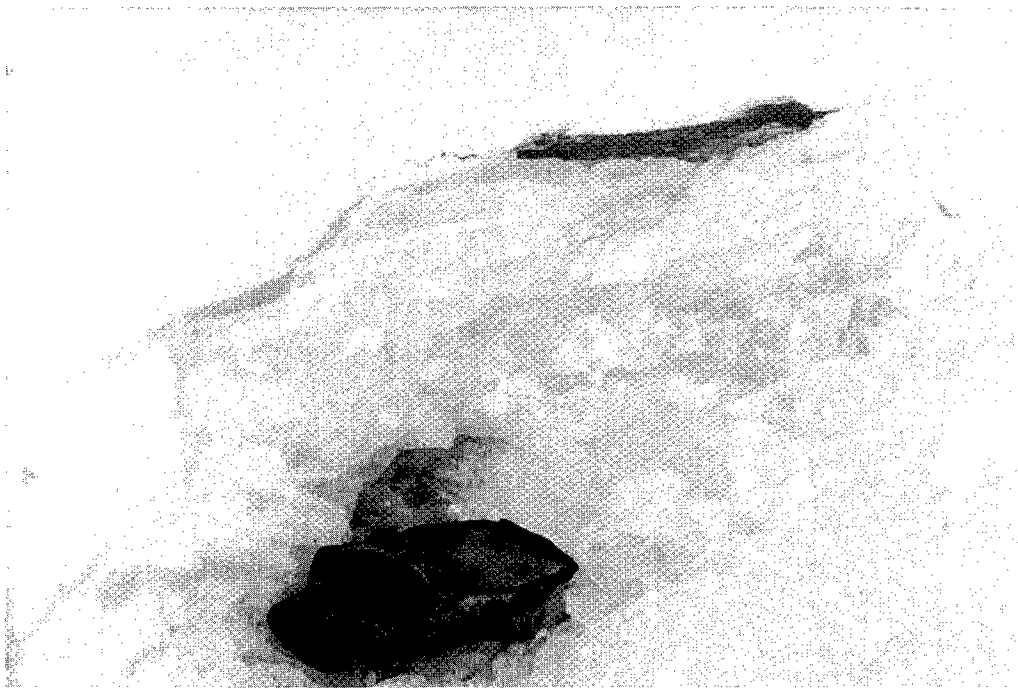
Figure 53. Failure planes in ice extending into sides of main cavity of failed area.
