WL-TR-97-3110

THE EFFECTS OF THE COLD  
WORKING PROCESS AND  
INTERFERENCE FIT BUSHINGS ON  
THE FATIGUE LIFE OF  
POLYCARBONATE SPECIMENS  
WITH HOLES

University of Dayton Research Institute  
300 College Park  
Dayton Ohio 45469-0110

Interim Report November 1994 – April 1997

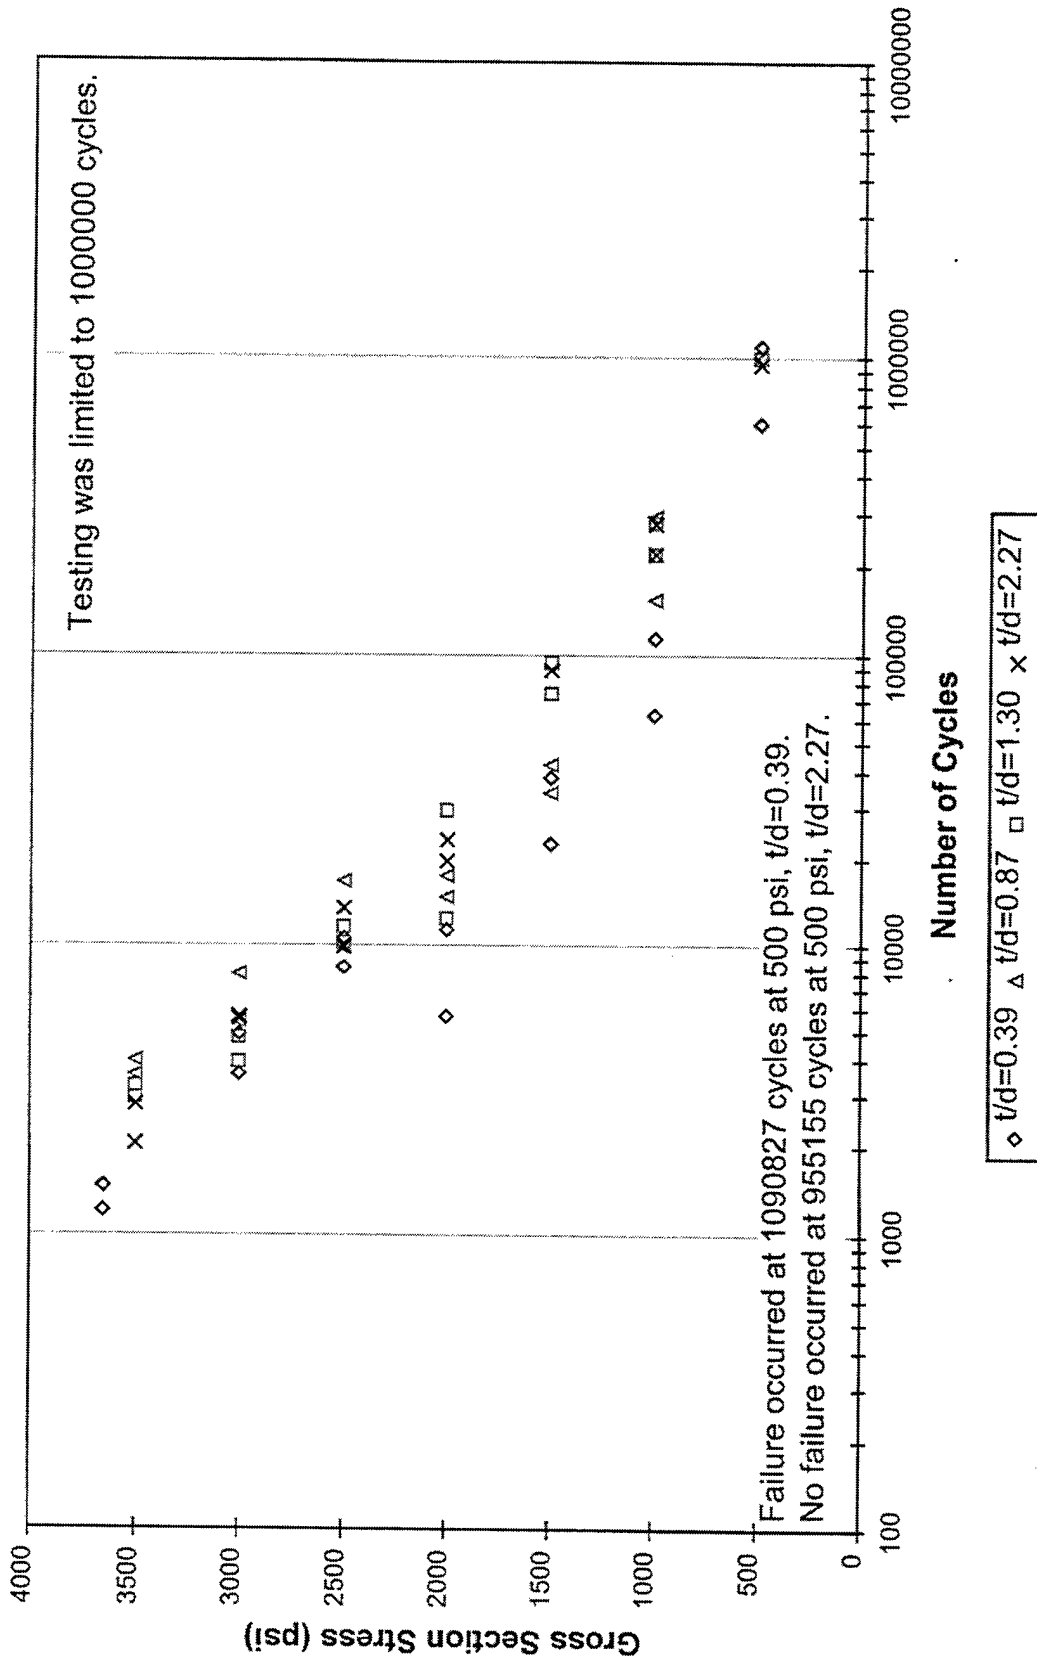
# 10 PERCENT COLD WORK COMPARISON

Figure 11. Test Results for Specimens with 10 Percent Cold Working.

One final group of plots is included as Figures 10 through 16. The four thickness-to-diameter ratios ( $t/d$ ) which were tested are plotted in each figure. The figures include the data for the baseline, 10 percent cold worked, 12 percent cold worked, 14 percent cold worked, 3 percent interference fit bushing, 6 percent interference fit bushing, and 9 percent fit bushing specimens, respectively. No evident trends were obvious in the data for the various  $t/d$  ratios; the use of cold working and interference fit bushings is applicable over a wide range of  $t/d$  ratios. The
