1. AGENCY USE ONLY (Leave blank)		2. REPORT DATE January 1994	3. REPORT TYPE AND DATES COVERED Stage 3 report, 1994	
4. TITLE AND SUBTITLE Laser Induced Reaction for Prebond Surface Preparation of Aluminium Alloys			5. FUNDING NUMBERS Contract number F61708-93-C005

LASER INDUCED REACTION FOR PREBOND SURFACE PREPARATION OF ALUMINIUM ALLOYS

Stage 3 report (7-10/93)
Contract No. F61708-93-C005

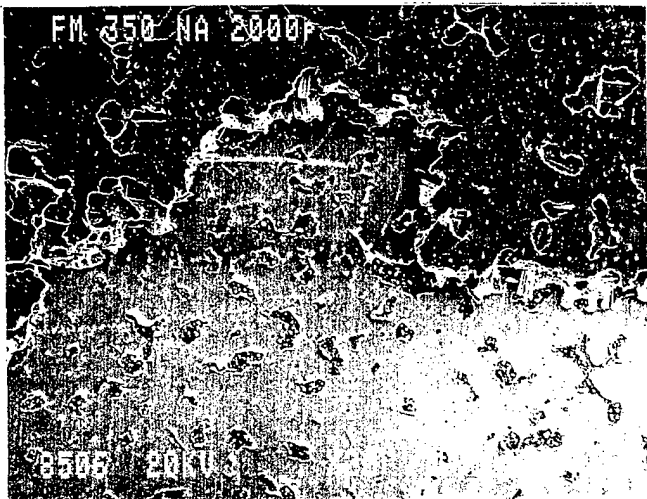
Fig. 3.7: SEM photographs of the surface failure morphology of SLS joints (table 3.1) with adhesive FM350NA, primer BR127, laser energy $180\text{mj/p}\cdot\text{cm}^2$ a: laser treated adherends, 600 pulses. b: laser treated adherends, 1000 pulses. c: laser treated adherends, 2000 pulses.

The failure mode of the laser treated adherends (fig.3.7) is adhesive even at high number of pulses.

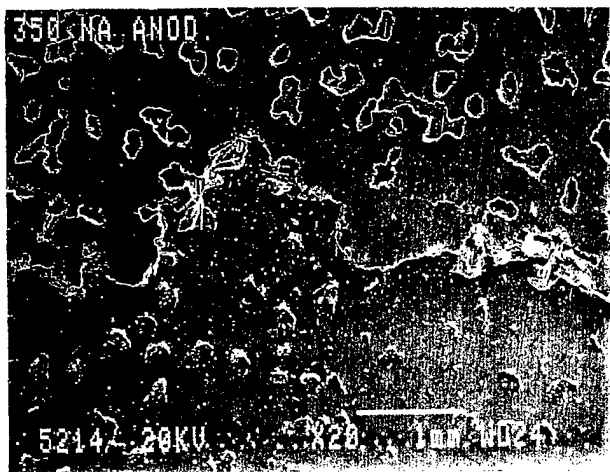
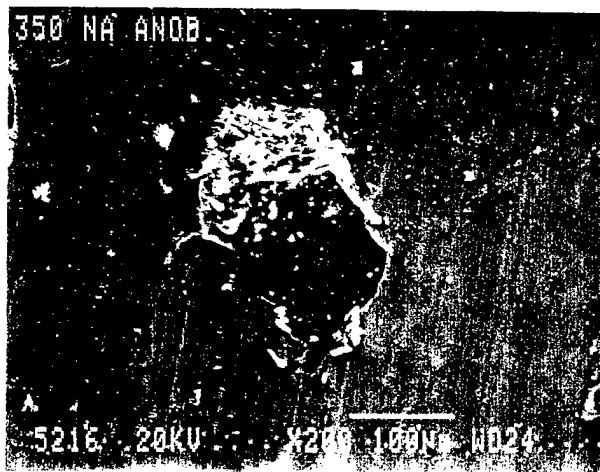
Fig. 3.8: SEM photographs of the surface failure morphology of SLS joints (table 3.3) with adhesive FM350NA, primer A187. a: without treatment. b: anodized adherends.

Figs. 3.8 -3.11 show the failure surface morphology of SLS adherends of joints bonded with FM350NA and primer A187. Comparison between the cohesive failure of the anodized adherends and the adhesive failure of the untreated adherends is shown in fig.3.8.

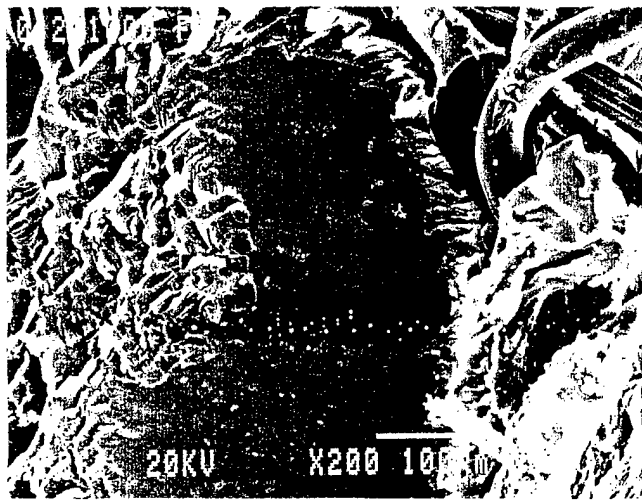
Fig. 3.12: SEM photographs of the surface failure morphology of SLS joints (table 3.4) with adhesive FM73, fresh primer BR127, laser energy $180\text{mj/p}\cdot\text{cm}^2$, 1000 pulses.

Experiments with a fresh BR127 primer and the adhesive FM73 (table 3.4) show that laser treated joints have shear strength similar to those with the primer A187 (329 Kg/cm²). Figs 3.12-3.13 show the cohesive failure mode of laser treated joints bonded with fresh BR127 and FM73. Experiments without a primer (table 3.5) and with an adhesive FM73 show shear strength of 321 Kg/cm². These results prove that the main effect of the surface treatment and improve adhesion strength arise from the laser irradiation while the primer has only a minor effect.

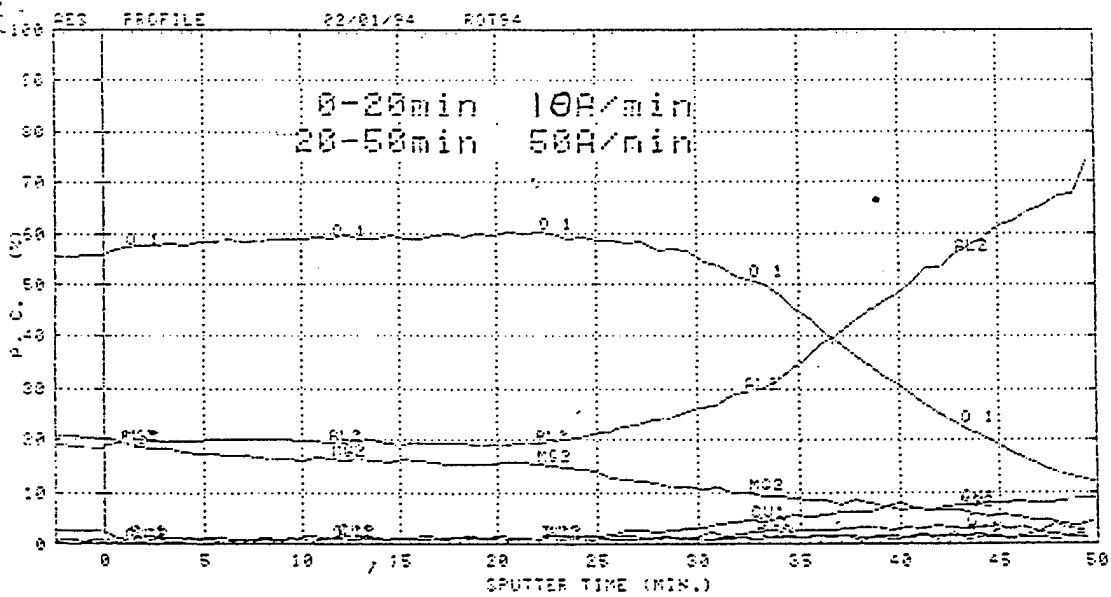
Fig. 3.20: Auger depth profile of Al irradiated at laser energy of $0.57\text{J/p}\cdot\text{cm}^2$. a.10 pulses b.1000 pulses.

Fig. 3.20 shows the auger depth profiles of Al specimen treated at laser energy of $0.57\text{J/p}\cdot\text{cm}^2$ with 10 and 1000 pulses. The oxides layers at this energy level were thicker (about 900Å) than those produced at laser energy of $0.18\text{J/p}\cdot\text{cm}^2$.

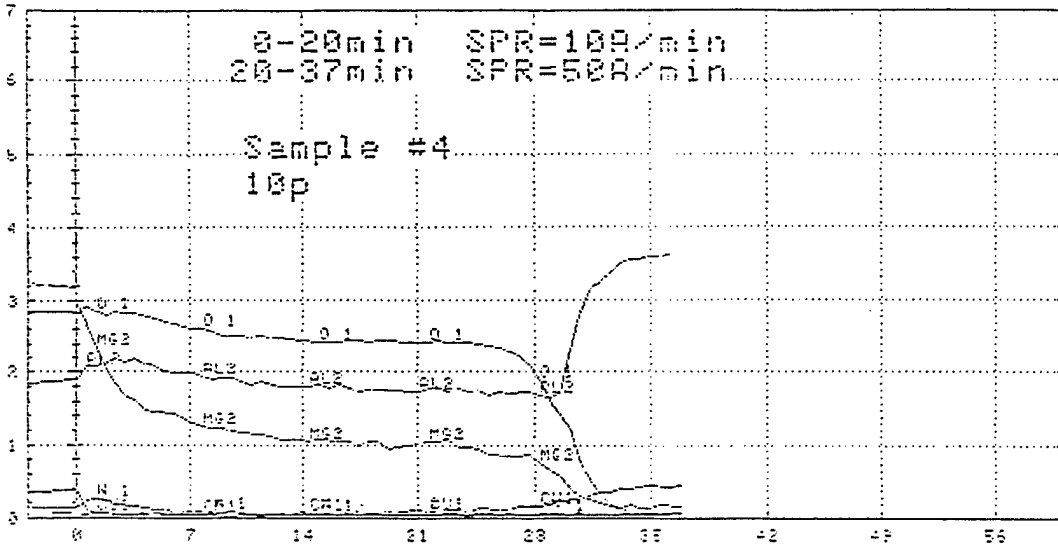
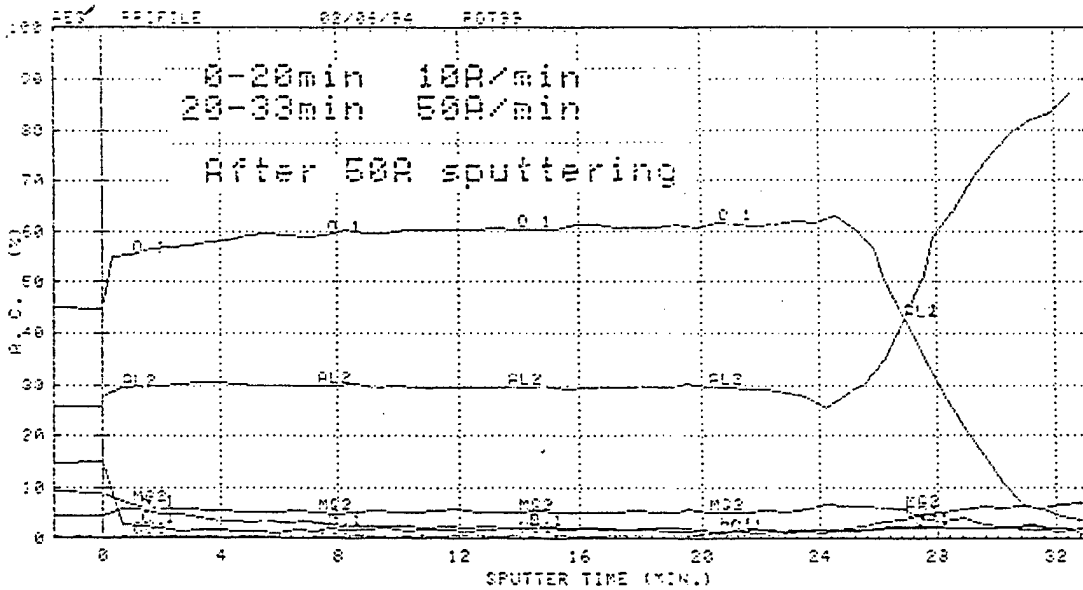
Fig. 3.21: Auger depth profile of Al irradiated at laser energy of $1\text{J/p}\cdot\text{cm}^2$. a. 10 pulses b. 100 pulses.

Fig. 3.21 shows the auger depth profiles of Al specimen treated at laser energy of $1\text{J/p}\cdot\text{cm}^2$ with 10 and 1000 pulses. Irradiation with 10 pulses resulted in oxide layers of Al and Mg with thickness of about 700Å probably due to ablation. Irradiation with 1000 pulses resulted in aluminum oxide layer (without Mg) in which the relationship between Al and oxygen was as in Al_2O_3 , i.e. O: 60% and Al: 30%.
