# Processing, Mechanical Properties, and Ballistic Impact Effects of Austempered Ductile Iron

by John F. Chinella, Brian Pothier,  
and Martin G. H. Wells

ARL-TR-1741

August 1998

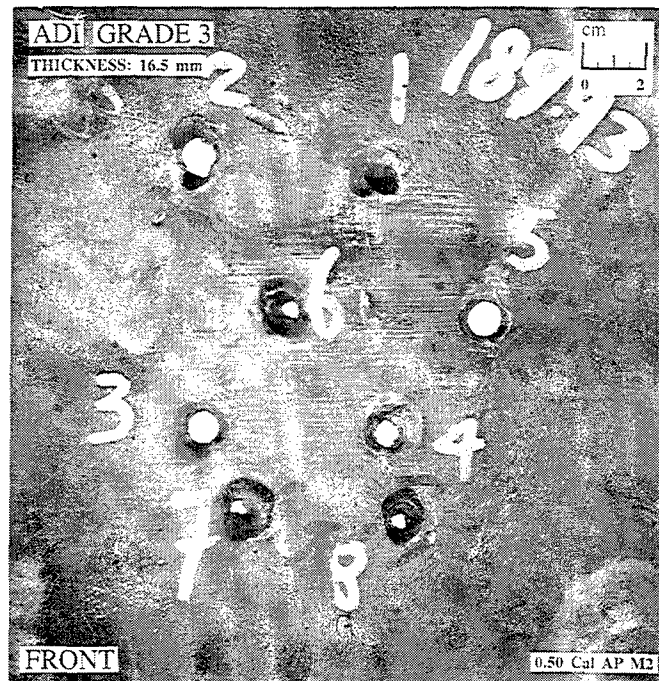
**Figure 5. Ballistic-Tested ADI Targets: (a) Target 151; (b) Target 151; (c) Target 189; (d) Target 189; (e) Target 187; and (f) Target 001, Arrows Indicate Casting Defects on Target Surface (continued).**

**4.3 Experimental Views: ADI Targets and Cross Sections.** The penetration modes of ADI targets from impact of 0.30- and 0.50-cal. APM2 projectiles (see Figures 5a-f) are complex. Penetration modes include contributions of ductile hole growth, bulging, star-shaped radial fracture, petaling, and scabbing. Star-shaped radial fractures formed on the back of the target after small amounts of bulging. Scabbing formed irregular-shaped craters from the front of the target and removed petal-fragments by crack delaminations of the target. Brittle fracture is defined as the condition of very little plastic deformation of metal during propagation of a crack (Reed-Hill 1973). Although failure modes of radial fracture and scabbing are dependent on crack growth, all target damage remained within three projectile (core) diameters near each impact, and the targets did not undergo structural failure from cracking after eight or nine impacts (see Figures 5a-f). Plugging modes of penetration did not occur with any impact of the target for either projectile.

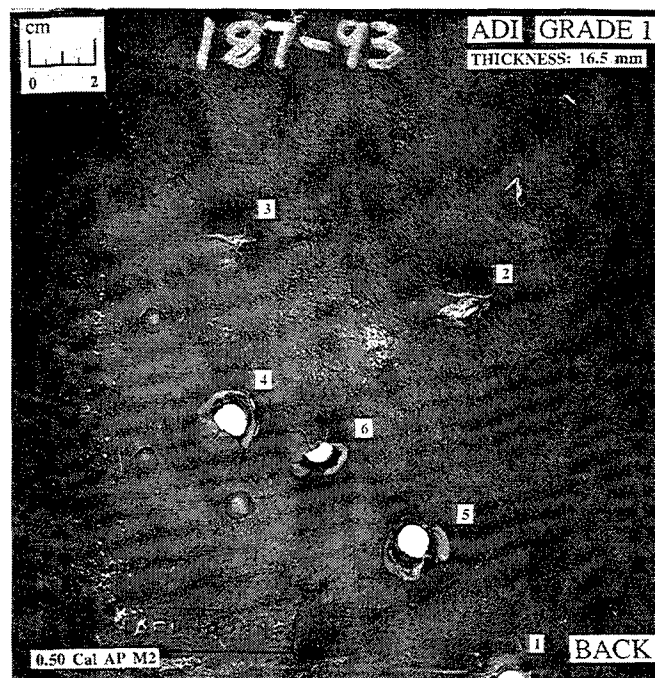
**Figure 5. Ballistic-Tested ADI Targets: (a) Target 151; (b) Target 151; (c) Target 189; (d) Target 189; (e) Target 187; and (f) Target 001, Arrows Indicate Casting Defects on Target Surface (continued).**

Targets 187 (G1) and 001 (G3) (see Figures 5e-f) have the greatest difference of scaled V-50s. Although the penetration modes of targets 187 and 001 appear similar, target 187 has the greatest V-50 and appears to have a greater amount of plastic deformation about impacted areas. More extensive tests of ADI material with greater ranges of strength and toughness would be required to better correlate mechanical and material properties to penetration mechanisms and ballistic performance.

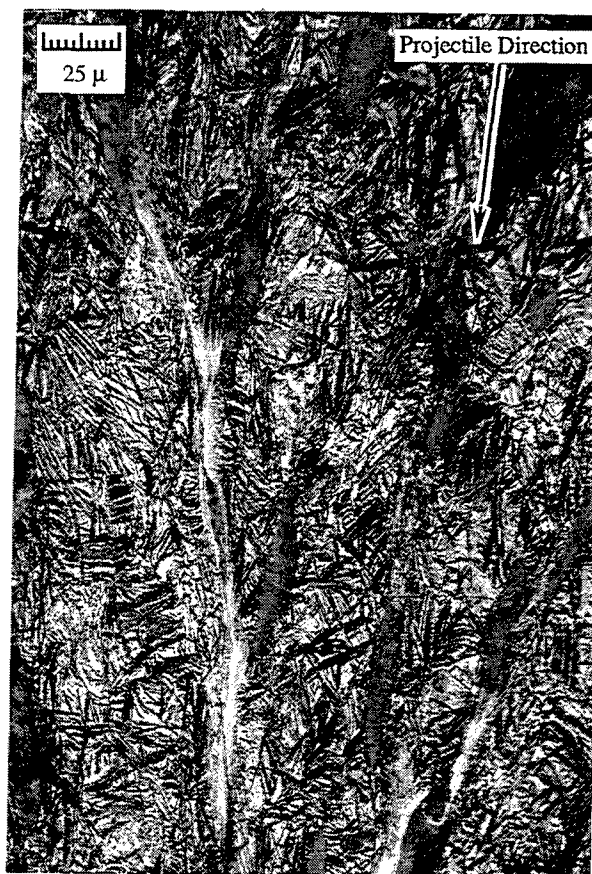
**Figure 9. Microstructural Changes: (a) (1) Shear Band; (2) Wear of Projectile and Target; (3) Along Deformed Nodules (0.30-cal. APM2 Projectile vs. G3 ADI, Target 151 Shot 2, Figure 8); (b) Regions From Figure 9a With Enhanced Levels of Stress.**

Views of the penetration mode of ductile hole formation for the 0.30-cal. projectile (see Figure 8) are shown in Figures 9a–b and A-1 of the Appendix. Large contributions of plastic deformation from ductile hole formation occurred in impacts by the 0.30-cal. APM2 projectile. The shapes of graphite nodules serve as witness markers to the deformation of the target material. Material effects include plastic deformation of the ADI graphite nodules and austenite-ferrite matrix, and localized microstructural changes, or transformation of the microstructure, as suggested by white-etching material. White-etching areas also reveal carbon-enriched austenite of the matrix. Cracks shown in Figure 9a developed from relief of residual stresses during sectioning.

Several forms of microstructural changes resulting in white-etching material appear to have occurred. White-etching regions on and adjacent to the projectile core appear to be effects of high pressures and heating from deformation and wear (see Figures 9a and A-1a). The HRC 60 projectile core is undeformed and shows wear surfaces with white-etching and dark-etching structures. Other, linear-shaped, discontinuous, white-etching regions of microstructural changes suggest the initial development of a shear band. The curvature of the linear shear band reveals that target material has been plastically deformed in the projectile direction.

White-etching material in the adiabatically deformed material appears dependent on effects of localized stresses that bridge the close-spaced and elongated graphite nodules. Plastic deformation and microcracking from localized stresses (the bridge effect) occurs during fracture of ductile irons (American Society for Metals 1987). The propagation direction of the white-etching material is opposite the direction of the projectile and of the plastically deformed target material, consistent with a load configuration of shear stress (see Figures 9b and A-1b).

The microstructural effects that propagate from nodule to nodule do not appear to have formed directly by accompanying shear of the adjacent material (see Figures 9b and A-1b). Bainitic ferrite and graphite structures that are separated by the microstructural changes remain continuous and are not sheared. Nodules appear unaffected by nucleation-growth or coalescence of microvoids. The shapes of nodules (indicating the bulk deformation of the ADI) near the leading edge of the microstructural changes do not differ from the nodule shapes farther away. The apparent dependence of the microstructural changes on localized stresses in regions between elongated graphite nodules suggests an effect similar to dynamic recovery (Lee et al. 1993). The absence of shears across the white etching region may be the result of (1) a stress-dependent mechanism that can propagate at much higher velocities than the speed of the projectile and more homogeneous shear of adjacent microstructure; (2) the constraint of adjacent untransformed microstructure; (3) an effect near the end of the period of penetration and deformation. Further investigation by transmission electron microscopy is required to determine the structure and formation mechanisms of white-etching material in ballistically impacted ADI.

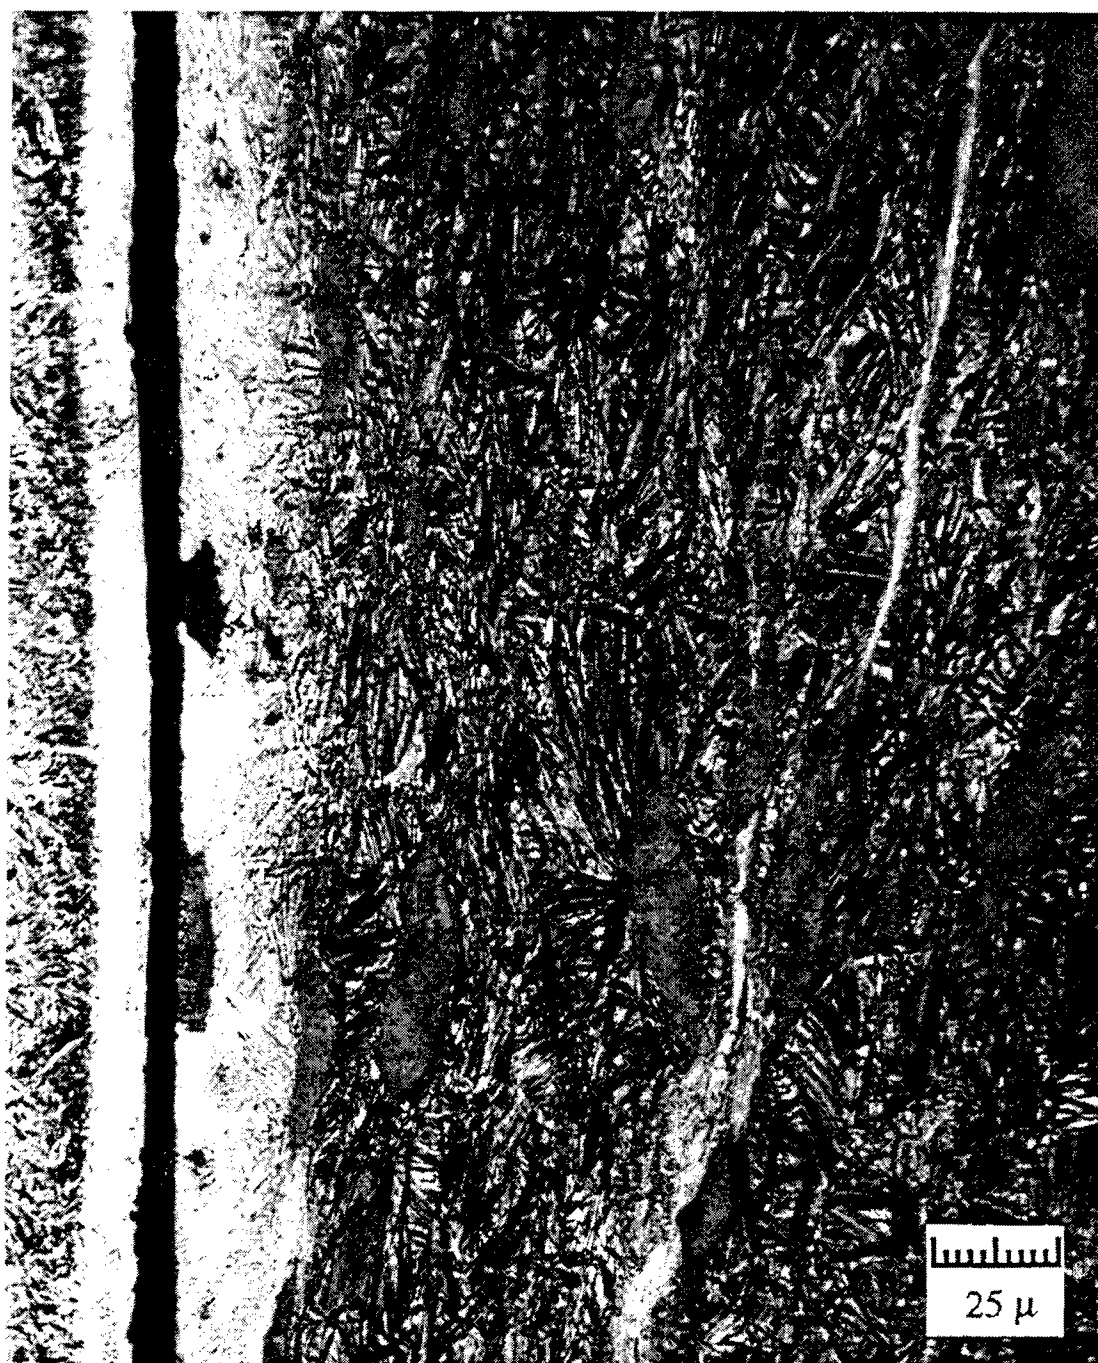
**Figure A-1a. Microstructural Changes in Target and Projectile Material During Ductile Hole Growth (See Figure 8). White-Etching Material Appears to Result From: (1) Microstructural Recovery Induced From Stress and Heat Conducted From Wear of Projectile; (2) Wear and Adiabatic Shear; (3) Recovery of Microstructure in Regions of Enhanced Levels of Stress Along Deformed Graphite Nodules. Nital Etch.**

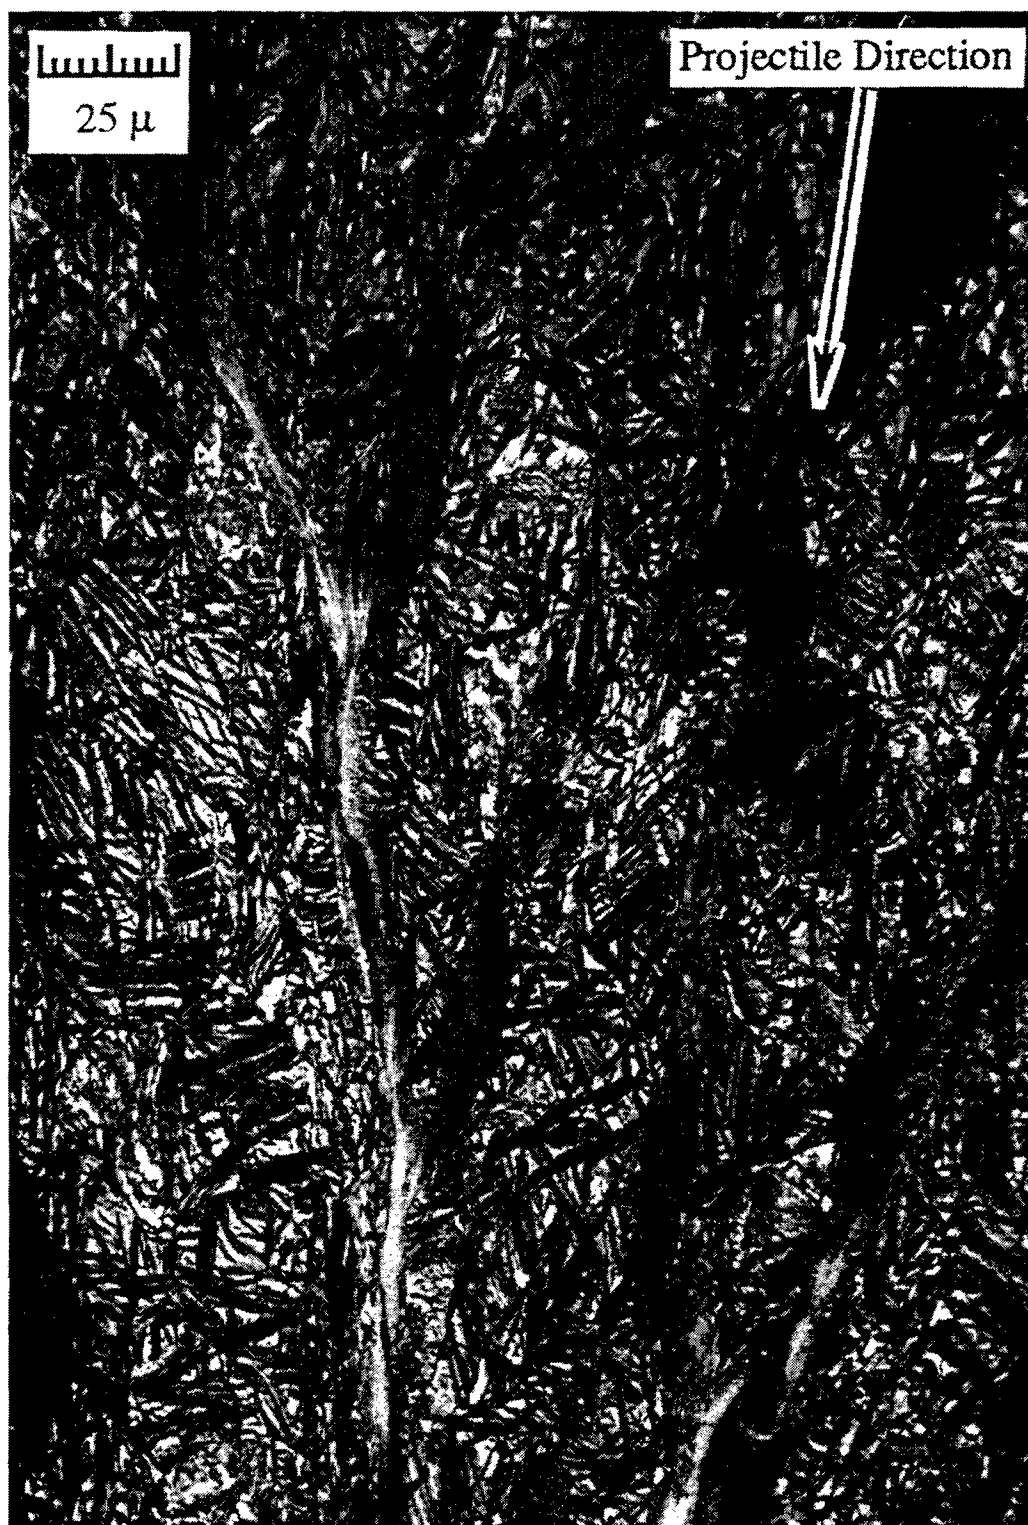
**Figure A-1b. Microstructural Changes in Target and Projectile Material During Ductile Hole Growth (See Figure 8). White-Etching Material Appears to Result From Recovery of Microstructure in Regions of Enhanced Levels of Stress Along Deformed Graphite Nodules. Nital Etch.**
