FEAP Technical Report 98/68
April 1998

Demonstration of Electro-Osmotic Pulse Technology for Groundwater Intrusion Control in Concrete Structures

by
Vincent F. Hock, Michael K. McInerney, and Erik Kirstein
U.S. Army Construction Engineering Research Laboratories
Champaign, IL 61826-9005

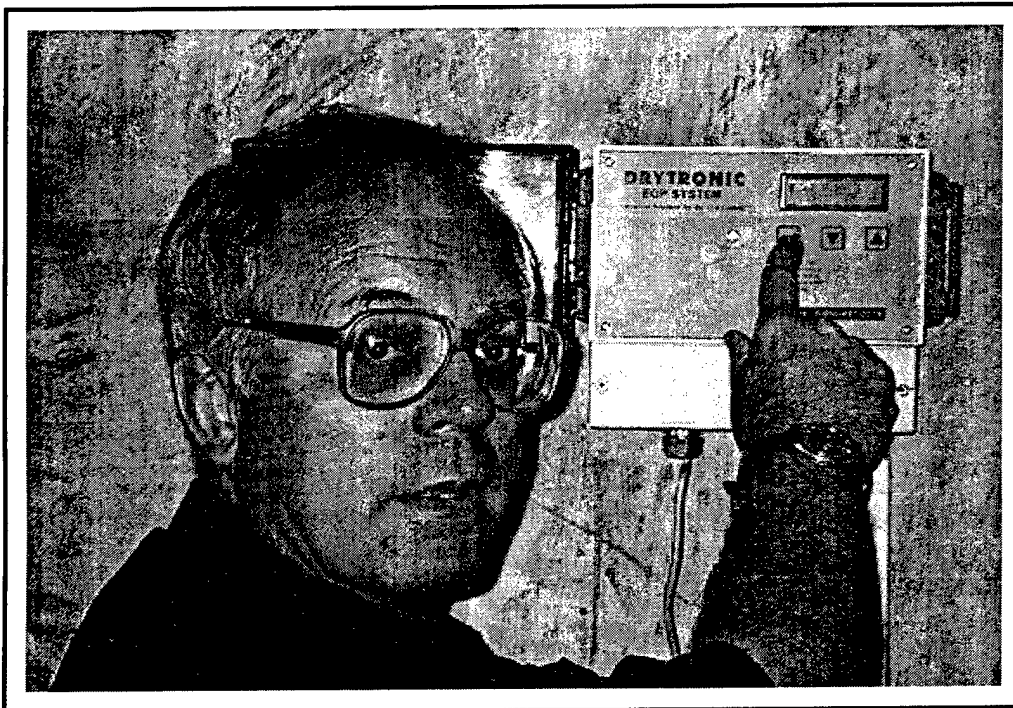
Figure 10. Mr. Cooper demonstrating the operation of the EOP control unit.

Figure 9 shows the basement mechanical room schematically, and highlights the locations of the EOP Control Unit, anodes, and cathodes. Figure 10 shows Mr. Cooper demonstrating the operation of the EOP control unit.

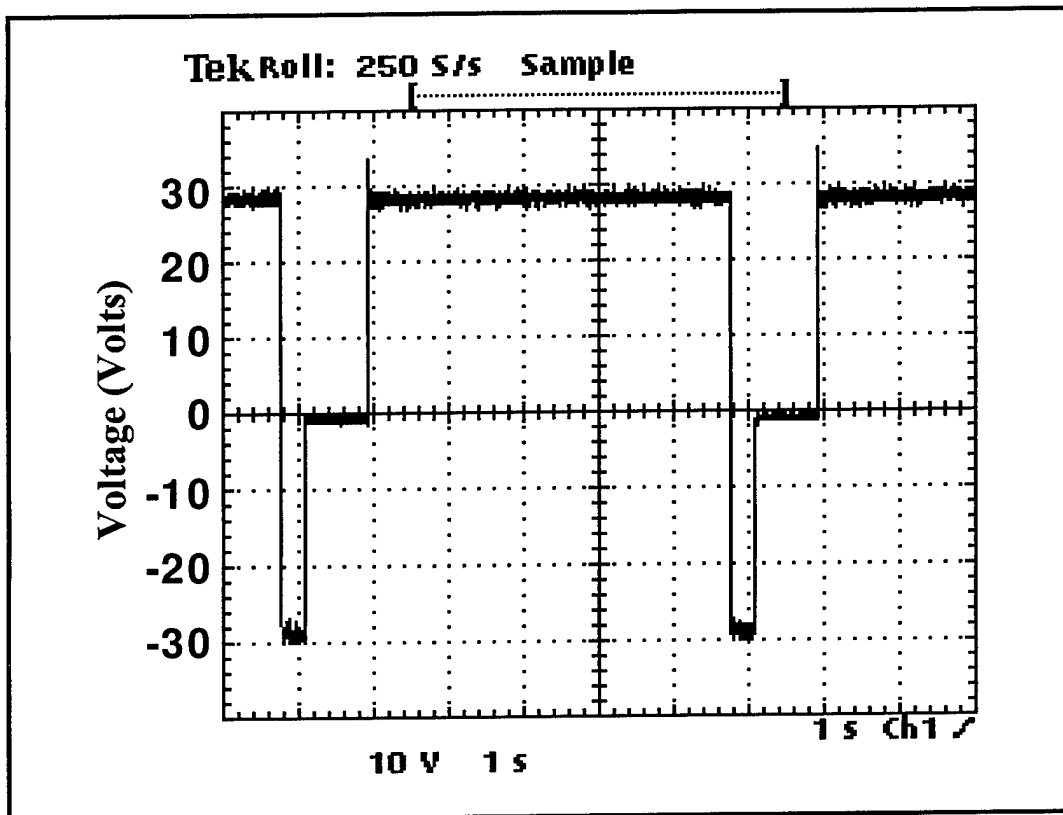
Figure 14. EOP unit output waveform recorded at McAlester AAP, November 1996.

Many of the same parameters that were recorded at Fort Jackson are being recorded at McAlester. The corrosion potential is taken using a 13-in. long piece of 0.5-in. steel rebar that was grouted into the wall along with a Ag/AgCl reference cell. The cell was installed so as to be behind the rebar, and separated from it by about 2 in. of concrete. The humidity of the concrete is sampled, but not with the same technique used at Fort Jackson. A small cavity (approximately 6-in. long) was made in the concrete wall for the insertion of a 4-in. long dual humidity/temperature probe. After the probe was inserted into the cavity, the cavity was sealed off from the room air. Since the cavity is sealed, this probe monitors the temperature and humidity of the cavity, giving an indication of the progress of the EOP system as it operates. The humidity of the cavity should be proportional to the moisture content of the concrete.
