Waterways Experiment  
Station

Final Report  
CPAR-SL-98-1  
September 1998

Technologies for Improving the Evaluation and  
Repair of Concrete Bridge Decks: Ultrasonic  
Pulse Echo and Polymer Injection

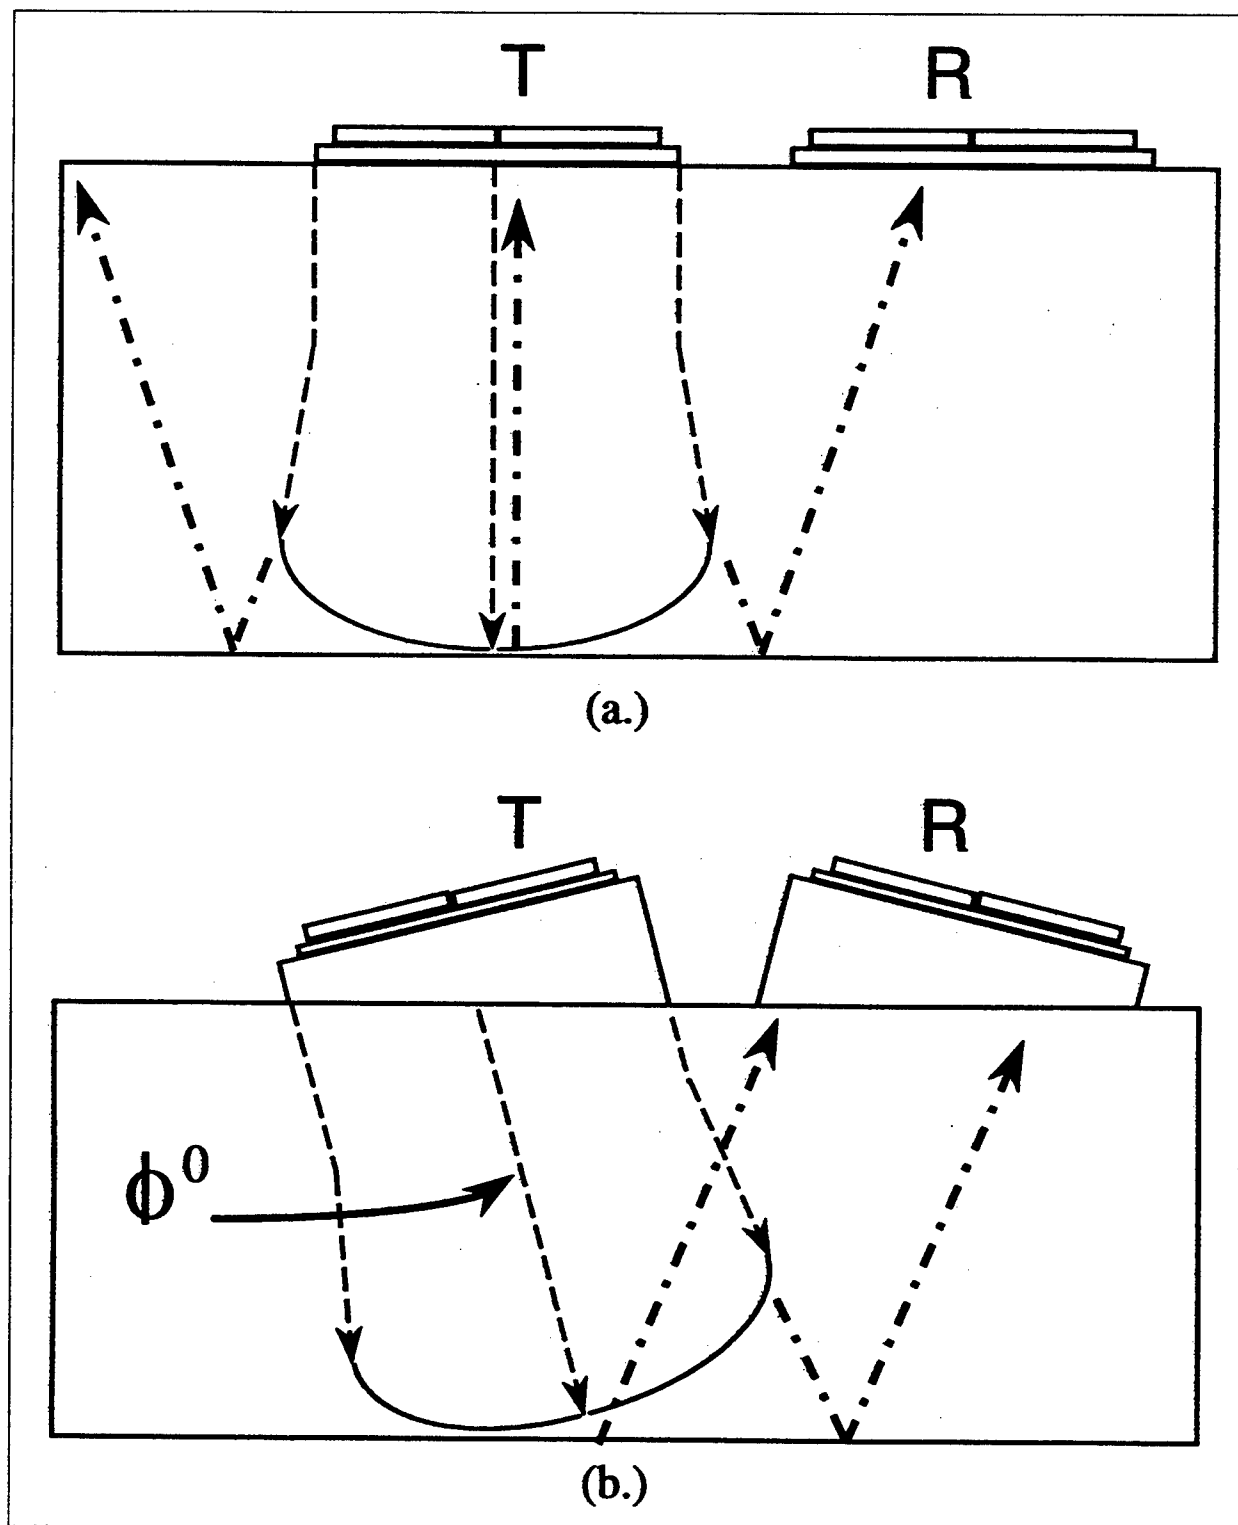
Figure 4. Pitch-catch mode configurations (a) Energy propagation with nondirected transducers. (b) Improved wavelength resolution and backwall-echo magnitude with directing wedge

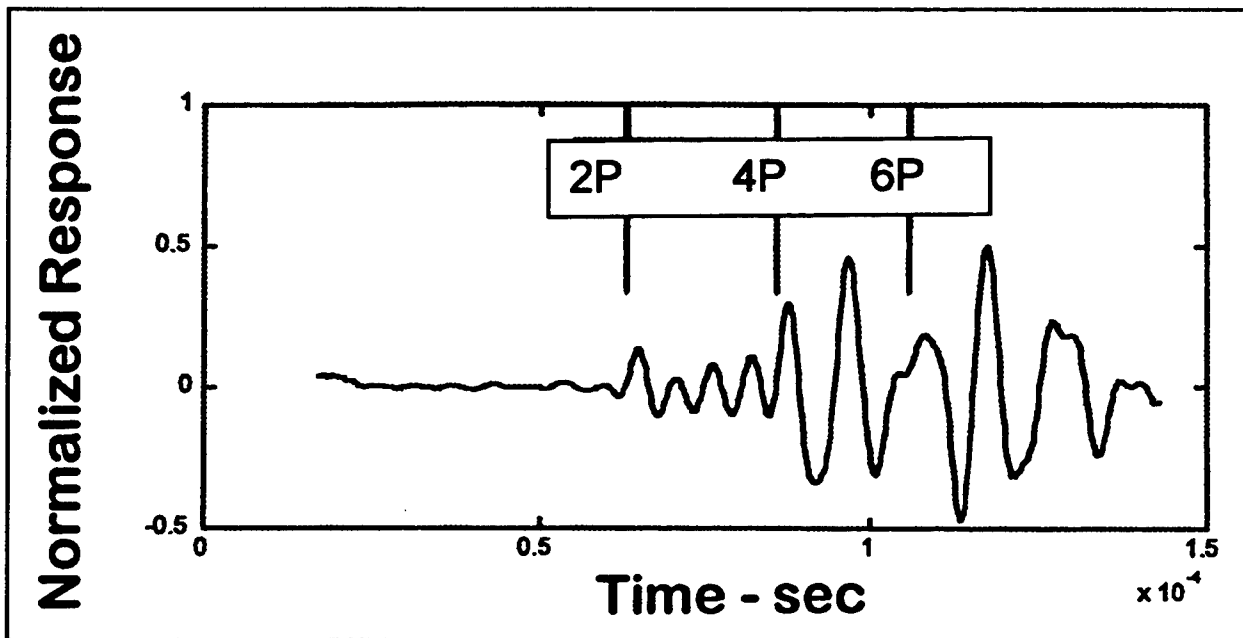
Figure 15. P-wave arrival calculated by RBM program for a 2-in-thick specimen

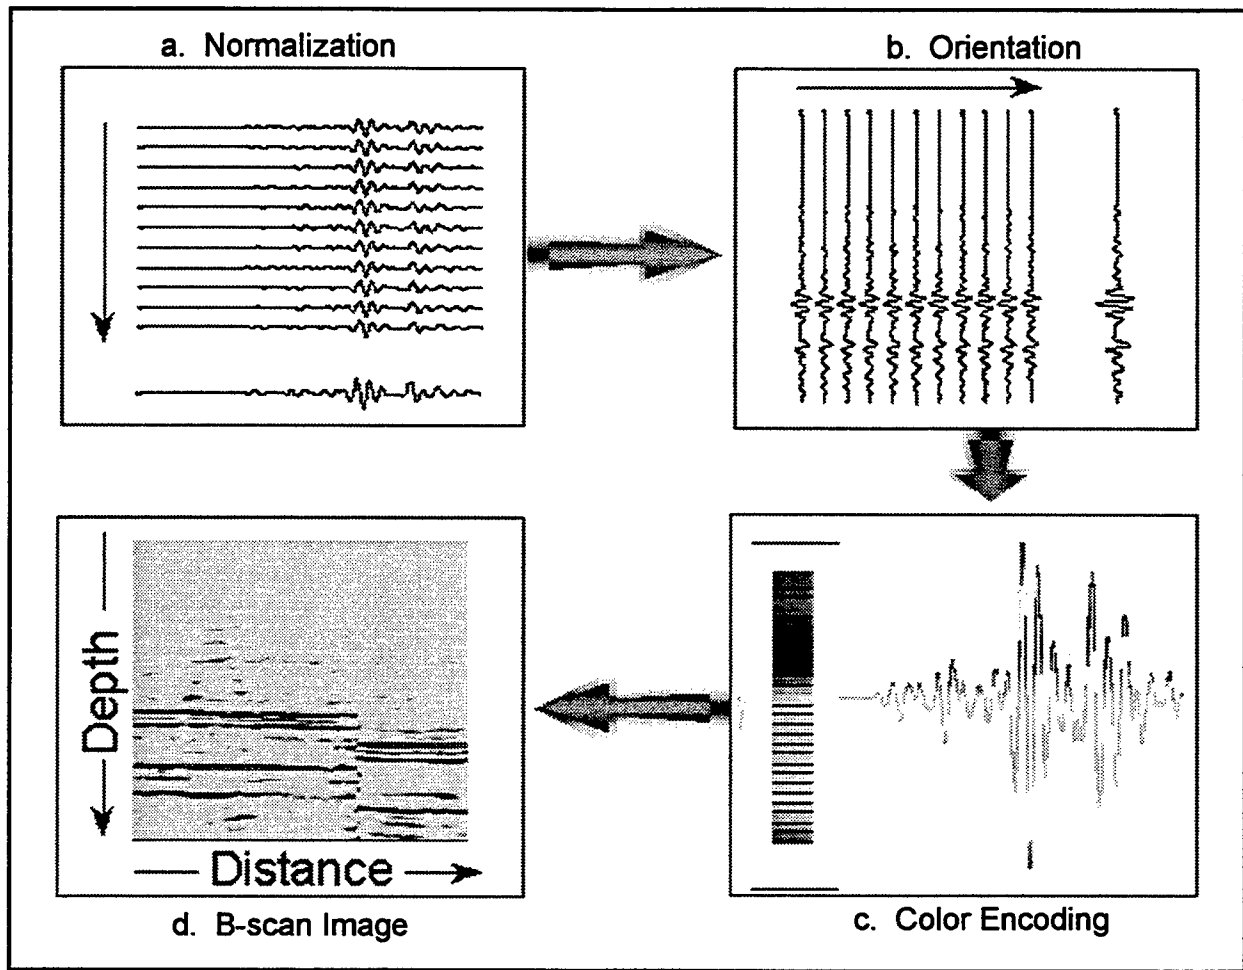
Figure 19. B-scan mapping procedure

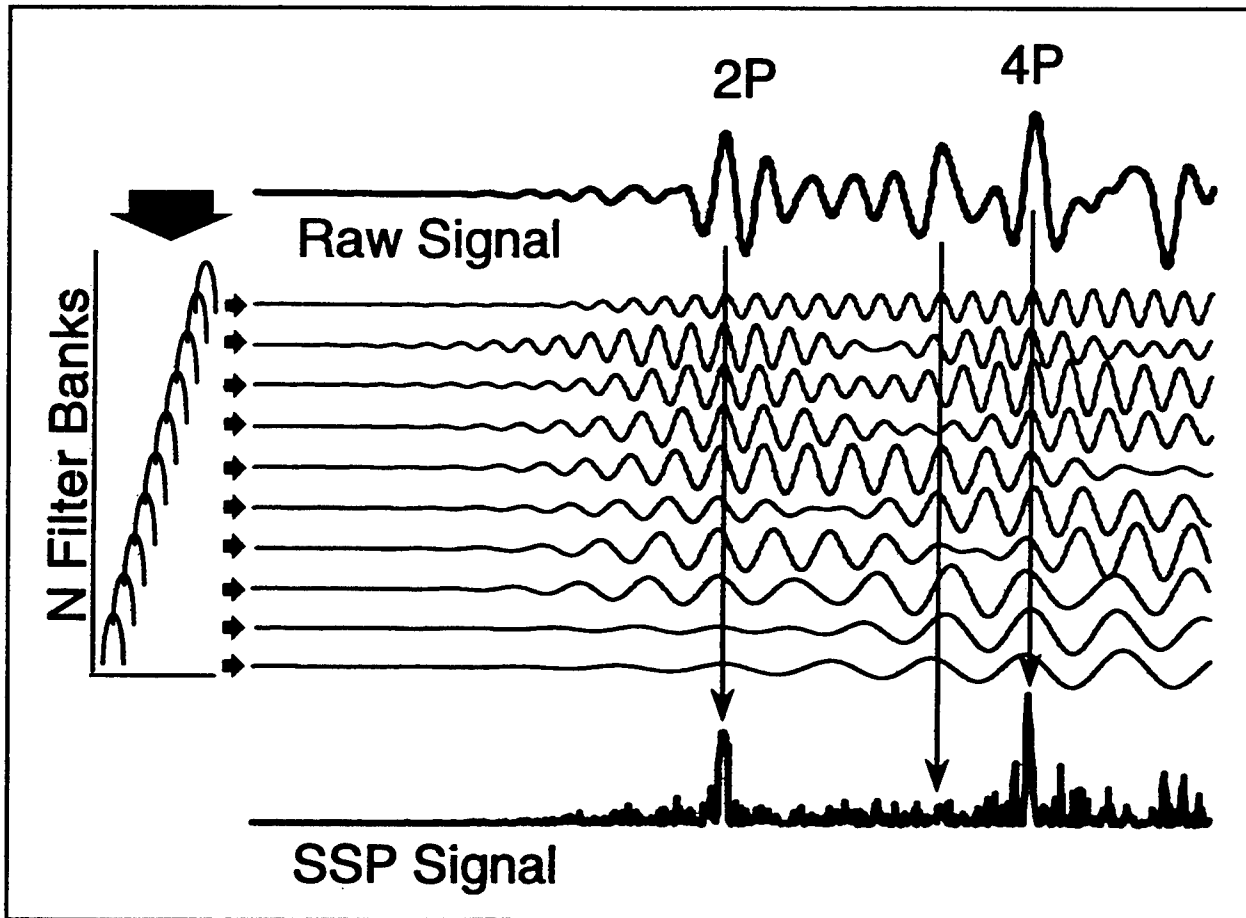
Figure 20. Representation of the SSP filtering and recombination procedure

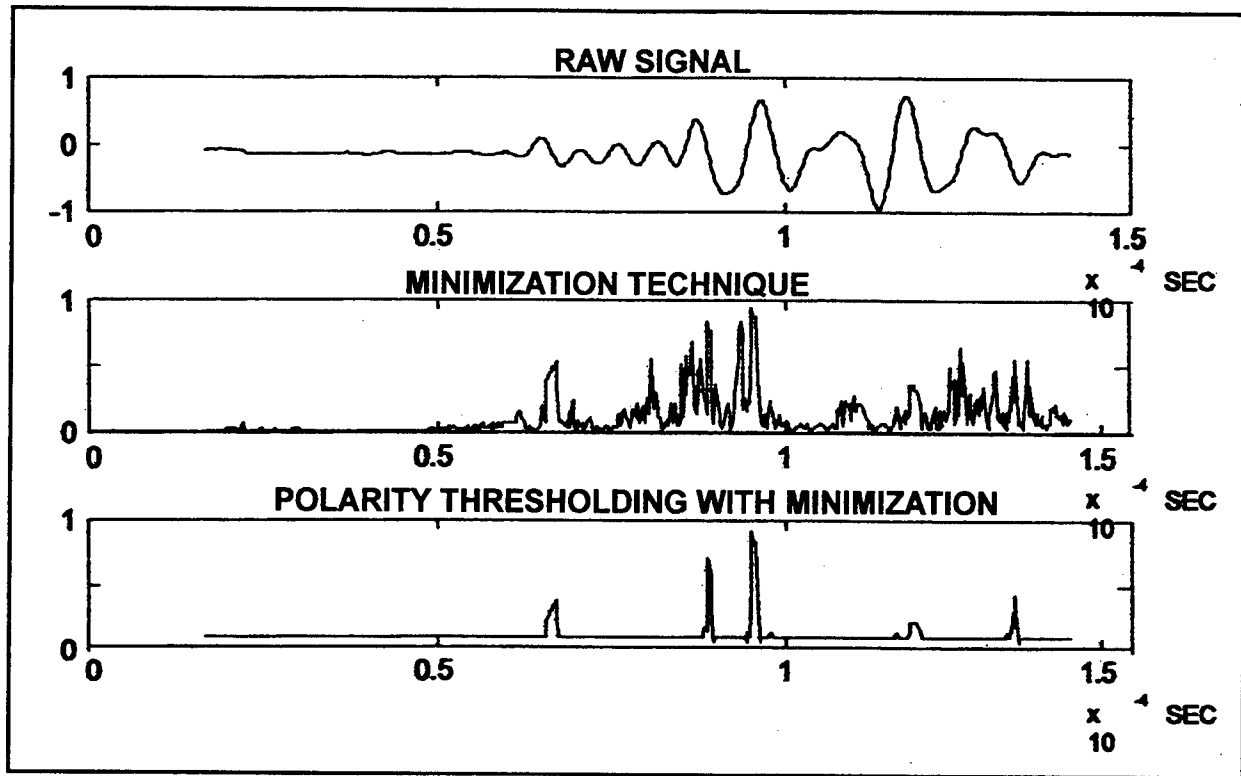
Figure 21. SSP with minimization and polarity thresholding for a 2-in.-thick concrete slab

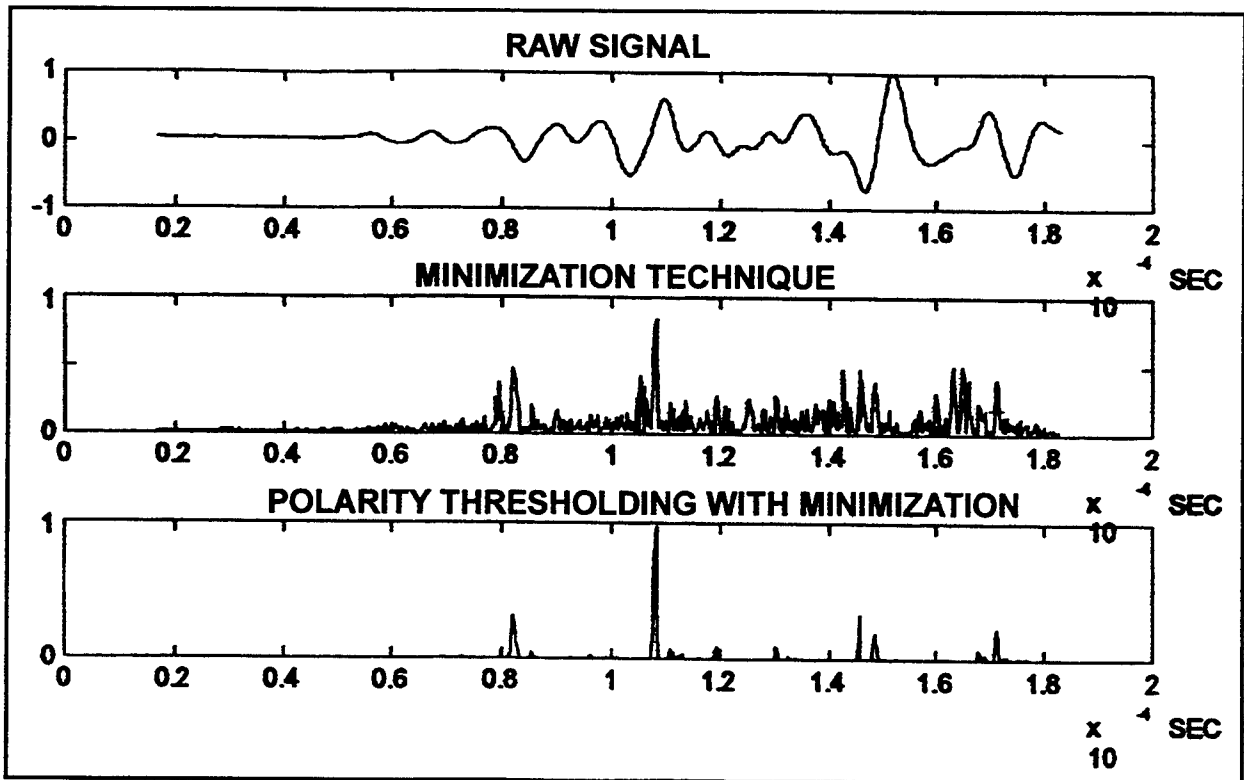
Figure 22. SSP with minimization and polarity thresholding for a 4-in.-thick concrete slab

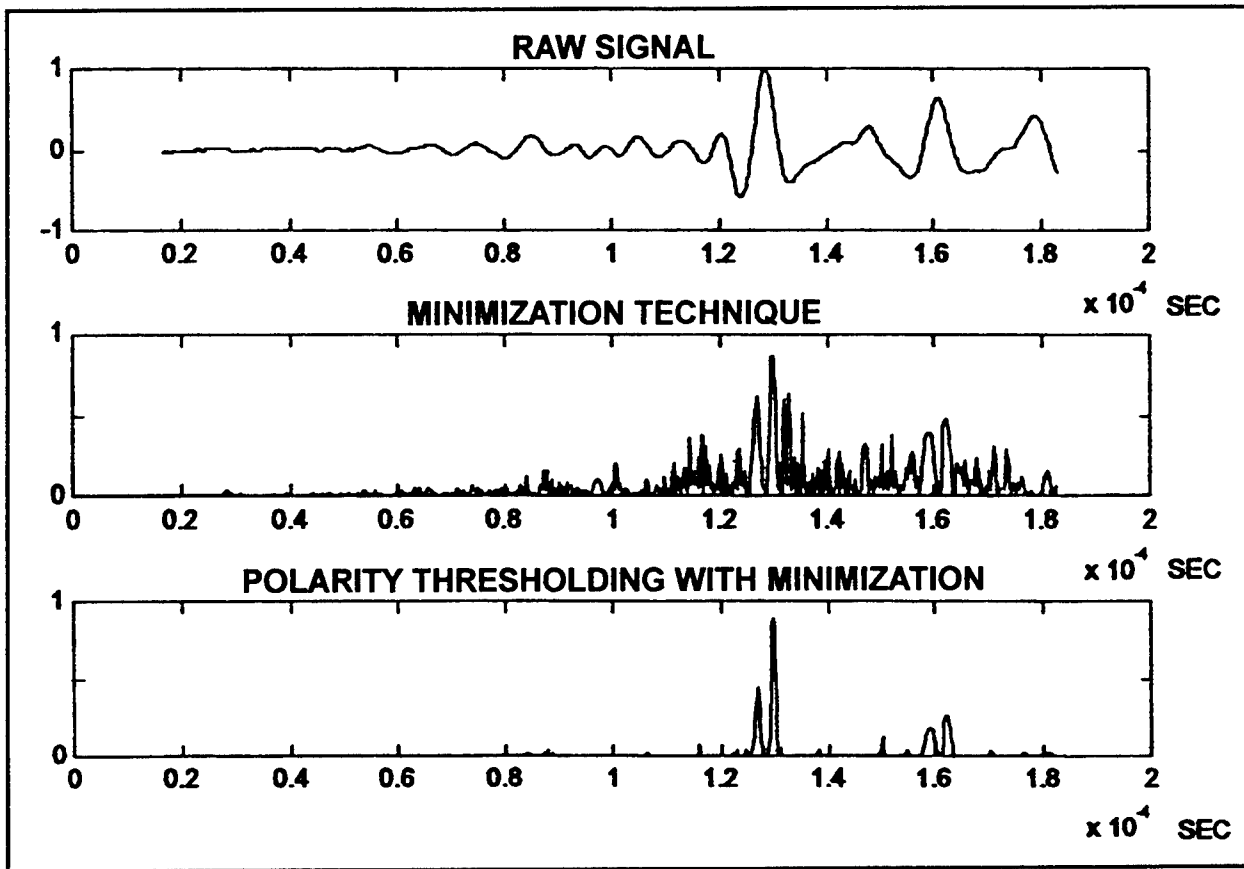
Figure 23. SSP with minimization and polarity thresholding for an 8-in.-thick concrete slab

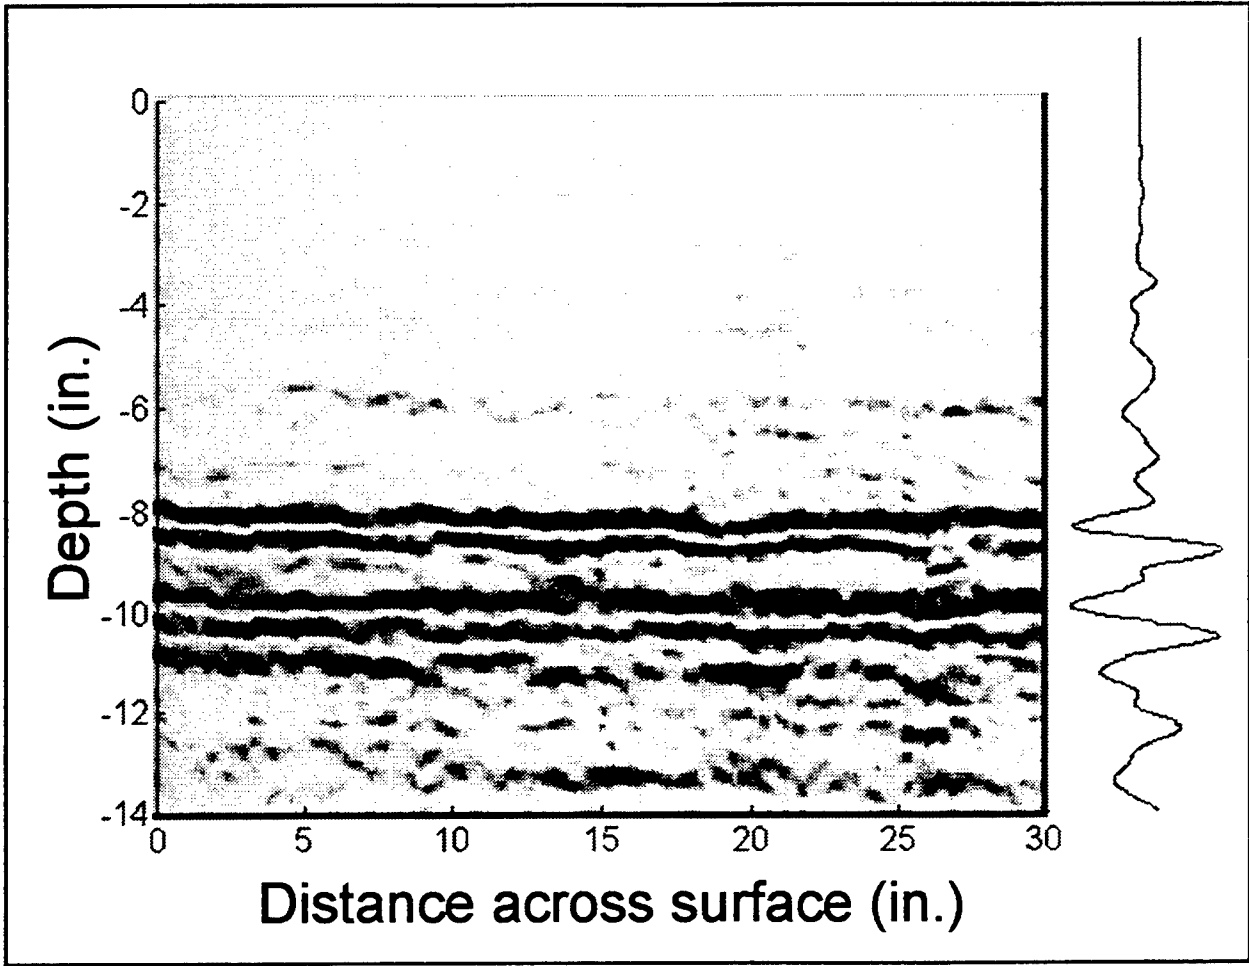
Figure 25. B-scan from an 8-in.-thick concrete bridge deck

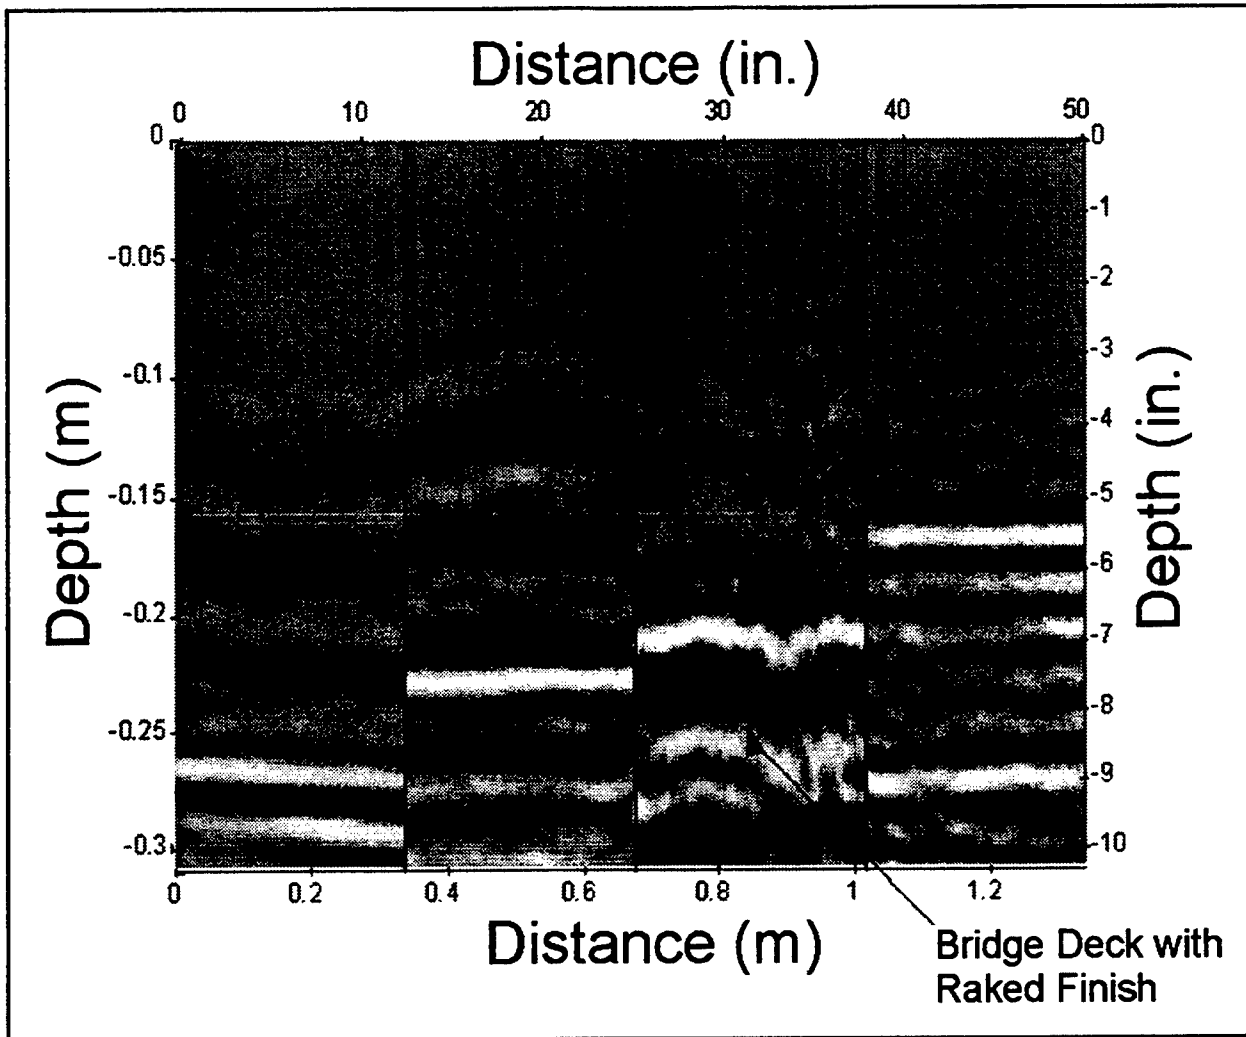
Figure 27. B-scan sections showing backwall reflections from concrete slabs of various thickness

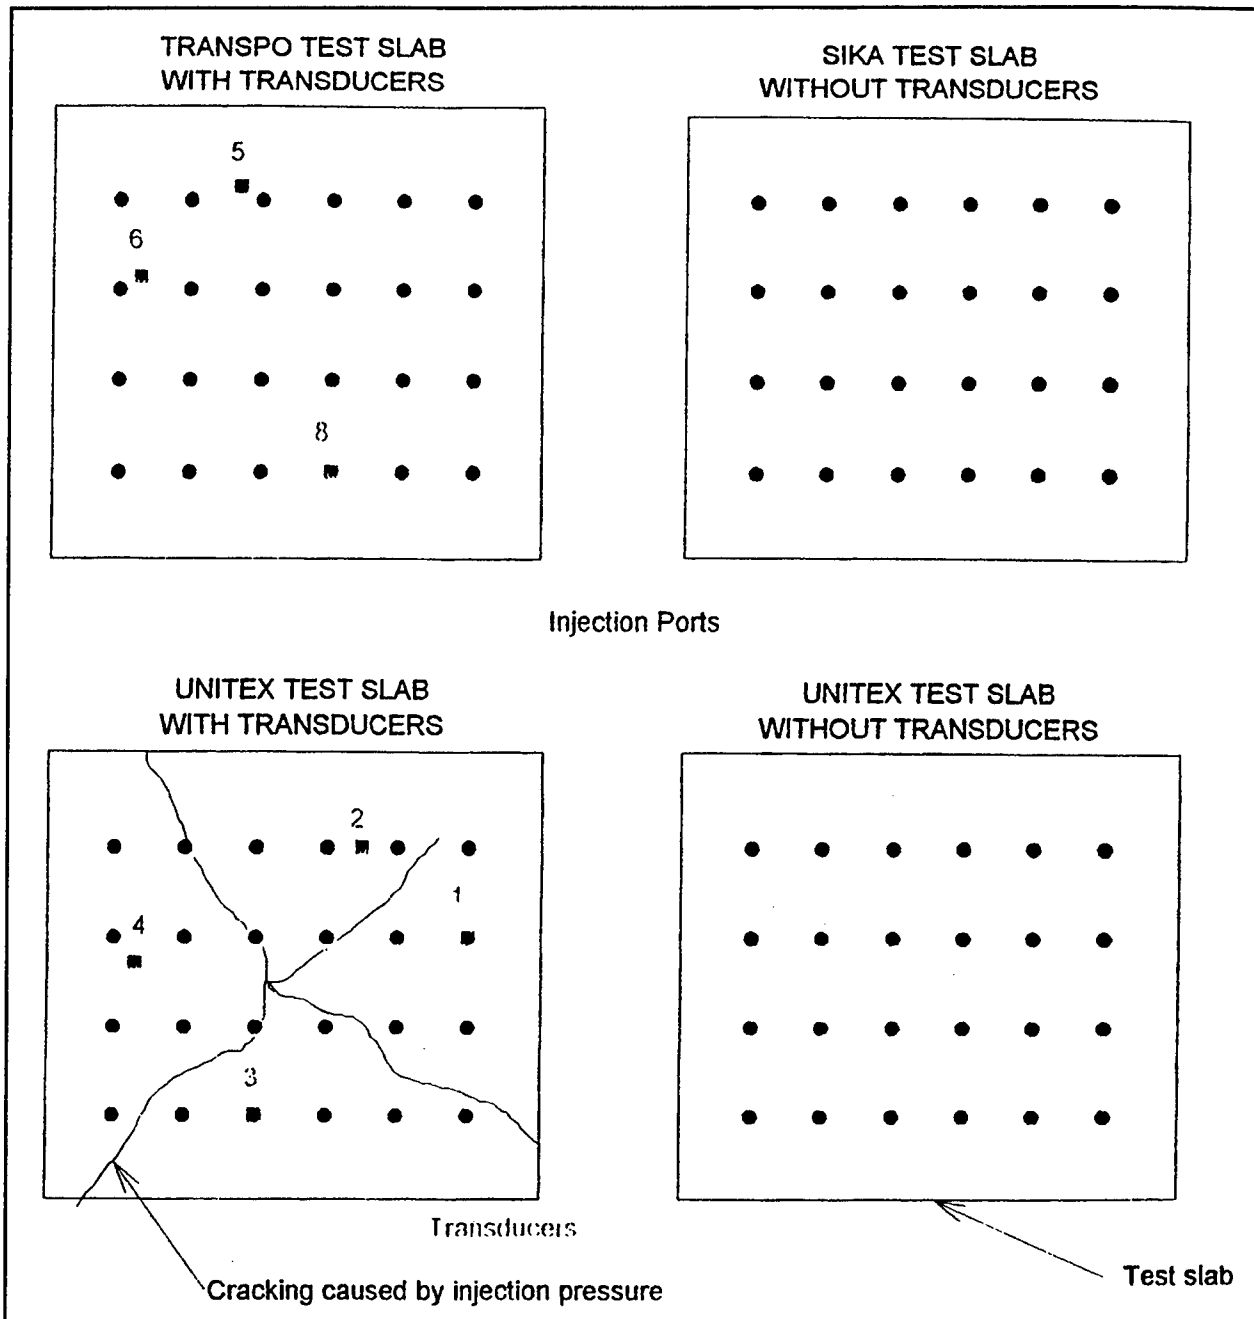
Figure 49. Test slab configuration

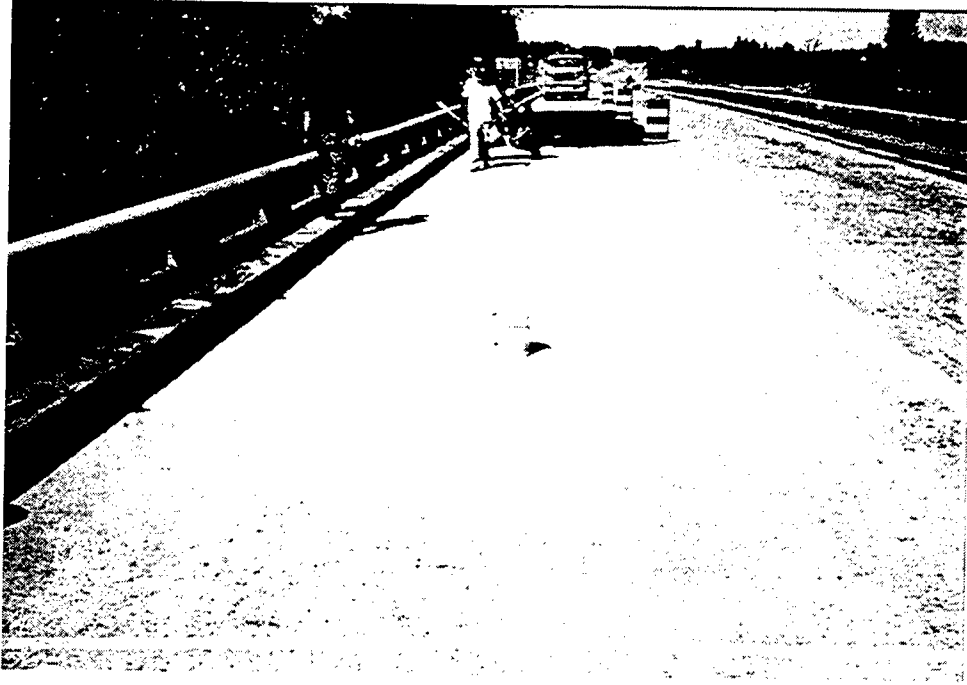
Figure 62. Bridge surface after sand blasting

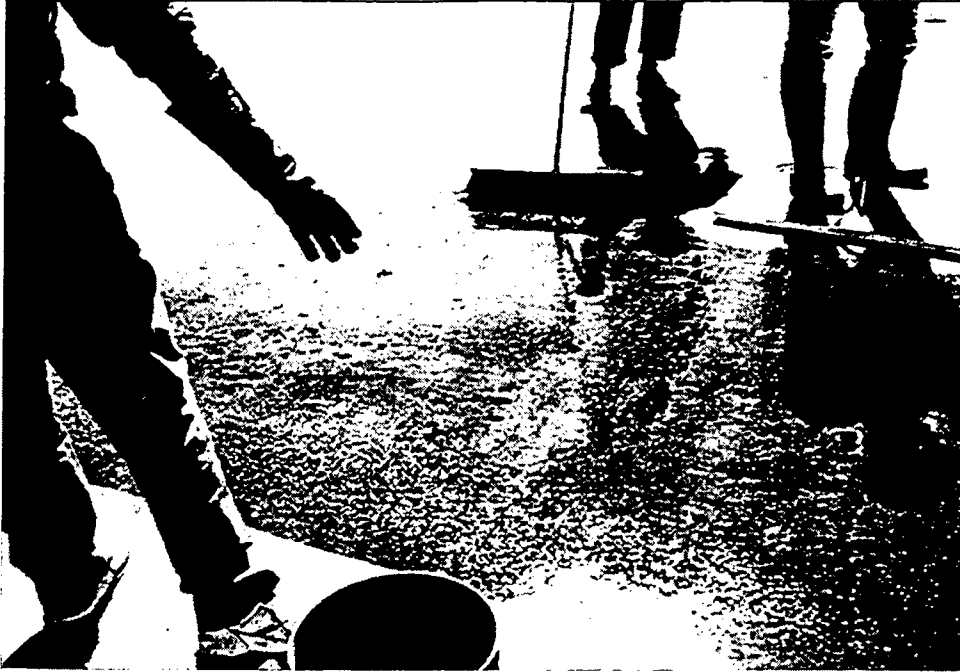
Figure 67. Material placement for Category-II overlay

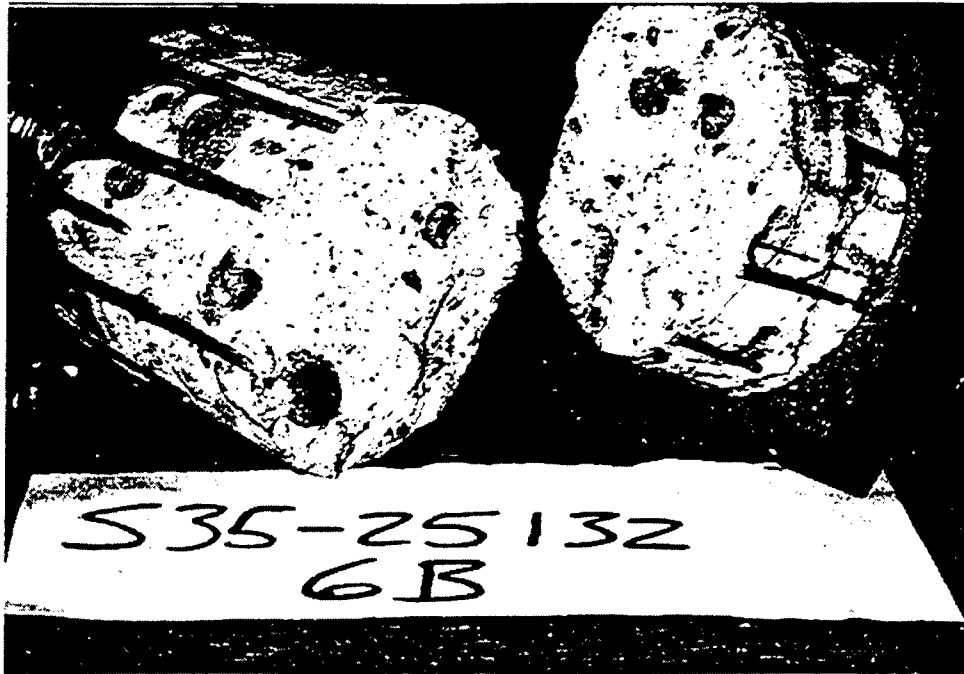
Figure 75. Specimen after tensile testing

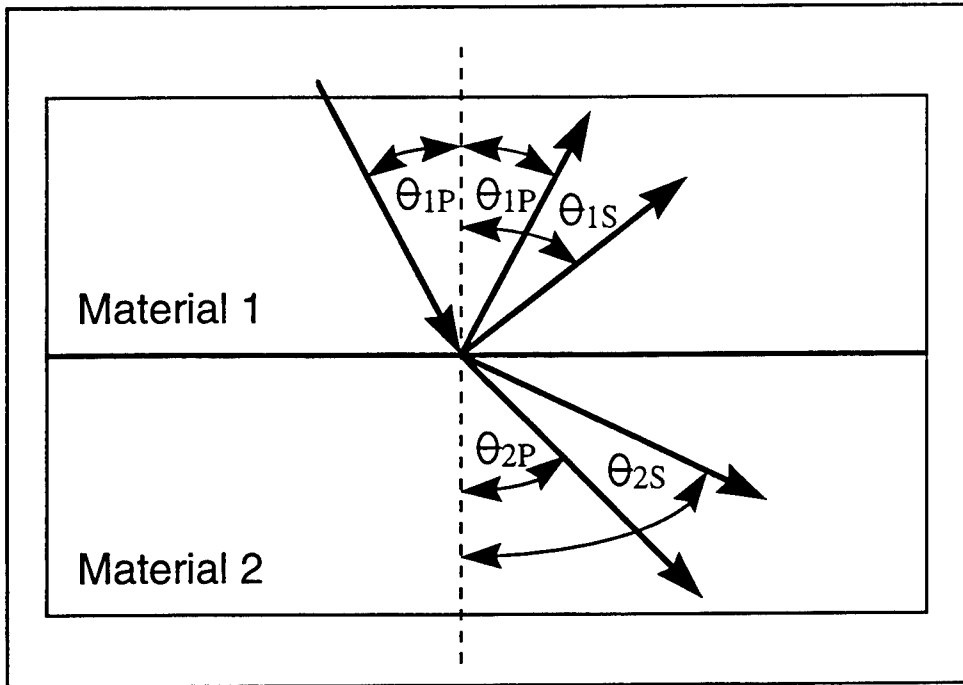
Figure E1. Mode conversion of incident P-wave at the interface of two materials

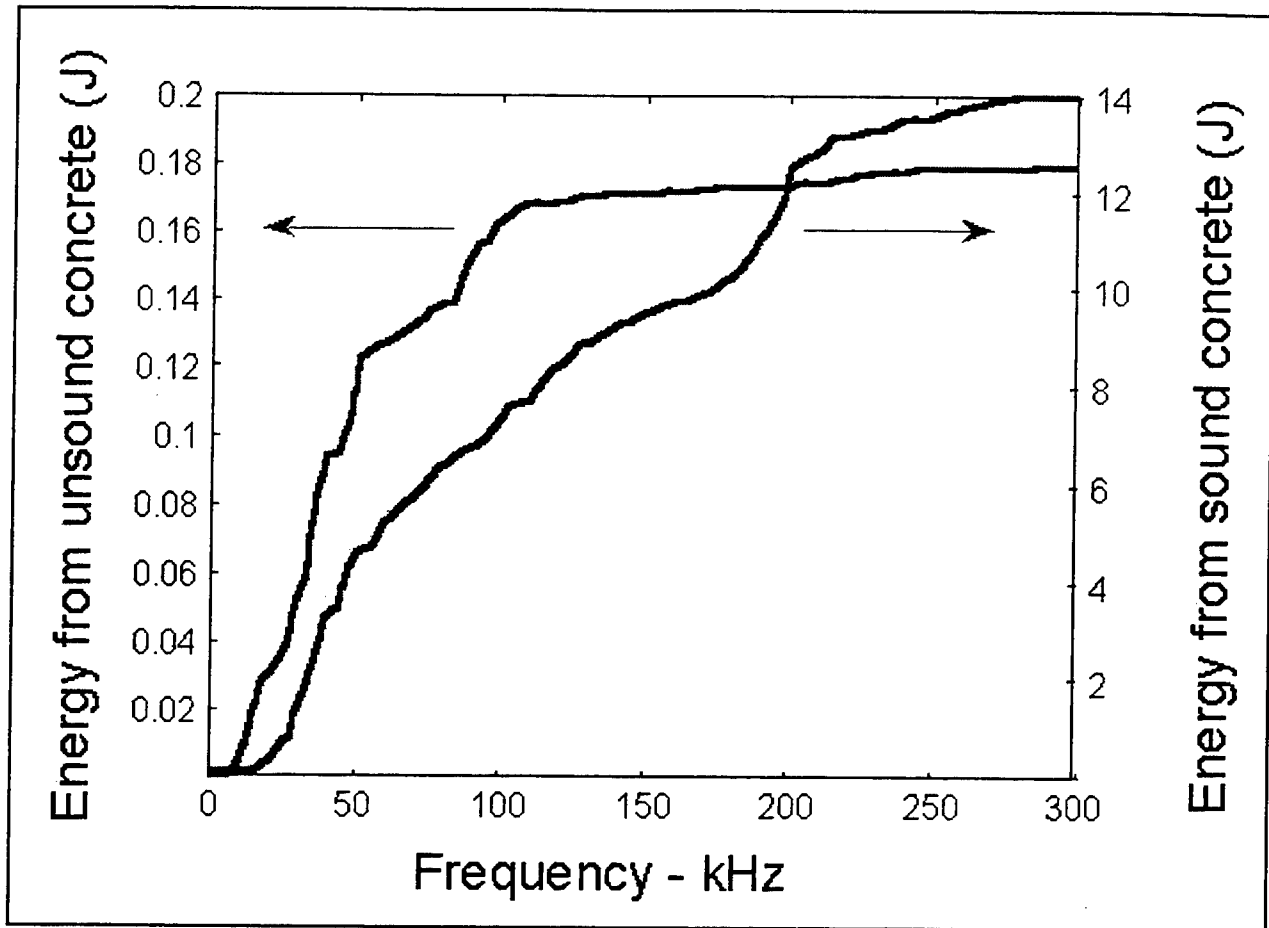
Figure H2. Two of the cumulative energy curves used as ANN inputs

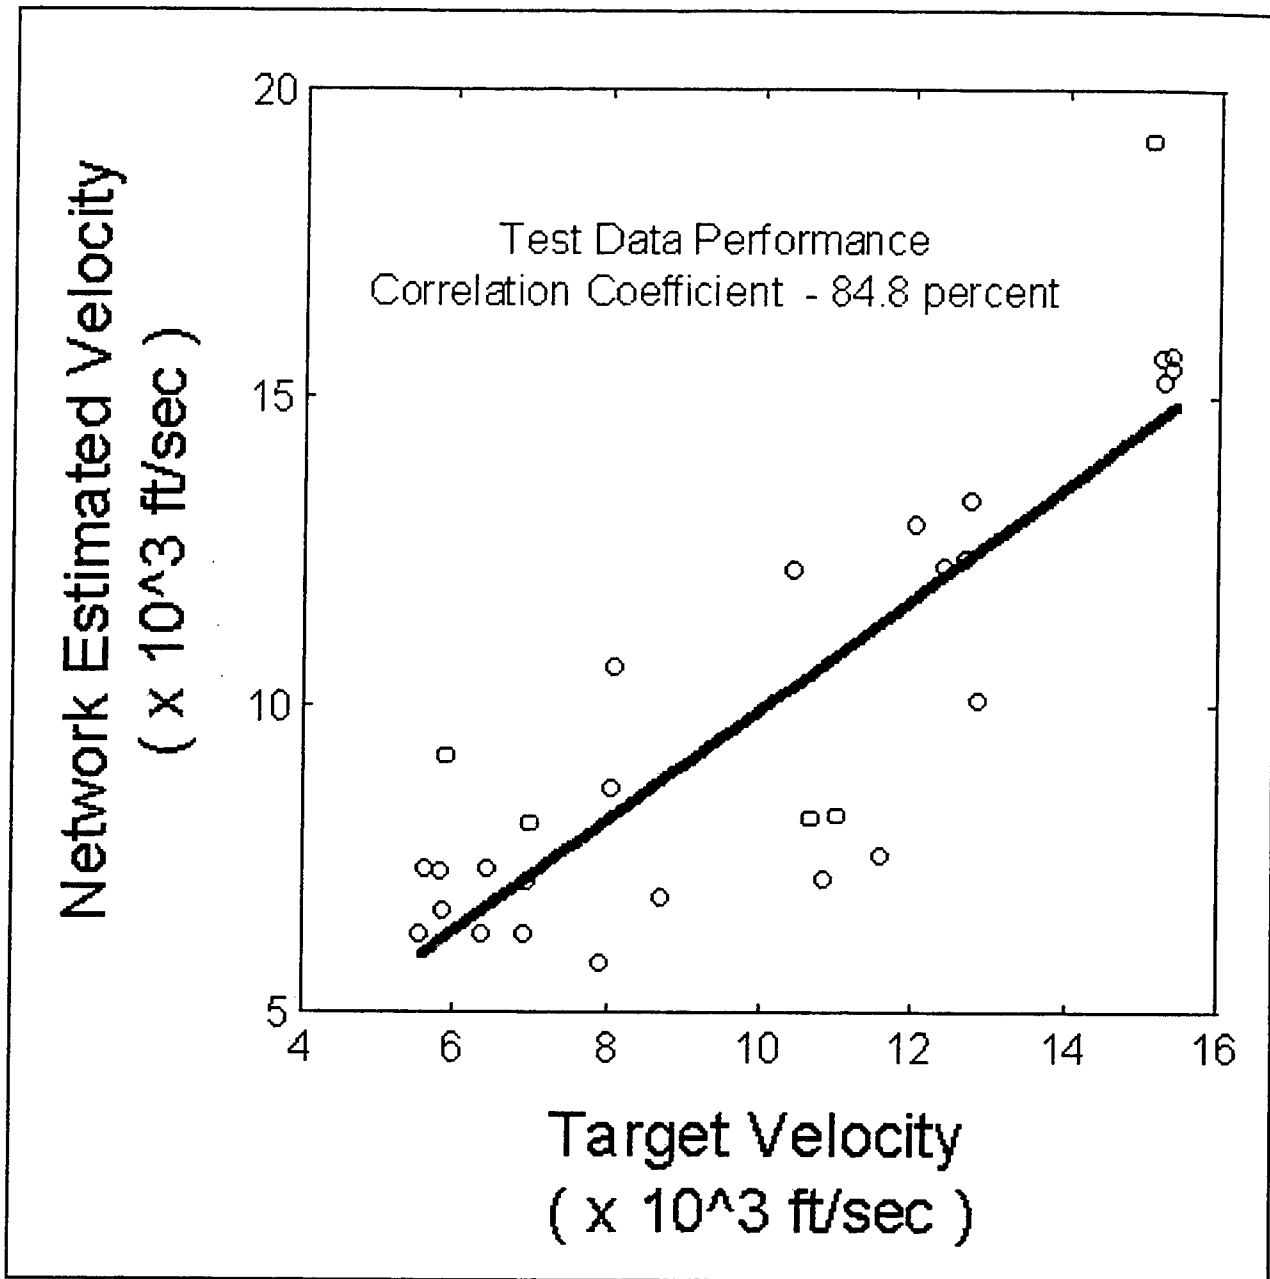
Figure H4. ANN performance on untrained test data, in characterizing ultrasonic velocity on microcracked concrete

measured (target) UPVs. The correlation coefficient was 84.8 percent. See Figure H4. The system was able to rank all six specimens in the correct order of deterioration. This investigation demonstrated that the automated interpretation of UPE signals for continuous interfaces by ANNs is feasible.

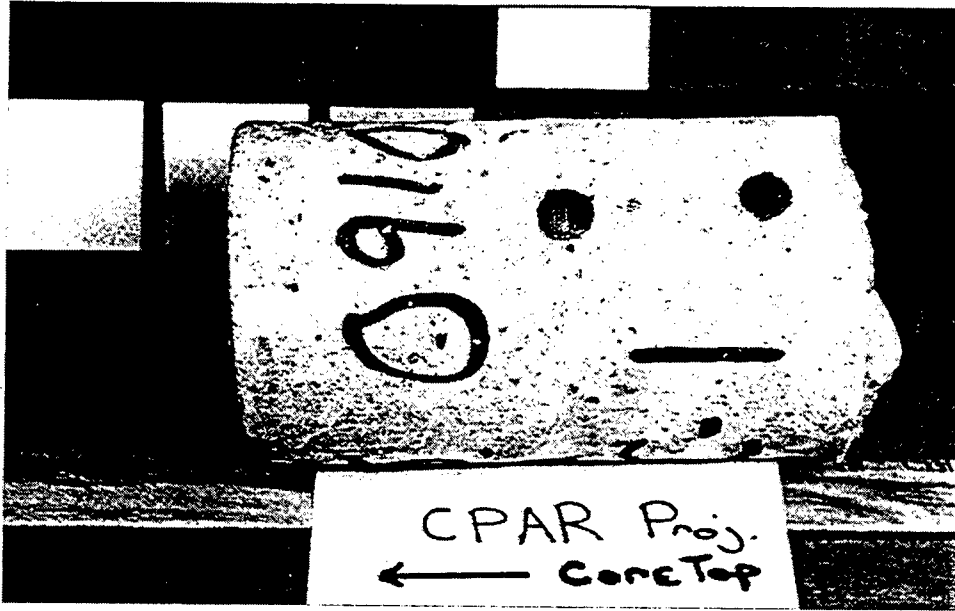
Figure J1. Core Sample No. S05-09101-C-1. Profile view of 4-in.-diam bridge deck core showing overall size, condition, and presence of steel reinforcement (two circular objects imbedded in the concrete)
