RTO MEETING PROCEEDINGS 10

## Airframe Inspection Reliability under Field/Depot Conditions

*Papers presented at the Workshop of the RTO Applied Vehicle Technology Panel (AVT)  
(organised by the former AGARD Structures and Materials Panel) held at Quartier Reine  
Elisabeth, Etat-Major de la Force Aérienne, Brussels, Belgium, 13-14 May 1998.*

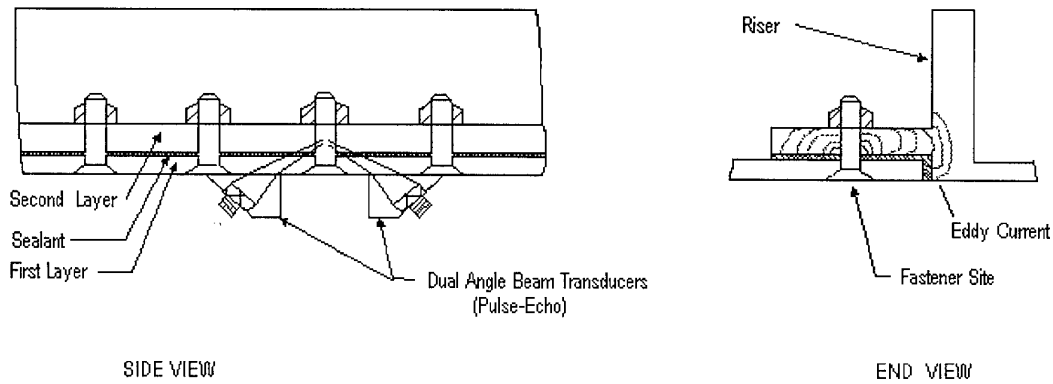
**Figure 1 Splice-Joint Configuration.**

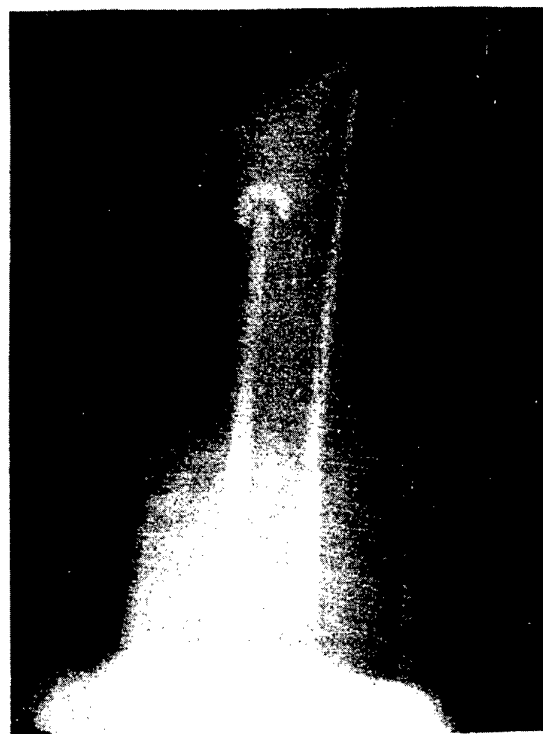
Fig. 5. Radiographic image of mottling of the gas turbine blade, with the exposure conditions: 155 kV, 1.0 mA, D7 film, 0.02 Pb screens, FFD: 360 mm, a (focus-specimen distance): 140 mm.
