Laboratory Investigation of Methods to Reduce Channel Degradation

MRD Hydraulic Laboratory Series Report No. 17

Mead Hydraulic Laboratory
Mead, Nebraska

September 1984

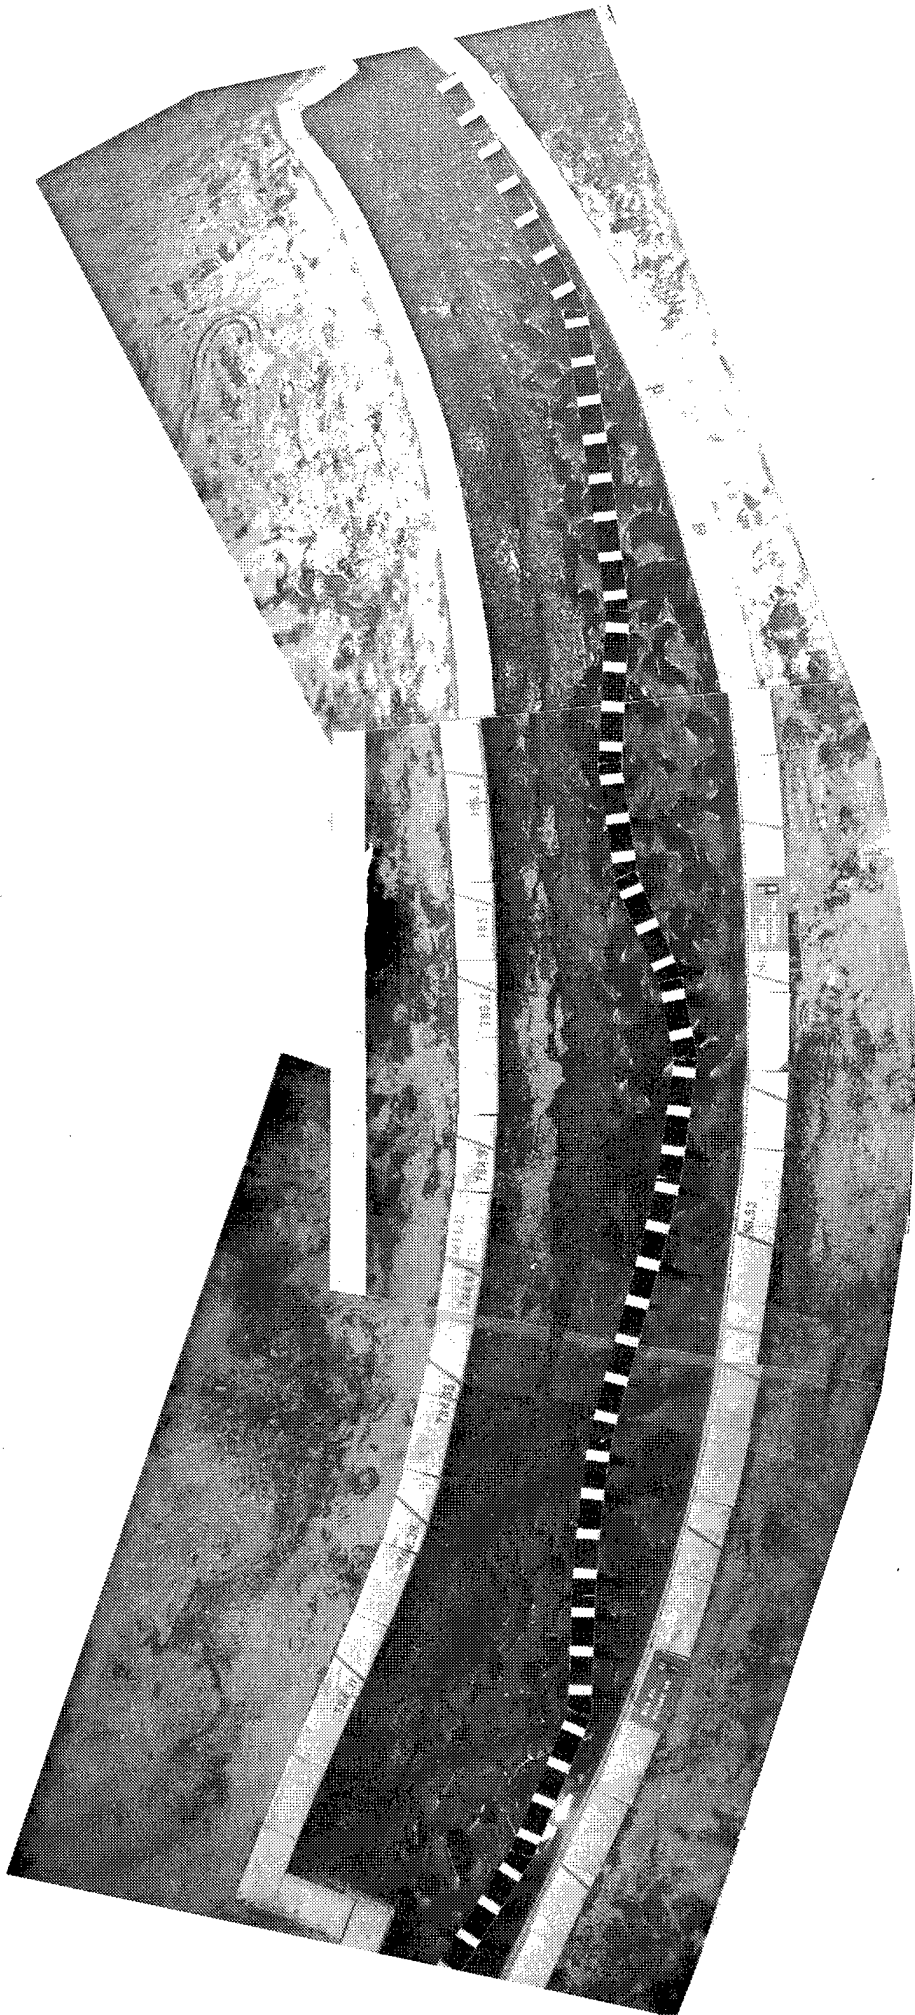
9. Overhead view of Browers Bend at end of Run 21 in which all dike structures had been removed. Flow was from right to left in photo. Note tendency of flow to meander in downstream half of bend as a result of dikes being removed.

- 9 Overhead view of Browers Bend at end of Run 21 in which all dike structures had been removed. Flow was from right to left in photo. Note tendency of flow to meander in downstream half of bend as a result of dikes being removed.

17. Depth Comparisons. Comparing the information from Table I to the data in Figure 1, Plate 3, it may be determined that the observed depths in most of the runs with grade control sills were within the ± 10 percent envelope. However, Run 44 falls just inside of the +10 percent envelope while Run 45 is outside of the +10 percent envelope. Both of these runs not only had grade control sills, but also included shortening of the dikes and removal of some river training structures. By contrast in Run 47, which did not include shortening of the dikes, the observed depth is in the -10 percent envelope. This would seem to indicate that the significant factors influencing depths in these runs were the increase in the effective width and the grade control sills. It may further be deduced that an increase in width produced a decrease in depth, while the grade control sills caused a slight increase in the depth. It would also indicate that the increase in width and not the removal of the training structures in Runs 22-25 was the significant factor causing the decrease in depth in these runs. In Runs 21-25 there was some loss of channel control although not as much as was expected. See Photo 9.
