**MRD HYDRAULIC LABORATORY SERIES  
REPORT NO. 9**

**LABORATORY INVESTIGATION OF  
EROSION CONTROL USING HARD POINTS**

**MEAD HYDRAULIC LABORATORY  
MEAD, NEBRASKA**

**U. S. ARMY ENGINEER DISTRICT, OMAHA  
MISSOURI RIVER DIVISION, OMAHA  
NOVEMBER 1977**

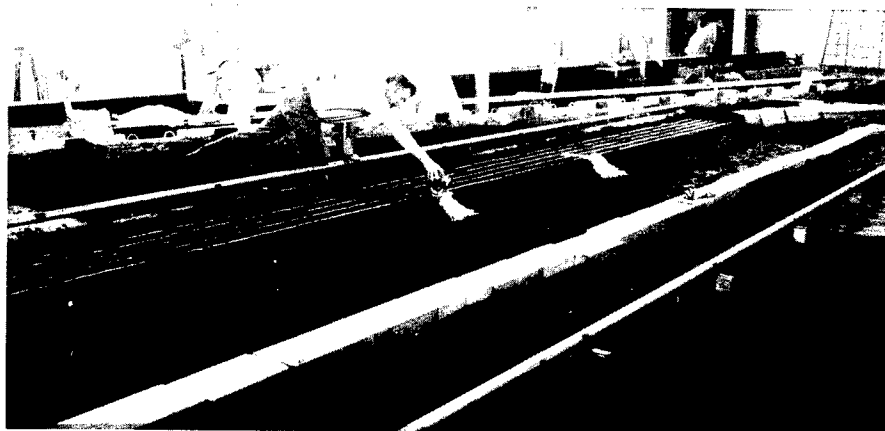
Picture 6: Placement of the rock used for the hard point structure formation.

After the channel bank was reformed, the selected hard point spacing interval was measured off and prepared for rock placement. Hard point structures require two types of rock placement, the root and the nose. A rectangular root trench was cut into the bank lines with the dimensions dictated by the preselected quantity of rock to be used. The trench was cut about a foot back and 0.2 foot deep and 0.4 foot wide. The trench was then filled with the specified quantity of rock per foot. The rock nose was formed by dumping the rock directly onto the channel bank and tied into the rock root. The process is shown in pictures 5 and 6. The gradation for the rock used in modeling the hard point structure was scaled down from the rock gradation currently being specified for hard points on the Missouri River. The gradation comparison is shown on plate 2.

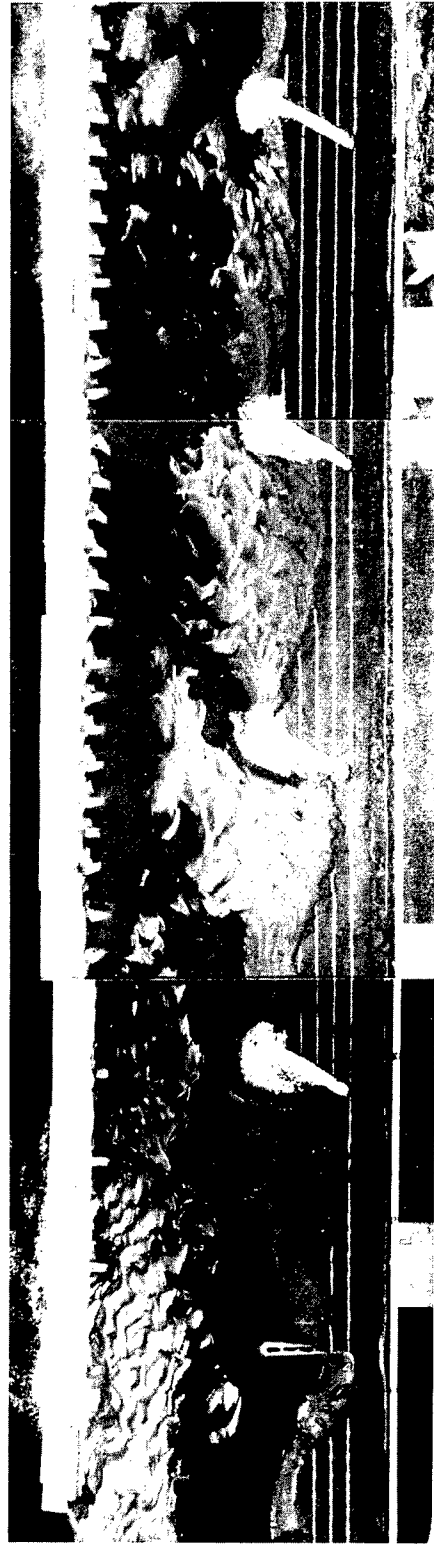
Picture 10: Development of erosion pattern with hard point root alignment at 30 degrees upstream from the perpendicular position. (Note the deterioration of the root.)

The effects on the erosion pattern resulting from root alignment changes were observed with a 7.5 foot spacing and alignment angles of  $60^{\circ}$  and  $30^{\circ}$ . The angles were measured upstream from a line perpendicular to the channel. The erosion patterns for the tests are shown on pictures 9, 10, and 11. A comparison of the pictures shows the erosion patterns to be essentially the same. However, the erosion in the  $60^{\circ}$  alignment is less than that for both the  $30^{\circ}$  and the perpendicular alignment. The reason for this is that in the  $60^{\circ}$  alignment much of the root is, in effect, used for bank erosion protection. Unless the root is designed for this windrow type of protection there is no need for, nor particular benefit from, angular root alignment to the channel.
