AFRL-ML-WP-TR-1999-4040

**TESTING OF AIRCRAFT RUNWAY
ICE CONTROL PRODUCTS**

MATERIALS COMPATIBILITY

**MATERIALS AND MANUFACTURING DIRECTORATE
AIR FORCE RESEARCH LABORATORY
AIR FORCE MATERIEL COMMAND
WRIGHT-PATTERSON AIR FORCE BASE OH 45433-7750**

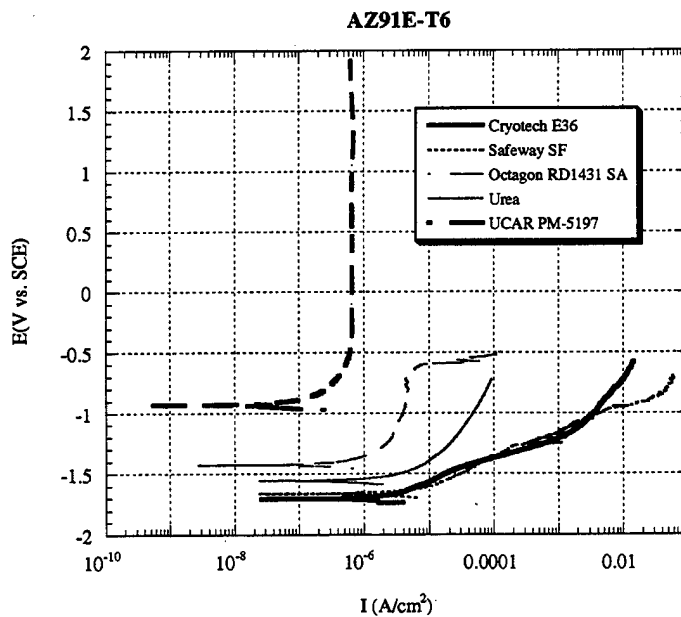
Figure 2. Potentiodynamic polarization curves of cast AZ91E-T6 in runway deicers. Urea was used as the control for the solid deicers, Safeway SF and Octagon RD1431 SA. Solid deicers were diluted with distilled water to 13 percent. UCAR was used as the liquid control.

Polarization curves of AZ91E, 7075 and 4140 in each of the deicers are shown in figures 2 through 4⁵. Predictions of corrosion behavior obtained from the polarization scans of AZ91E in the deicers correlate well with the corrosion observed on the alternately immersed coupons. For example, there was no passive region of AZ91E in Cryotech E36 or Safeway SF. The scans indicate active general corrosion, which was observed on the coupons from the immersion test. The slope of the curve for urea was greater, indicating less active corrosion compared to Cryotech E36 or Safeway SF, which is what was also observed on coupons. The curve of AZ91E in Octagon RD1431 SA showed passivation before breakdown at about -625 mV where pitting would be predicted to occur. A few pits were found on these coupons from the alternate immersion test. The UCAR deicer did not react with AZ91E. This inert behavior is predicted by the extremely large passive region of the polarization curve.

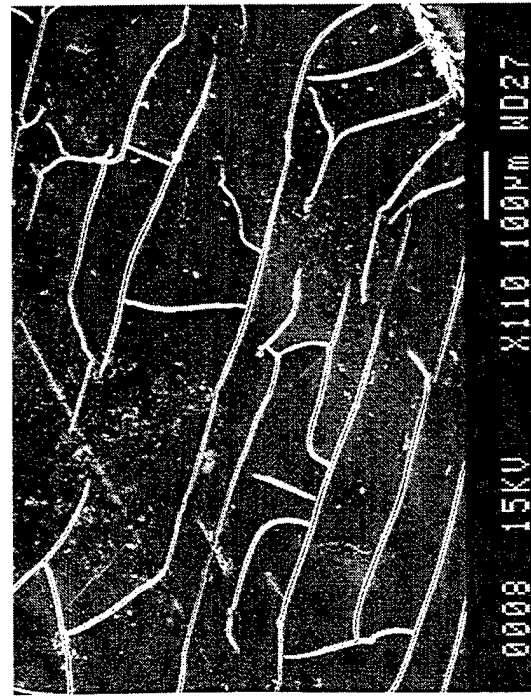
Figure 24. SEM photos of the IM7/5250-4 surfaces (A: tool side; B: bag side) exposed to the UREA deice fluid (sandwich corrosion). Cracking in the outer layer (surface) of the resin was observed.
