**DOT/FAA/AR-97/88**

# **Crack Growth-Based Predictive Methodology for the Maintenance of the Structural Integrity of Repaired and Nonrepaired Aging Engine Stationary Components**

April 1999

Final Report

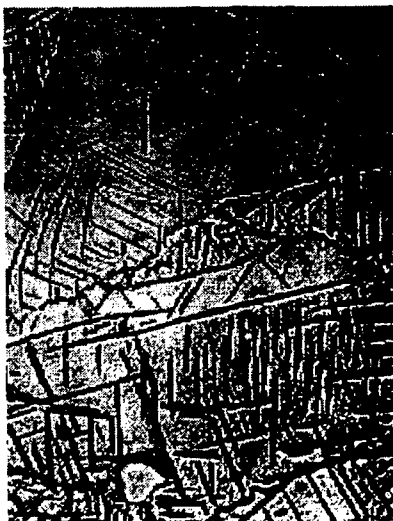
FIGURE 22. MICROSTRUCTURES FROM WROUGHT IN718 (NEW CF6-80 LPT CASE) EXPOSED TO STANDARD HEAT TREATMENT AND 30 SIMULATED REPAIR (1700°F) CYCLES AND CF6-6 COMPRESSOR REAR FRAME RETIRED AFTER SEVERAL YEARS SERVICE AND MULTIPLE REPAIR CYCLES

CF6-80 LPT Case (New)  
Standard H.T.

CF6-80 LPT Case (New)  
Standard H.T. +  
30 Repair (1700°F) Cycles

CF6-6 CRF (Field)  
Standard H.T. + Several Years  
Service and Multiple Repairs

Figure 23 shows the FCGR of cast+HIP IN718 in the unexposed, exposed, and in-service conditions. Data scatter was a problem with the cast material as the cracks propagate tortuously (e.g., accelerate/decelerate) through the coarse structure. FCGR data from the exposed new casing and the field casing follow a slightly steeper slope than the baseline data. This is similar to the wrought behavior except that the field case has a slower crack growth rate than the exposed material. The field case microstructure (figure 24) has very little delta precipitated into the matrix unlike the abundance of delta needles present in the new casting exposed to 30 simulated repairs.

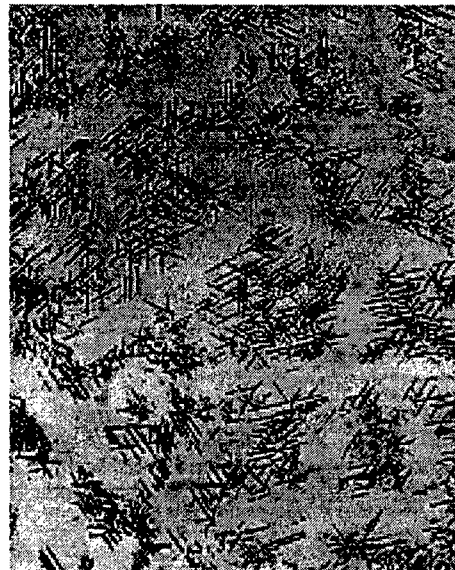
FIGURE 27. MICROSTRUCTURES FROM WROUGHT IN718 TUNGSTEN INERT GAS WELD HEAT AFFECTED ZONE EXPOSED TO STANDARD HEAT TREATMENT AND 30 SIMULATED REPAIR (1700°F) CYCLES

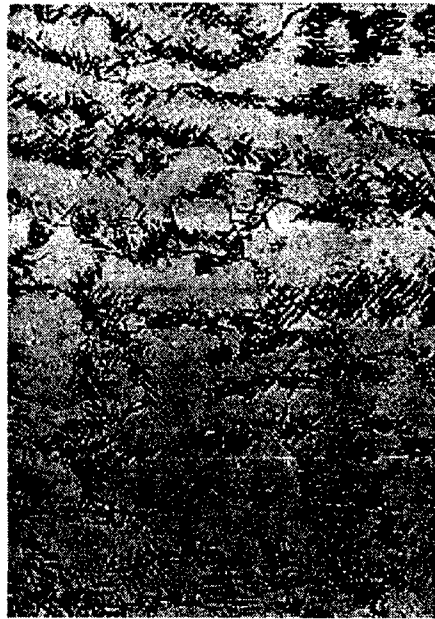
FIGURE 28. MICROSTRUCTURES FROM CAST+HIP IN718 TUNGSTEN INERT GAS WELD EXPOSED TO STANDARD HEAT TREATMENT AND 30 SIMULATED REPAIR (1700°F) CYCLES

Cast+HIP IN718 Weld  
Standard H.T.

Cast+HIP IN718 Weld  
Standard H.T. + 30 Repair (1700°F) Cycles

Multiple exposures were found to have little effect on the crack growth rate of TIG welds in either wrought or cast IN718 (figures 25 and 26). The fine dendritic structure of the weld shows precipitation of delta phase after the 30 simulated repairs (figures 27 and 28); however, it is not as extensive as shown in the exposed parent metal (figure 24).

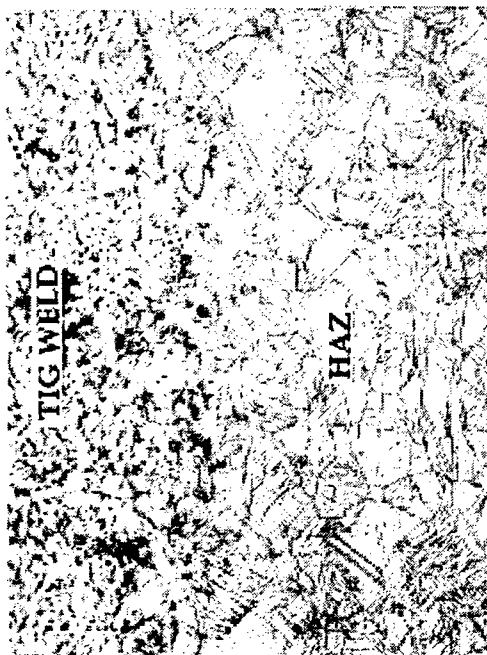
Wrought IN718 Weld HAZ  
Standard H.T. + 30 Repair (1700°F) Cycles

Crack growth rates in the weld heat affected zones (HAZ) were comparable to nonwelded baselines. However, the HAZ in both materials shows some crack growth rate acceleration after exposure to 30 thermal cycles. Results (figures 29 and 30) indicate a greater effect (i.e., faster acceleration) of the exposures in the cast HAZ than the wrought HAZ. However, the cast material tests again had a high degree of scatter which had to be edited over larger  $da/dn$  vs.  $\Delta K$  ranges in order to achieve a reasonable comparison. Extensive delta phase precipitated throughout the HAZ after exposure (figures 31 and 32).

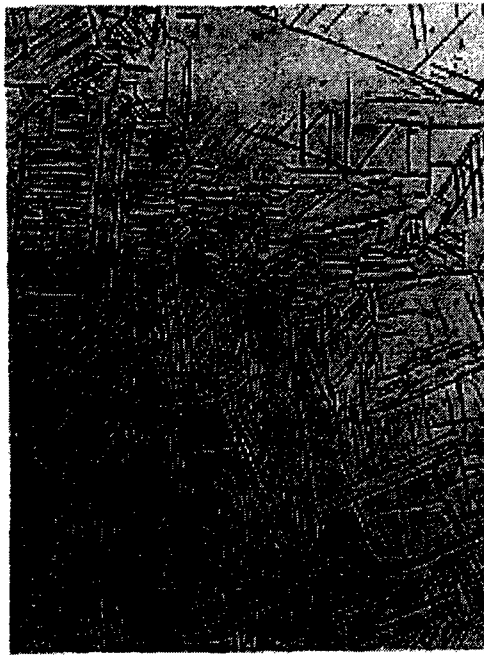
FIGURE 31. MICROSTRUCTURES FROM WROUGHT IN718 TUNGSTEN INERT GAS WELD HEAT AFFECTED ZONE EXPOSED TO STANDARD HEAT TREATMENT AND 30 SIMULATED REPAIR (1700°F) CYCLES

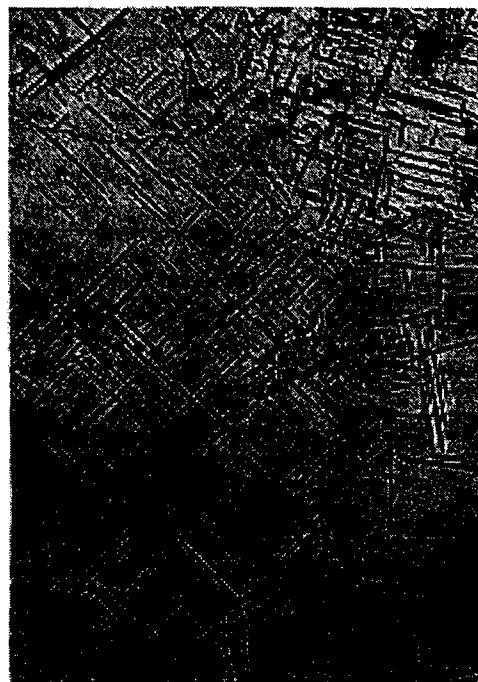
Cast+HIP IN718 Weld HAZ  
Standard H.T.

Cast+HIP IN718 Weld HAZ  
Standard H.T. + 30 Repair (1700°F) Cycles
